## Photographs

All photographs taken by City of Hamilton staff on March 13, 2024, unless otherwise noted.

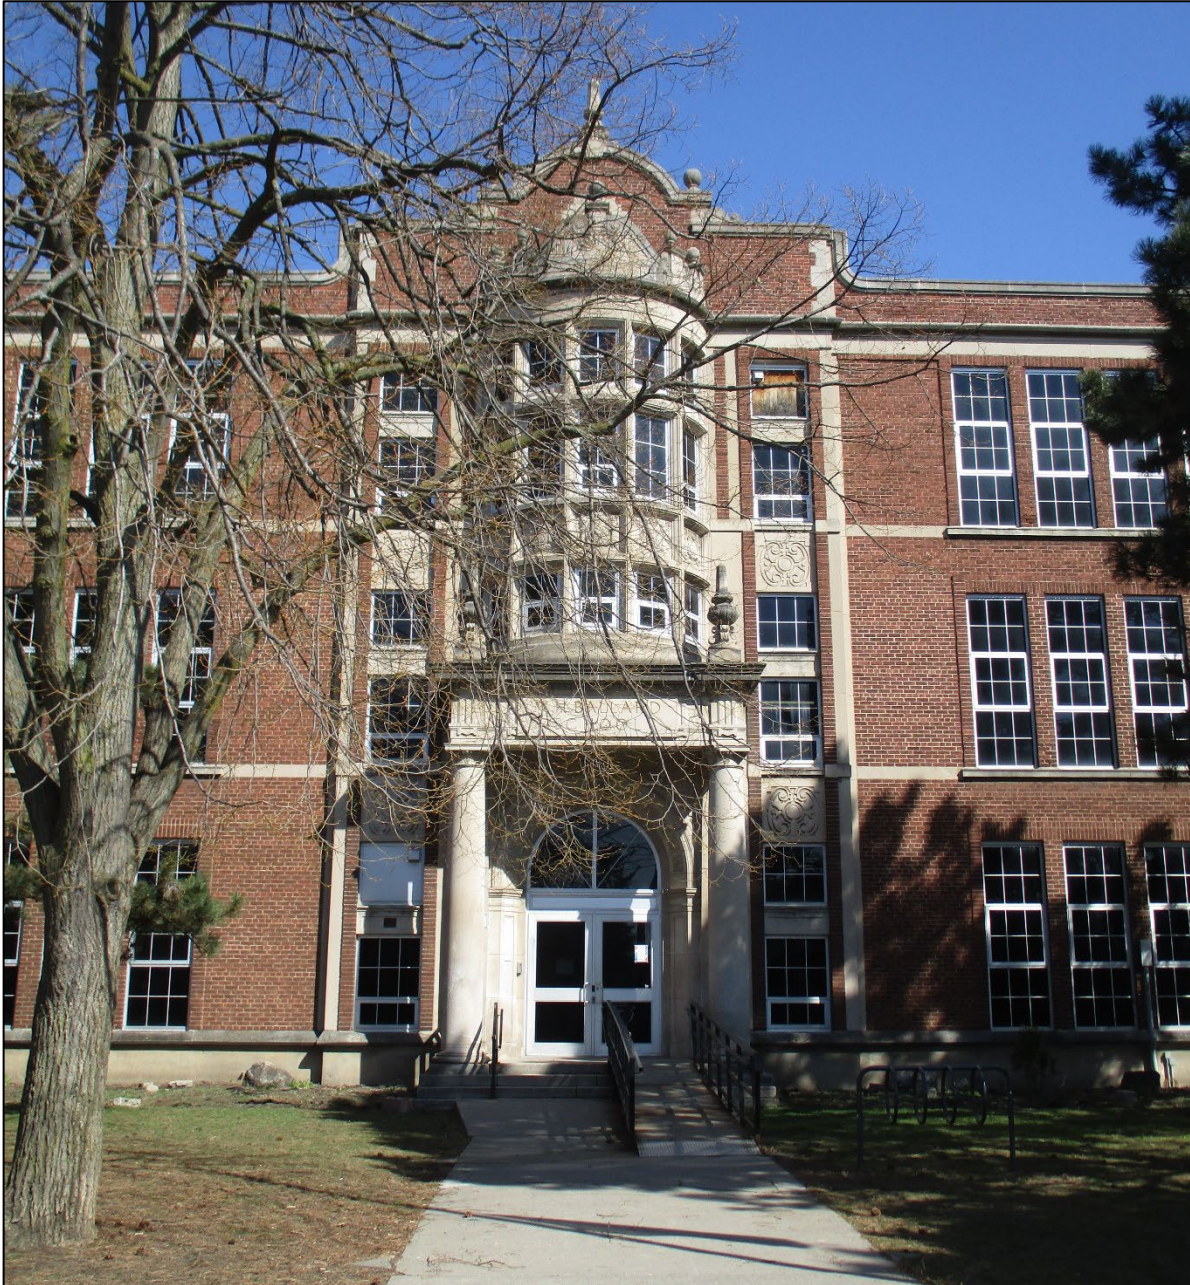
Figure 1: W.H. Ballard School, central front (south) elevation.

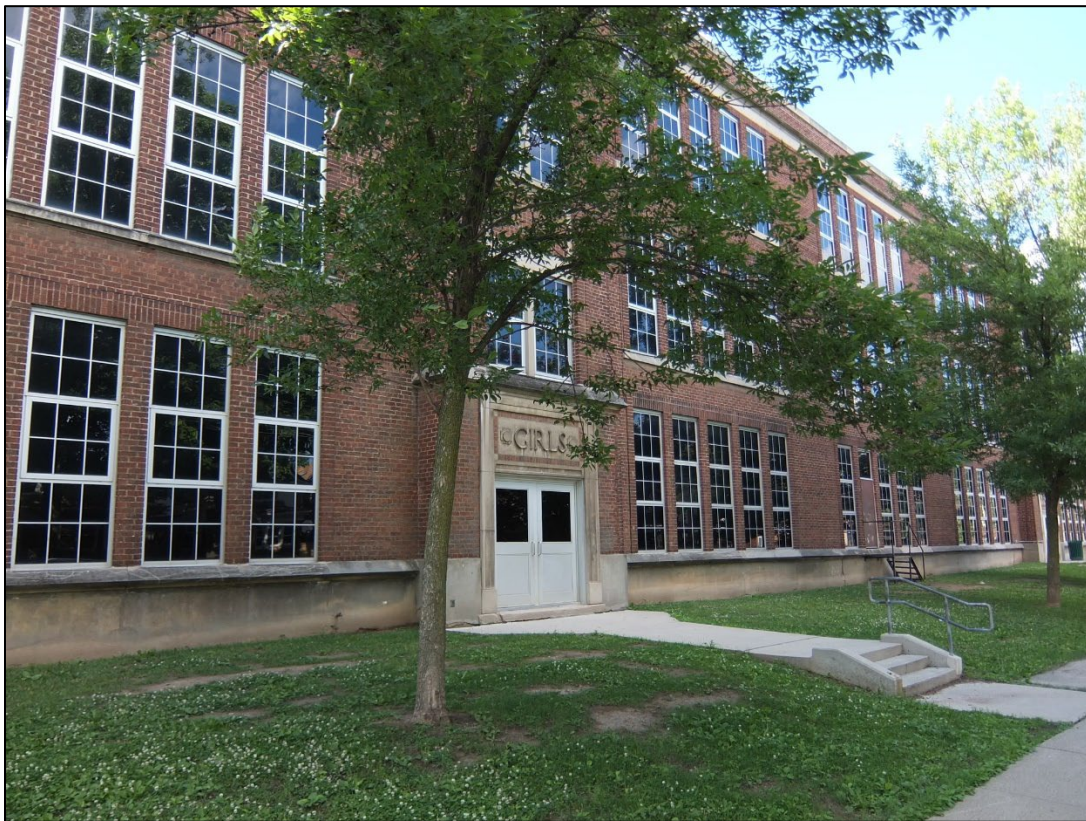
Figure 5: East elevation of subject property. City of Hamilton staff, July 9, 2014.

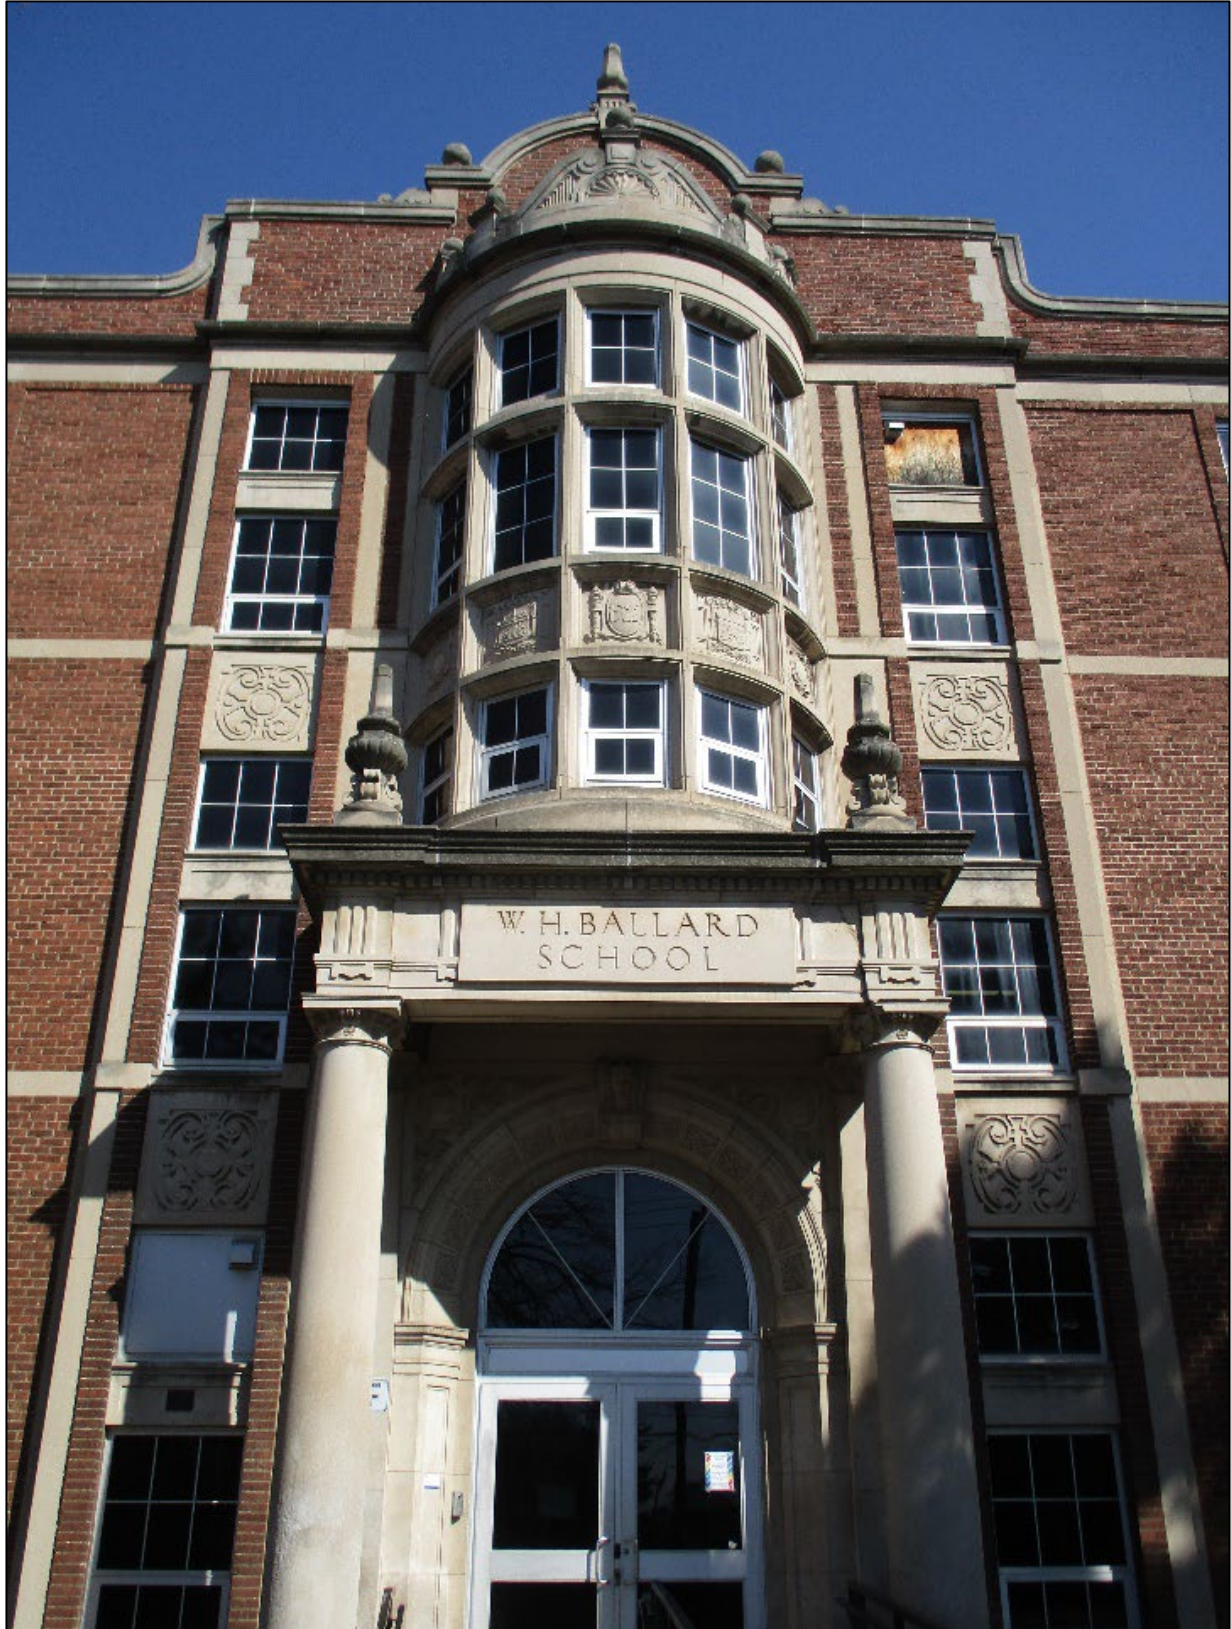
Figure 6: Detail view of front entrance.

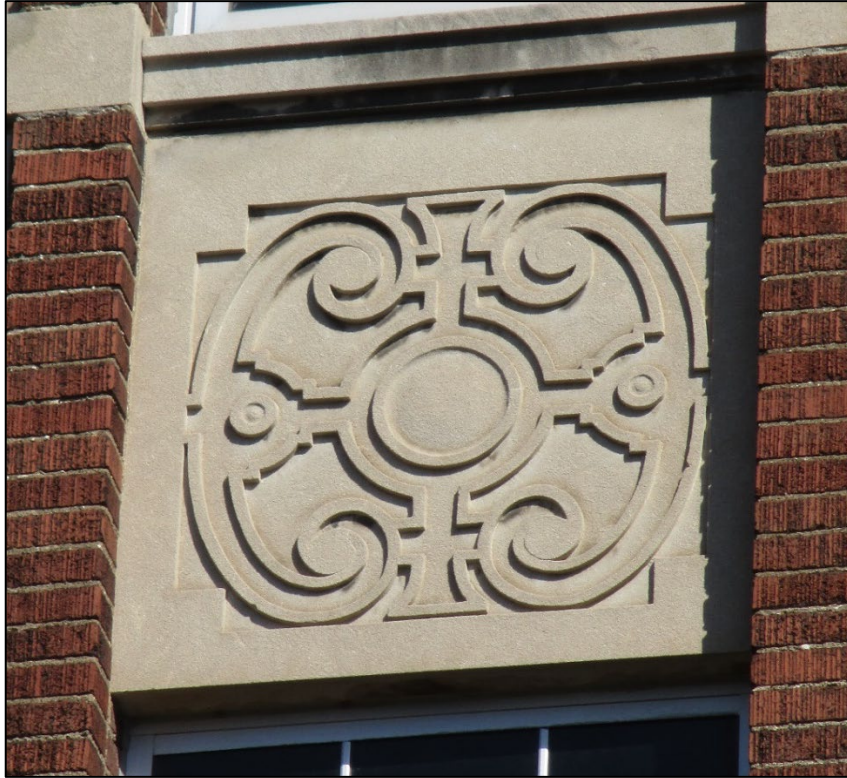
Figure 7: Detail view of stone decorative element.

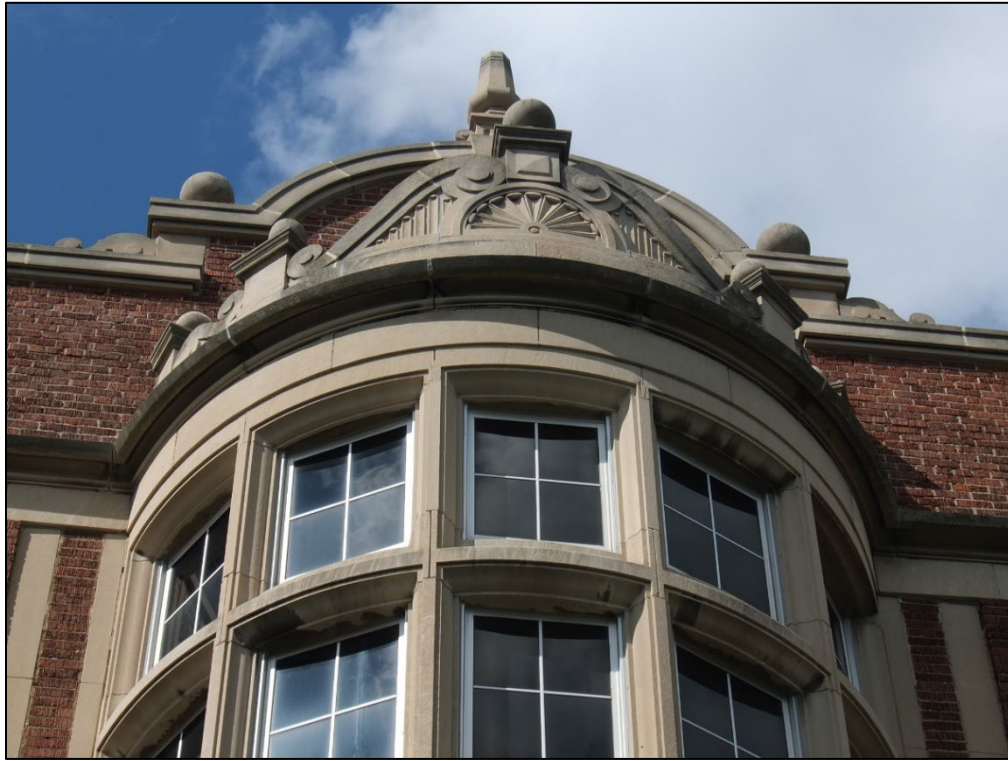
Figure 11: Detail view of parapet on circular bay. City of Hamilton staff, July 9, 2014.

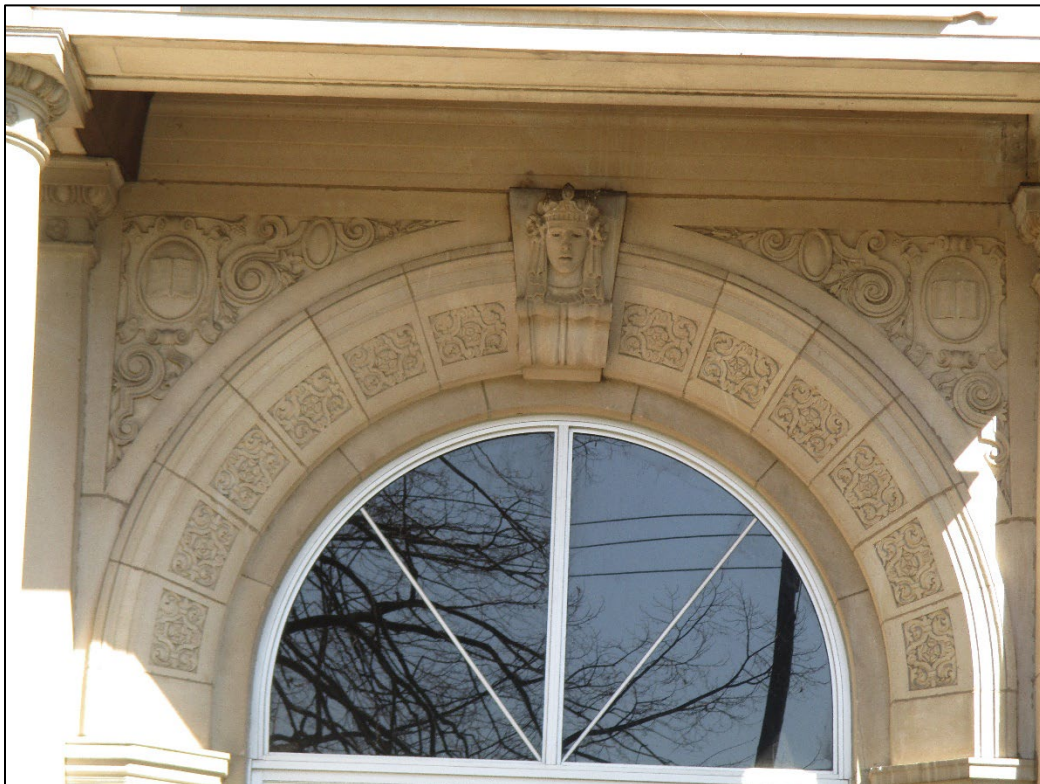
Figure 12: Detail view of decorative stone elements over main entrance doorway.

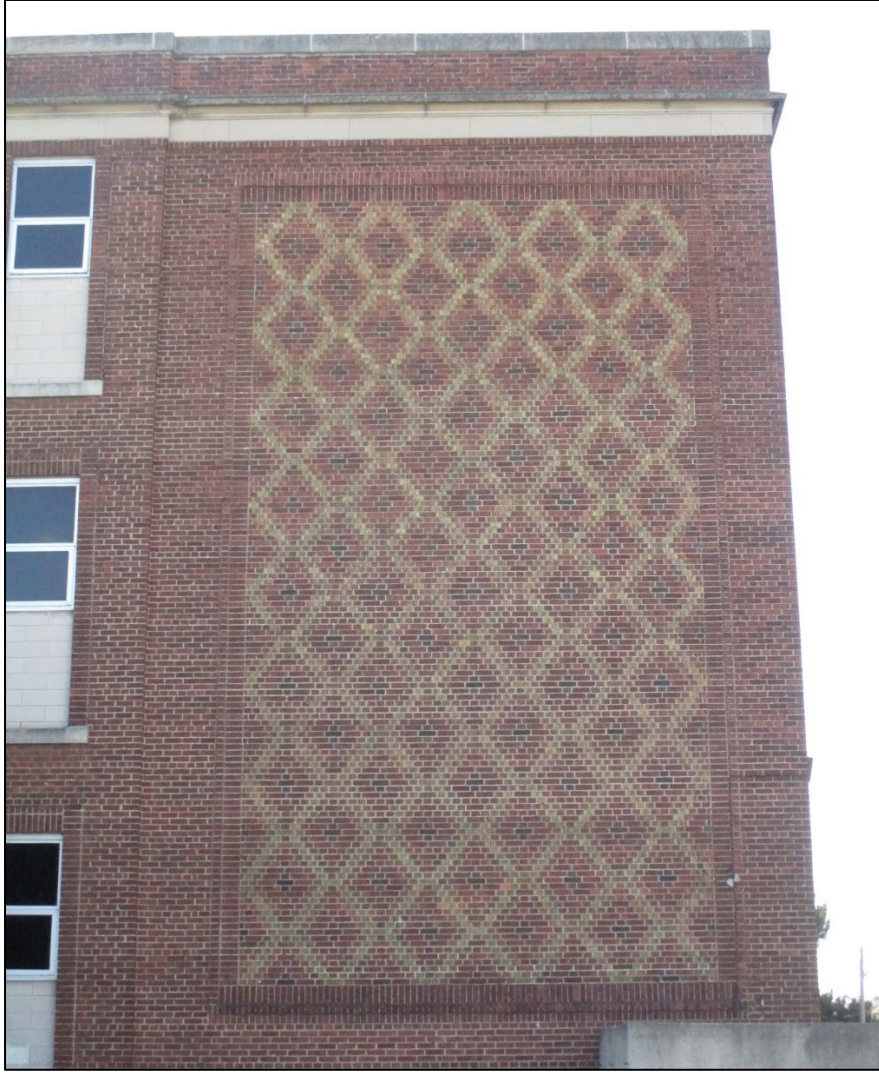
Figure 13: Representative brick panel detail, northwestern corner.

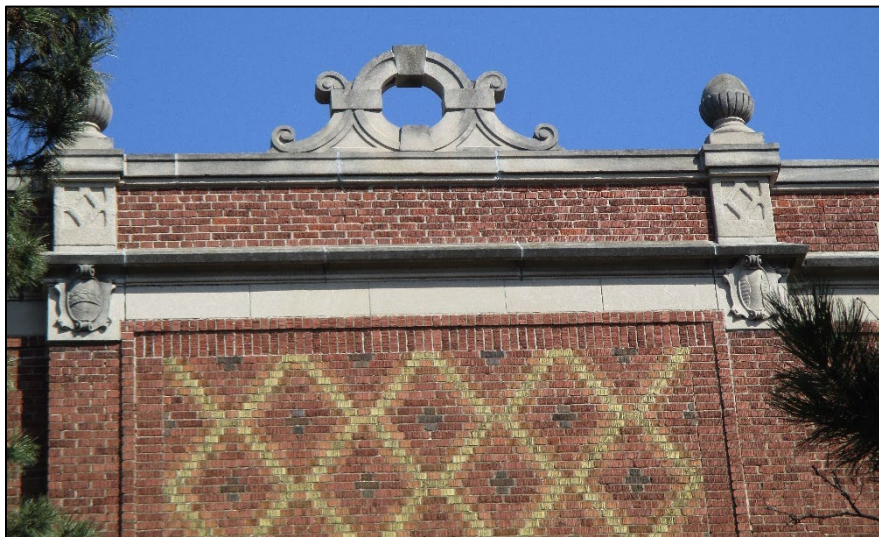
Figure 14: Detail view of decorative stone elements atop brick parapet.

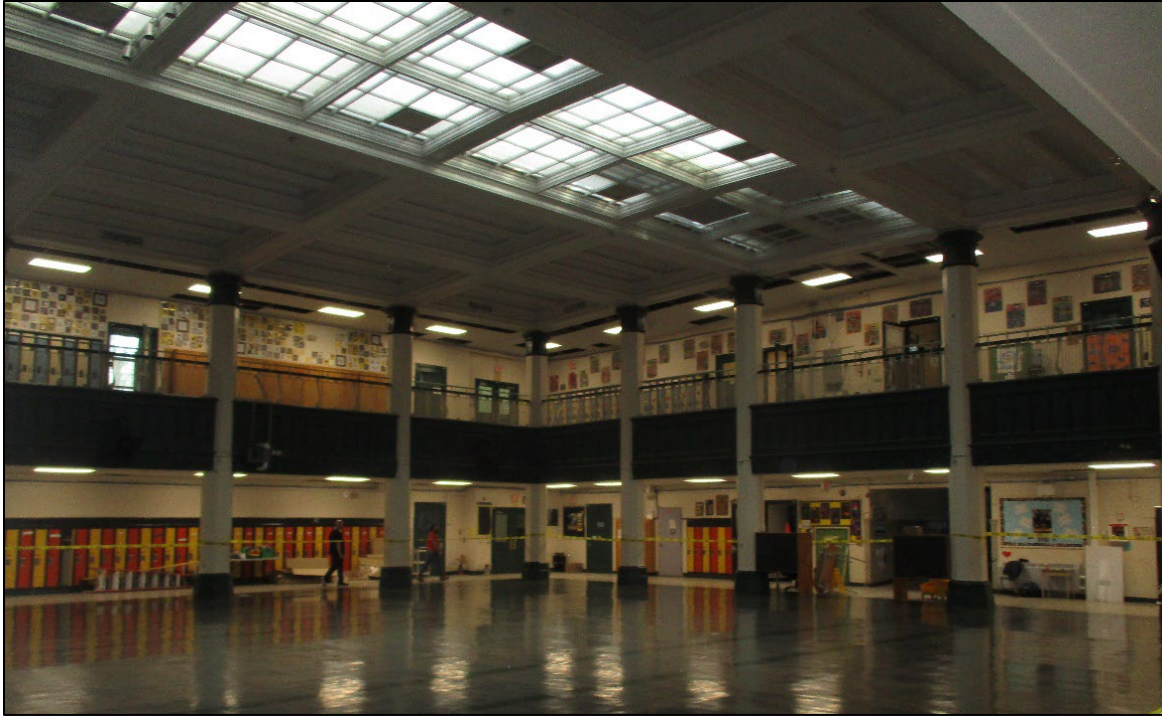
Figure 22: Central two-storey auditorium with skylight.

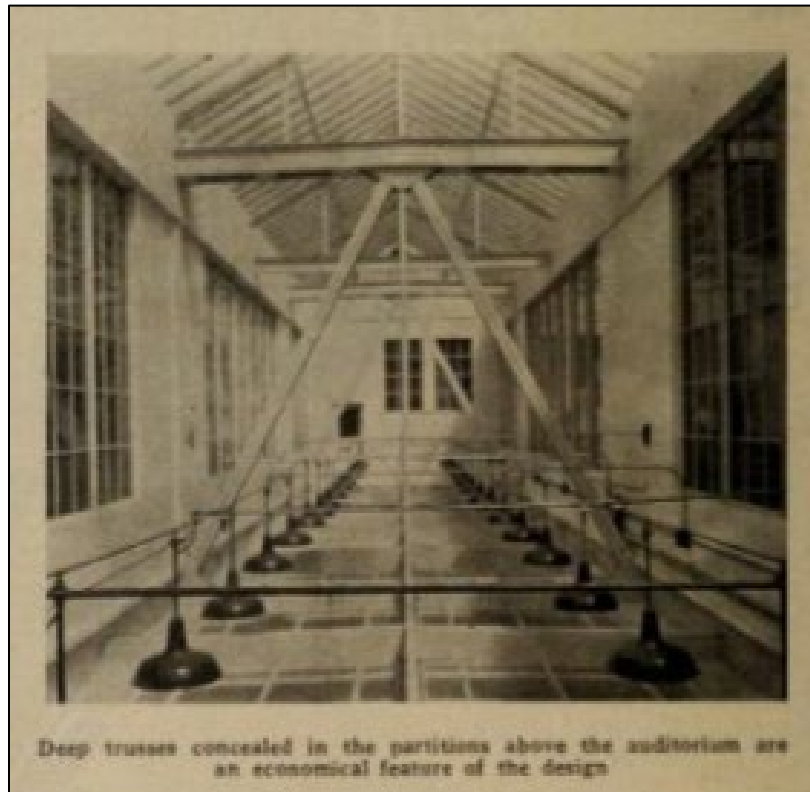
Deep trusses concealed in the partitions above the auditorium are an economical feature of the design

Figure 23: Covered light well and steel trusses supporting third storey classrooms, 1924  
(*Contract Record and Engineering Review*, December 1924)

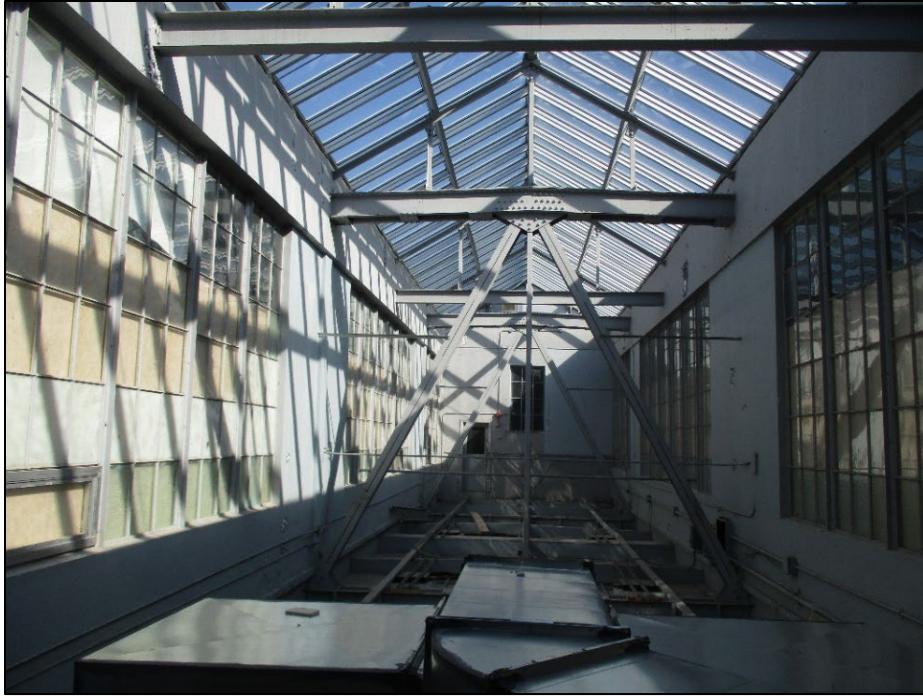
Figure 24: Covered light well and steel trusses supporting third storey classrooms.
