HERITAGE IMPACT ASSESSMENT

Proposed Security Upgrades at UFC Courthouse N05805

55 Main Street W
Hamilton, ON

Colliers Project# 1102792-274103
a+LiNK Project #: 2341
Final Report (R03): 2025-04-16

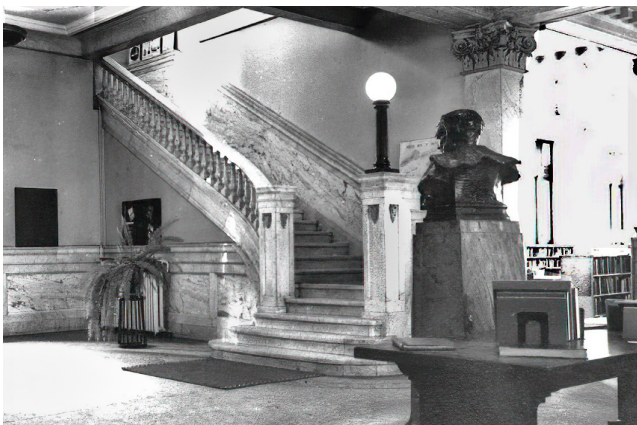
Image 3.9: Archive photo of Main Hall interior at east stair showing original floor which appears to be mosaic.

The floors at the Main Hall and Lobby are finished in a carrara marble tile which has a white body with grey veining. This flooring appears not to be original to the building and was more likely a part of a previous renovation, the marble selected to match the existing marble stairs, columns and pilasters. Historical images of the Main Hall appear to show a mosaic tile floor (refer to images #3.5 & 3.6 in Section 3.3).

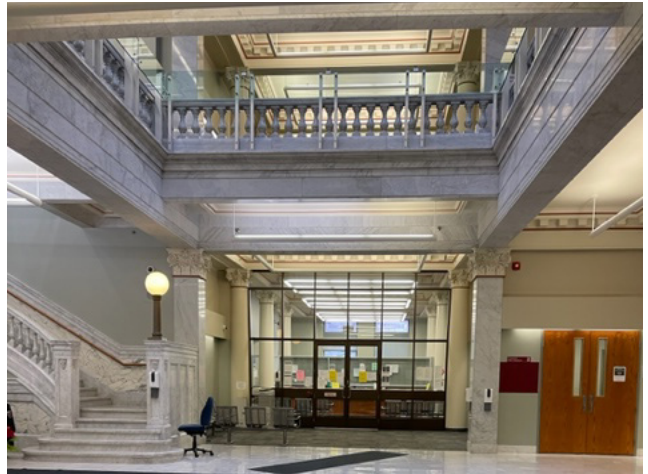
Image 3.7: Interior view of the Main Hall space with east stair and upper atrium with skylight.

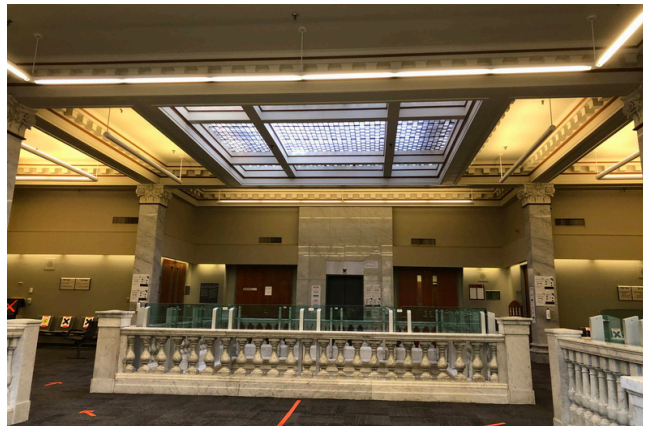
Image 3.8: Interior view of the heritage skylight above the central open space in the Main Hall.

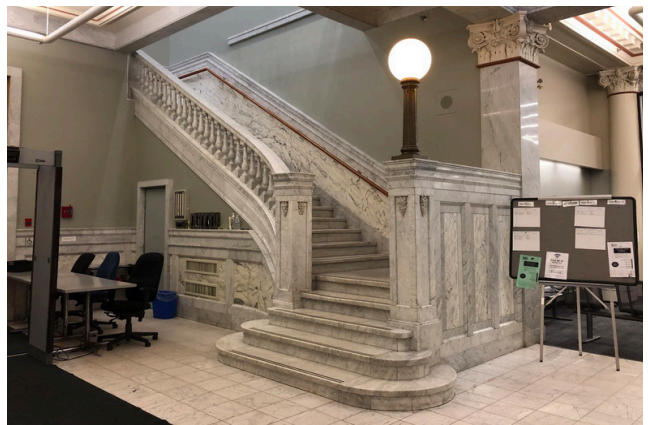
Image 3.10: Current view of east Heritage Stair in the Main Hall with existing 12"x12" marble tile flooring.

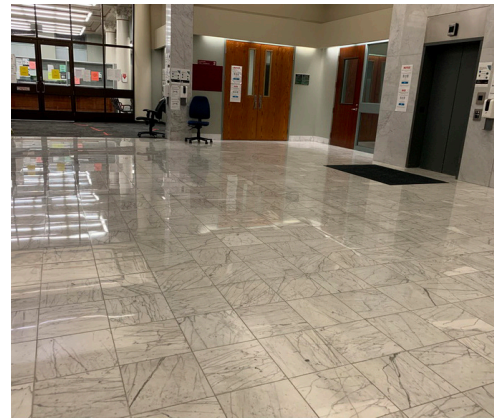
Image 3.11: Interior view of marble floors in the Main Hall

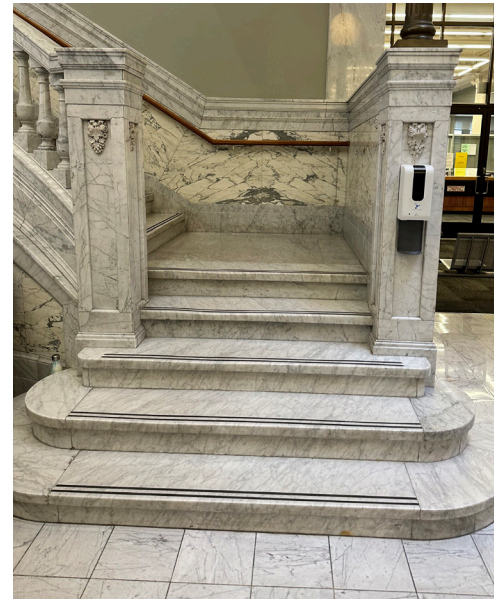
Image 3.12: Interior view of Heritage Stair (east).

Perhaps the most striking elements in this grand space are the two marble staircases which are located at the Lobby space and open to the Main Hall. These stairs provide access to the upper floor to a large atrium space open to below and skylight above, with courtrooms and offices beyond. The marble used for the treads, square newel posts, balusters and balustrades, base and trim banding at the wainscoting is a carrara marble with the inset marble panels of the wainscoting being of a calacatta marble, which has a more white base with dark grey/black veining. Some minor alterations have been made to the double staircases over the years, including the addition of anti-slip tape at the stair nosings and a hand sanitizer unit mounted on the east stair wall.

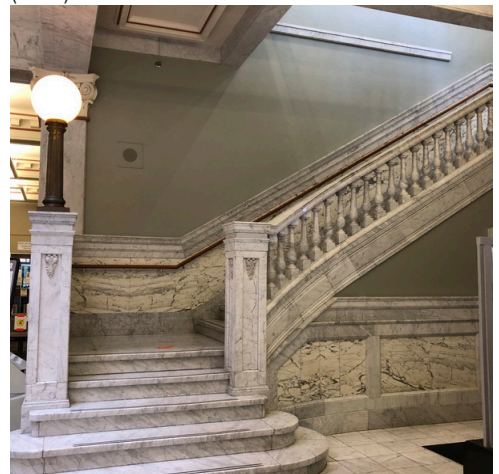
Image 3.13: Interior view of Heritage Stair (west).

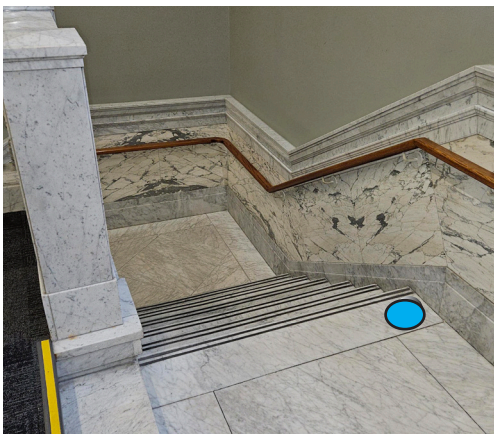
Image 4.5a: Proposed location of the new swing gate at the top of the west stair.

Additional security is provided via a turnstile swing gate that is located at the top and bottom of the west stair. The lower gate is to be located at the edge of the stair landing while the top gate is to be at the first tread at the top of the stair. These single-swing gates are required to restrict public access up these stairs from the Lobby while allowing exiting down through the stair in the case of an emergency. Due to the concern for possible damage to the existing marble staircase, several options were explored in order to minimize the number of penetrations through the marble. These are described in Section 5 of this report.
