INFORMATION REPORT

TO: Chair and Members Planning Committee	WARD(S) AFFECTED: WARD 5
COMMITTEE DATE: September 17, 2013	
SUBJECT/REPORT NO: 178 Hixon Road, Hamilton - Slope Stabilization (PED13157/PW13066) (Ward 5)	
SUBMITTED BY: Tim McCabe General Manager Planning and Economic Development Department Gerry Davis, CMA General Manager Public Works Department	PREPARED BY: Tony Sergi (905) 546-2424 Ext. 2744 Bryan Shynal (905) 546-2424 Ext. 4622
SIGNATURE:

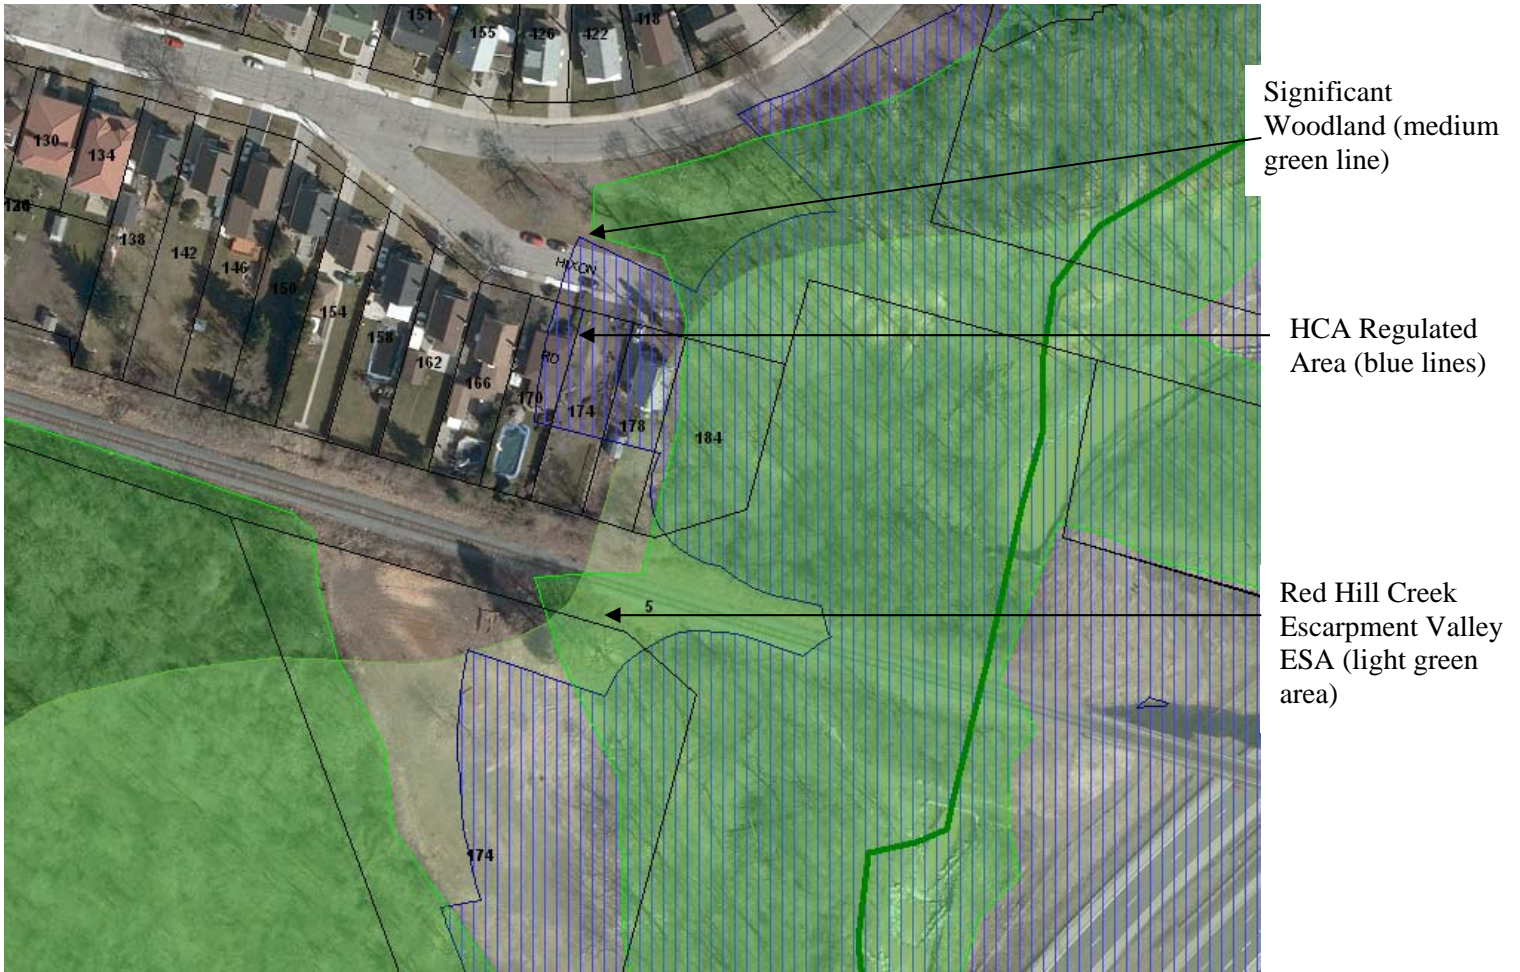
Appendix "A" – Detailed Environmentally Significant Area Map

178 Hixon Road, Hamilton

The subject property abuts City-owned lands which comprise, in part, the west slope of the Red Hill Valley. The slope is vegetated by a mature woodlot (see Appendix "A") and exhibits visible evidence of localized soil instability affecting the top of the bank and the abutting lands including visible cracks in the masonry foundation of the single-family dwelling on the property. The property owner has appealed to the City of Hamilton for assistance and, accordingly, this Report has been prepared.

The property is currently zoned for a single-family home. Staff consulted with the Hamilton Conservation Authority (HCA) regarding the development or home reconstruction options on 178 Hixon Road. The property in question is located within the HCA regulated area (see Appendix "A"). Any development of the lot would require a permit from the HCA. The exact requirement would depend on the type of development. New development would have to be located beyond stable slope line plus erosion access allowance. Typically a 6.0 metre setback would be required from stable top of bank. As the lot in question has dimensions of only 40 feet by 152 feet (approximately 12 metres by 46 metres), this would make it undevelopable or very restrictive. However, subject to appropriate studies including a geotechnical report on the Slope Stability and Environmental Impact Statement (EIS), the ultimate setbacks would be established as part of this review at site plan stage. It is estimated that following the site plan process, additional field surveying, an EIS geotechnical investigation could cost between \$15,000 to \$25,000. As the form of development and the full appreciation of the restricted access to evaluate the existing conditions is unknown, this cost could increase substantially.
