**CITY OF HAMILTON**

| <b>SUBJECT/REPORT NO:</b> Pedestrian Signal Program (TOE01010a) - (City Wide)<br>(Outstanding Business List) | |

## **Pedestrian Courtesy Crossing Pilot Project In the City of Kingston**

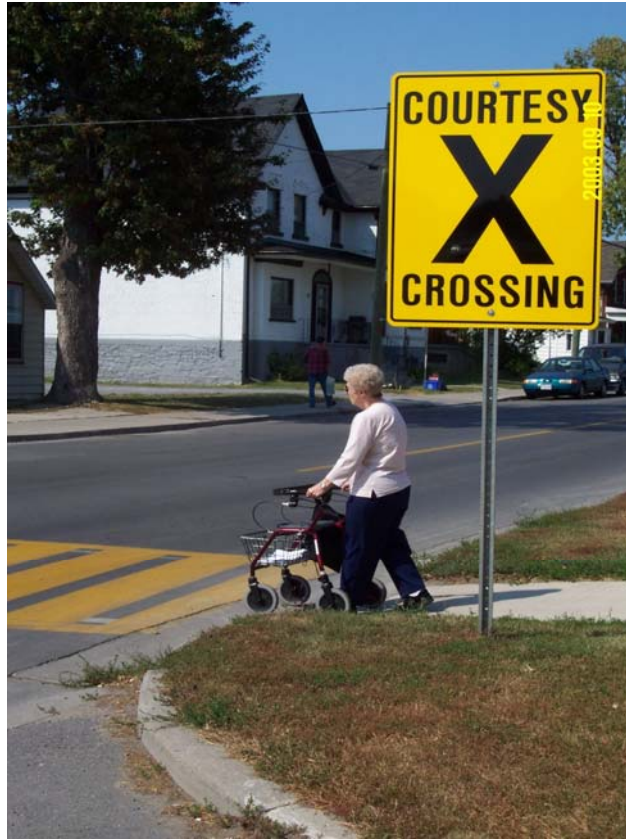
In June of 2003, in response to numerous requests for the City of Kingston to provide an improved pedestrian crossing adjacent to this seniors’ residence, the City installed a Courtesy Crossing as a pilot project. As shown in **Figure 1**, this Courtesy Crossing consisted of oversized (90 by 120 cm) fluorescent yellow warning signs that stated “COURTESY CROSSING” along with a large black X. Oversized advanced signage, illustrated in **Figure 2**, was also installed in order to warn motorists that a pedestrian crossing was ahead. Bright yellow ladder-type pavement markings were also installed to draw further attention to the crossing.

**Figure 1: Rideau Street – Courtesy Crossing Sign**

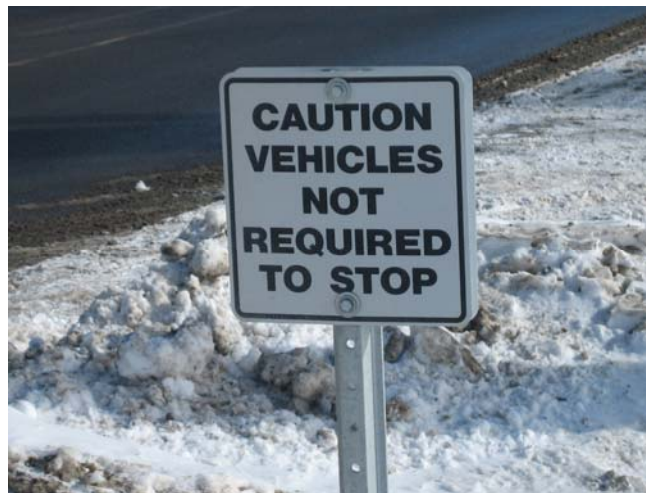
In accordance with the *Highway Traffic Act of Ontario*, pedestrians still do not have the right-of-way over vehicles while in a Courtesy Crossing. So that pedestrians did not gain a false sense of security, signs were posted that stated, "Caution - Vehicles Not Required to Stop". These signs, shown in **Figure 3**, were installed such that they were not visible to motorists. An educational campaign regarding this Courtesy Crossing was commenced in the community, and information bulletins were distributed throughout the area.

**Figure 3: Pedestrian Caution Sign at Courtesy Crossing**

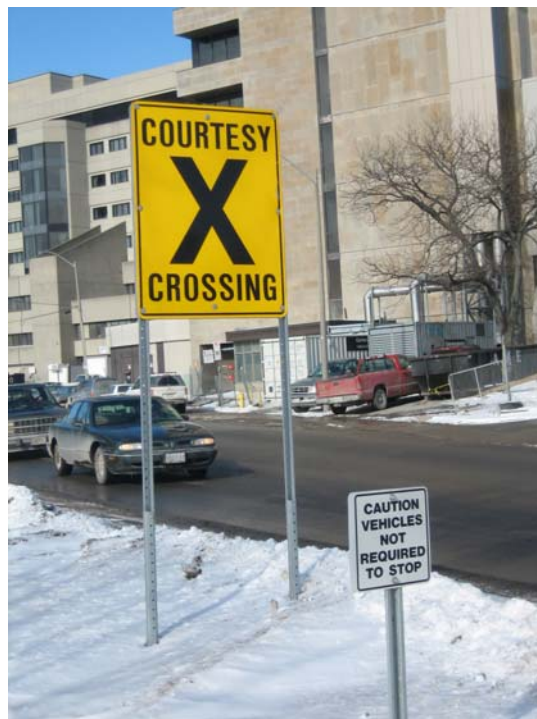
The signage installed at the King Street Courtesy Crossing was identical to what was utilized on Rideau Street. Oversized fluorescent yellow warning signs that stated "COURTESY CROSSING", as illustrated in **Figure 4**, were installed adjacent to the crossing in addition to oversized advance signs. In order to draw further attention to the new crossing, portable variable message signs were utilized for the first two weeks in advance of the hospital area that stated, "CAUTION – NEW PEDESTRIAN CROSSING AHEAD".

**Figure 4: King Street Courtesy Crossing**

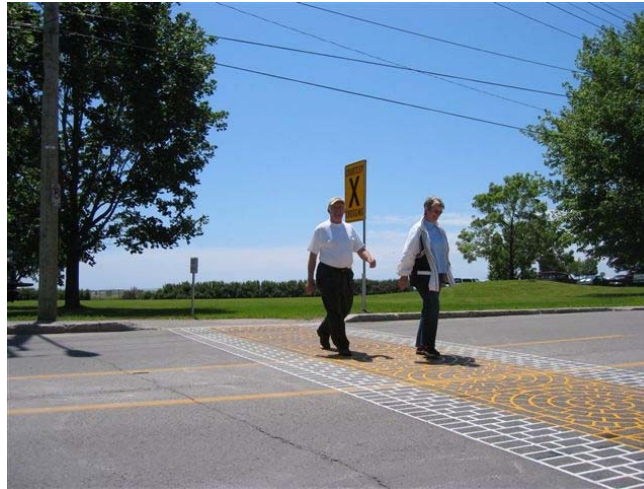
For the first time in Kingston, DuraTherm (StreetPrint) was utilized, as shown in **Figure 5**, for the pavement markings at the crossing on King Street. DuraTherm is an asphalt-based inlaid thermoplastic product that provides a wide range of pattern and colour choices. The City chose this product for the King Street Courtesy Crossing in order to provide a highly visible and durable crossing that would require no maintenance for several years. The disruption to traffic during the installation was minimal.

**Figure 5: DuraTherm Crosswalk Markings on King Street**
