**RE: Feasibility Assessment  
Confederation Park Boat Ramp, Hamilton  
Our File: 14-2162**

This letter presents our assessment of feasibility of reopening the former launch ramp in Confederation Park.

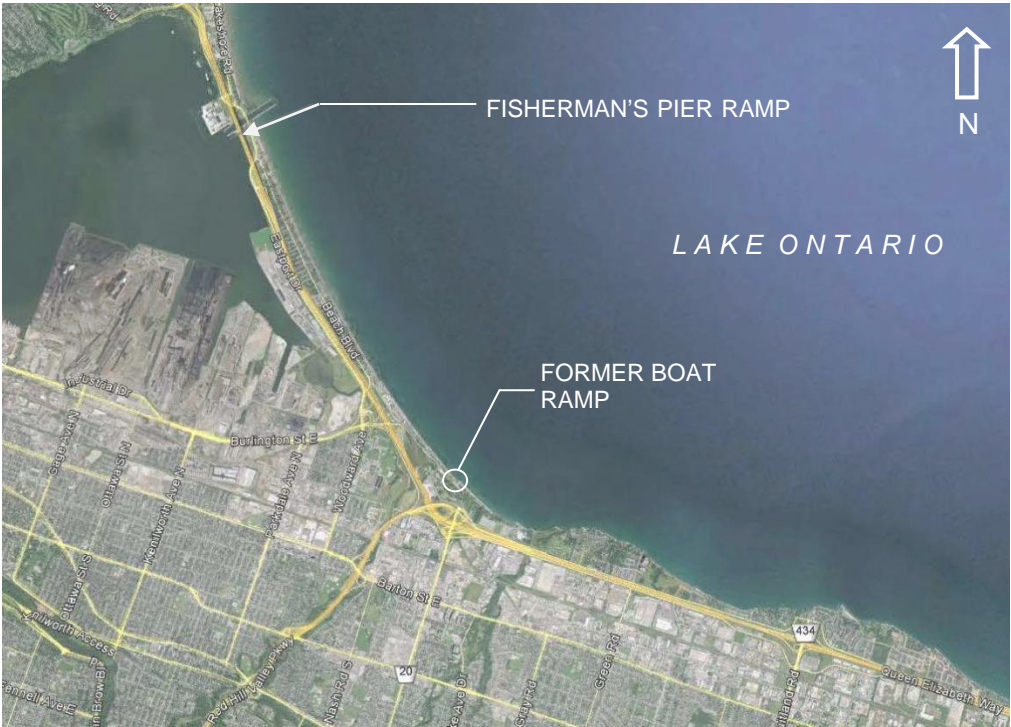
The shoreline at this location is a natural sand and gravel beach (Photos 1 and 2). Several stone mound groynes were observed along the shoreline in both directions. From a provincial planning perspective, as outlined in the Provincial Policy Statement and under the criteria given in the MNR Technical Guidelines, this site is classified as a dynamic beach. As such, the dynamic beach hazard would be applicable at this site. The default dynamic beach hazard is defined as the landward limit of the flood hazard plus a 30 metre dynamic beach allowance. We expect that the dynamic beach hazard at this site lies landward of the back of the beach. Generally, development is not permitted within the dynamic beach hazard.

The former launch ramp is enclosed between two groynes. The groynes appear to be a steel sheet pile wall caisson structure with a concrete cap (Photos 1-3). The east groyne is approximately twice as wide as the west groyne. A short nodule is located on the inner, seaward corner of each groyne (see Figure 1). On the day of the site visit, the ramp surface, if it remains, was buried beneath accumulated beach material and not visible

**Photo 1:** Boat ramp, looking north-west along shoreline

We do not recommend replacing or improving the existing structure at the existing location primarily on the basis of potential impact on the downdrift shore and the need for ongoing maintenance.

In summary, based on our site review and assessment, we do not recommend reopening the existing launch ramp. We would also advise against replacing or undertaking improvements to reduce the siltation of the ramp at the existing location.
