Notice of Intent to Cut Application Form – Woodland Conservation By-law

**NOTICE OF INTENT TO CUT, BURN, OR DESTROY TREES
BY OTHER MEANS, PURSUANT TO
THE REGION OF HAMILTON-WENTWORTH
WOODLAND CONSERVATION BY-LAW NO. R00-054**

Existing Conditions
 Forest Assessment
 Project: P1380
 Date: 25 October 2016
 Scale: 1:300

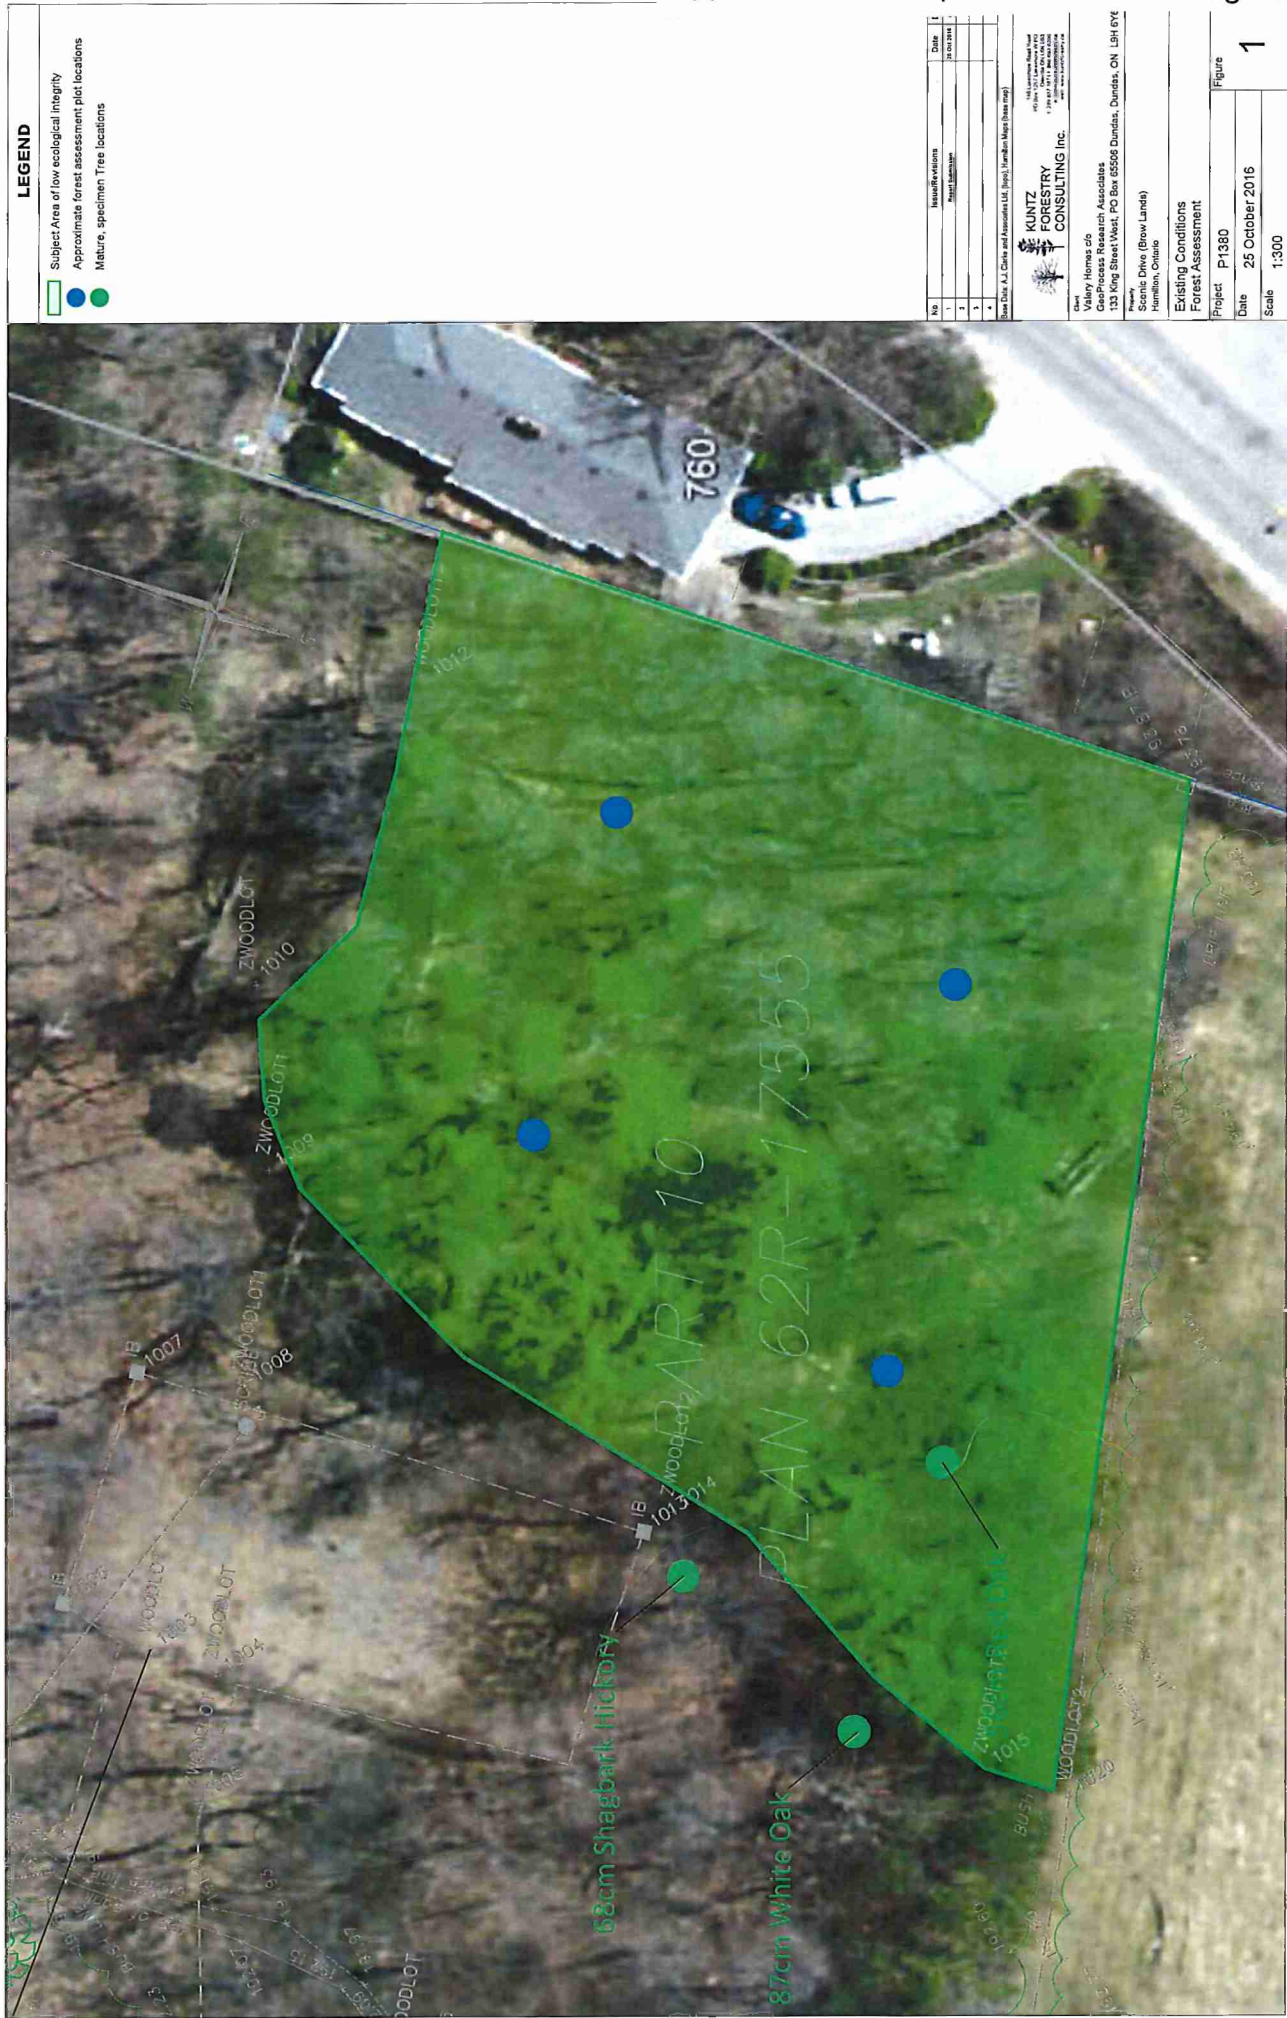
The subject area has poor ecological integrity with low native tree species diversity and a high population of non-native, invasive Common Buckthorn. The forest floor is disturbed with little to no native tree species regeneration. If left unmanaged, it is unlikely that this wooded feature would be able to self regenerate due to the lack of tree regeneration and dense Common Buckthorn cover. Based on these characteristics, the subject area represents a low constraint to development. It is recommended that the Shagbark Hickory and White Oak be protected at their dripline. Preservation of the Red Oak may be considered during the planning process via a Tree Inventory and Preservation Plan report.

Photo 3. Open, understory with disturbed forest floor and limited to no tree regeneration

Replacement of the conifer plantation through restoration of other lands on the subject property is recommended. The removal of trees within the conifer plantation may be compensated by planting trees along the escarpment brow, as recommended by GeoProcess Research Associates' Restoration Plan (12 January 2017) and shown in Figure 2 of this report. Currently, the area along the top of the escarpment brow is very narrow and consists of a few scattered trees. The intent of the replacement tree plantings is to expand the wooded area along the top of the escarpment brow through reforestation techniques. Plantings will be contiguous to the larger ecological feature, replacing Sanatorium Road with a forested area. All planted trees will be native and reflective of the local landscape (ecological land type). The area of conifer plantation proposed for removal is approximately 0.28 ha and the area of replacement plantings is approximately 1.03 ha. The recommended replacement plantings will serve to buffer and expand the larger ecological feature along the escarpment brow while increasing the ecological function and value of the area to be restored.

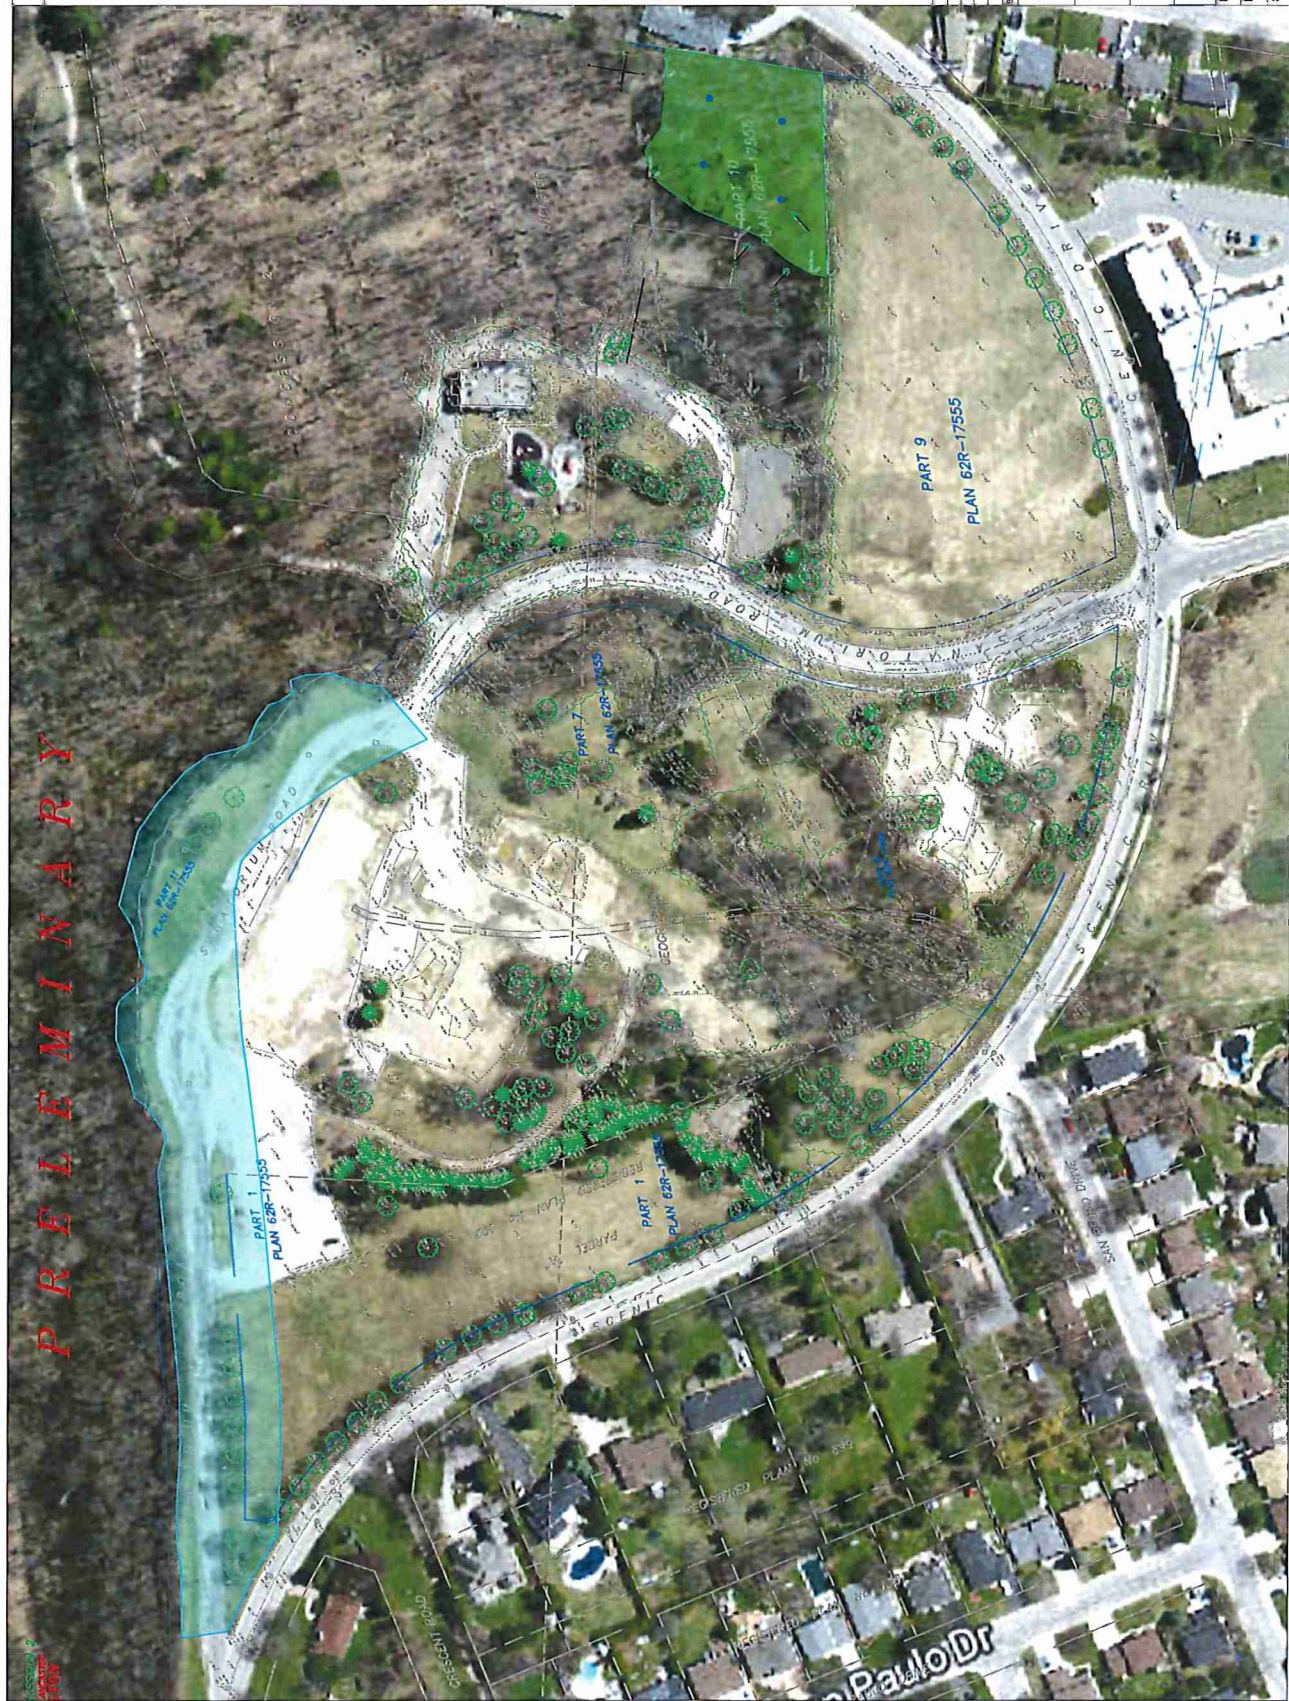
Figure: 2

- Subject Area of low ecological integrity (0.28 ha)
- Approximate forest assessment plot locations
- Mature, specimen Tree locations
- Approximate Restoration Planting Zone (1.03 ha)*

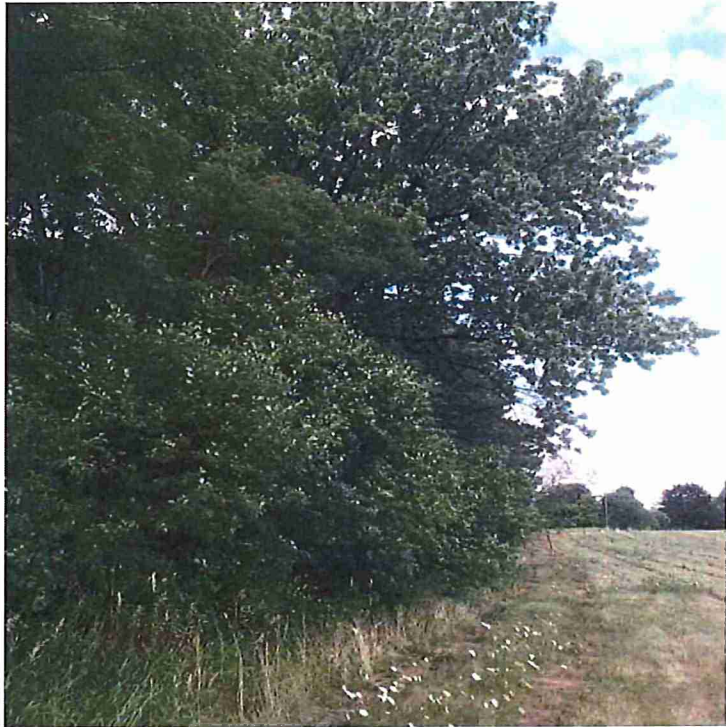
<p>Photo # 2</p> <p>Brow Lands</p> <p>July 27, 2016</p> <p>Eastern Woodland – mature Red Oak and Scots Pine in foreground</p>

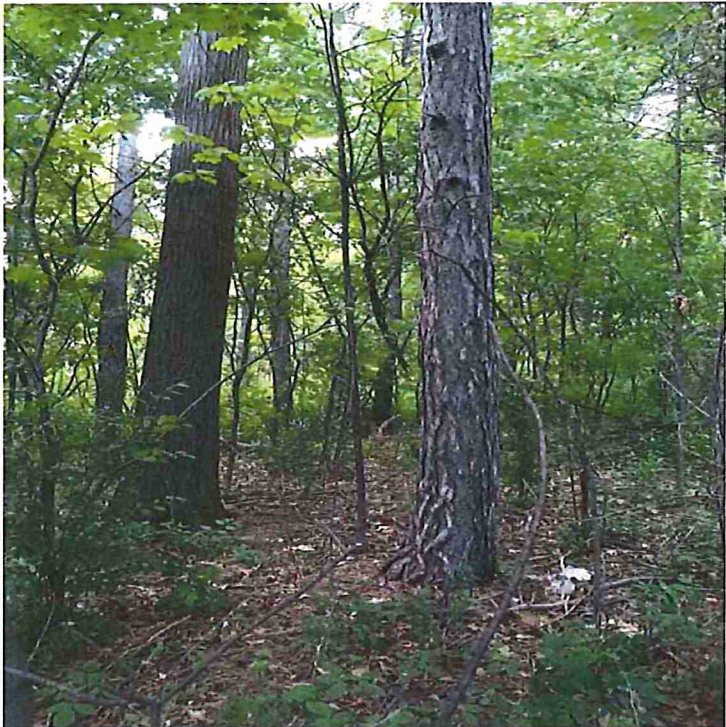
Photo # 3

Eastern Woodland –
mature plantation
and deciduous trees
naturalizing with
younger tree
specimens

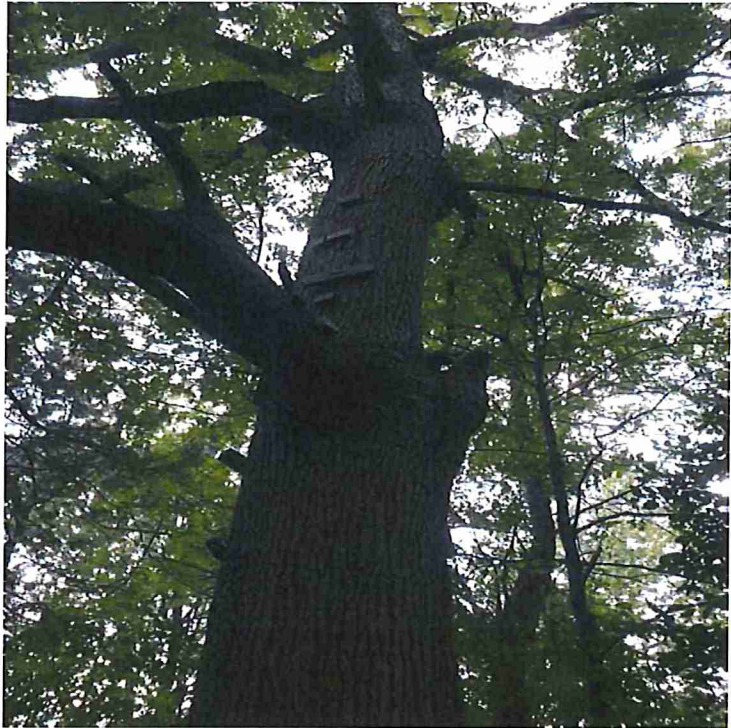
<p>Photo # 6</p> <p>Brow Lands</p> <p>July 27, 2016</p> <p>Eastern Woodland – poor forest structure due to high levels of non- native invasive species and historic and on-going recreational use</p>
