**HERITAGE ASSESSMENT**  
**BROWLANDS, CHEDOKE HOSPITAL, HAMILTON, ONTARIO**  
**for**  
**DEANLEE MANAGEMENT INC.'s OFFICIAL PLAN SUBMISSION**

SBA Project #: A0679

June 2007

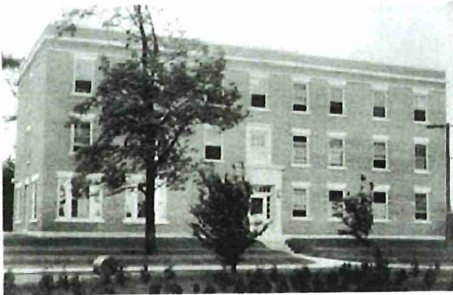
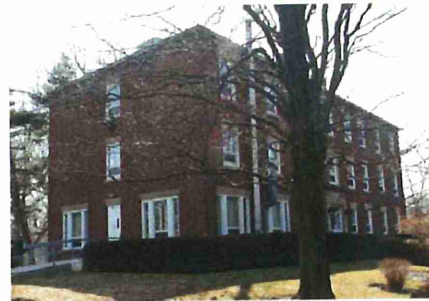
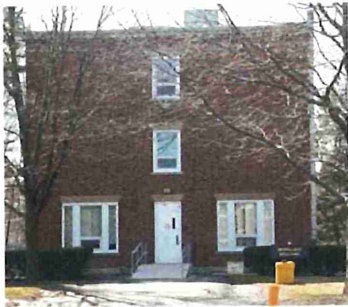
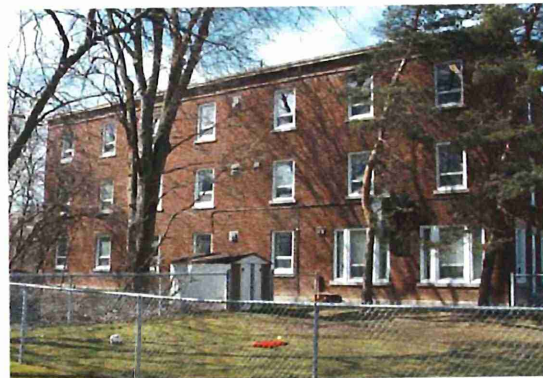
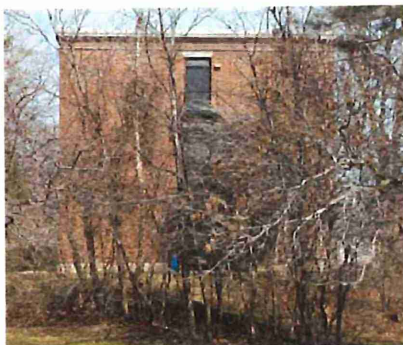
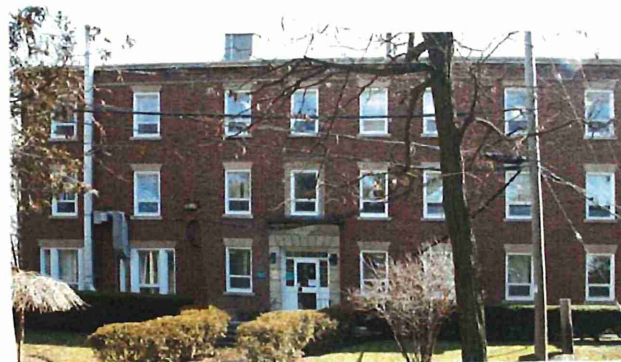
**.9 Photo Elevations**

- Exterior is intact except for: missing parapet and original windows (The new windows are vinyl clad with a small operating lower sash, while the originals were wood, double hung, 9 panes over 9 panes.)
- Interior extensively altered

The building envelope is in very good condition and feasible for reuse.

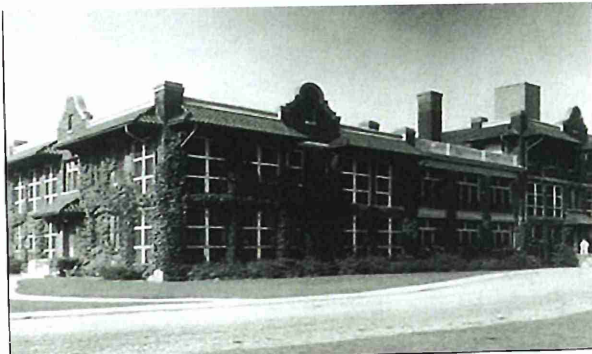
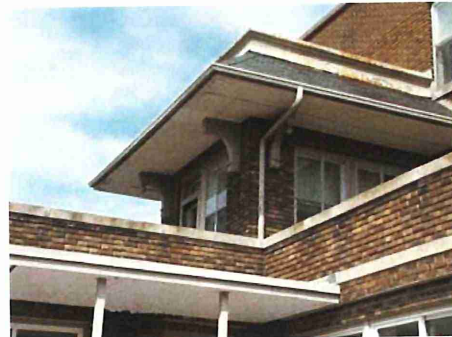
**Early north elevation - Brow Building**

The second floor sundeck is the only location where any of the sloped features remain.

The Brow Infirmary Building as it appears today has little architectural merit and does not reflect the original design intent. It would be possible to reconstruct the missing architectural features but this would be pure reconstruction, not preservation of existing significant features.

- .1 Preserve the facades of the outer two bays (see sketch) and reconstruct all missing architectural features.
- .2 Reconstruction should include window openings, window types, tile roofing elements, straight and decorative parapets, stone and decorative metal copings, and railings.
- .3 Maintain the massing back as far as the central corridor.
- .4 The central bay could be dealt with as an infill or reconstruction to approximately the existing height.
- .5 Massing could be added to the rear, south, of the building providing it is stepped backwards.

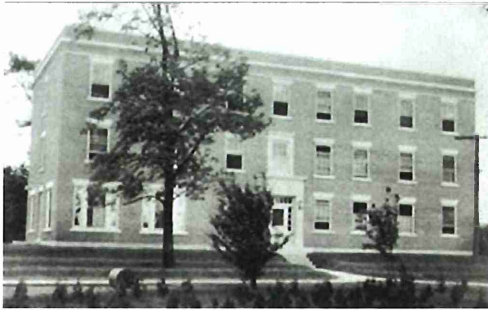
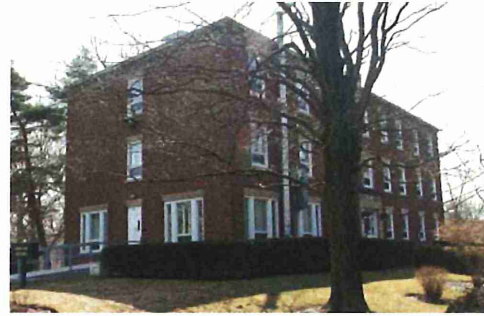
Early north elevation - Moreland Building

It is the building sited farthest from the brow. It is both architecturally and historically more closely associated with the orchard site than the Browlands.

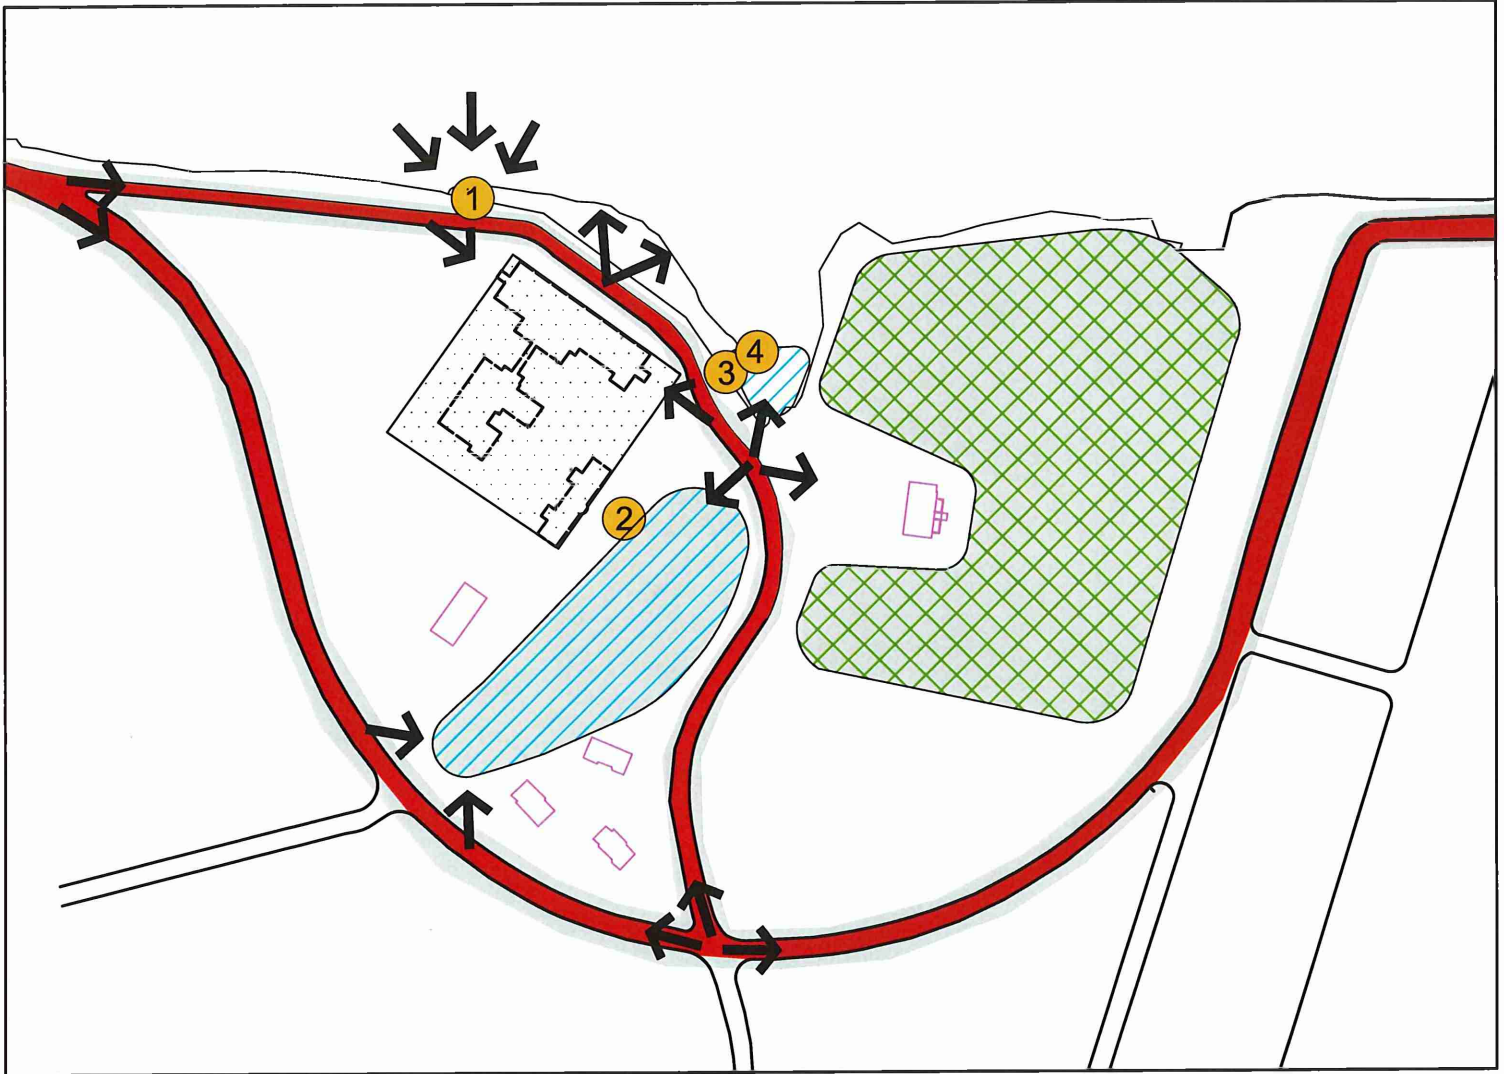
## CULTURAL LANDSCAPE FEATURES WITH HERITAGE VALUE

The heritage value of this cultural landscape is found in the various character defining features still found on site and dating from the development period of the Mountain Sanatorium. Figure 1 in Appendix A is a plan illustrating the landscape features of the site with heritage value. These features include:

All built features with heritage significance including the pedestrian bridge, the stone wall and pillars at the vehicular bridge, and the Cross of Lorraine should be protected, and retained in their current location, and repaired as needed.
