HERITAGE ASSESSMENT
BROWLANDS, CHEDOKE HOSPITAL, HAMILTON, ONTARIO
for
DEANLEE MANAGEMENT INC.'s OFFICIAL PLAN SUBMISSION

SBA Project #: A0679

June 2007

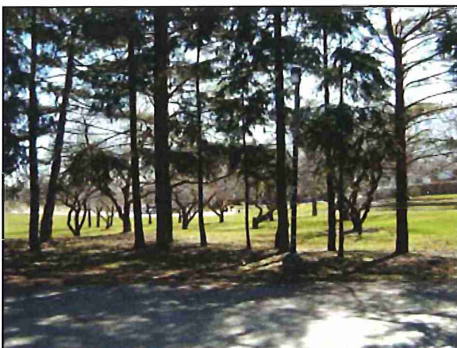
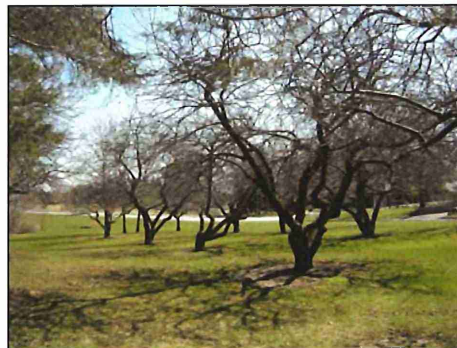
.2 Plantation Planting

In contrast to the unmaintained natural woodlot, the interior of the site contains a large grouping of deliberately planted conifers – spruce and pine planted in the mid twentieth century. These trees are closely spaced and as a result much of the lower branching shows significant dieback. A group of ornamental fruit trees of alternating bloom colour is located along Scenic Drive, also dating from the second half of the twentieth century.

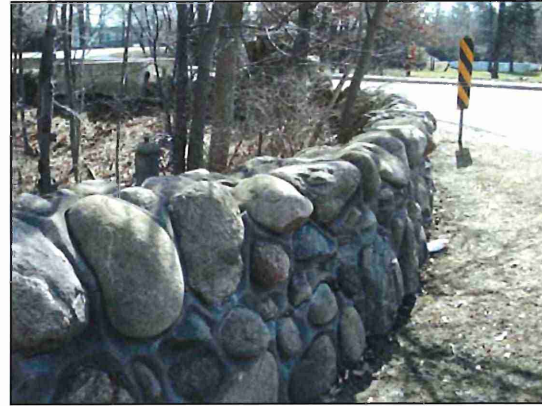
.3 The Stone Wall and Pillars at the Vehicular Bridge

The stone wall and two pillars at the vehicular bridge along the edge of escarpment are a rare example of ornamental rustic stone work with raised ribbon jointing. The deliberately selected granite boulders contrast the indigenous limestone of the escarpment found below it. There is evidence of extensive repairs being completed and oral history confirms that a staff person repaired or built a section of the wall in the 1950s. Pillars mark the end of the bridge section with a lower wall extended north around the top of the brow for several metres.

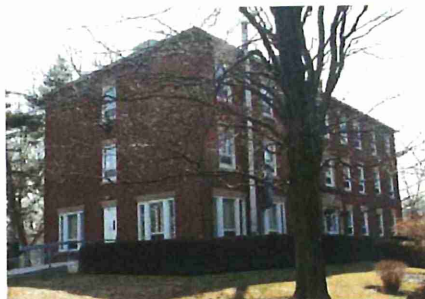
PHOTO TAKEN AT 2007

- Exterior is intact except for: missing parapet and original windows (The new windows are vinyl clad with a small operating lower sash, while the originals were wood, double hung, 9 panes over 9 panes.)
- Interior extensively altered

The building envelope is in very good condition and feasible for reuse.

Although built as a residence, in order to retain the original appearance, the building is most suitable for continued use as offices.

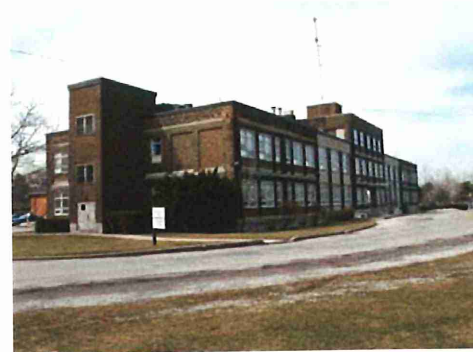
2007 north (front) elevation

The Brow Infirmary Building as it appears today has little architectural merit and does not reflect the original design intent. It would be possible to reconstruct the missing architectural features but this would be pure reconstruction, not preservation of existing significant features.

- .1 Preserve the facades of the outer two bays (see sketch) and reconstruct all missing architectural features.
- .2 Reconstruction should include window openings, window types, tile roofing elements, straight and decorative parapets, stone and decorative metal copings, and railings.
- .3 Maintain the massing back as far as the central corridor.
- .4 The central bay could be dealt with as an infill or reconstruction to approximately the existing height.
- .5 Massing could be added to the rear, south, of the building providing it is stepped backwards.

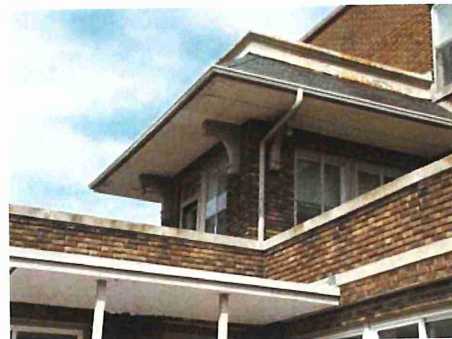
Sundeck (original brackets and roof flashings)

The second floor sundeck is the only location where any of the sloped features remain.

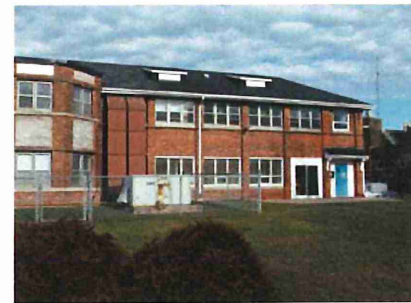
2007 east elevation

This building has already lost many of its significant features. New entries and the enlargement of windows on the west elevation would be essential to the conversion. These interventions required to convert the structure to row housing would further distort the building's historical design intent of being a pavilion like structure having the architectural features associated with the garden city movement in England.

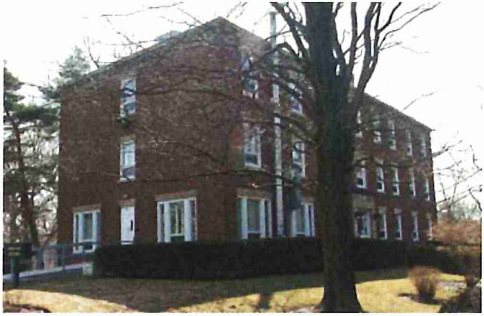
2007 north elevation

It is the building sited farthest from the brow. It is both architecturally and historically more closely associated with the orchard site than the Browlands.
