# Added Presentation to Item 8.1

City of Hamilton

April 1, 2019

Subject: Unsafe Roadway South Service Rd, East of Belgraden Ave. Stoney Creek

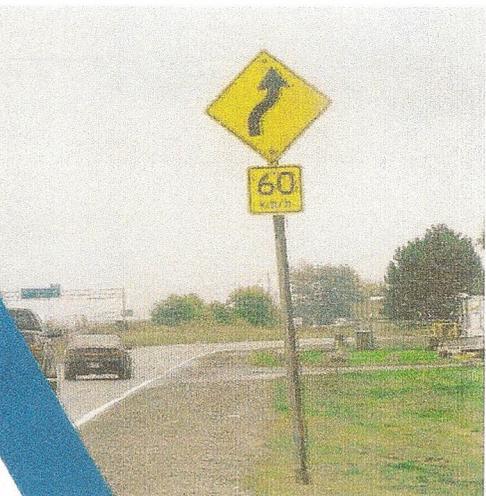
explicit and strong visual information to the contrary. The "information" to be provided to the road user, as mentioned above, is typically delivered via TCDs that better inform motorists of the actual roadway alignment. Without these TCDs, the perceptual illusion creates a violation of driver expectancy, and a trap for the unwary motorist. Since, the road authority did not provide either CHEVRON ALIGNMENT signs and/or a CHECKERBOARD sign to inform motorists that the South Service Road curved to the right, the road authority created an unreasonable risk of harm for eastbound motorists.
