From: [REDACTED]
 To: [Ferguson, Lloyd; Golden, Alissa](#)
 Cc: [Bishop, Kathy](#); [REDACTED]
 Subject: Cultural Heritage comments for FC-15-081/ for the 105 Filman property
 Date: January 25, 2021 11:54:57 AM
 Attachments: [Filman Rd City Contract.pdf](#)
[Heritage Comments - FC-15-081 \(11\).doc](#)
[105 Filman Ancaster Heritage Assessment Report.pdf](#)
 Importance: High

105 FILMAN ROAD, ANCASTER

January 16, 2021

Prepared by: T. Murison Heritage Consultant

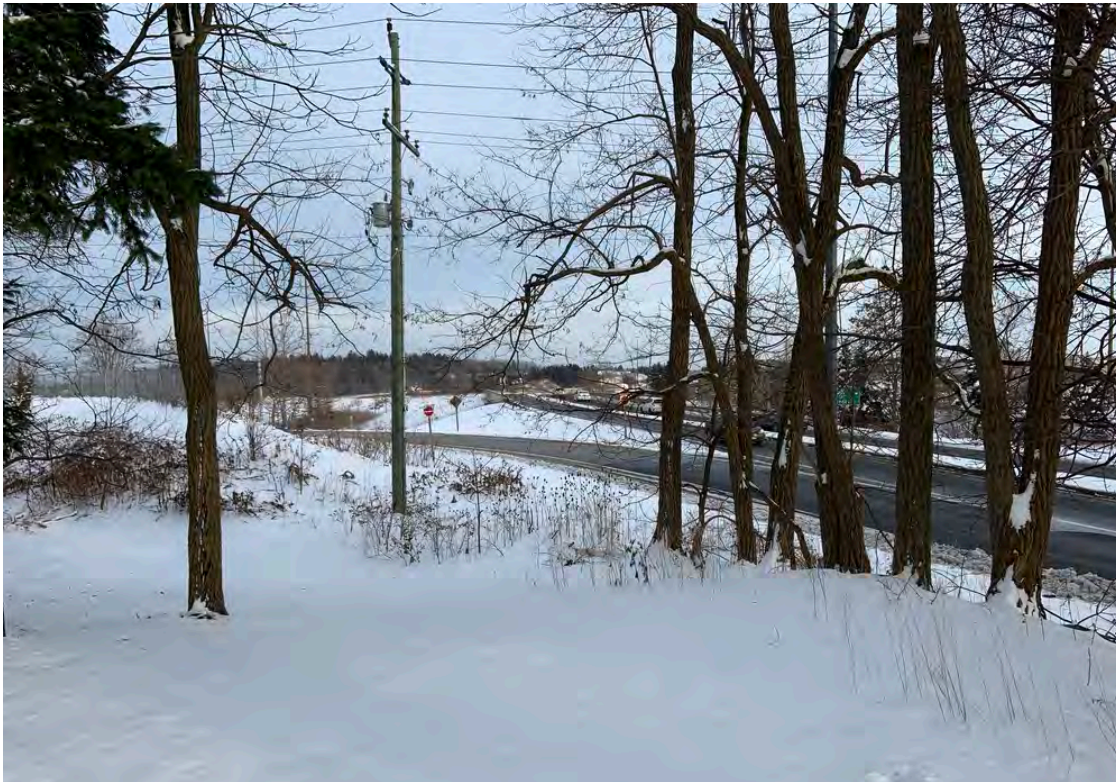
View to the east from the south eastern corner of the lot. Note the presence of many trees and elevation difference to the road below. Mohawk Road is an overpass here with Highway 403 below.

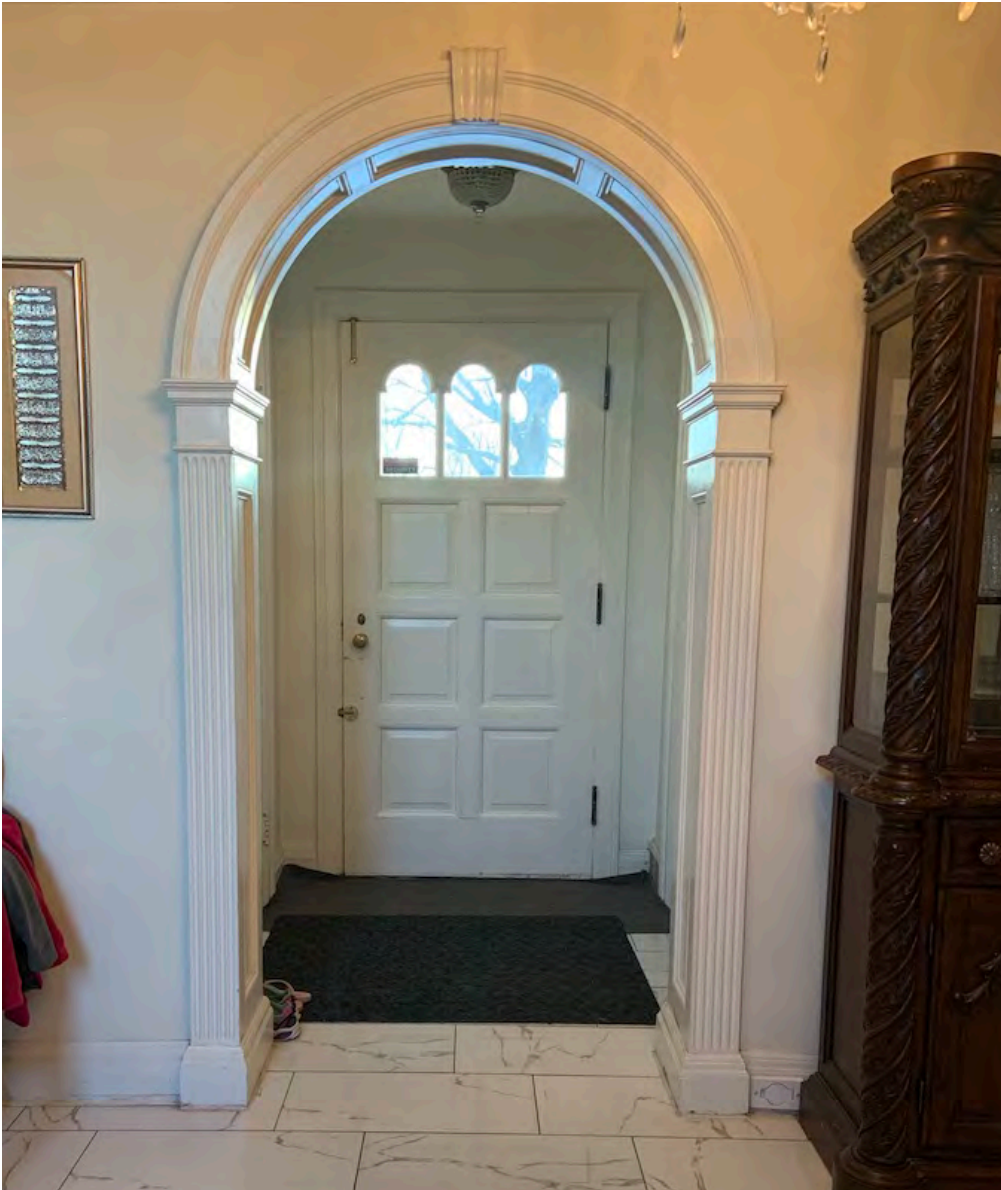
- 01.42** The built-up mouldings in the cornice around the hall emphasize horizontal layers of moulding but lack the “excitement” of deep shadow lines and reverse curvature that modulates the ceiling light. The effect is bland and difficult to define, but that may have been the intention of the builder.
- 01.43** The rather low ceiling height becomes obvious when one looks at the stairwell. The cornice mould is coped to terminate at the edge of the ceiling just above the foot of the stairs.

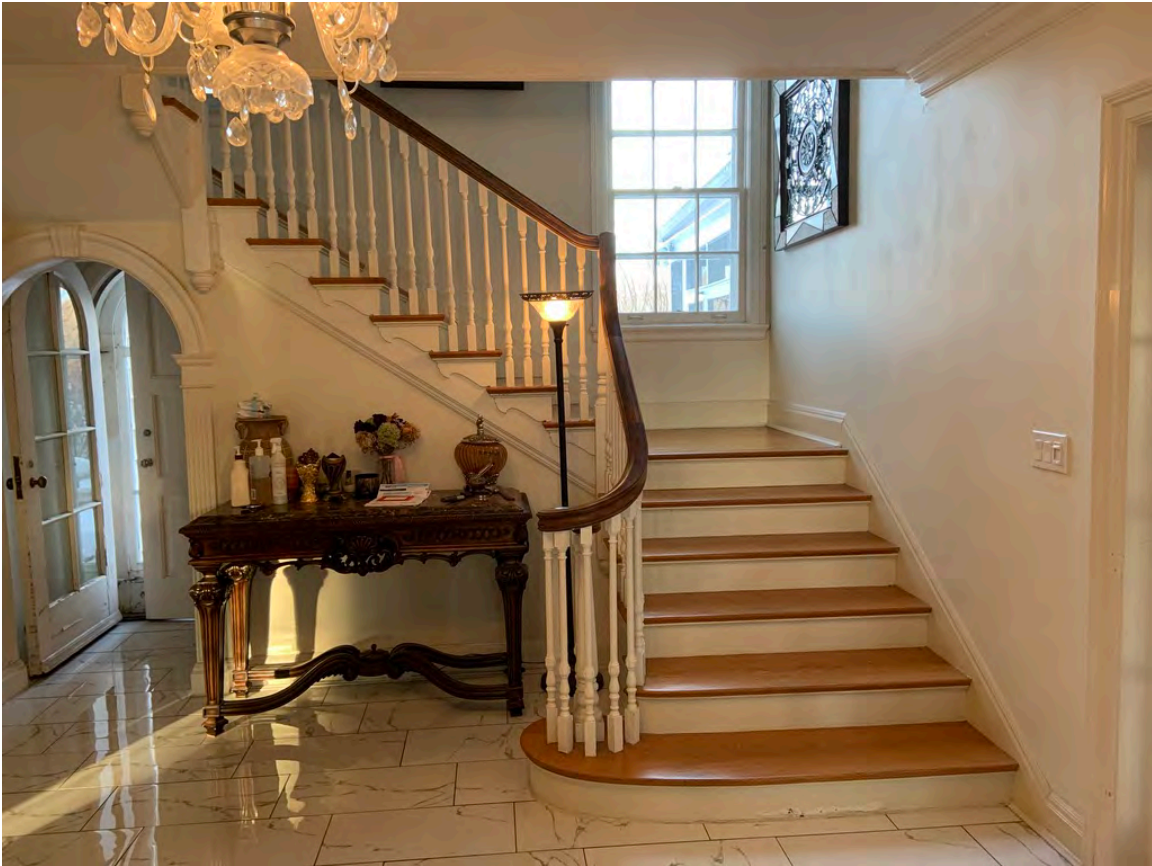
01.45 Principle staircase to second floor, at entry hall.

01.46 While the stairs are beautifully formed with a “spindle basket” wrapping around a central newel on the lowest tread, the window that illuminates the quarter landing is truncated when seen from the doorway from the entry. The impression is one of insufficient headroom and ominous weight of the floor above.

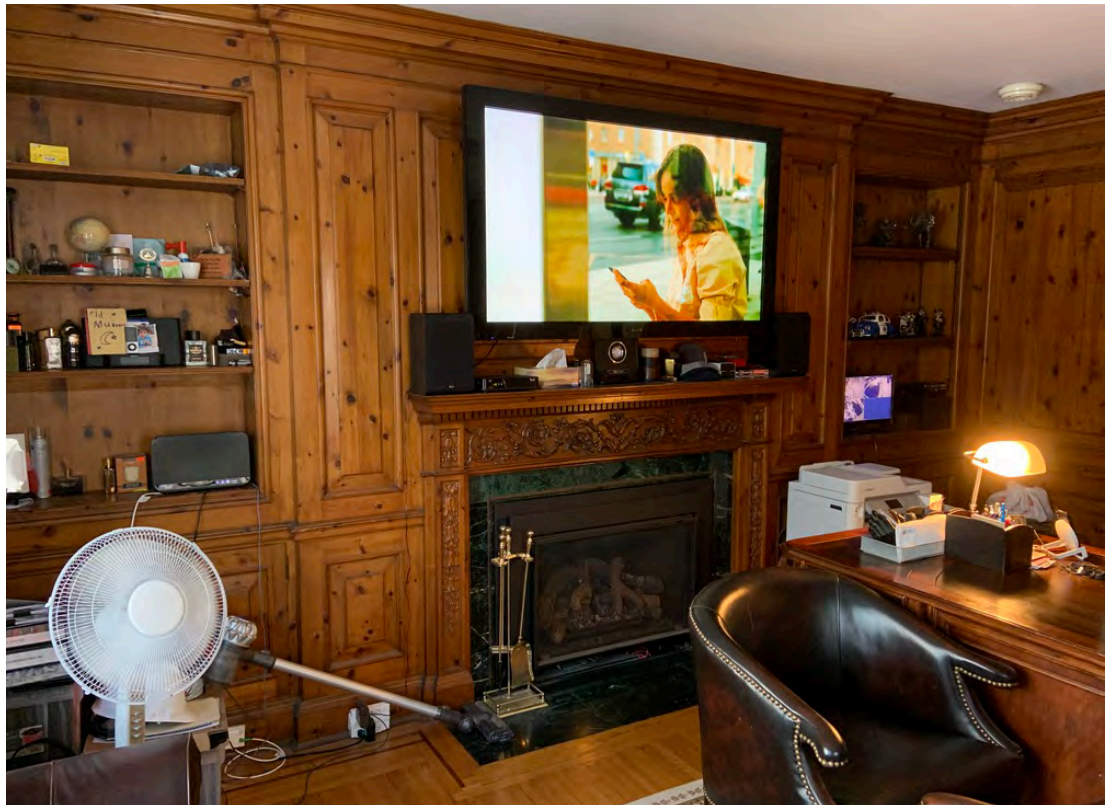
- 01.75** A study or home office is located across the hallway from the former dining room. The room is paneled with elaborate varnished pine cornices, raised panels and built in cabinetry. The working fireplace has an unusual pine mantle with dentils and elaborate botanical carvings of laurels, flowers and fruit. The hearth and fireplace surround were made with a deep green marble with white veins. The pine window and door trim suggests that this work is original to the house. This would indicate that the first owner used this room as his home office or study when the house was built. The absence of closets, change room or adjoining washroom, is good evidence that this comfortable room was not built for a physician. The windows have been replaced with modern vinyl casements, but the side door to the exterior is an original 8 pane fixture.

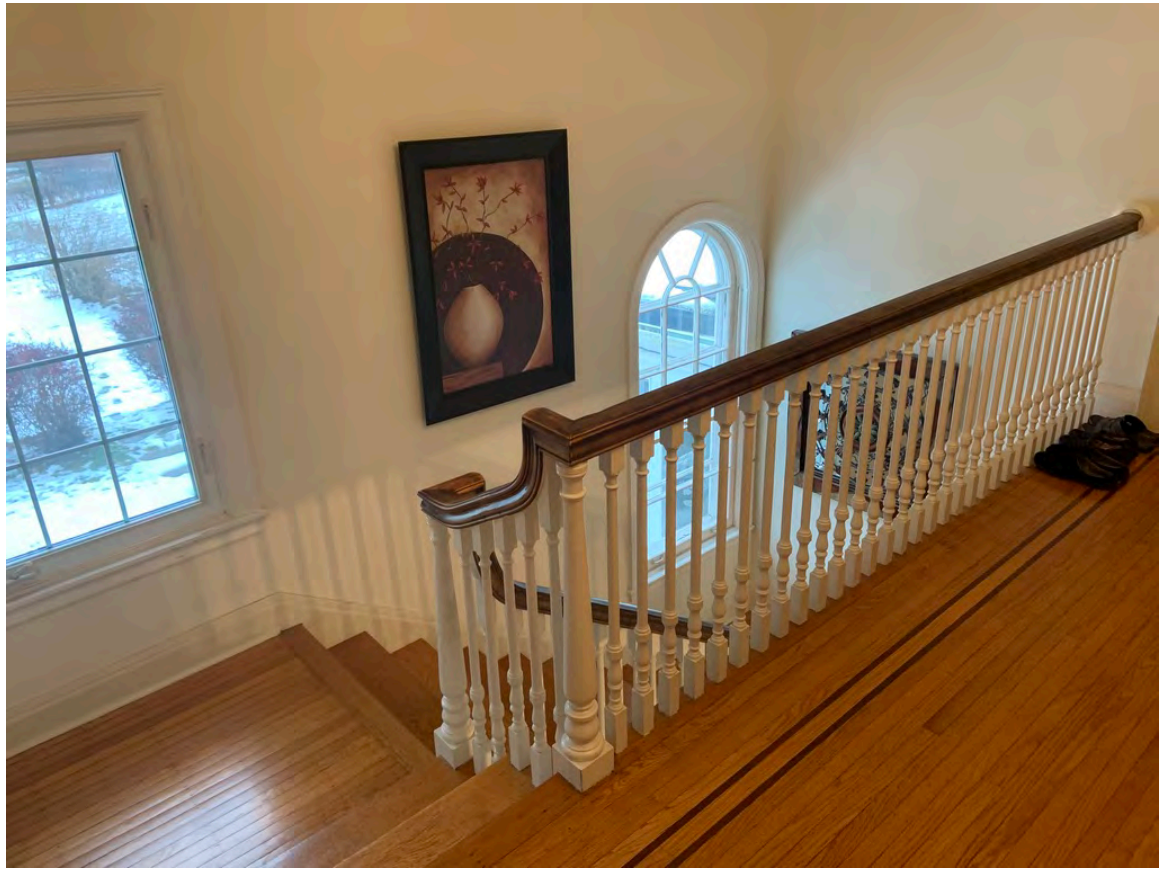
- 01.76** The second floor main hallway is open to the stairs below. The north slope of the roof is only visible above the ascending stairs. The roof is high enough at the landing to be 100" clear of the landing.

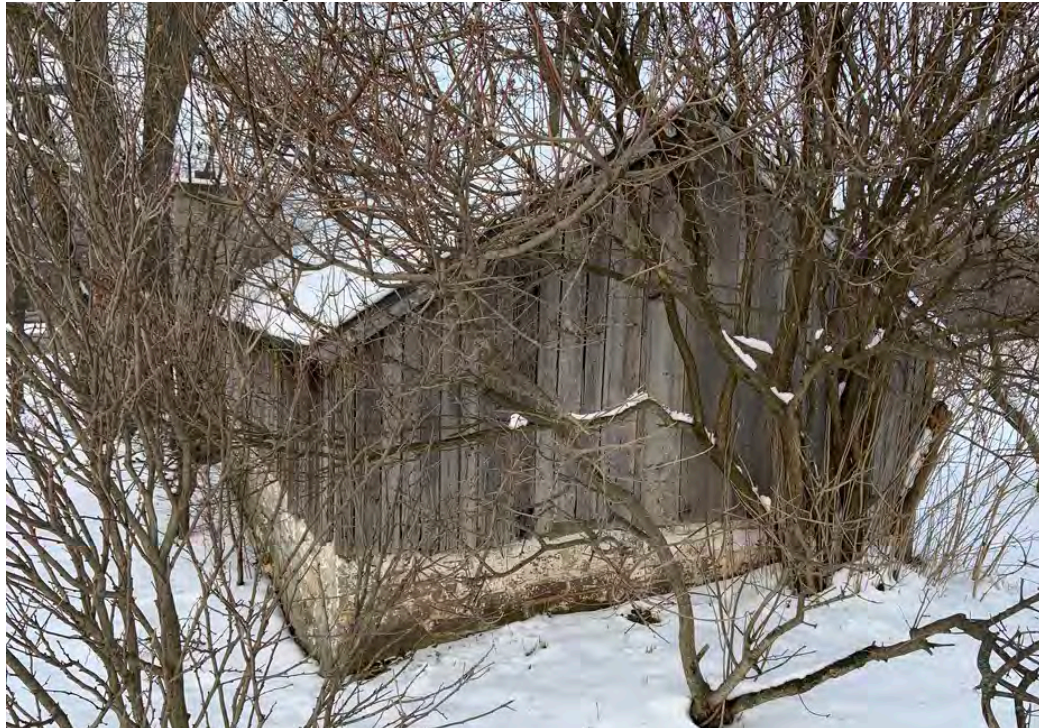
- 02.11** If the building were used as a storage shed or other utility building, it would likely have had another single or double door in the eastern end of the structure. The only access is via the narrow west door.
- 02.12** One might consider whether the building was a chicken coop or poultry house. In this case it would likely have had small access doors to allow the birds to come and go to access food and water during the day, and also be shut in at night to isolate them from foxes and raccoons. There are no signs that the wall boards were ever different than we now see them.

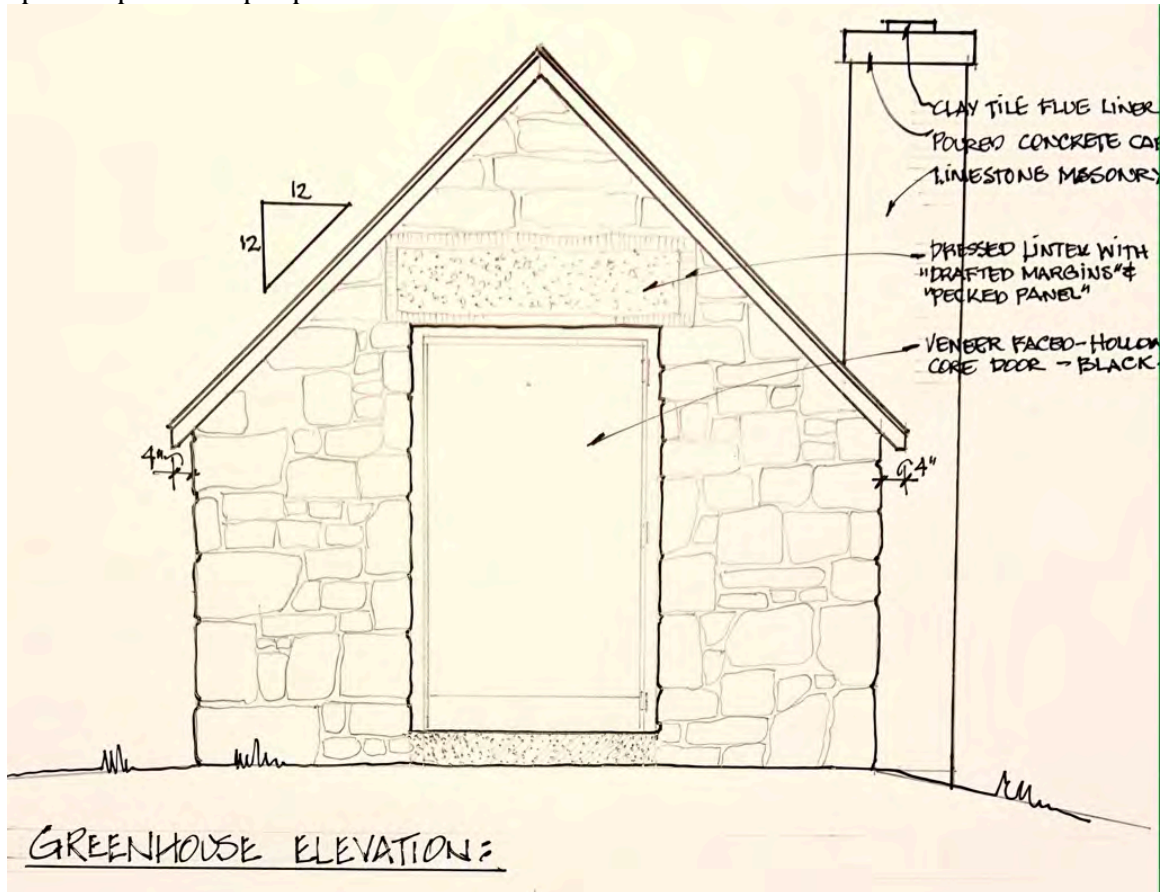
- 02.19** Sketch of the west elevation with single entry door. The chimney was added later. The only dressed stone, the lintel is reclaimed from another structure.

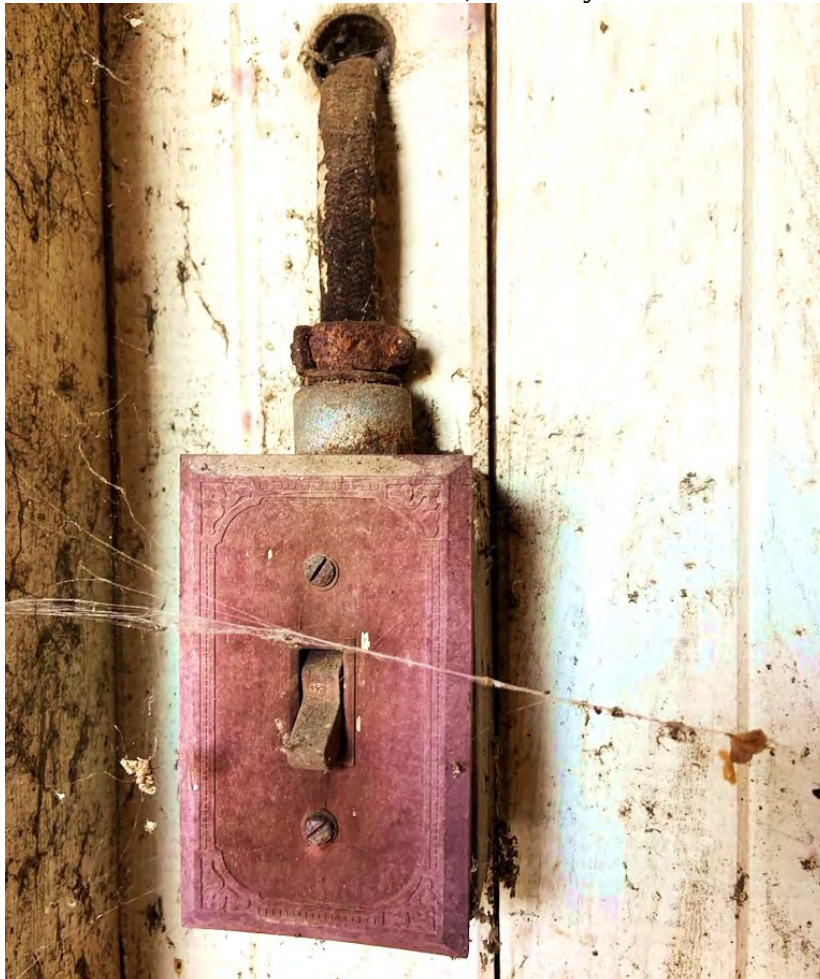
- 02.23** The electrical panel, switch plate & black asphaltic paper wrapped wiring are typical of the 1920's and 1930's and appear to have been installed when the building was constructed. Ceramic blocks for the lightbulbs were fastened to the collar ties and wiring fed from above.
- 02.24** It is possible that the first door to the shed was a batten door, since that would match the interior door and explain the necessity for replacement roughly forty years ago. The second door is a "batten and rail" door which

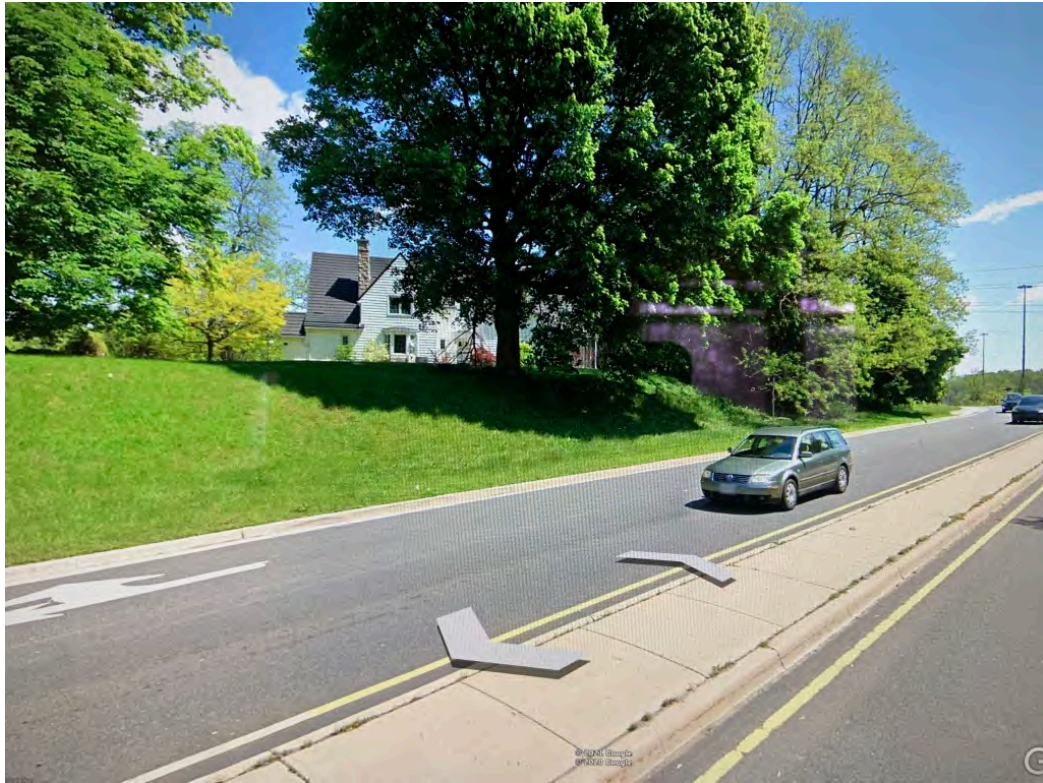
- 03.02** View of the house from Mohawk Road. Note that this image, from Google Earth, is taken at a lens height of 8' above the road. The house is obscured further by the earthen berm. Most drivers will have a viewpoint of 4' or 5' above grade. They have a fleeting glimpse of the house and can barely see the ground floor. It cannot be considered a landmark when it is so obscured.
- 03.03** This may have been an isolated rural lot 95 years ago, but is affected now by its proximity to major traffic routes which diminish it's appeal as a idyllic suburban home with large gardens. It is now just another suburban house on a busy road.
- 03.04** Subdivisions to the west and south of the property were built in the early 1960's and later. At least part of one house on Mohawk and another on

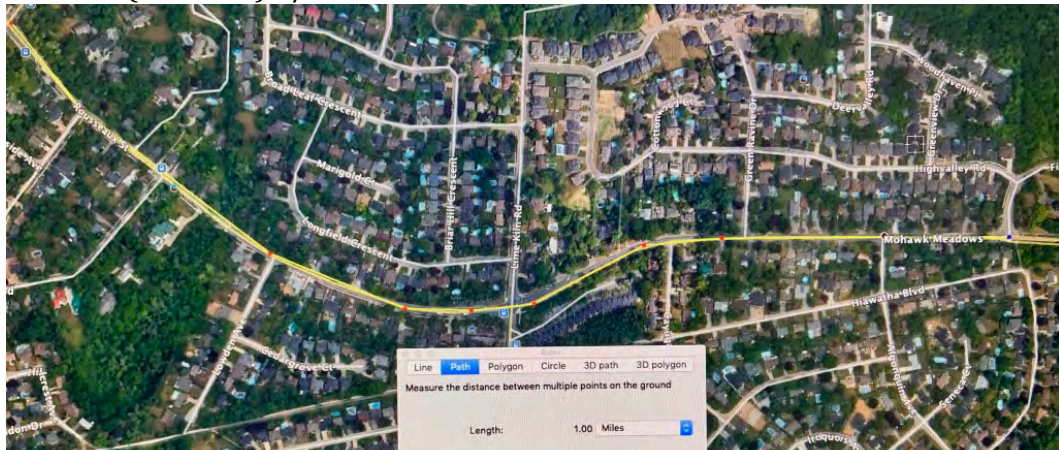
- 03.06** Google Earth Map showing intersection of Rousseau and Wilson top left, and Filman and Mohawk (formerly Rousseau) center right. This distance (yellow line with red squares) is exactly one mile or 5,280 feet.

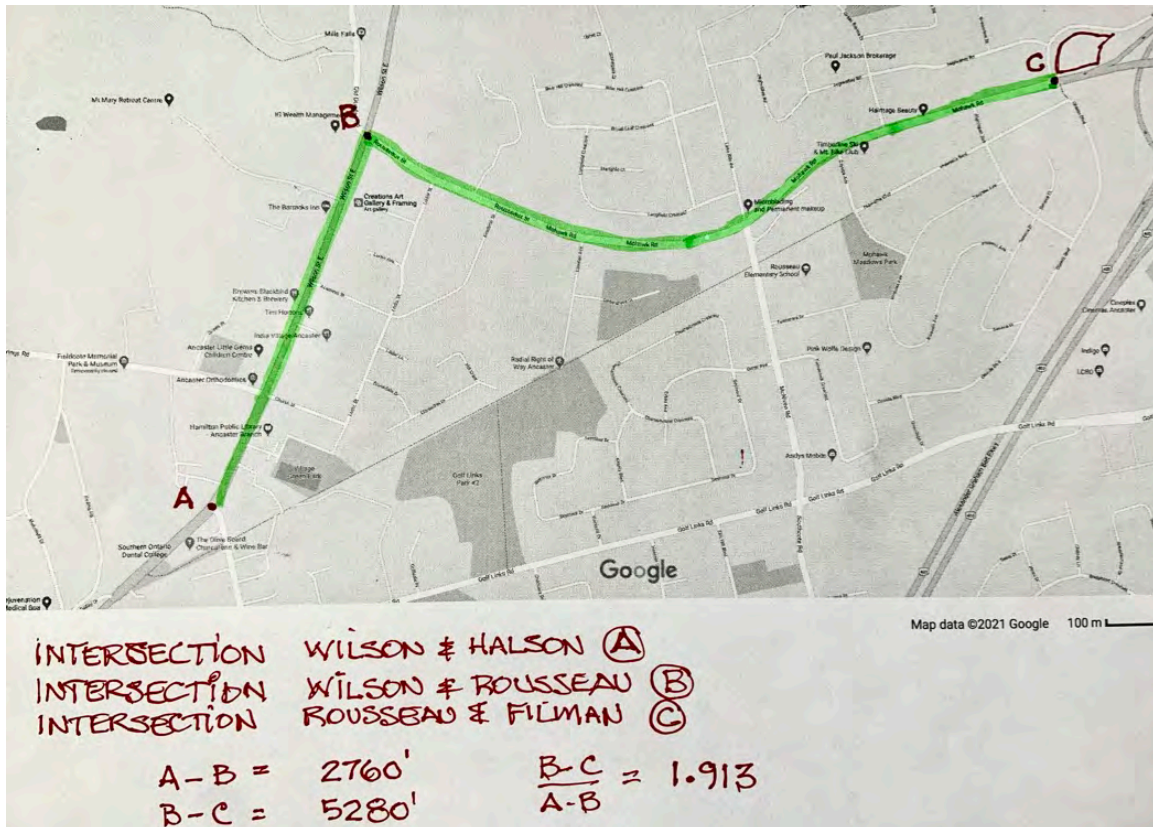
03.07 This map shows the extrapolated distance along Wilson and from Wilson to Filman as a green line ending at the south west corner of the property.

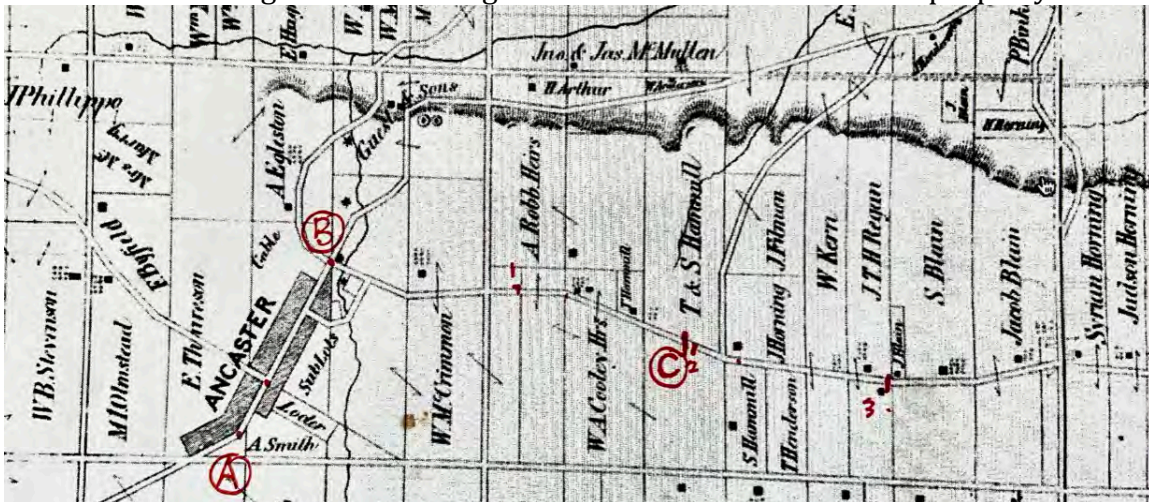
03.08 This segment of the 1875 Wentworth map shows the modern measurements transferred to the 1875 map (using Wilson Str. as the yardstick.)

A. Intersection of Halson & Wilson. B. The intersection of Wilson & Rousseau, and C. Is the intersection of Rousseau (now Mohawk) & Filman. **Notice the red bar across the road above C. (the unoccupied lot of T. & S. Hammill), between the houses of T. Hammill and J. Horning.** The Horning house was approximately 130 yards to the east of Filman. This is where the Hwy. 403
