CULTURAL HERITAGE IMPACT ASSESSMENT (CHIA)

for
**392, 398, 406, 412 Wilson Street East and 15
Lorne Avenue**
Ancaster, Ontario

GBCA Project No: 21006

Date of issue: Friday, June 4, 2021

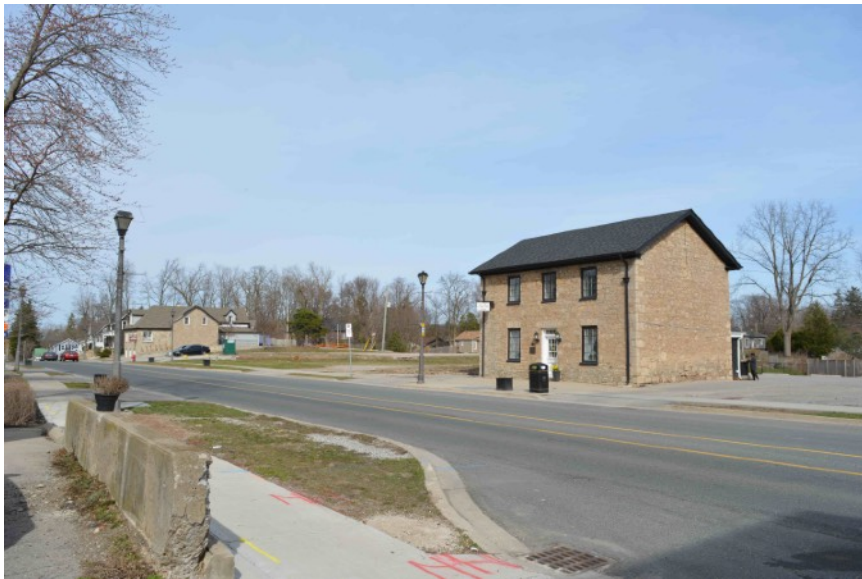
A view from the west side of Wilson Street East looking towards the property at 392 - 406 Wilson Street East looking south. The Marr House is visible here, and is adjacent to a surface level parking lot to the south. This is the location of the former gas station.

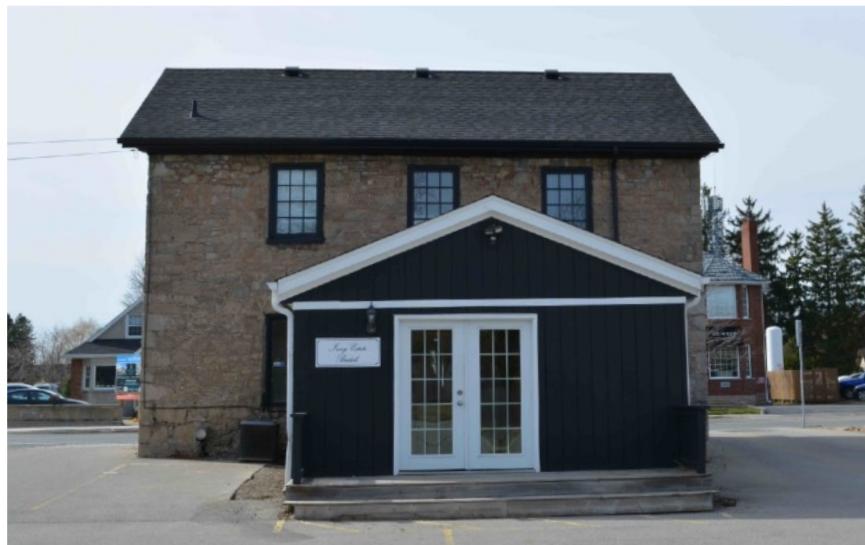
Marr House, 2021 (GBCA). East Elevation. Rear tail covers to ground level openings.

- The removal of the tail from the main residence will require repair, infill of new stone, reinstatement of original openings, refinishing and repainting upon removal of the extension. Restoration and conservation of the former Marr House will involve rehabilitating the rear facade based on archival material, in keeping with the original design intent which would be further explored in a forthcoming Conservation Plan.
