CHIA ADDENDUM

GORE BUILDINGS 18-30 KING STREET EAST HAMILTON, ONTARIO

06 JULY 2021

MEGAN HOBSON CAHP
M.A. DIPL. HERITAGE CONSERVATION
BUILT HERITAGE CONSULTANT
mhobson@bell.net

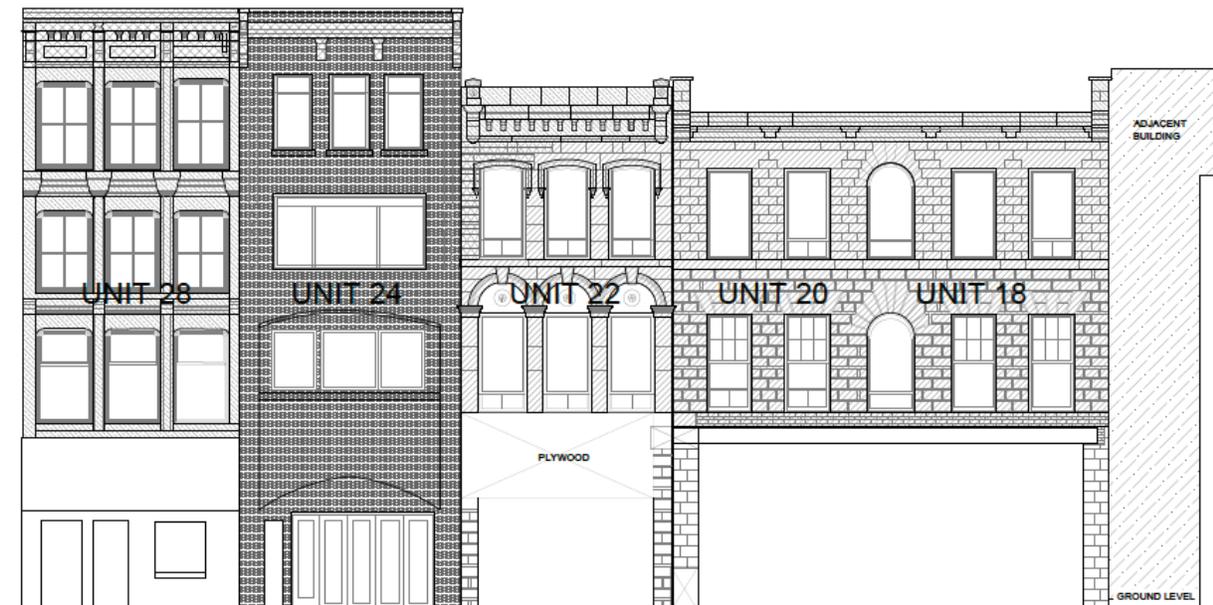
EXISTING FACADE MASONRY TO BE DISMANTLED, SALVAGED, REPAIRED AS REQ. OFF SITE, AND RESET.

EXISTING FACADE TO BE DISMANTLED, REPLACED WITH NEW MATERIAL.

DECORATIVE ELEMENTS (METAL CORNICE AND SIM.) TO BE REMOVED, SALVAGED AND REINSTATED

GORE BUILDINGS – conservation strategy for heritage facades [John G. Cooke & Associates]

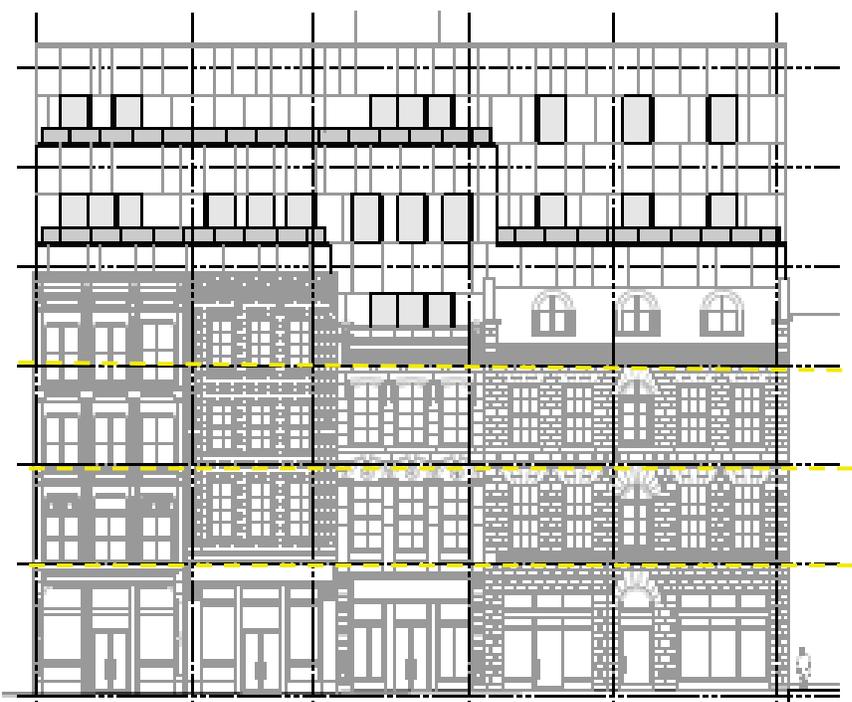
PROPOSED DEVELOPMENT – King Street East Elevation [DPAI] – yellow line indicates the continuous floor plates of the new building – the only area where the new floorplates are not consistent with existing window sill heights is on the 3rd floor of 28 King Street East (Glassco Building)

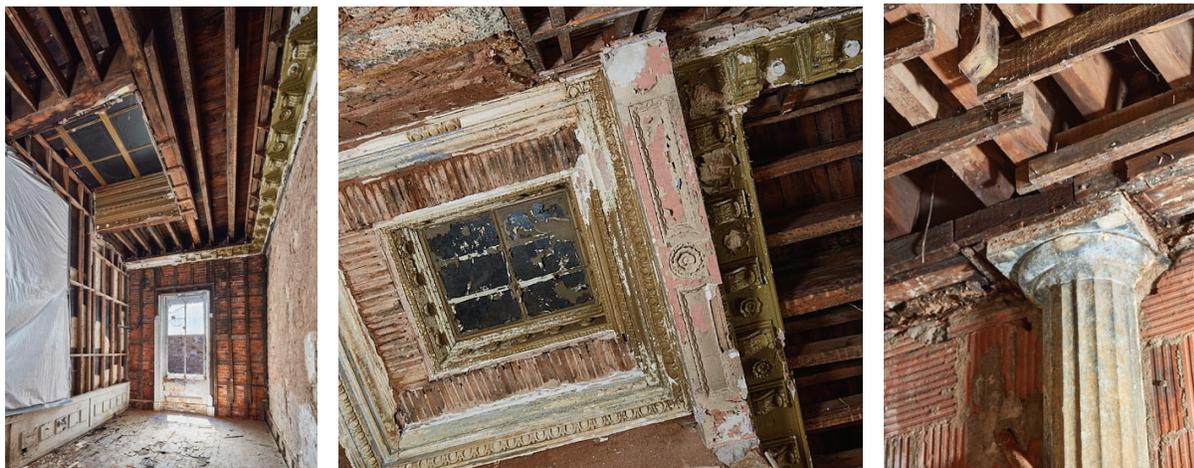
18-22 KING E (THE KERR BUILDINGS) – photo-documentation of ornamental plasterwork and Doric columns on the 1st floor revealed during remediation work

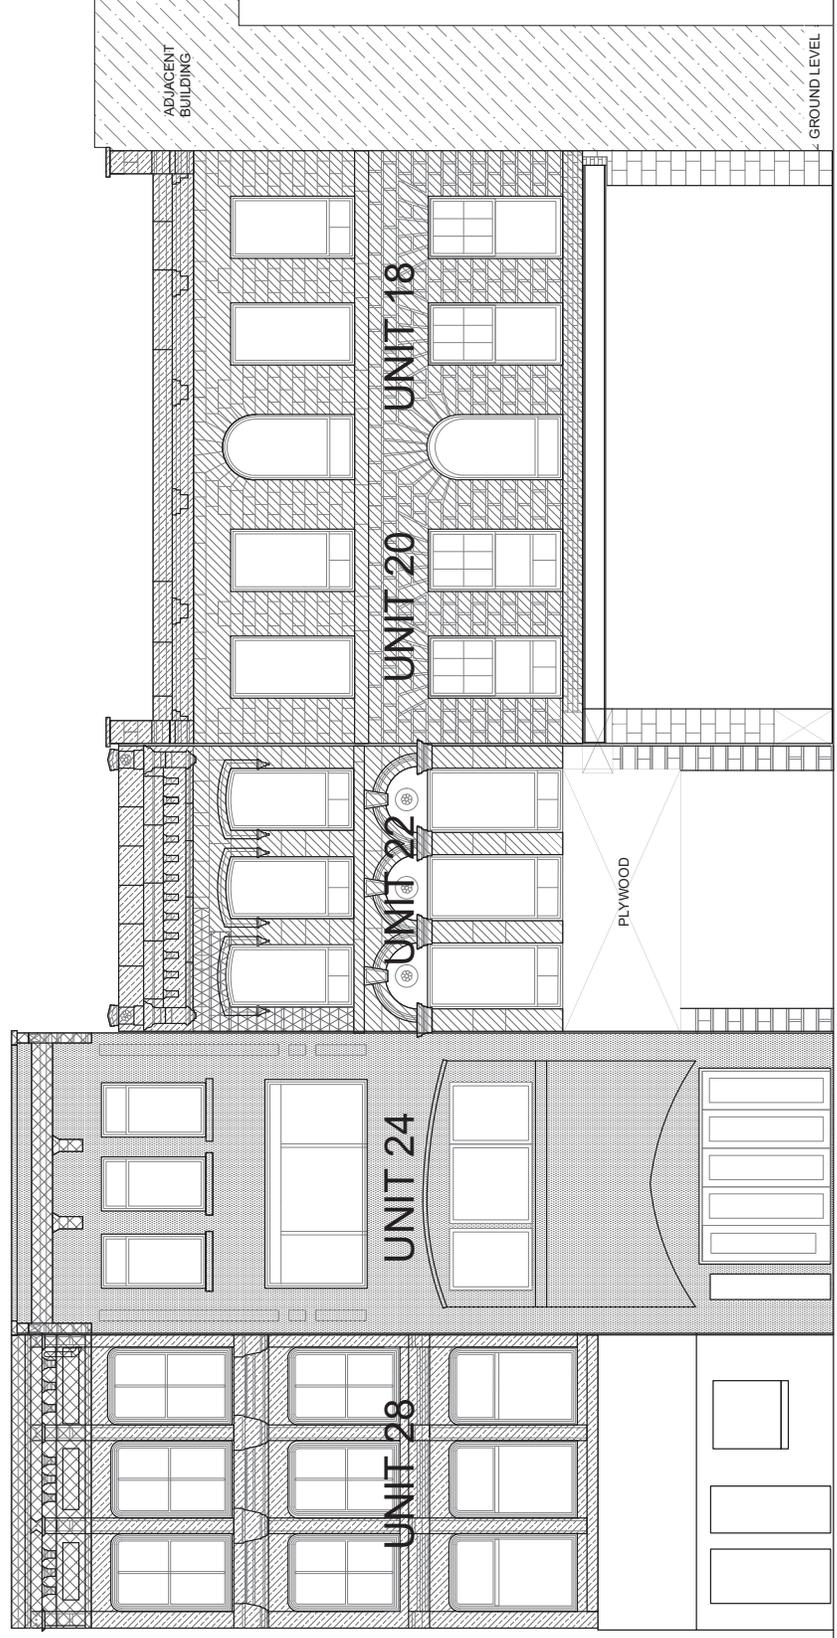
1
 SK-S1

DECORATIVE ELEMENTS (METAL CORNICE AND SIM.) TO BE REMOVED, SALVAGED AND REINSTATED
