Forest Lane Farms House
(also known as Russell Christie House)
1541 Fiddlers Green Road, Ancaster, Ontario

Documentation & Salvage Report
Prepared for: Leanne Dekaneas

Revision 1: August 18, 2023

Re: 1541 Fiddlers Green Road, Ancaster, ON – Documentation & Salvage Report – Revision 1

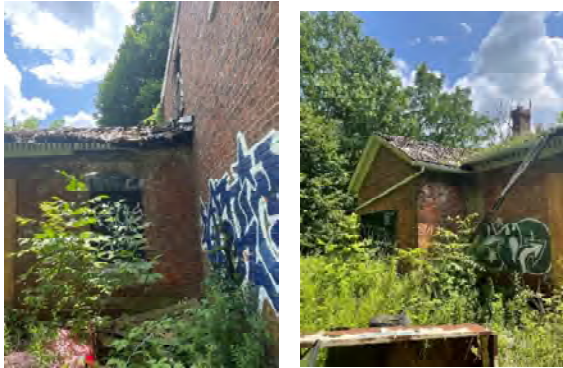
Figure 8 Rear Façade and Garage Graffiti

Graffiti is a common sight throughout the building. Most are on the interior but some larger ones are seen prominently displayed on the façade of the house and on the garage walls.

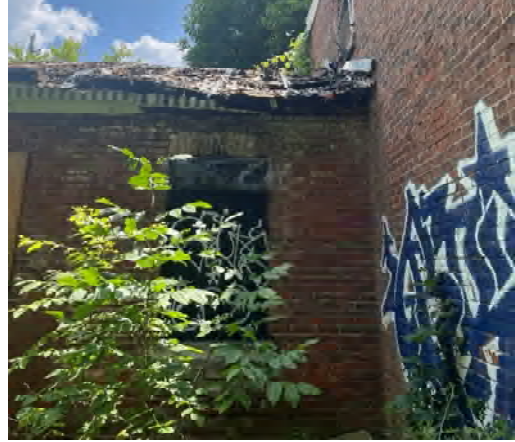
The fire has destroyed the roof above the main house. There remains little examples of carpentry. See Figures 9 – 13. Eaves troughs have completely burnt away along with all other supporting members over the main house. All rainwater leaders are no longer visible. Fascias have been destroyed. The same case remains for most of the soffits except for what remains above the garage.

The exterior carpentry above the garage has some portions intact however still sustained a large amount of damage and is thus not feasibly intact enough for salvaging. Wood appears to be rotted or in the process of rotting. What remains has continued to deteriorate along with the rest of the house.

Figure 12 Collapsed roof, rotting soffits and eaves troughs to the rear of the house above the garage

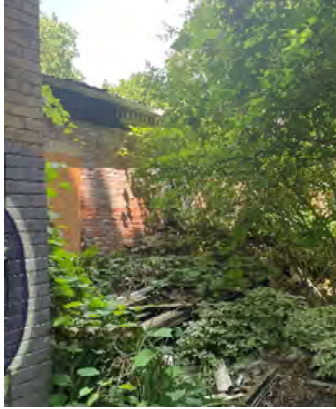
Figure 16 View of the location where the cover side porch would have been located.

All Exterior wooden architectural fenestrations such as the side porch roof structure, and side doors with jambs and sills were lost in the fire. There remain no physical examples of these elements after the fire. Please refer to archival photos for porch photos.

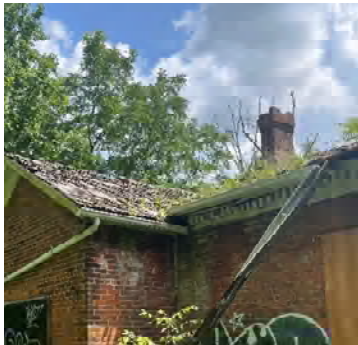
Figure 19 View of the existing chimney at the rear of the building.

The chimneys were found to be in very poor condition. As shared in structural assessment report prepared by Tacoma Engineers dated August 17, 2023 'The three chimneys were found to be in intact, but in very poor condition. The chimneys have loose bricks at the top that are considered a fall hazard.' Hence the existing chimneys are not in a salvageable condition and would need to be removed.
