1284 Main Street East
Hamilton, ON

CULTURAL HERITAGE IMPACT ASSESSMENT

August 1, 2023

1284 MAIN STREET HAMILTON CONDITION ASSESSMENT

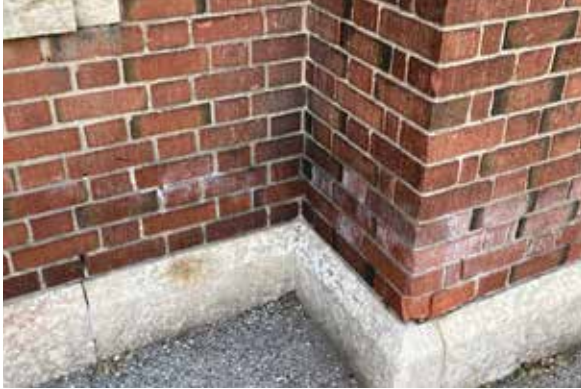
Fig. 1. Example of minimal spalling and efflorescence.

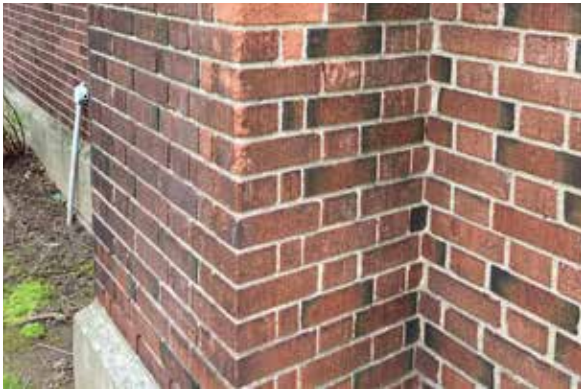
Fig. 2. Example of minimal spalling.

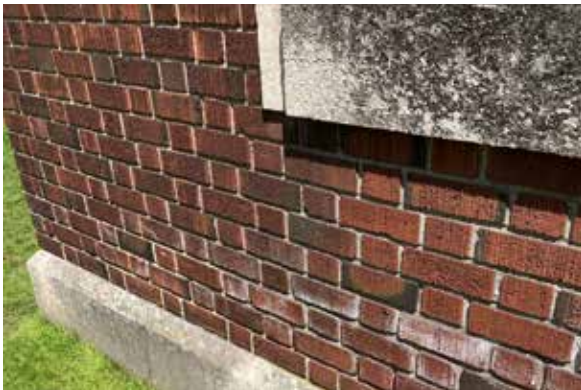
Fig. 3. Example of efflorescence towards base of exterior.

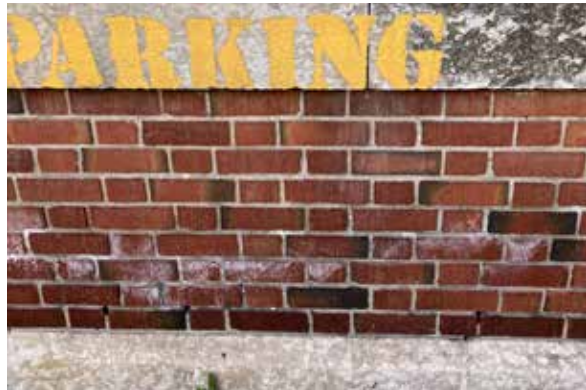
Fig. 7. Example of efflorescence towards base of exterior.

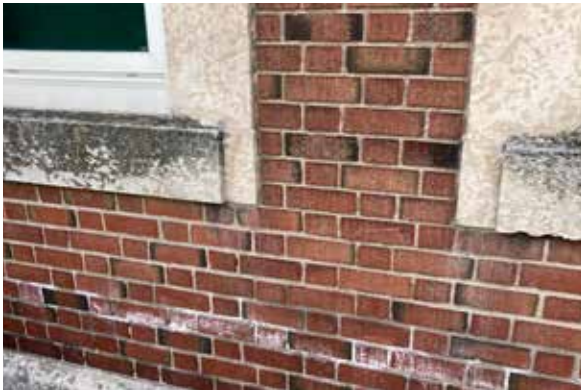
Fig. 4. Example of efflorescence towards base of exterior.

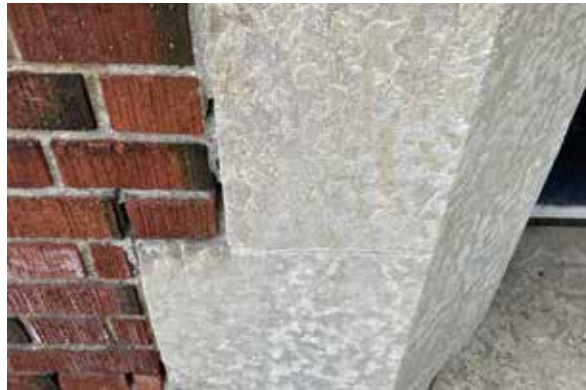
Fig. 8. Recessed mortar joints between stone and brick.

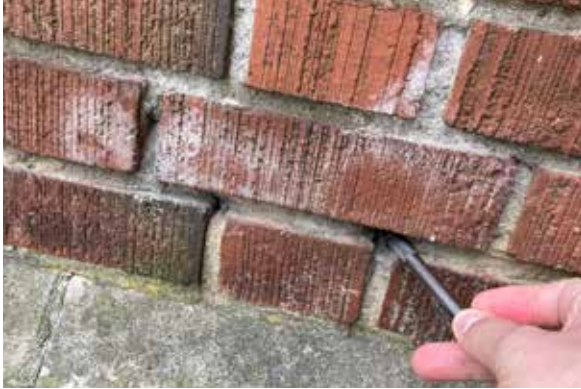
Fig. 9. Recessed mortar joints.

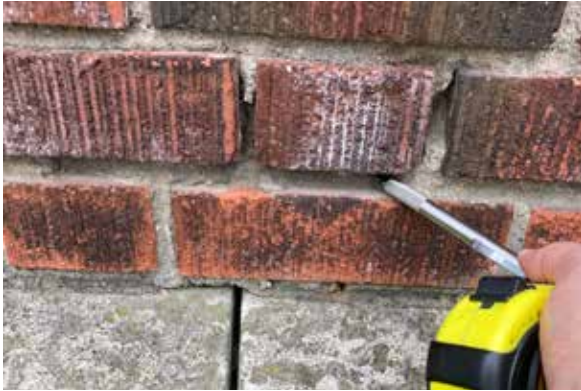
Fig. 10. Recessed mortar joints.

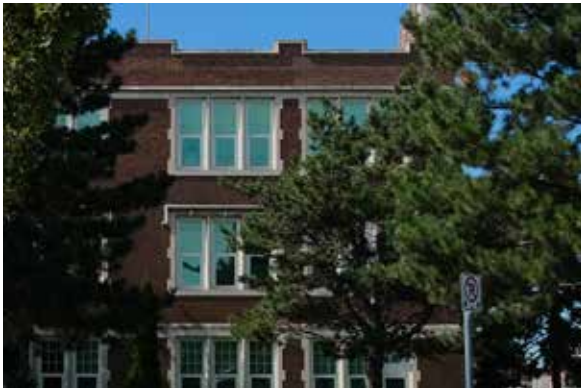
The North Front Wing, representing the portion of the building completed in 1924, is constructed of solid brick and stone masonry at the exterior walls, set into a concrete and steel structural frame that supports reinforced concrete floors. The backup wall behind the face brick and stone is comprised of 12” hollow clay tile. The exterior face brick entrance, parapet coping, and east, west and central towers. The rug face brick is in generally good condition, with only minimal spalling and chipping in evidence (Fig. 1 & Fig. 2) and minor concentrations of efflorescence predominantly near the wall base (Fig. 3 - Fig. 7). The efflorescence is consistently represented as a tide mark across the first several brick courses, most notably at the north and east elevations, and is likely a result of frequent snow buildup and leaching of soluble salts into the masonry. Mortar joints are slightly recessed from the brick face and in good condition generally, with localized erosion and loss of material occurring primarily near the base of the exterior walls (Fig. 8 - Fig. 10). Joints along the Tyndall limestone base and window sills are generally washed out. Select portions of the building appear to have been previously repointed, as evidenced by the change in appearance of the mortar joints near the top of walls (Fig. 11).

Fig. 11. Evidence of repointing in the lighter areas of brick.

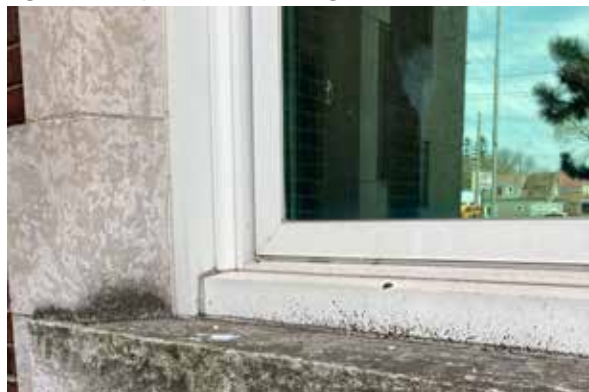
Stone elements on the exterior walls are generally in good condition, with only minor cracking and chipping in select areas (Fig. 12 - Fig. 14). Frequent staining, light surface pitting and occasional organic growth was observed at window sills (Fig. 15 - Fig. 17). A number of sills in the east and west parking lot areas have been overpainted (Fig. 18 - Fig. 20).

Fig. 16. Significant stone staining and organic growth.

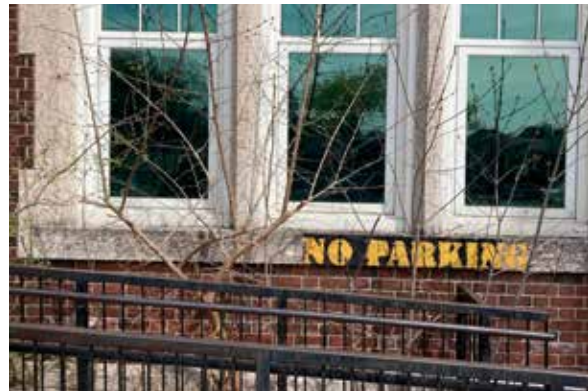
Fig. 19. Example of overpainting on exterior sills.

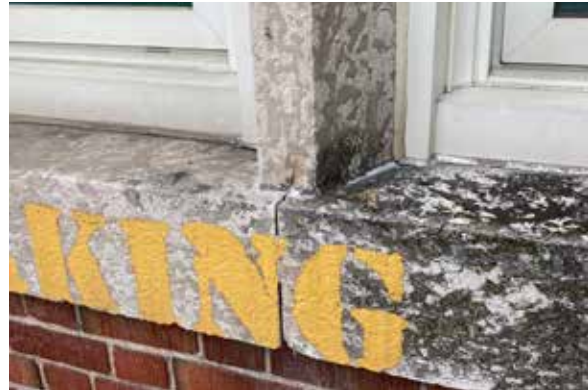
Fig. 20. Example of overpainting on exterior sills.

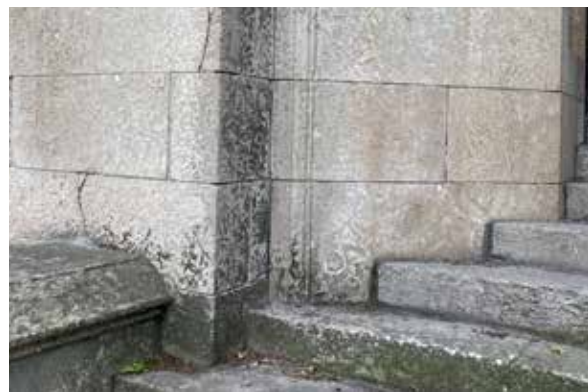
The front entrance features a pointed archway and decorative surround flanked by gabled pilaster elements. Joints have typically eroded in this area (Fig. 21), with moderate pitting and loss of detail observed in areas around the archway (Fig. 22). Large cracks have formed at the base of both pilasters, with complete fracture and loss of material on the west side (Fig. 23 - Fig. 25). The stone front steps are generally worn, with moderate surface pitting, staining and organic growth noted throughout (Fig. 26). A section of missing stone on the west pilaster was observed, which is indicative of a previous patch repair held in place with mechanical fixings still embedded in the stone (Fig. 27). There is significant ivy overgrowth on the west side of the tower, which impeded most observation of the underlying masonry at the time of inspection (Fig. 28). In the areas that were visible, joints appear to be generally washed out (Fig. 29).

Fig. 21. Eroded stone joints & organic growth.

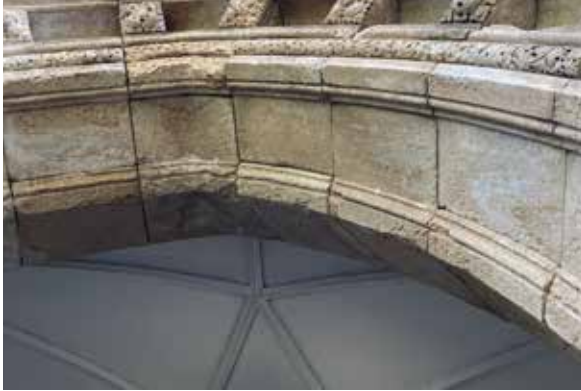
Fig. 22. Moderate pitting and loss of detail in stone arch.

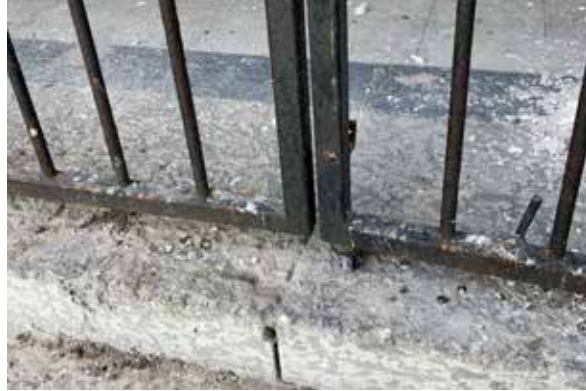
Fig. 26. Damage and staining to steps.

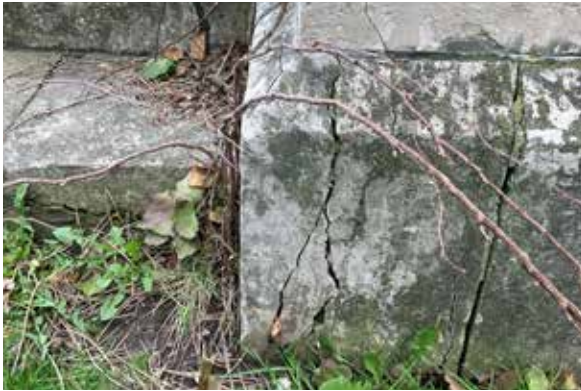
Fig. 23. Large cracks at base of pilasters.

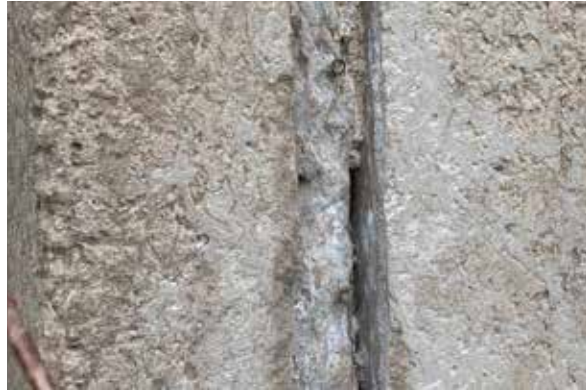
Fig. 27. Evidence of patch repair damage to stone.

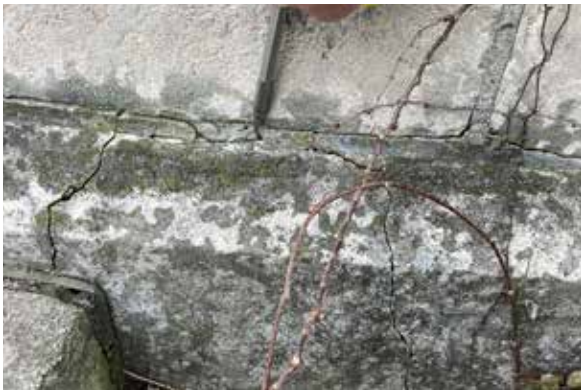
Fig. 24. Large cracks at base of pilasters.

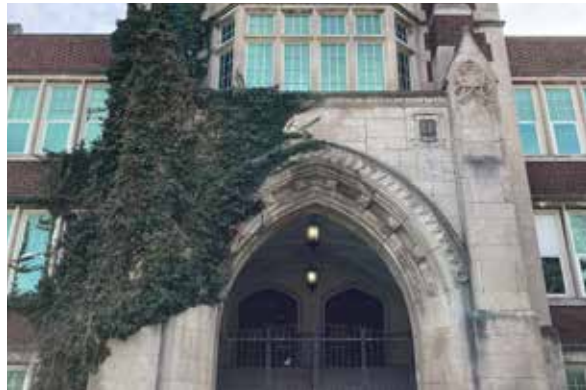
Fig. 28. Growth on the tower impeded proper inspection.

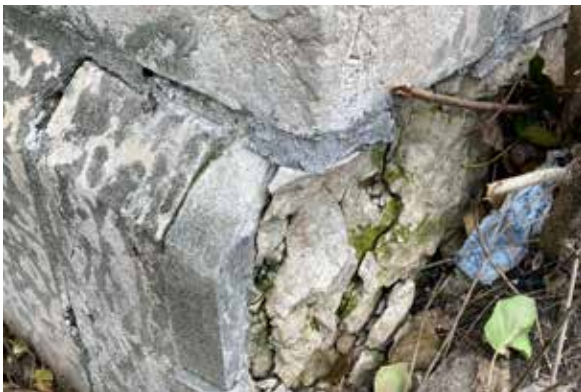
Fig. 25. Large cracks at base of pilasters.

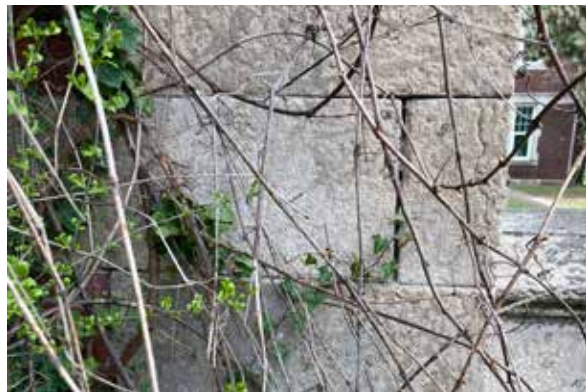
Fig. 29. Washed out joints are visible behind growth.

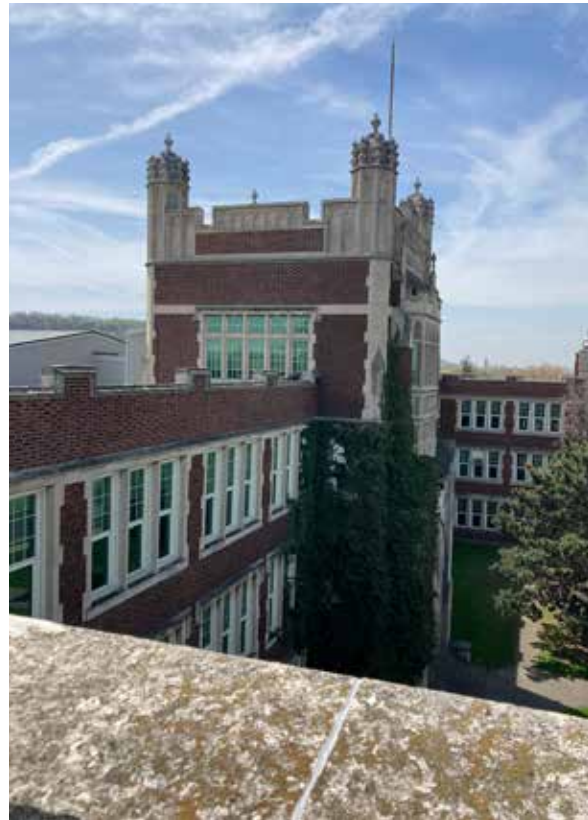
Fig. 31. Evidence of patch repair damage to stone.

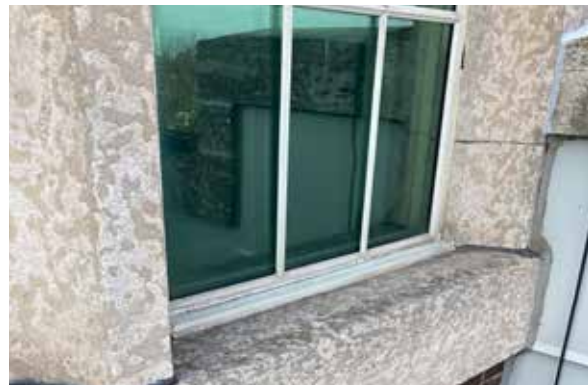
Overall, the decorative stone carved elements at the upper portion of the central tower and east and west facades, appear to be in a good state of repair (Fig. 30 - Fig. 32). An unsympathetic joint sealant was used to point the east facing stone window surrounds of the central tower (Fig. 33).

Fig. 33. Washed out joints are visible behind growth.

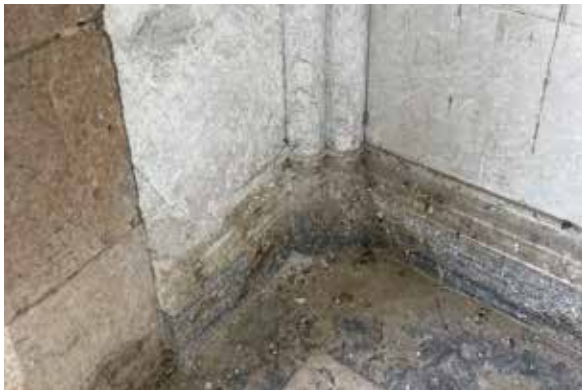
The rib vaulted entrance stair is in fair to good condition overall, with most ceiling and wall elements intact – particularly towards the top of the stair. There is some local deterioration of the stucco coating and rib elements lower down at the outer wall, notably around the upper half of the stone archway (Fig. 34 & Fig. 35). These areas appear to have suffered extensive wetting leading to corrosion and rust-jacking of the expanded metal lath, as well as localized failure of the stucco from freeze-thaw damage. There is general soiling of finish surfaces throughout, primarily from dirt and pigeon droppings (Fig. 36 & Fig. 37). Metal handrails are not original but remain serviceable.

Fig. 36. Soiling at base and floor.

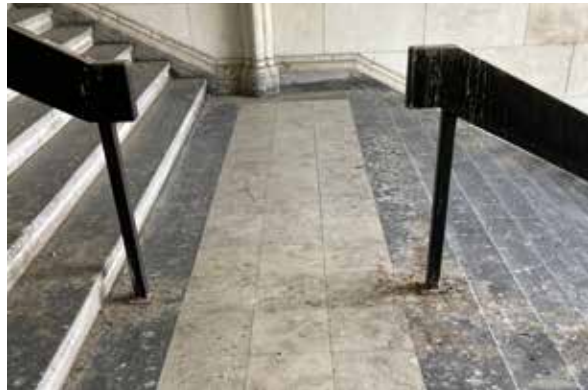
Fig. 37. Soiling at base and floor.

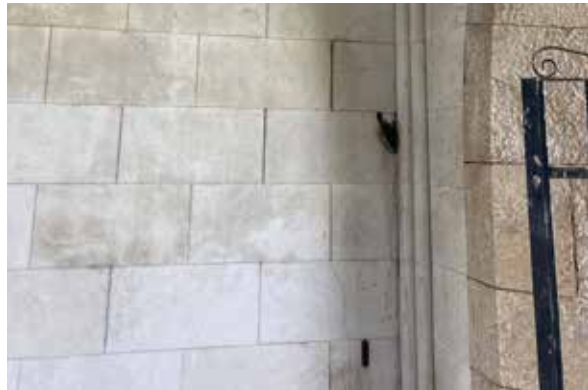
Marble veneer wall panels are in good condition, with some local deterioration and a missing piece on the north face (Fig. 38). Graffiti markings were noted at the west side of the upper landing. Most wall joints have opened and are in need of repointing. A central pendant light fixture was operational at the time of inspection and appears to be in good condition with general soiling evident on the outer surfaces (Fig. 39). Marble steps appear in fair to good condition, with moderate surface wear and occasional vertical cracking found on individual risers.

Fig. 38. Missing piece of marble veneer.

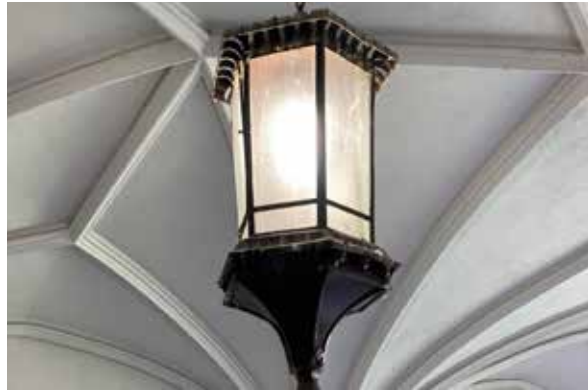
Fig. 39. Minimal soiling on outer surface of pendant light.

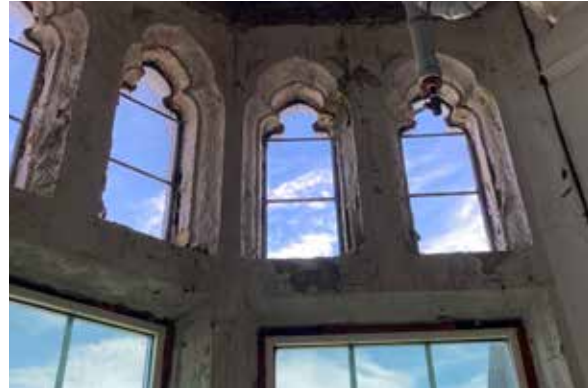
Most of the original windows in the North Front Wing have been replaced with new metal clad vinyl sash windows with insulated glazing units, fabricated to approximate the original appearance. The replacement glass has a reflective low-e coating and strong greenish tint. The windows appear to have been installed in 2004 and are in good condition generally, with no visible signs of condensation, damage or disrepair. Caulking at the brick moulds ranges from fair to good condition overall, with some areas exhibiting light crazing and debonding at the Tyndall stone (Fig. 40). The upper row of trefoil arched openings near the top of the central tower features the original glazing, which appears to be in good condition (Fig. 41 & Fig. 42).

Fig. 42. Trefoil arched openings with original glazing.

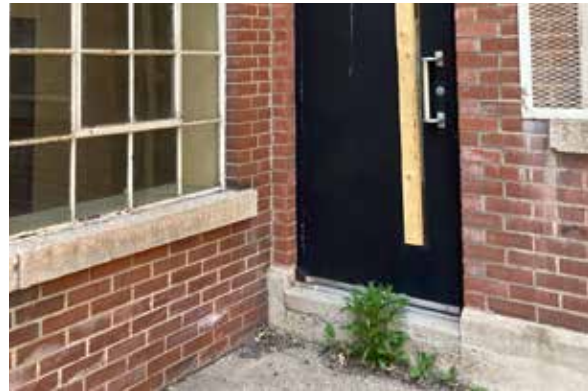
Fig. 43. Cast in place concrete base wall.

Courtyard walls are comprised of smooth faced red brick laid in stretcher bond, with Tyndall limestone elements at the ground floor windows and parapet coping. There is a cast stone band course above the ground floor windows on the north wall, and the wall base consists of cast in place concrete (Fig. 43). Upper floor windows in the courtyards feature cast stone sills (Fig. 44). In the east courtyard, there has been extensive brick replacement on the north wall using an unsympathetic substitute brick (Fig. 45). This brick has also been used to infill the original clerestory windows of the east upper wall of the auditorium (Fig. 46). There is severe efflorescence with occasional spalling on the lower portion of the wall (Fig. 47 & Fig. 48), which is indicative of previous water ingress at the window jambs and sills. Flashing has been added to shed water from the headers of the first floor windows (Fig. 49 & Fig. 50), and PVC downspouts have been added at both lower and upper roofs (Fig. 51). There is a displacement in the upper downspout, which has led to failure of the water management system at this location. Noticeable staining and organic growth around the roof drain is indicative of excess water and inadequate drain capacity. There is significant vegetal overgrowth at the base of the north wall (Fig. 52).

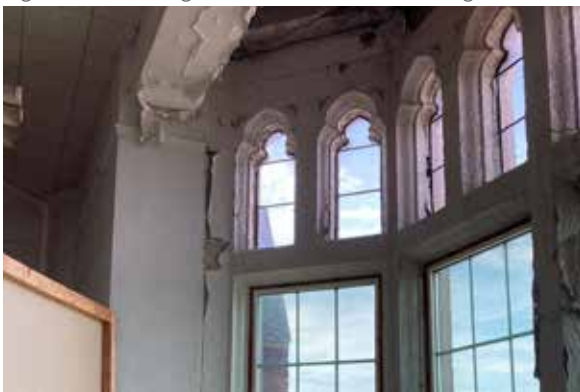
Fig. 41. Trefoil arched openings with original glazing.

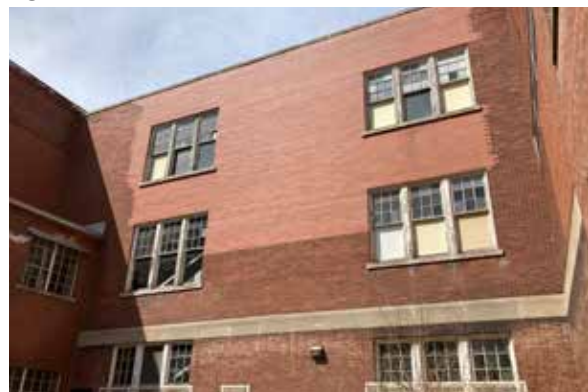
Fig. 45. Unsympathetic brick replacement.

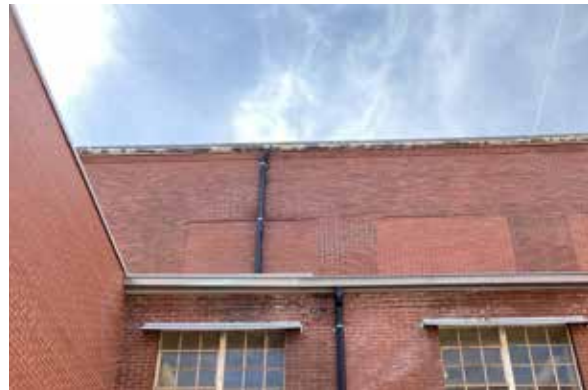
Fig. 49. Added flashings over first floor windows.

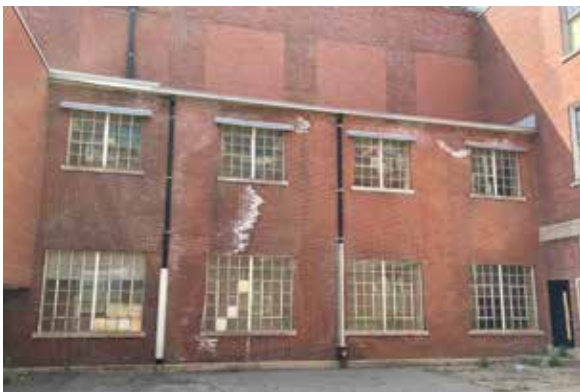
Fig. 46. Brick infill of pre-existing clerestory.

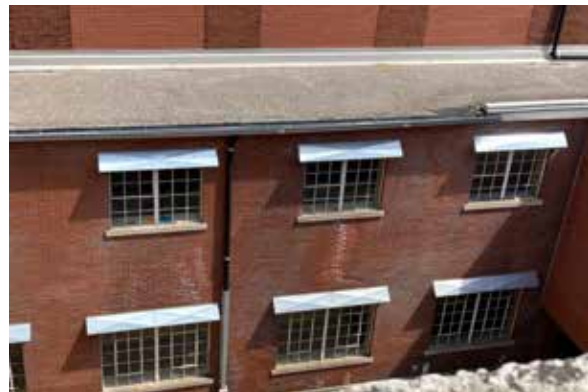
Fig. 50. Added flashings over first floor windows.

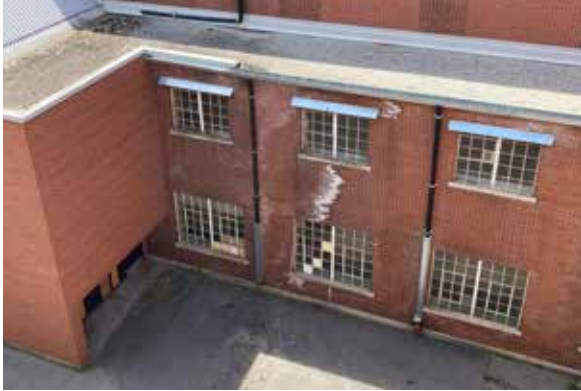
Fig. 51. Added flashings and PVC downspout.

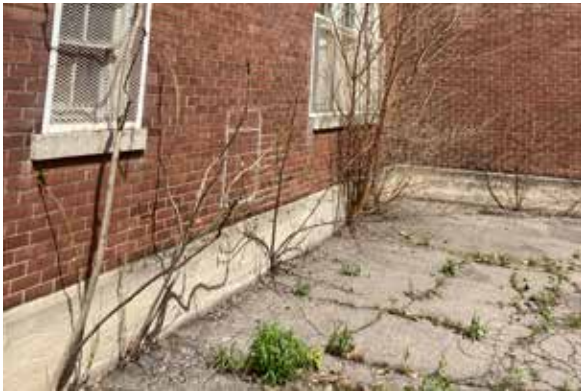
Fig. 52. Vegetal growth at base of north wall.

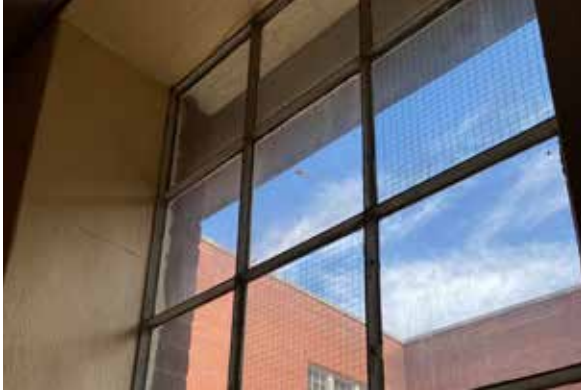
The adjacent walls enclosing the auditorium corridor feature eight original steel factory glazed windows, arranged in a grid pattern with operable casements on the ground floor. Many of the individual lites have been replaced as part of a previous repair and maintenance program (Fig. 55 & Fig. 56). The steel frames have been overpainted several times making it difficult to assess the condition of the underlying steel (Fig. 57). Occasional corrosion blooms were observed on the exterior frame, suggesting light to moderate corrosion of the steel substrate beneath the paint layer. Further testing will be required to confirm this. Caulking joints around the windows have generally cracked and have completely failed at the sills (Fig. 58).

Fig. 56. Replaced window lites.

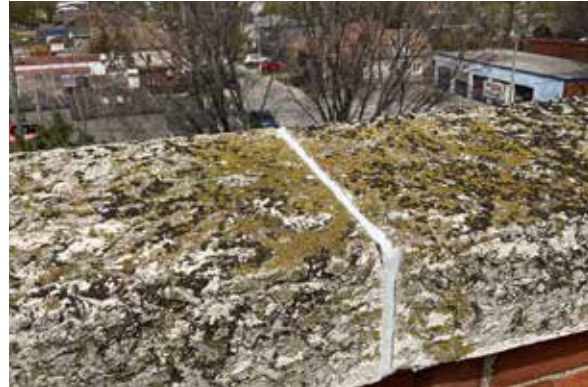
Fig. 60. Pitting, staining and organic growth on parapet.

Moderate to severe surface pitting of the Tyndall coping stones was generally noted, with some areas exhibiting staining and organic growth (Fig. 59 - Fig. 61). Some older joint sealants at the coping stones and parapet wall flashing have generally reached the end of their service life (Fig. 62), while more recently applied sealants appear to be performing adequately (Fig. 63 & Fig. 64) with only a few areas exhibiting visible signs of stress and related degradation (Fig. 65 & Fig. 66). The smooth-faced brickwork ranges from good to poor condition generally, with some sections exhibiting varying degrees of spalling and surficial loss (Fig. 67 - Fig. 70). Mortar joints are in fair condition overall, with occasional erosion and loss of material (Fig. 69 & Fig. 71). Other sections of the parapet wall have cracked along joints (Fig. 72). Some previous spalls and open joints have been patched with an incompatible cement (Fig. 70, Fig. 73- Fig. 76).

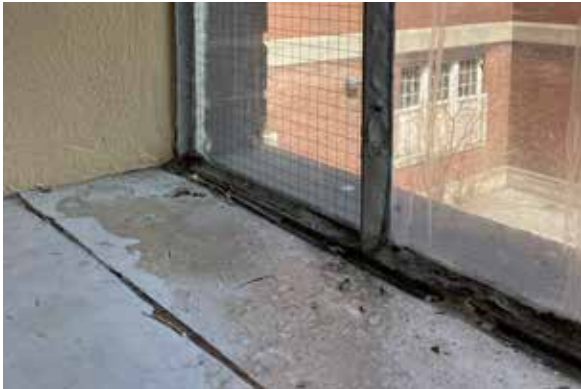
Fig. 57. Overpainting of steel frames.

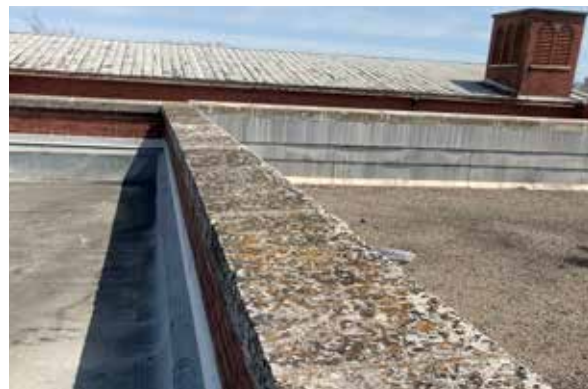
Fig. 63. Pitting, staining and organic growth on parapet.

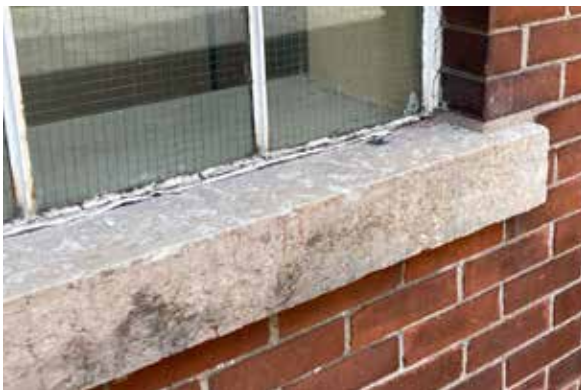
Fig. 58. Failed caulking joints at window sills.

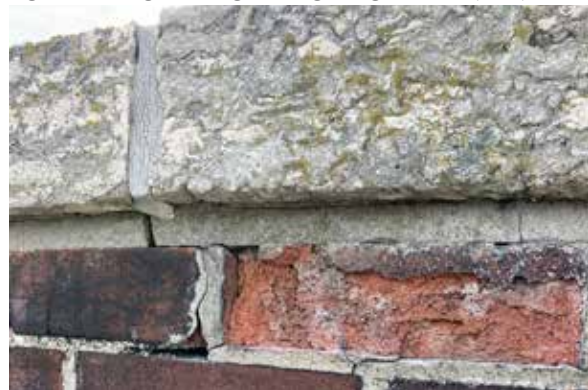
Fig. 61. Failed mortar joint.

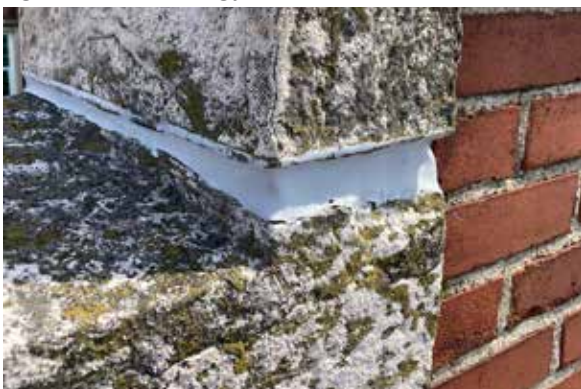
Fig. 59. Pitting, staining and organic growth on parapet.

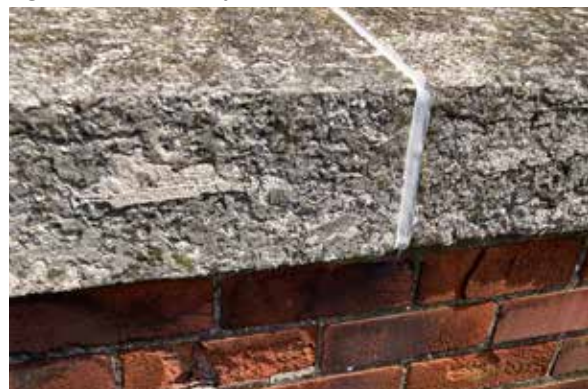
Fig. 62. Replaced mortar joint.

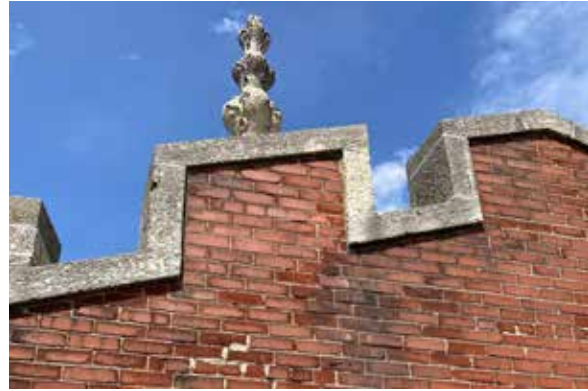
Fig. 66. Area of stone degradation and chipping.

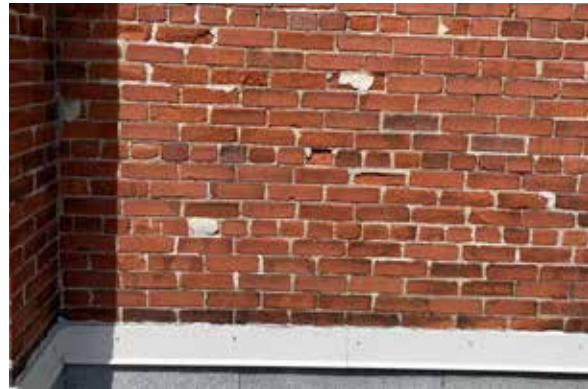
Fig. 67. Evidence of spalled brick and Incompatible repairs.

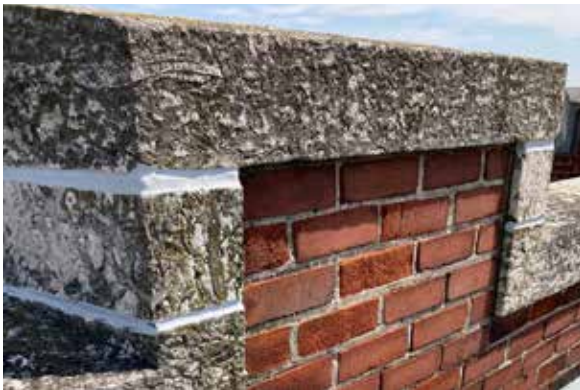
Fig. 64. Replaced mortar joint.

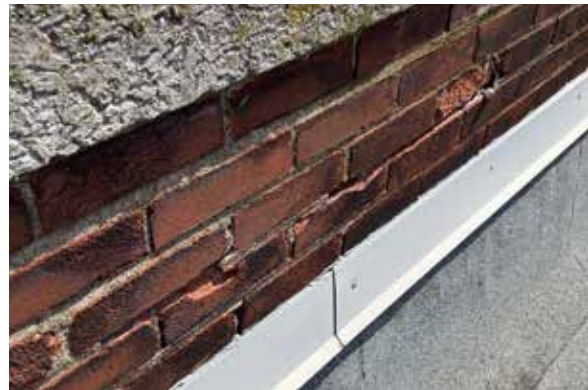
Fig. 68. Chips and spalled brick.

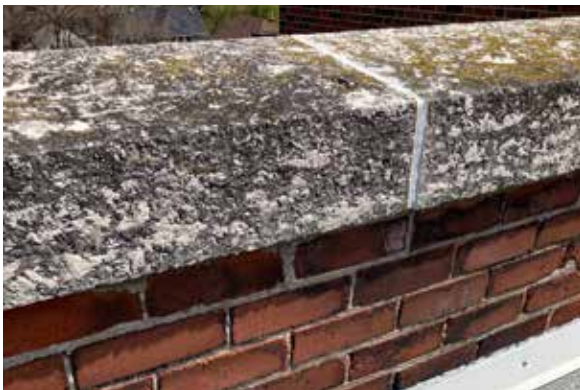
Fig. 65. Area of stone degradation.

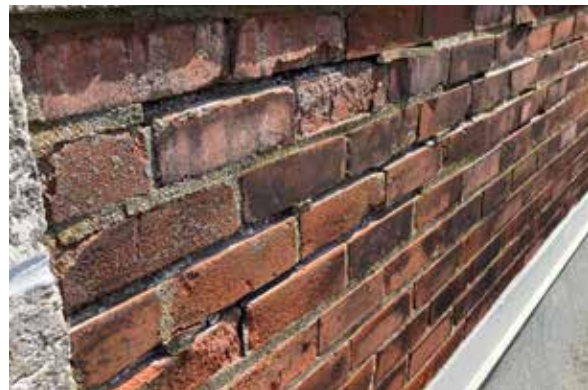
Fig. 69. Spalled brick and loss of mortar joints.

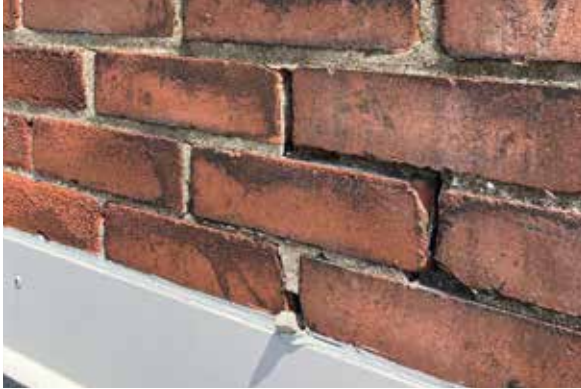
Fig. 71. Significant loss of mortar joints.

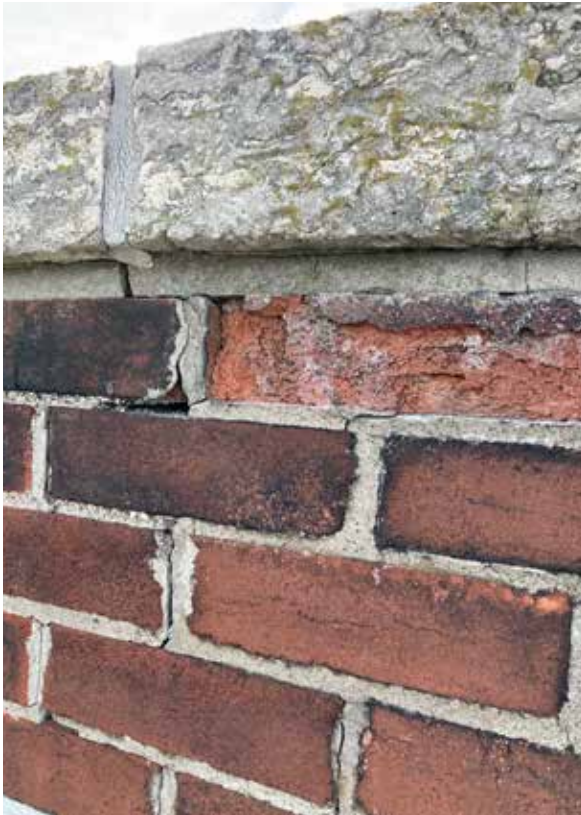
Fig. 72. Mortar cracking between bricks.

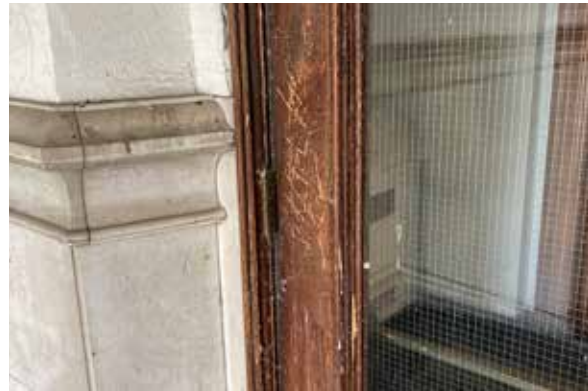
The north entrance doors are original and appear to be in fair condition generally, with some surface scratching present on the exterior facing stiles and bottom rails through repeated use and vandalism (Fig. 77 - Fig. 79). The exterior clear coat over the stain has begun to degrade, as evidenced by the general presence of crazing (Fig. 80 & Fig. 81). The top transom windows are in good condition, with original glass still present and few signs of disrepair aside from bird droppings along the sill line (Fig. 82). One small section of the moulding on the east transom has broken away (Fig. 83). Door hardware appears to be original, and glazing inserts have been previously replaced with wired safety glass (Fig. 84).

Fig. 78. Surface scratching of northern entrance door.

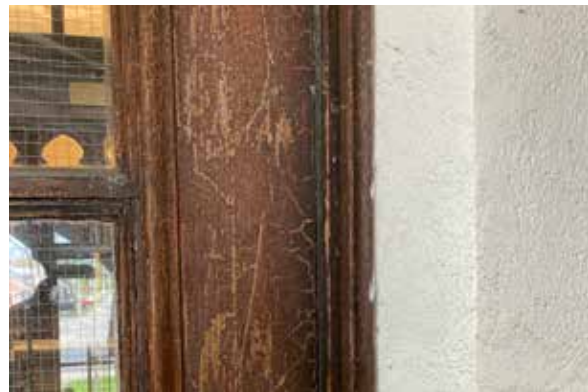
Fig. 79. Surface scratching of northern entrance door.

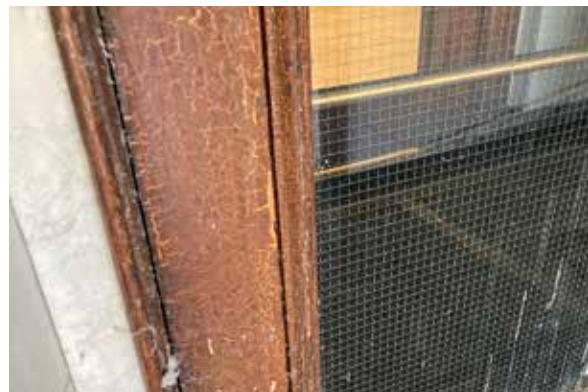
Fig. 80. Crazing of wood coating.

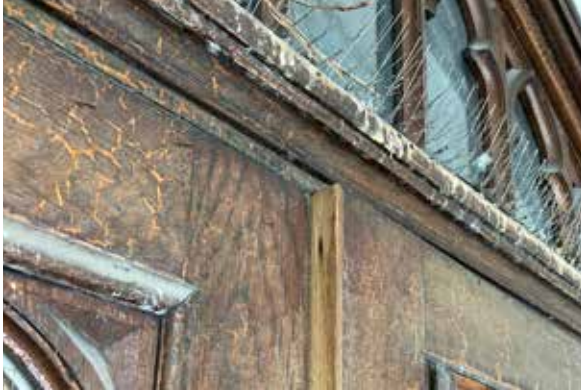
Fig. 81. Cracking of wood coating.

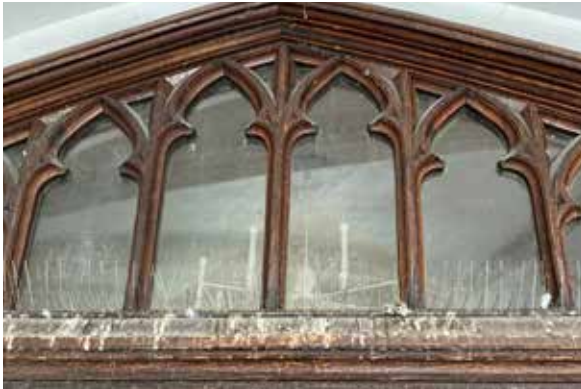
Fig. 82. Bird droppings on otherwise intact transom.

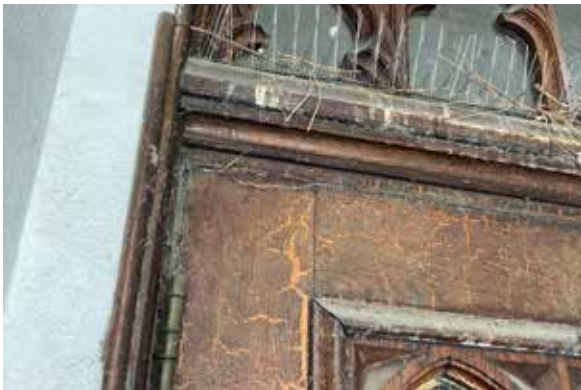
Fig. 83. Broken section of moulding below transom.

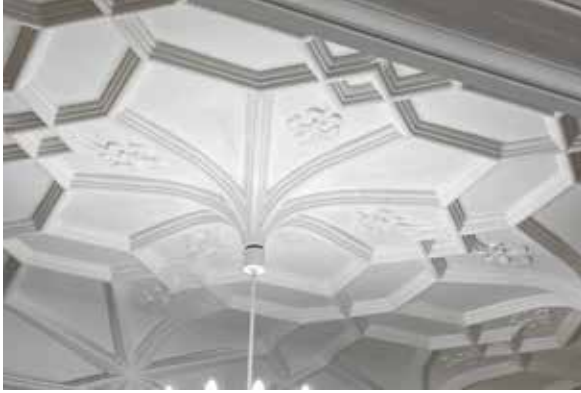
The main lobby and vestibule spaces are in good condition with most finishes, including plaster ceiling elements, original wood doors and marble flooring, intact and exhibiting only minimal signs of surface wear on the floor and doors (Fig. 94 - Fig. 97). The existing pendant lights in the lobby and vestibule are not original. Further destructive work is needed to confirm that the original wood paneling was removed as part of the 1970s renovations (Fig. 98).

Fig. 94. Main lobby plaster ceiling.

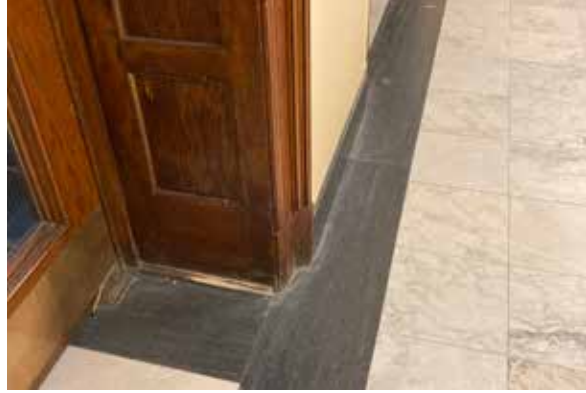
Fig. 97. Main lobby surface wear.

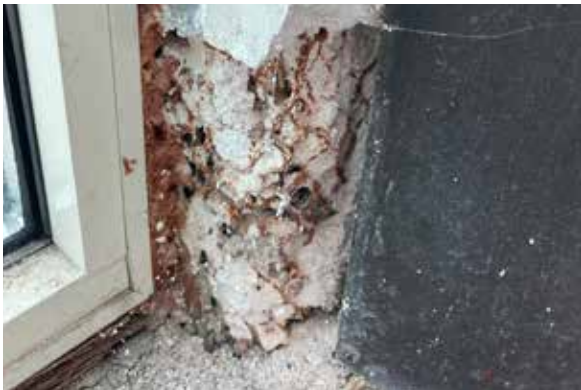
Fig. 112. Deteriorated wooden sills.

Interior wood sills have generally deteriorated near the windows (Fig. 112). The trefoil arched single glazed openings above the window appear to be original and intact (Fig. 113). Below these openings, fixed vinyl replacement windows have been installed.

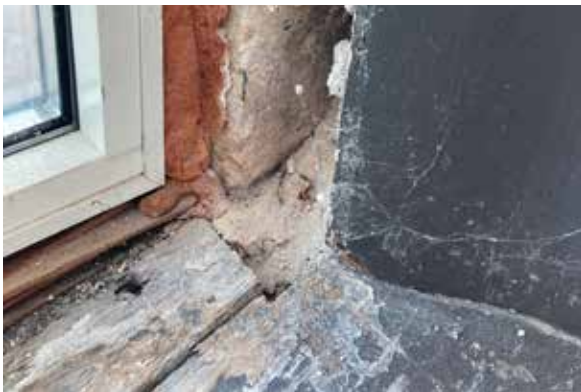
Fig. 109. Failed concrete sill.

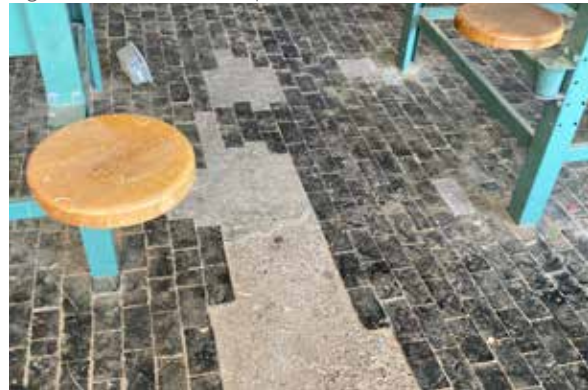
Interiors are in a good state of repair generally, having gone through previous renovations. Ceilings have been overlaid with suspended acoustic tile, and floors consist of mastic tile. It is unclear if the mastic tiles are original or a later replacement. The wood shop consists of a 2 in. thick wood block floor over a concrete slab. The block floor is generally intact and in good condition, with moderate to heavy surface wear throughout and a few areas patched with concrete (Fig. 116 & Fig. 117).

Fig. 116. Block flooring concrete patches.

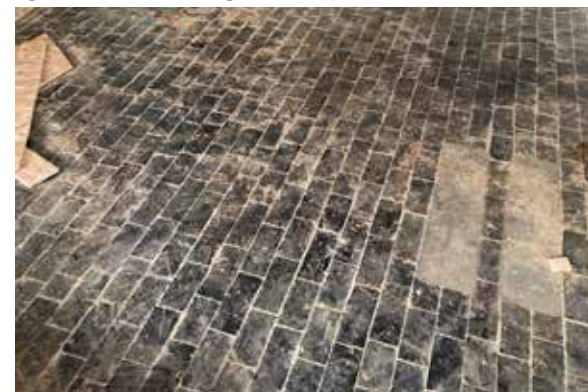
Fig. 117. Block flooring concrete patches.
