TREE INVENTORY AND PROTECTION PLAN

616 Mill Street
City of Hamilton
September 2023

SUBJECT: Tree Inventory and Protection Plan, 616 Mill Street, City of Hamilton

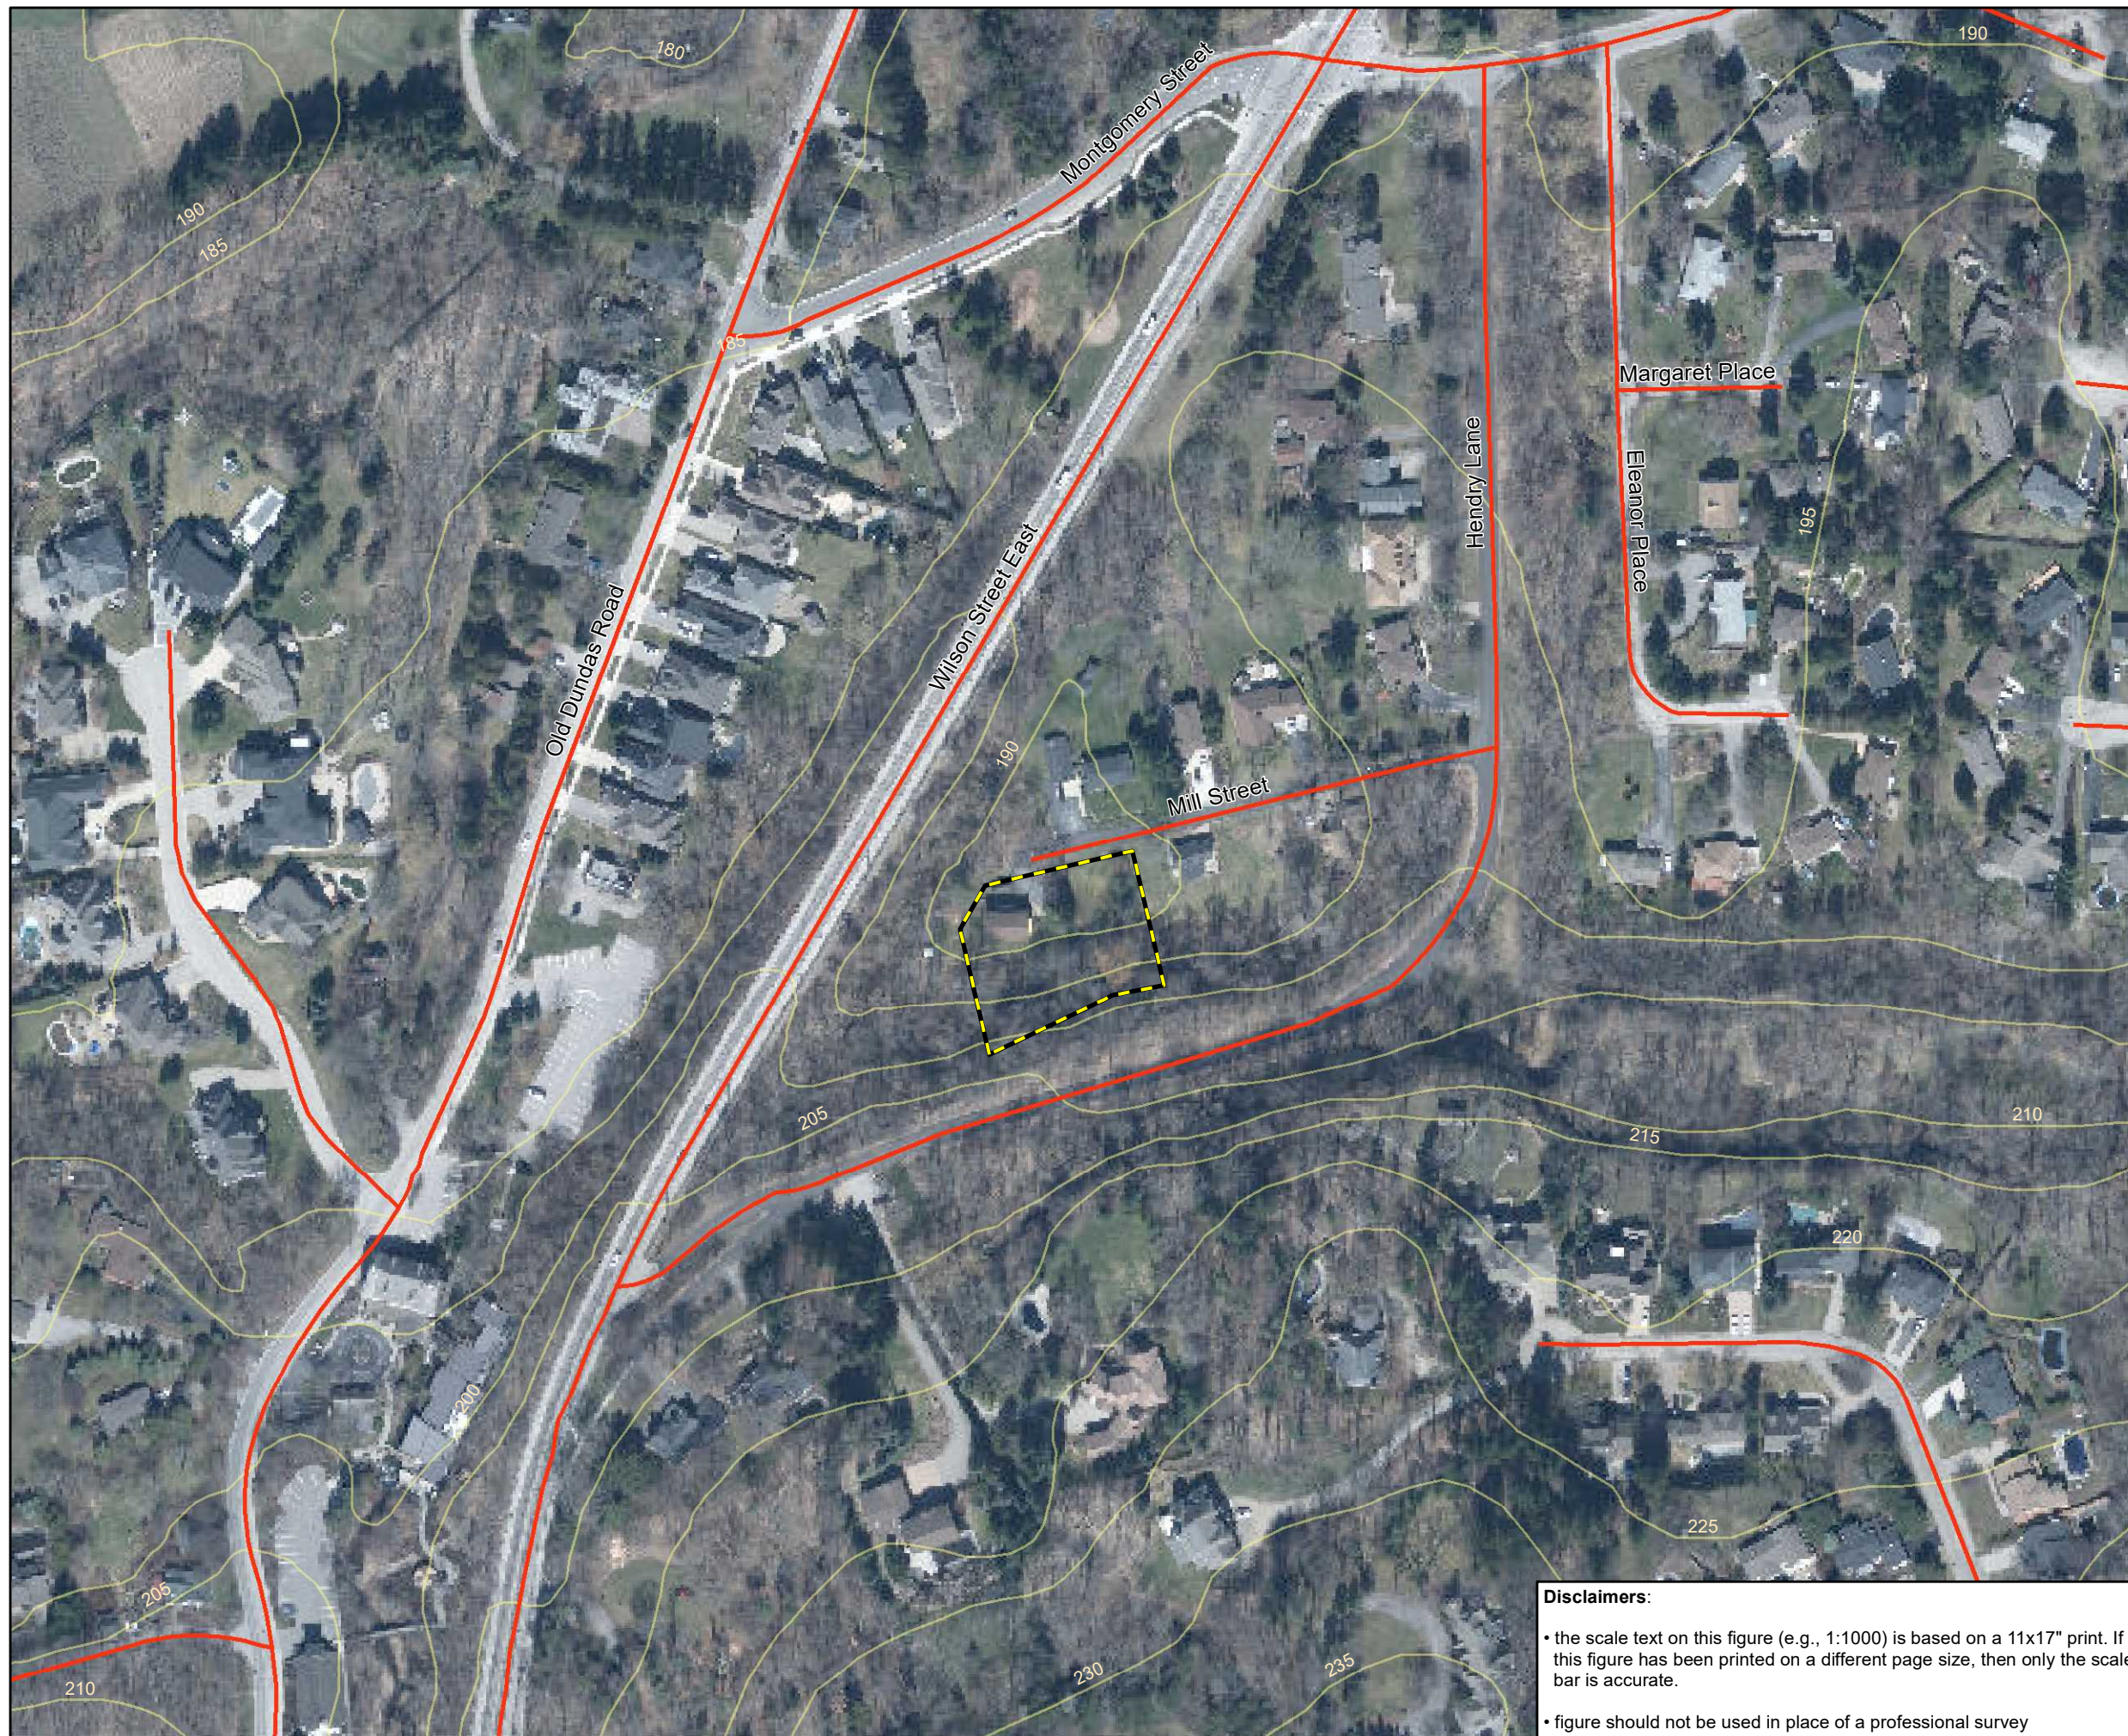
- Severed Lot 1 – Trees 947, 948, 949, 950 and 951 are assumed to require removal for development. All of these trees are in fair to good condition and located within a landscape feature where limbs have been pruned and undergrowth suppressed.
- While trees 944, 945 and 946 are located solely on the retained lot, these trees should be considered boundary trees due to their location to the property boundary. Any maintenance (e.g., pruning), removal or work within the dripline of these trees requires permission from the adjacent property owner.
- Tree protection fencing is recommended along the edge of the significant woodland and to the severance side of tree 944, 945 and 946 as indicated on Figure 3.
