CULTURAL HERITAGE IMPACT ASSESSMENT

**89 Park Street North,
Hamilton**

Date:
October 2023

Prepared by:
**MacNaughton Hermesen Britton Clarkson
Planning Limited (MHBC)**
200-540 Bingemans Centre Drive
Kitchener, ON N2B 3X9
T: 519 576 3650
F: 519 576 0121

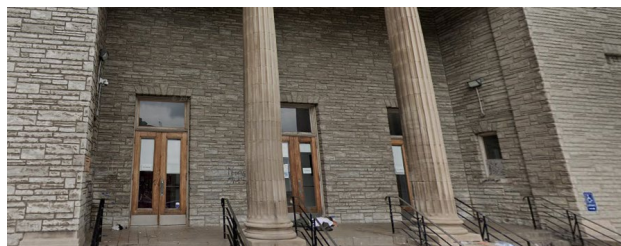
All wood double doors within the portico along the Park Street North façade

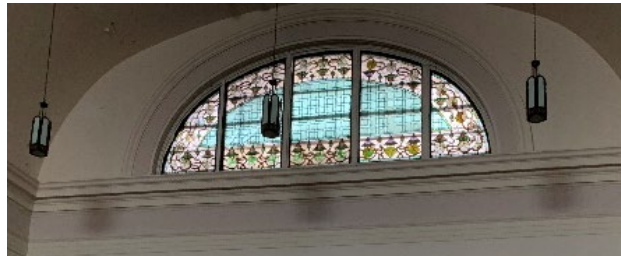
All stained-glass windows including those along the ground floor of the York Boulevard elevation and the ellipse windows within the roof gables

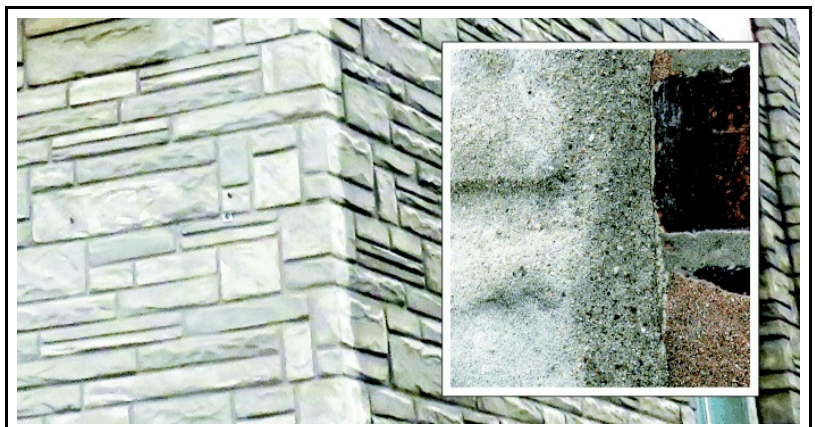
- 4.1 It was observed that the cement-based mortar had been plastered/parged over the brickwork to simulate rock-faced ashlar modular-coursed stone masonry. (Photograph 1) Although it varied, from a review of the termination joint with the side elevation brickwork, the mortar appeared to have been applied at a nominal minimum one-inch thickness within the simulated mortar joints. (Inset image)

Photo 1 with inset image: The mortar was plastered over the brickwork to simulate the appearance of ashlar-coursed stone masonry. The minimum thickness varied but appeared to be a nominal 1-inch minimum within the simulated mortar joints.

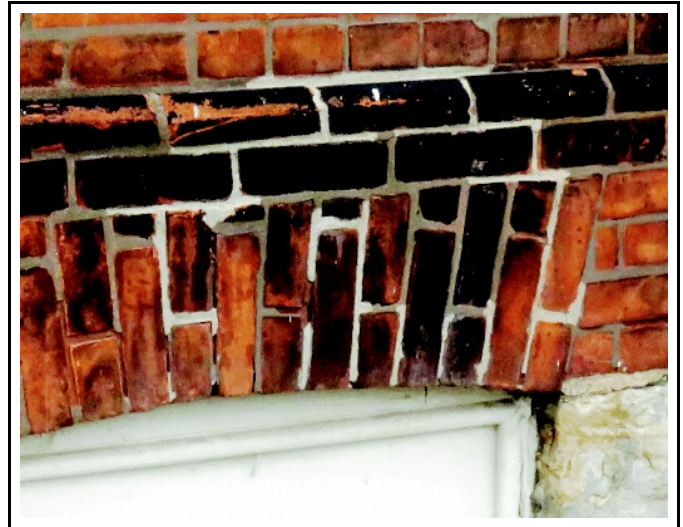
- 4.4 There was also evidence within the side elevation that several attempts had been made to repoint deteriorated/cracked brickwork adjacent to window openings. It was also evident that joints have continued to deteriorate within the repointed areas.

Photo 3: Evidence of several attempts at repointing cracked or deteriorated mortar joints adjacent to window openings

- .1 It is the author's opinion that the damage has been caused - and continues to occur - because the lintels were not designed nor constructed to extend far enough beyond the openings. This has resulted in a concentration of gravity loads at the openings from the effects of wind, snow-loading, thermal movement, etc.

- .2 It is the author's opinion that similar damage must be anticipated to be revealed within other elevations, should the mortar be removed.

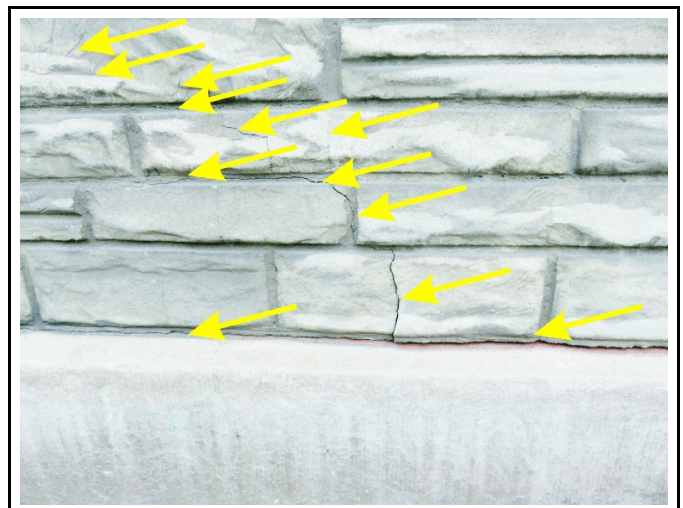
- 4.5 Although the extent is uncertain without further investigation, there was evidence that the mortar has cracked within some locations.

- .1 It is the author's opinion that additional damage to the underlying brickwork will have occurred due to the penetration of rainwater through the cracks. Experience indicates that this damage is likely to be in the form of crumbling of the bricks due to the expansive forces created during ice formation within the saturated masonry.

Photo 4: Evidence of cracks within the hardened mortar

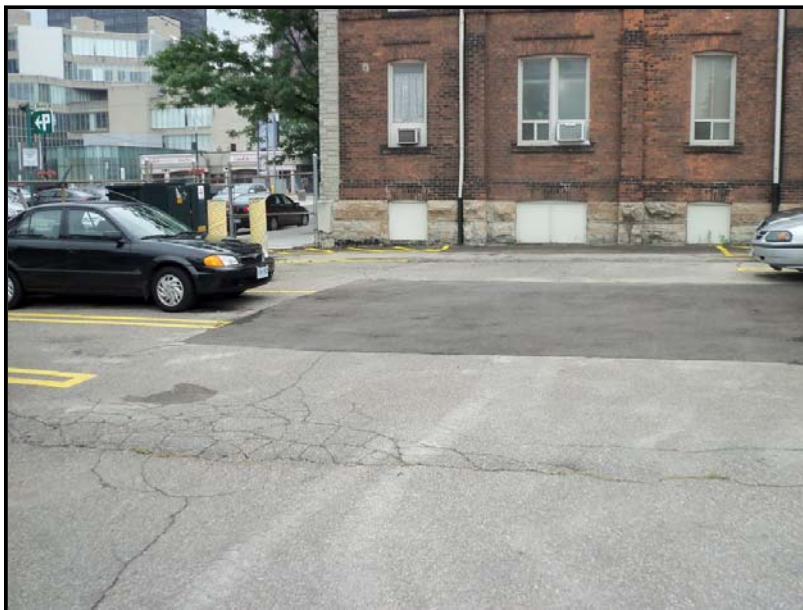
Photo No. 8: Asphalt at Church Lot

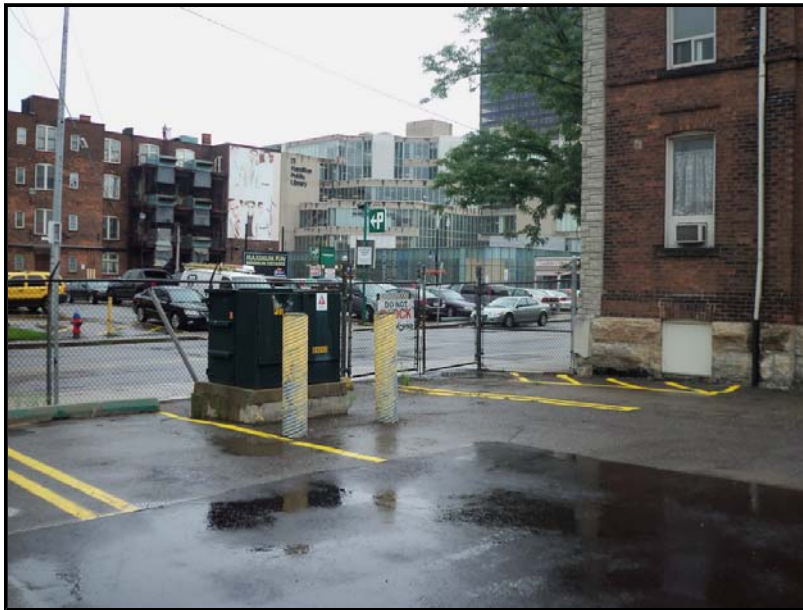
Photo No. 9: Electrical Transformer

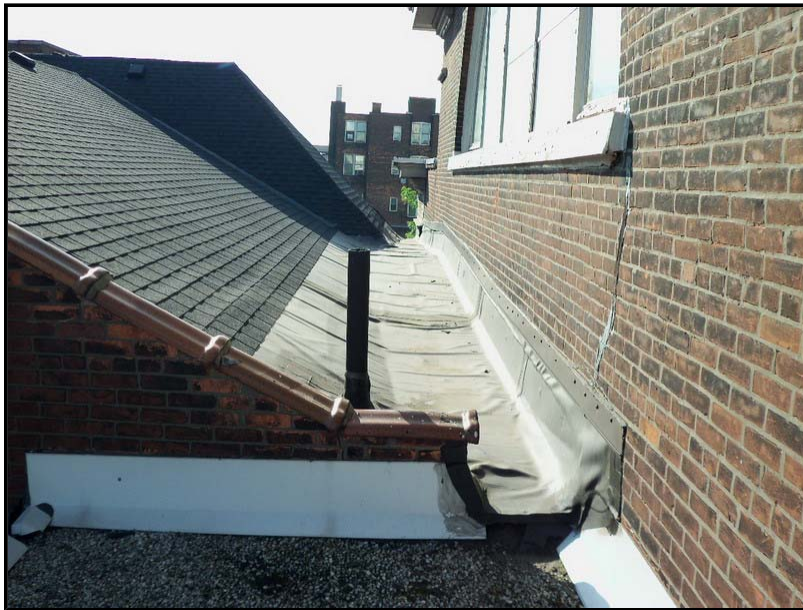
Photo No. 12: Roofing membrane at Original Building

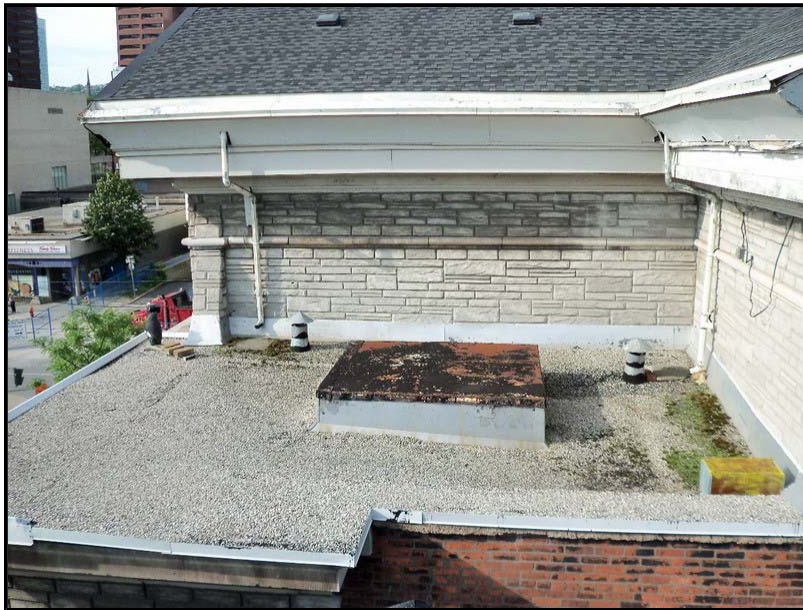
Photo No. 13: Sanctuary Corner Flat Roof

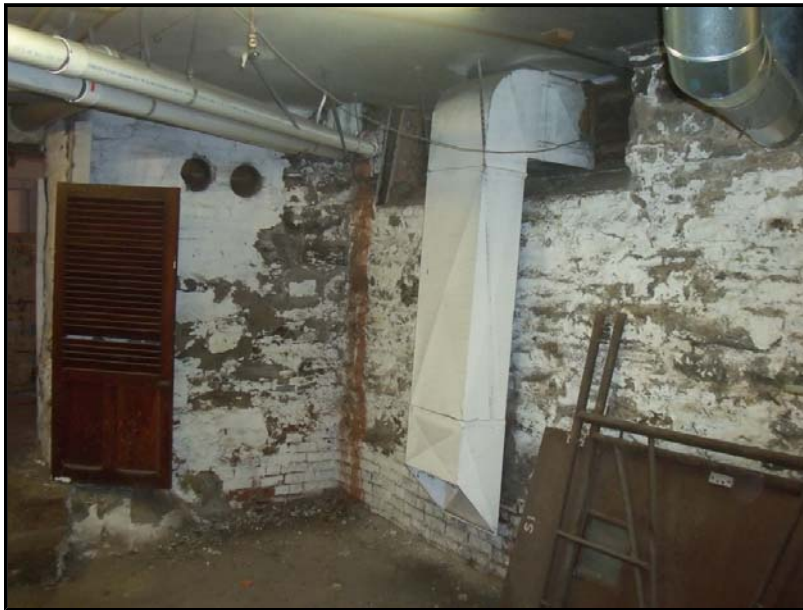
Photo No. 25: Stone Foundation

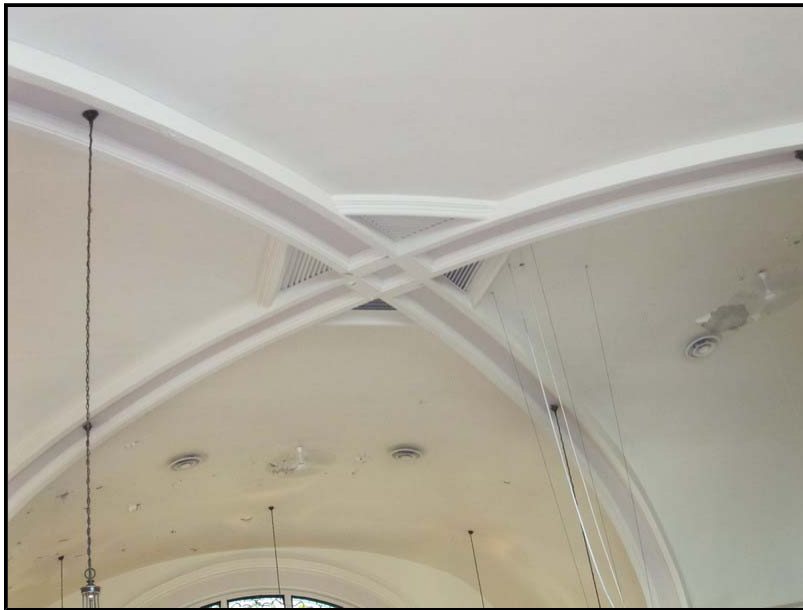
Photo No. 35: Sanctuary roof interior

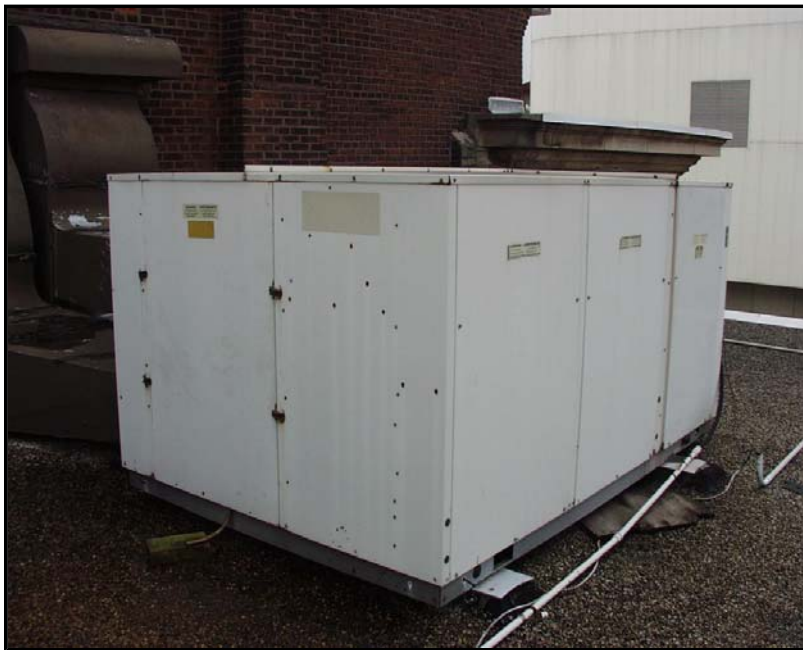
Photo No. 38: Older Keeprite Packaged Air Conditioner

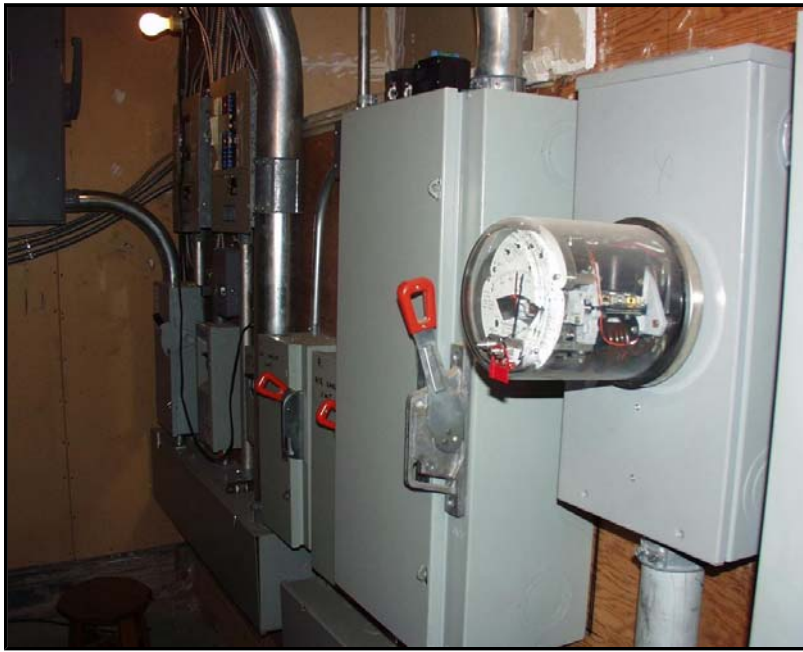
Photo No. 41: Typical Electrical Disconnects

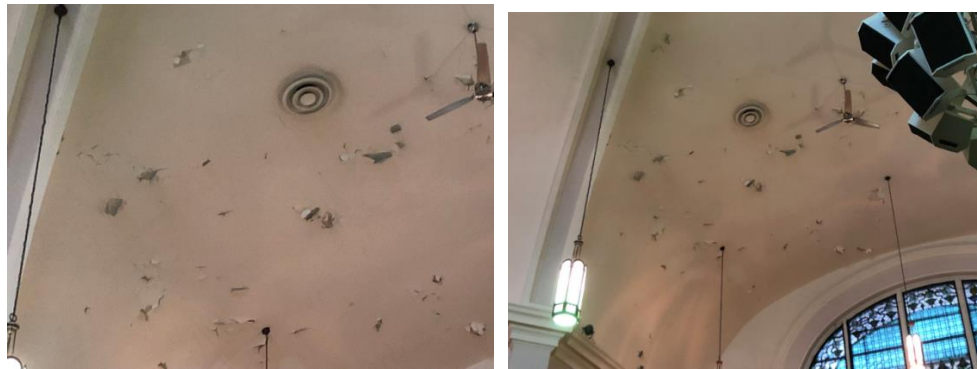
Figure 1: View of typical damage on Sanctuary ceiling

Regardless, the Sanctuary ceiling requires significant work to return it to a good condition. Combined with improvements to the attic insulation and vapour barrier, plaster repair and repainting will be required, and because of the design of the space this would only be possible with the installation of scaffolding on the floor of the Sanctuary, thus causing a temporary closure of the room so that the work could be done.

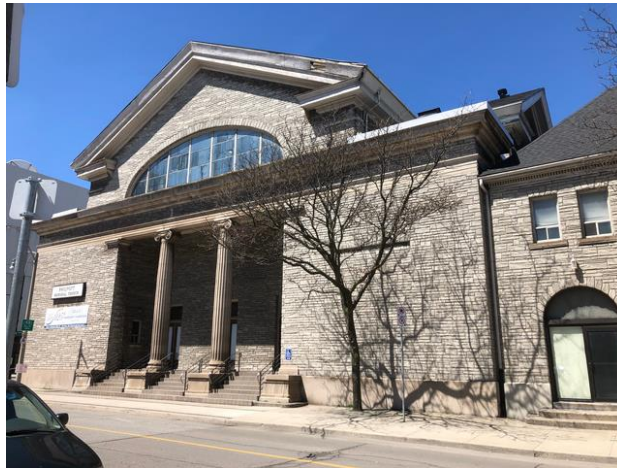
A major feature of the East elevation is a pair of decorative stone columns in a Corinthian style, with four matching bases. This assembly forms the main entry from Park St. with the bases forming the boundaries of, and defining the stairway at this location into three sections. The stone is exhibiting signs of weathering and deterioration. The original sharp edges of the features are rounded and dull, and there is staining from being exposed to the elements since 1906. There does not appear to be any cracking or other issues that would cause a concern about the structural capacity of the stones, however, any joints between adjacent stone pieces no longer have any sealant protecting them, allowing water to enter the interior cavity of the bases. On one of the bases this has caused significant movement within the assembly due to the freeze-thaw action affecting the water being able to displace the stones. Sealing all the joints and cleaning the stone is recommended in order to ensure these prominent assemblies do not worsen in condition.

Figure 2: East Elevation

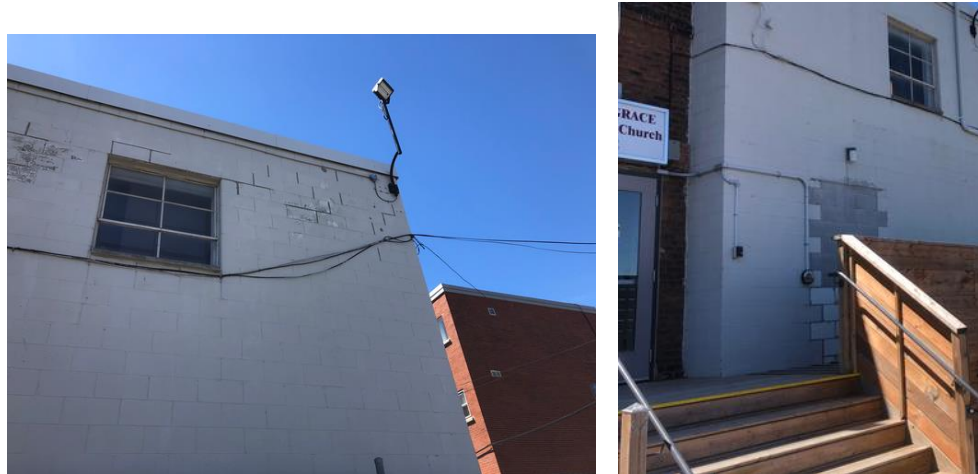
- Mortar joints with receding mortar
- Step cracking through the mortar lines
- Paint flaking and peeling

Figure 4: Views of typical masonry condition on North elevation

Evidence of past repairs including masonry repointing and infilling of former window openings was also noted. None of the individual areas or types of damage noted are considered significant, but when the sum of the damage is considered the actions required to make effective repairs can be considered a moderate size of project. It is estimated that about 25% of the wall area (2,000ft²) may require masonry repointing or other types of masonry repair while the entire concrete block wall masonry (8,000ft²) should be re-painted. An alternative to consider would be installing a new, more weather resistant and lower maintenance cladding system like pre-finished steel panels or similar, however, the initial cost to do this will be significantly more than the repairs.

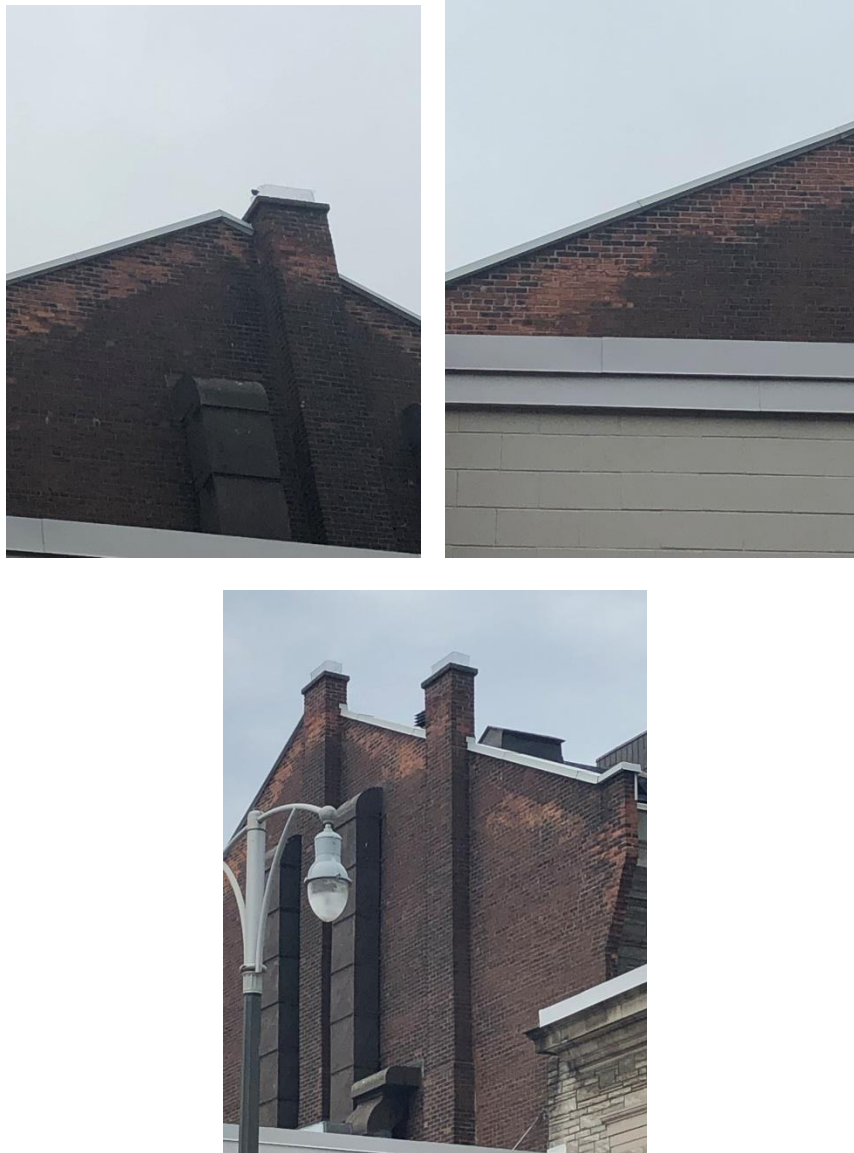
Clearly observed were bricks with delaminating faces (i.e. flaking brick material), most likely due to these walls not being insulated and being exposed to cold and moisture from snow and ice build-up against the back of the parapet on the roof side of the wall. Zoomed-in photographs show that besides the brick flaking and discoloration there were no other issues identified. No mortar appears missing, though there is evidence of past repointing repairs being done judging by the colour of the mortar in parts of the wall. While the damaged bricks do present a deficiency that needs addressing, it is not an uncommon type of deficiency in masonry buildings the age of Philpott Church, and could be repaired.

Figure 5: Parapet wall on West side of Sanctuary roof

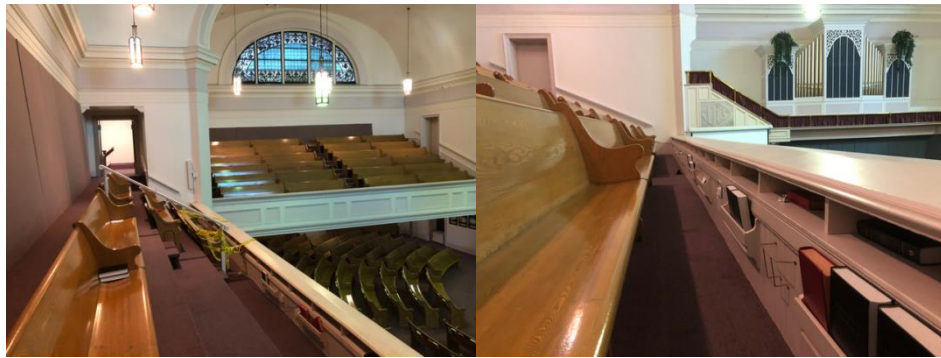
Figure 7: Views of the balcony overlooking Sanctuary

In order to correct this a possible solution is to install a handrail on top of the wall to the minimum heights required by the OBC. This could be a simple upgrade, but at a moderate cost point.

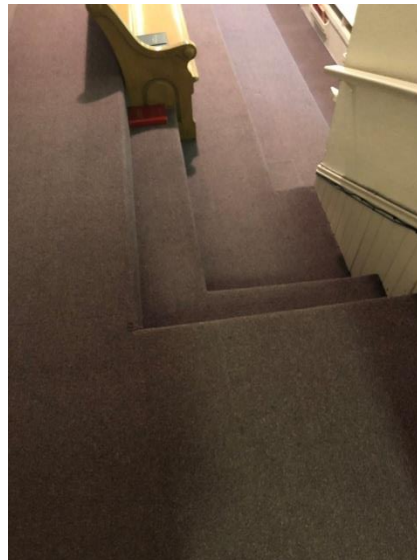
To access the balconies, users climb a main stairway (one at each corner of the East side of the Sanctuary) to reach the second-floor level, then descend another short flight of stairs to the balconies. These second stairways end with "L" shape stair treads in a corner, with a low railing on one of the stairways, but no railing on the other. The layout of the stairs combined with the low railings presents a potentially difficult access path for users, and one that could present a risk of falling to some users. This design should be reconsidered to incorporate a better railing system that minimizes the difficulty of using these stairs.

Figure 8: "L" Shape Stairway at Balcony Seating Area

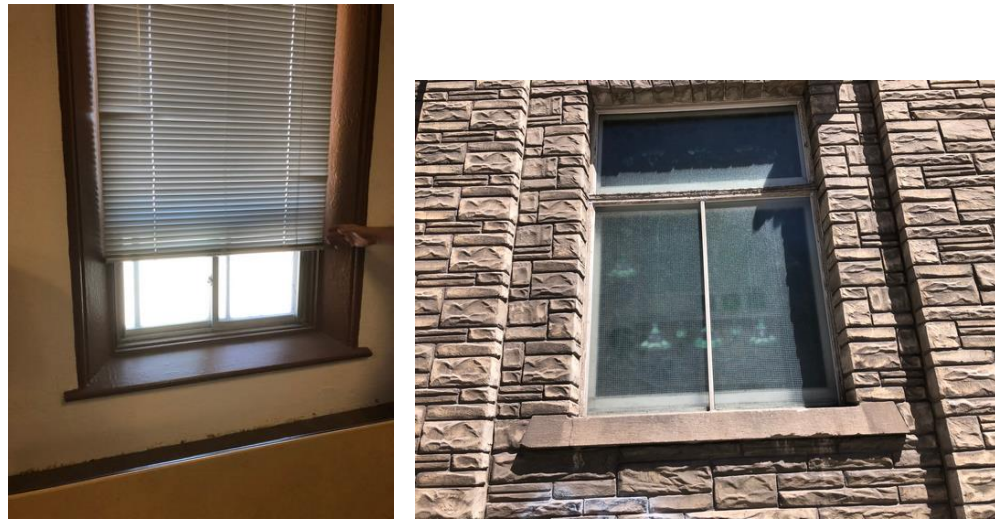
The wood frames require, at minimum, cleaning and repainting, including the patching of damaged wood. Re-caulking around the window openings is also required. These tasks will help improve the look of the building and provide a minor improvement to the air-resistance of the windows. However, because of the age and single glazing characteristics of the windows, full replacement with sealed double-glazed units with other energy efficiency features would be recommended. These units can be designed to match the heritage characteristics of the building.

Figure 9: Typical windows on South or East elevation

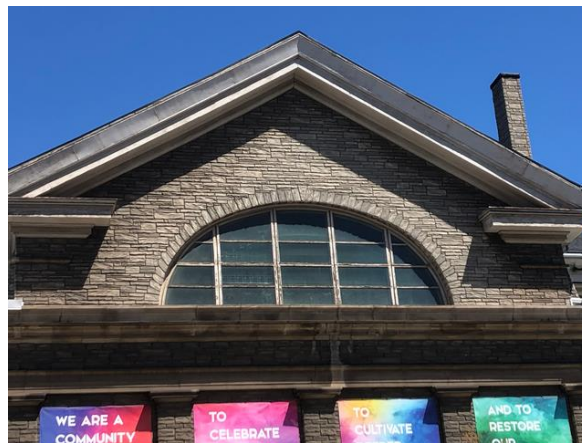
On the East and South walls of the upper elevations of the Sanctuary there is a roughly semi-circular shape stained glass window that fills about half of the space in the wall. These windows are irreplaceable, so care must be taken in their maintenance. Close inspection was not possible due to access limitations, but on the exterior side of the stained-glass window is a wood frame glazed window assembly that provides some weather protection to the stained glass. This is good, but the condition of the protective windows is similar to that of the other building windows: the wood requires repainting and patching, and re-caulking is likely also required. Replacement with an improved window assembly would be recommended in these two locations.

Figure 10: View of stained-glass window on South elevation

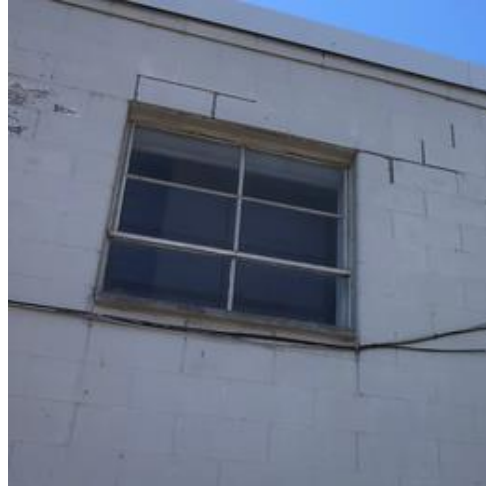
Windows on the 1968 Atrium addition are also of an unconfirmed vintage, but based on observations appear that they may date from the original construction of the Atrium. These windows are set high in the elevations and therefore difficult to assess, however, they do appear to be vertical sliding type windows with metal

frames and most likely single pane glazing. Due to their height they are likely not operated regularly. Replacing these windows with modern assemblies would provide some minor improvements to the overall energy efficiency of the building, but this would be a lower priority project compared to other windows.

Figure 11: Typical window on Atrium section

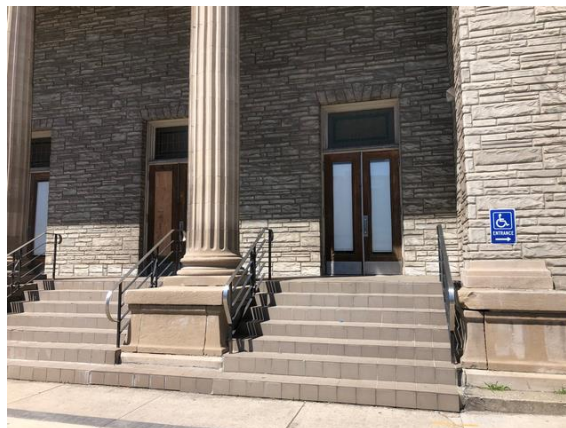
The entry area to the Sanctuary section consists of three sets of wooden double doors with glazing units set in wooden frames. This entry was formerly the main entry to the Sanctuary, though it is not clear if it remains so. The doors require refinishing of the wood, and one of the glazing units is currently replaced with a piece of plywood. The entry point is not accessible: installation of a ramp that meets AODA guidelines would be difficult within the available space, so installation of a handicap lift system would be required.

Figure 13: Main entry to Sanctuary from Park St. N.

While the doors are of an age and in a condition where replacement would be recommended, given that this entry forms a major visual feature of the Church and the doors are a part of that, it is recommended instead that the doors be repaired and refinished in order to return them to good condition.

4.10	Repair to Park St. main entry doors	3	unit	\$ 6,000.00	\$ 18,000.00	\$ 8,000.00	\$24,000.00	
4.2	new domestic water service with backflow / removal of lead lines	1	flat rate	\$ 35,000.00	\$ 35,000.00	\$ 40,000.00	\$40,000.00	not including benefits available from City of Hamilton

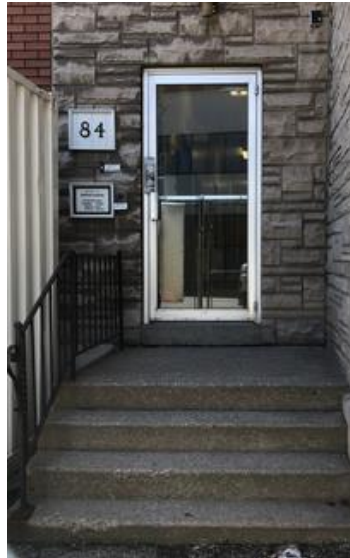
The door to the office area is in better condition, but also would be recommended for replacement. It is a metal framed glazed door. It is newer than the other doorways noted, but installation of a new door with better energy efficiency and security properties is recommended. Access to this door is via a concrete stairway and is not of an accessible design. With the amount of space available it would be difficult to install an accessibility ramp at this entryway.

Figure 14: Entry to office area from York Blvd.

4.10	Replacement of double doorway: Park St. entry	1	unit	\$ 7,500.00	\$ 7,500.00	\$ 10,000.00	\$10,000.00	
4.10	Replacement of single doorways: York Blvd.	3	unit	\$ 3,000.00	\$ 9,000.00	\$ 4,500.00	\$13,500.00

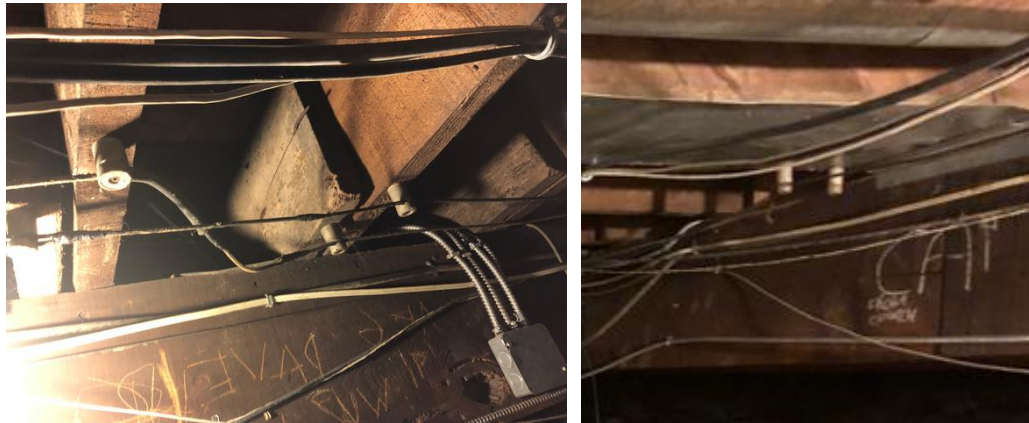
Within the basement area at the South-East corner of the building (near the furnace room in this area) knob and tube wiring was noted installed under the ground level floor assembly. According to the Electrical Safety Authority (ESA)⁶ this type of wiring was used between the early 1900's to the 1940's. From what was visible in the Church basement it is not clear what elements the knob and tube wiring is serving, nor the total extent of the wiring installed in the Church building. What is visible is the inclusion of tape wrapped around the cabling in use, the purpose of which is not clear, but possibly the tape is used as a material to protect damaged areas of the original cable casing.

Provided that the knob and tube wiring is maintained properly and not allowed to deteriorate in condition, the ESA indicates that it may remain in use. However, this is not advised, and in the Church building the cable casing appears to be decaying. Knob and tube wiring circuits do not have the same safety systems that modern wiring systems have. Circuits are limited to 15Amp capacity and require specialized treatment to ensure the circuit is grounded. There also exists a higher risk of fire if the materials deteriorate. Furthermore, some property insurance companies will not provide coverage if knob and tube wiring remains in use.

Figure 15: Examples of knob and tube wiring in basement

It is recommended that all the full extent of the knob and tube wiring elements be determined and replaced with modern electrical components. Due to the unknown details regarding this item a firm cost estimate for the recommended work cannot be determined, however an estimate is provided that includes a high contingency allowance in order to account for unknowns with this type of work.

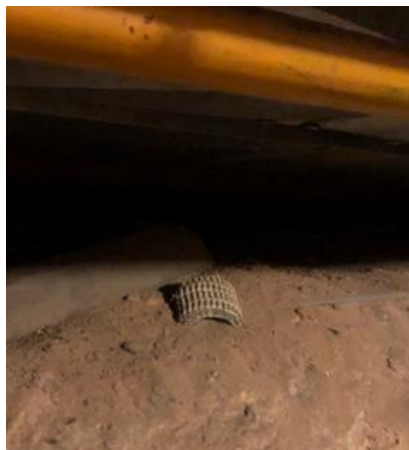
- Asbestos pipe insulation - confirmed asbestos material in a friable state was observed in the basement area
- Asbestos based material in floor tiles (non-friable state)
- Suspected asbestos based material in roof membrane
- Lead based paints, lead based pipe and electrical solder, lead in ceramic tile products
- Mercury in thermostats or fluorescent light fixtures
- PCB product in fluorescent light ballasts
- Silica in crystalline form in concrete and masonry

Figure 16: Likely asbestos based material (pipe insulation) noted in basement

Because of the known existence of these materials – particularly the asbestos – any future renovation work in the Church will require a detailed DSS study of the materials in the work area, and most likely adherence to strict abatement requirements to ensure the materials are removed safely and without harm to workers and occupants of the Church, as well as neighbours of the Church, adding to any renovation costs.

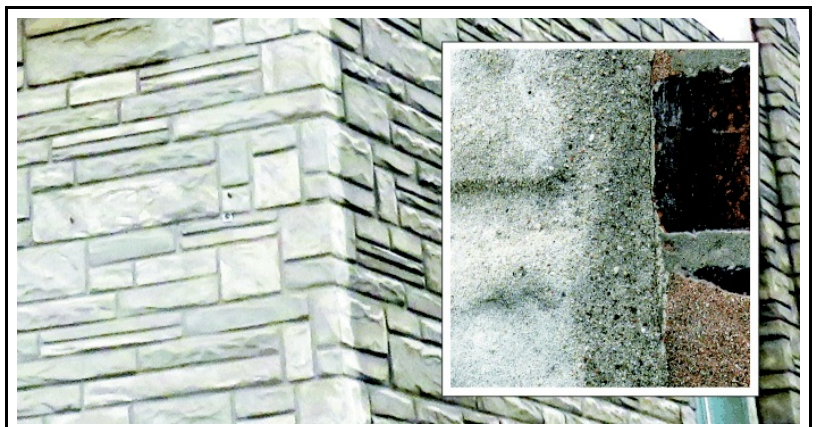
- 4.1 It was observed that the cement-based mortar had been plastered/parged over the brickwork to simulate rock-faced ashlar modular-coursed stone masonry. (Photograph 1) Although it varied, from a review of the termination joint with the side elevation brickwork, the mortar appeared to have been applied at a nominal minimum one-inch thickness within the simulated mortar joints. (Inset image)

Photo 1 with inset image: The mortar was plastered over the brickwork to simulate the appearance of ashlar-coursed stone masonry. The minimum thickness varied but appeared to be a nominal 1-inch minimum within the simulated mortar joints.

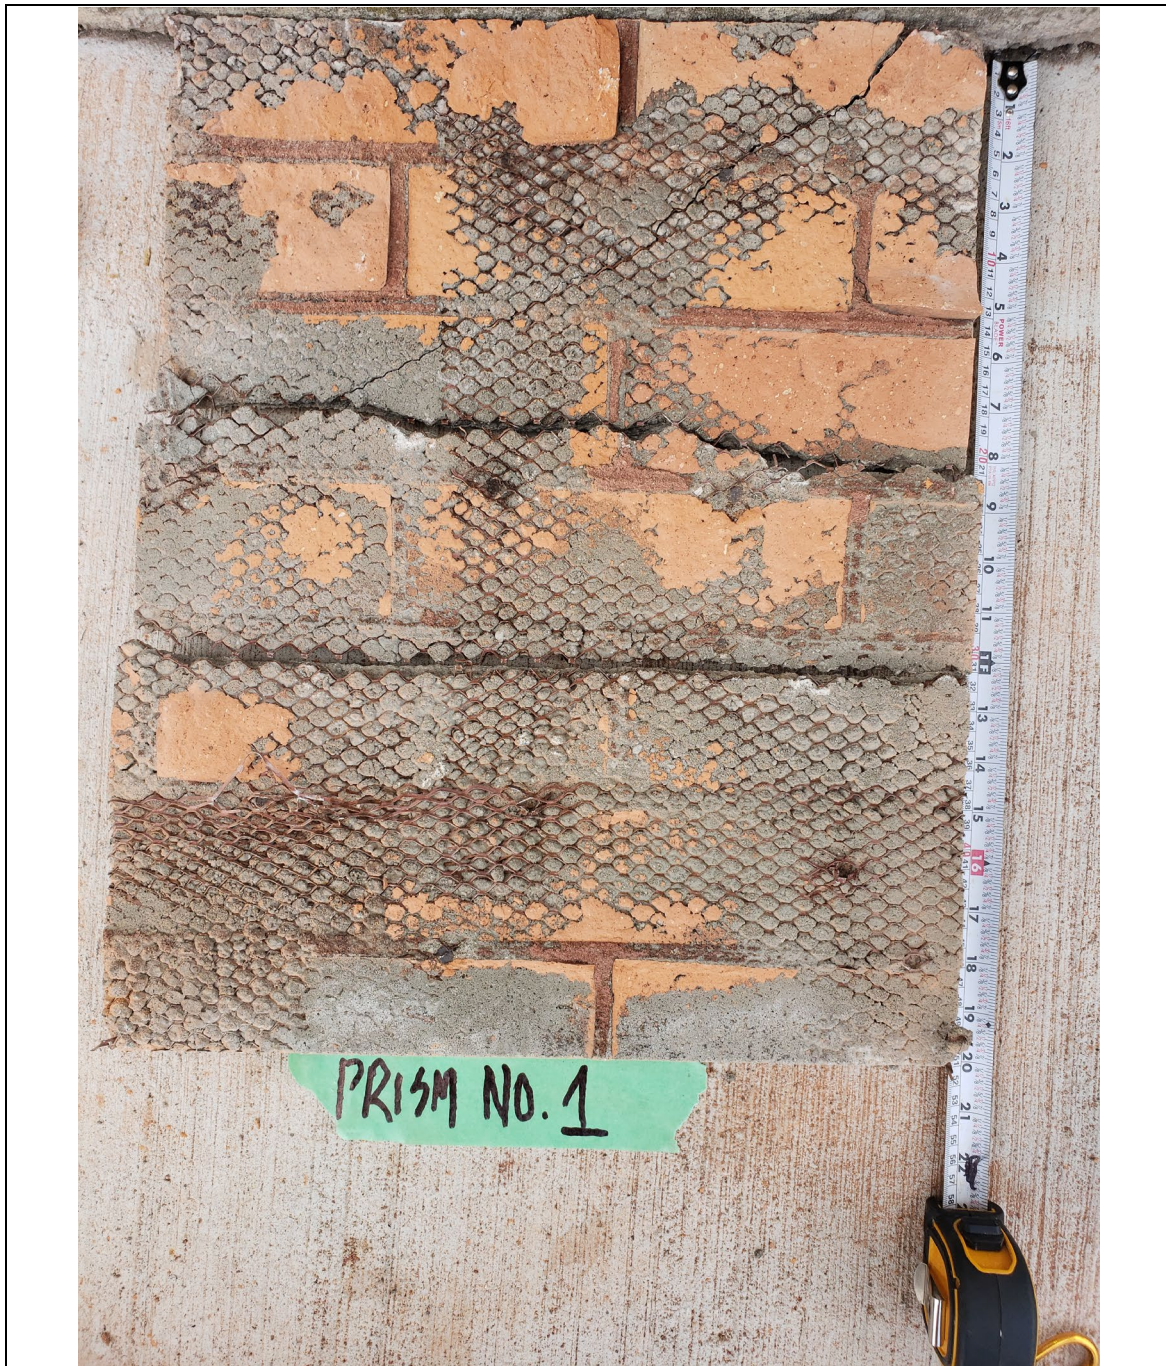
3. The stone facing (~6 to 12mm thick) was applied to a base mortar coating layer (~8 to 12mm in thickness), that contained expanded steel mesh, which was attached to the brick using one-inch-long steel concrete nails (see Photograph No. 4).

Photograph No. 4, showing test location for Brick Prism No. 1, upon removal of the stone work. Note the visible rusted steel mesh and rusted steel concrete nail heads holding the mesh to the brick. Stonework base mortar was still bonded to the brickwork for most of the area.

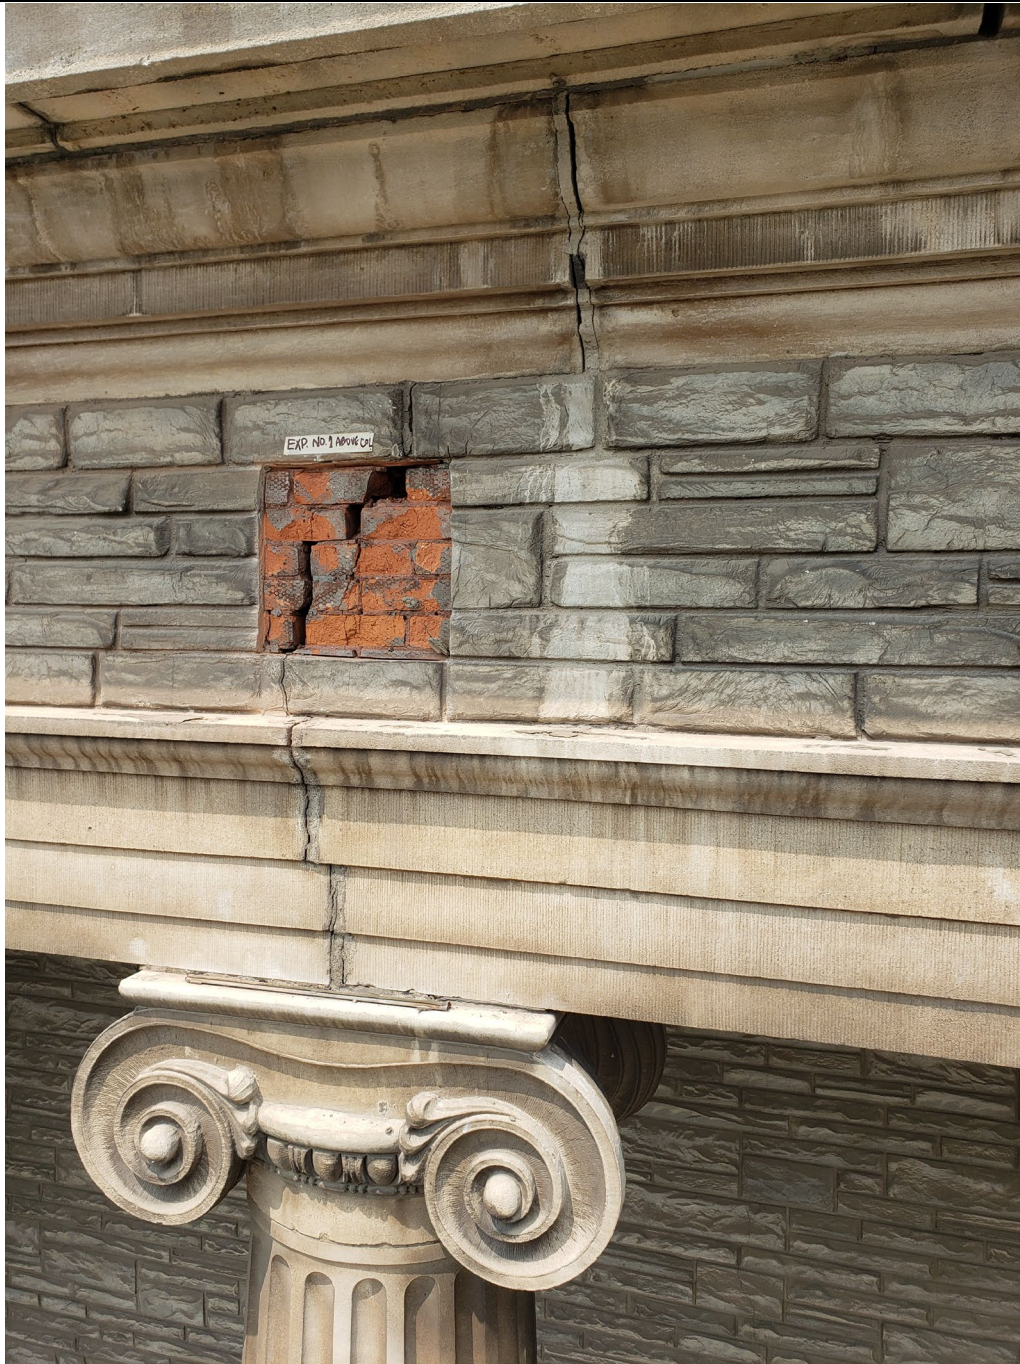
Photograph No. 19, showing an overall view of the stonework for Exploratory Opening No. 1 after removal of the stone. Note the open joints above and below the opening, which likely allows water to penetrate the masonry work and cause freeze-thaw damage to the brick work.

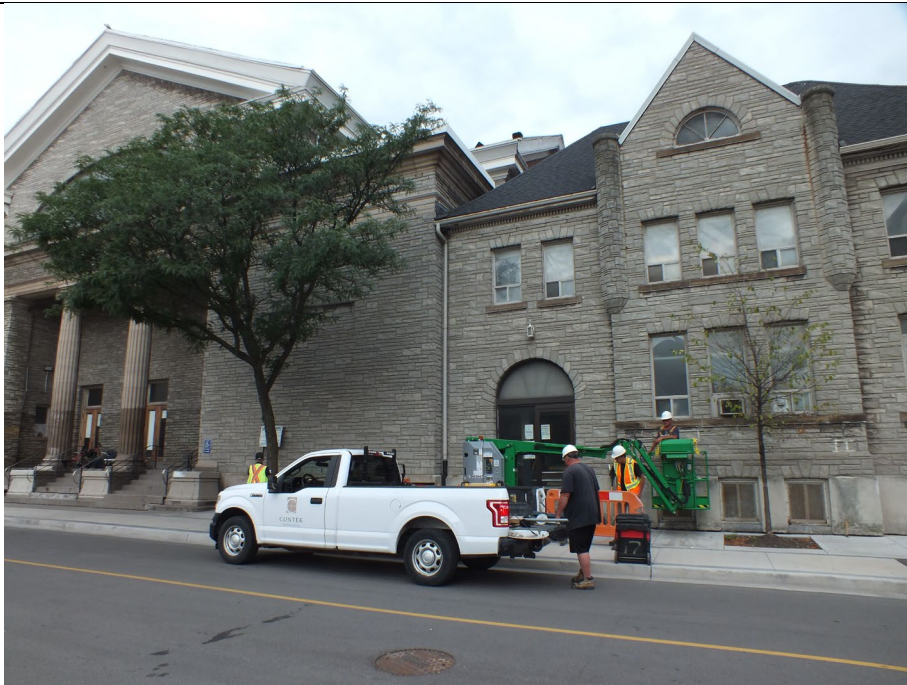
Photograph No. 21, showing the approximate location of the eave's trough down spout shown in Photographs No. 19, where the separation in the stonework was noted.

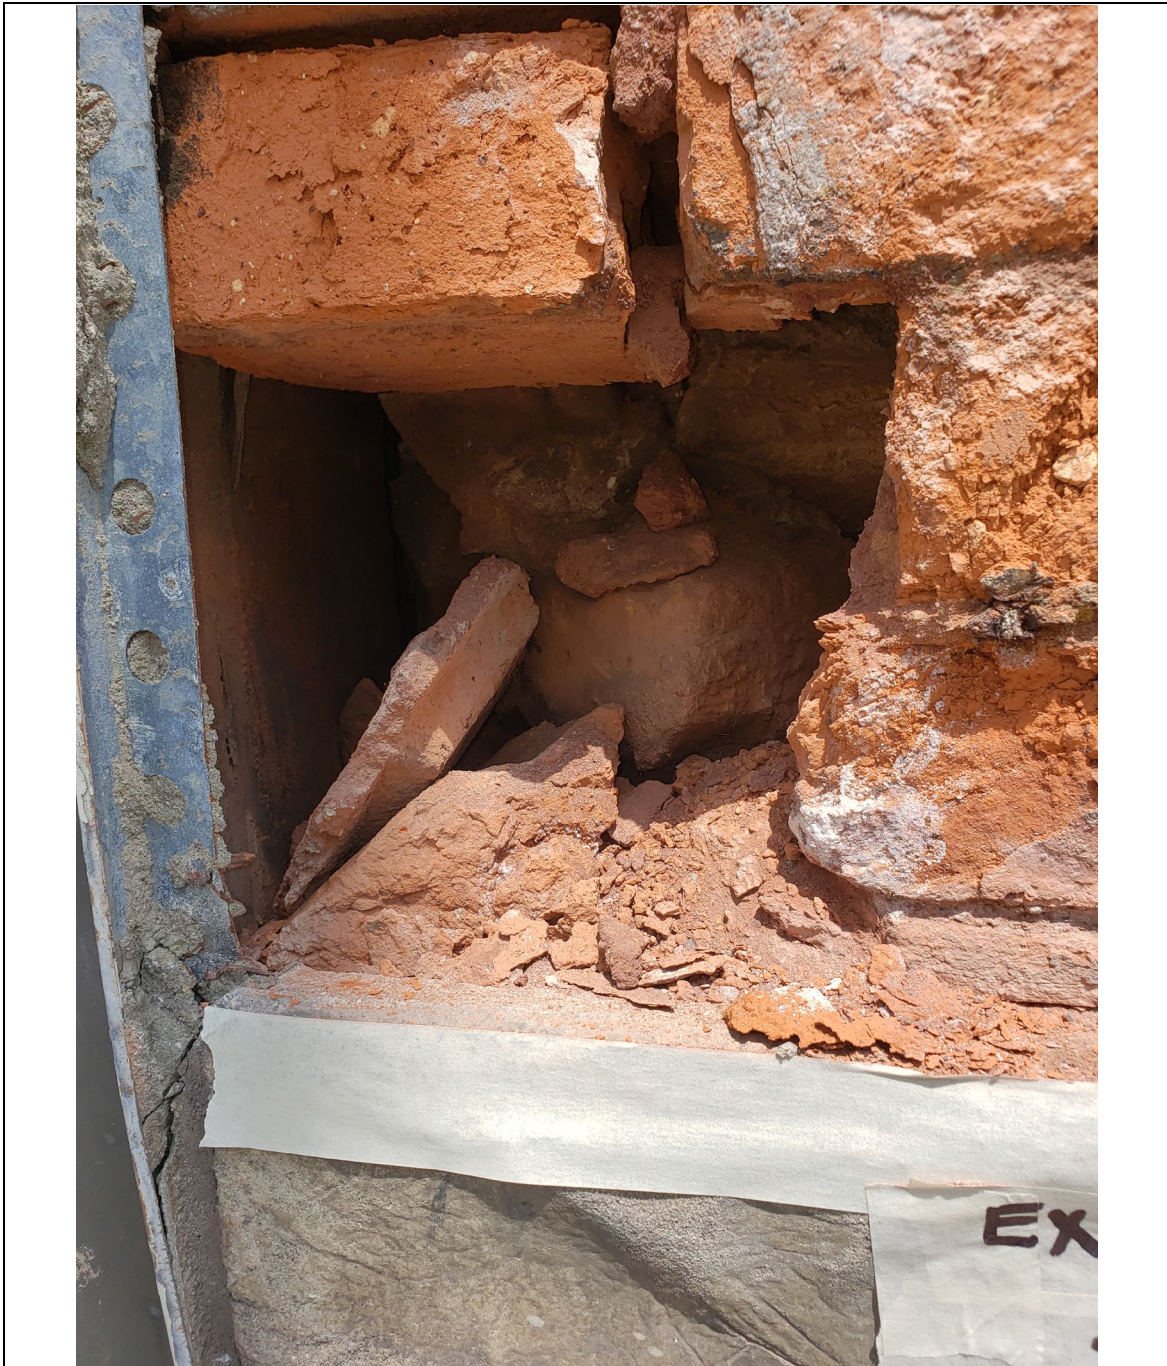
Photograph No. 26, showing a close-up view of Exploratory Opening No. 2 after removal of the stonework. Note the spalled and missing (disintegrated) brick, likely due to freeze-thaw damage.

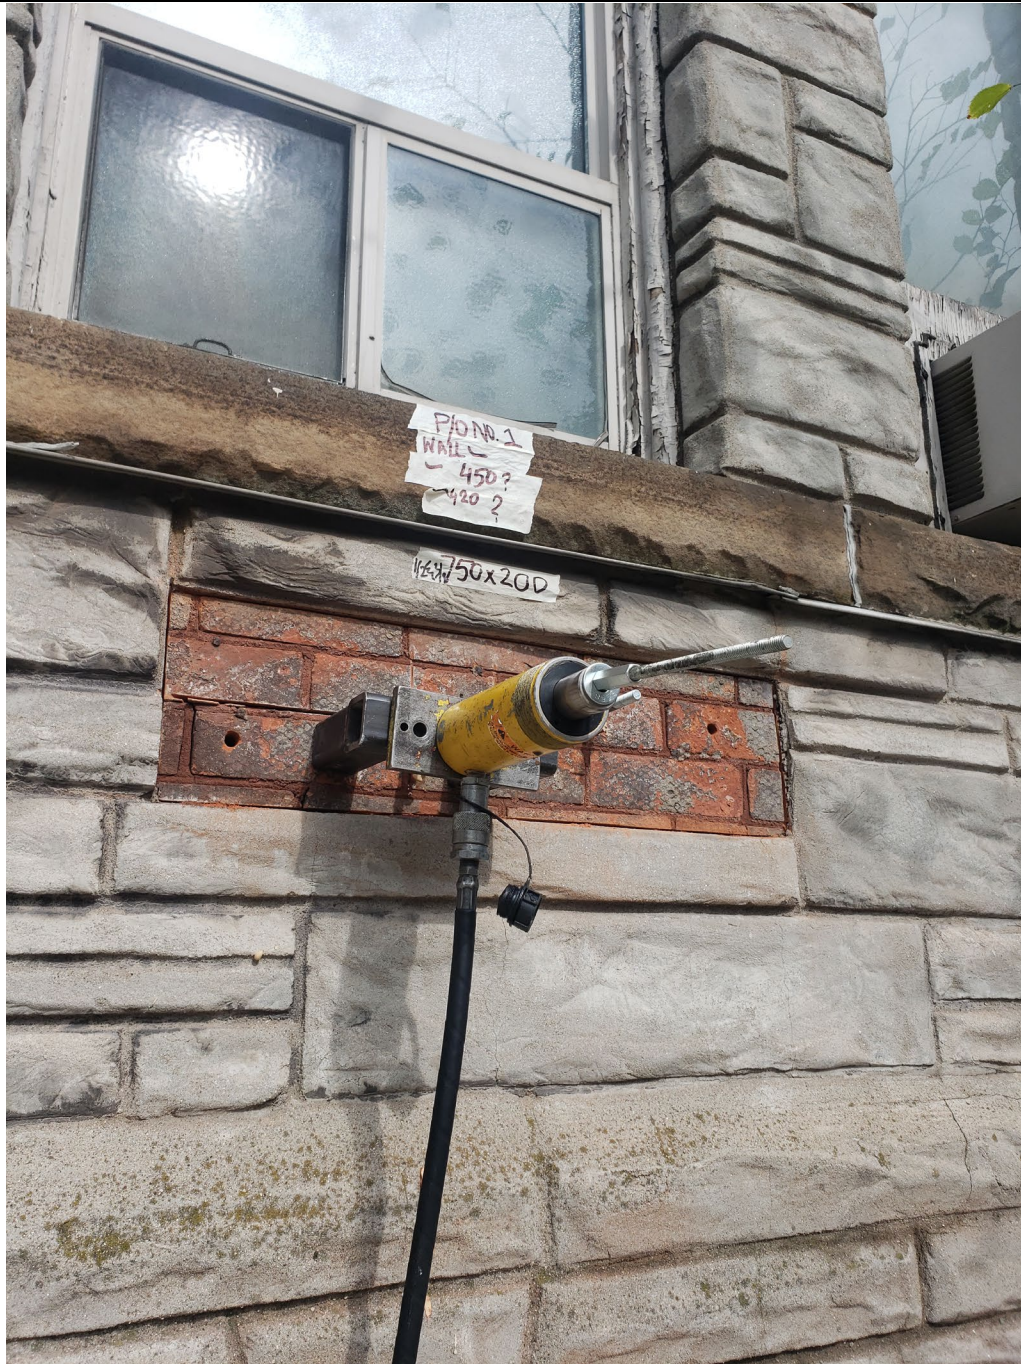
3. Hammer sounding of the stone veneer, indicated a solid sound, indicating the stone facing was bonded to the underlying brick.
4. Upon removal of the stone facing, the brick-and-mortar joints were seen to be in a generally intact condition (see attached Photograph No. 37, also typical pull-out test apparatus, Photograph No. 38 and 39 (backside of stonework). Hammer sounding of the brick indicated a hollow condition, indicating possible internal damage to the brick, or lack of bedding mortar.

Photograph No. 37, showing a typical load test setup for Anchor Pull-Out Location No. 1.
