CULTURAL HERITAGE IMPACT ASSESSMENT

**89 Park Street North,
Hamilton**

Date:
October 2023

Prepared by:
**MacNaughton Hermesen Britton Clarkson
Planning Limited (MHBC)**
200-540 Bingemans Centre Drive
Kitchener, ON N2B 3X9
T: 519 576 3650
F: 519 576 0121

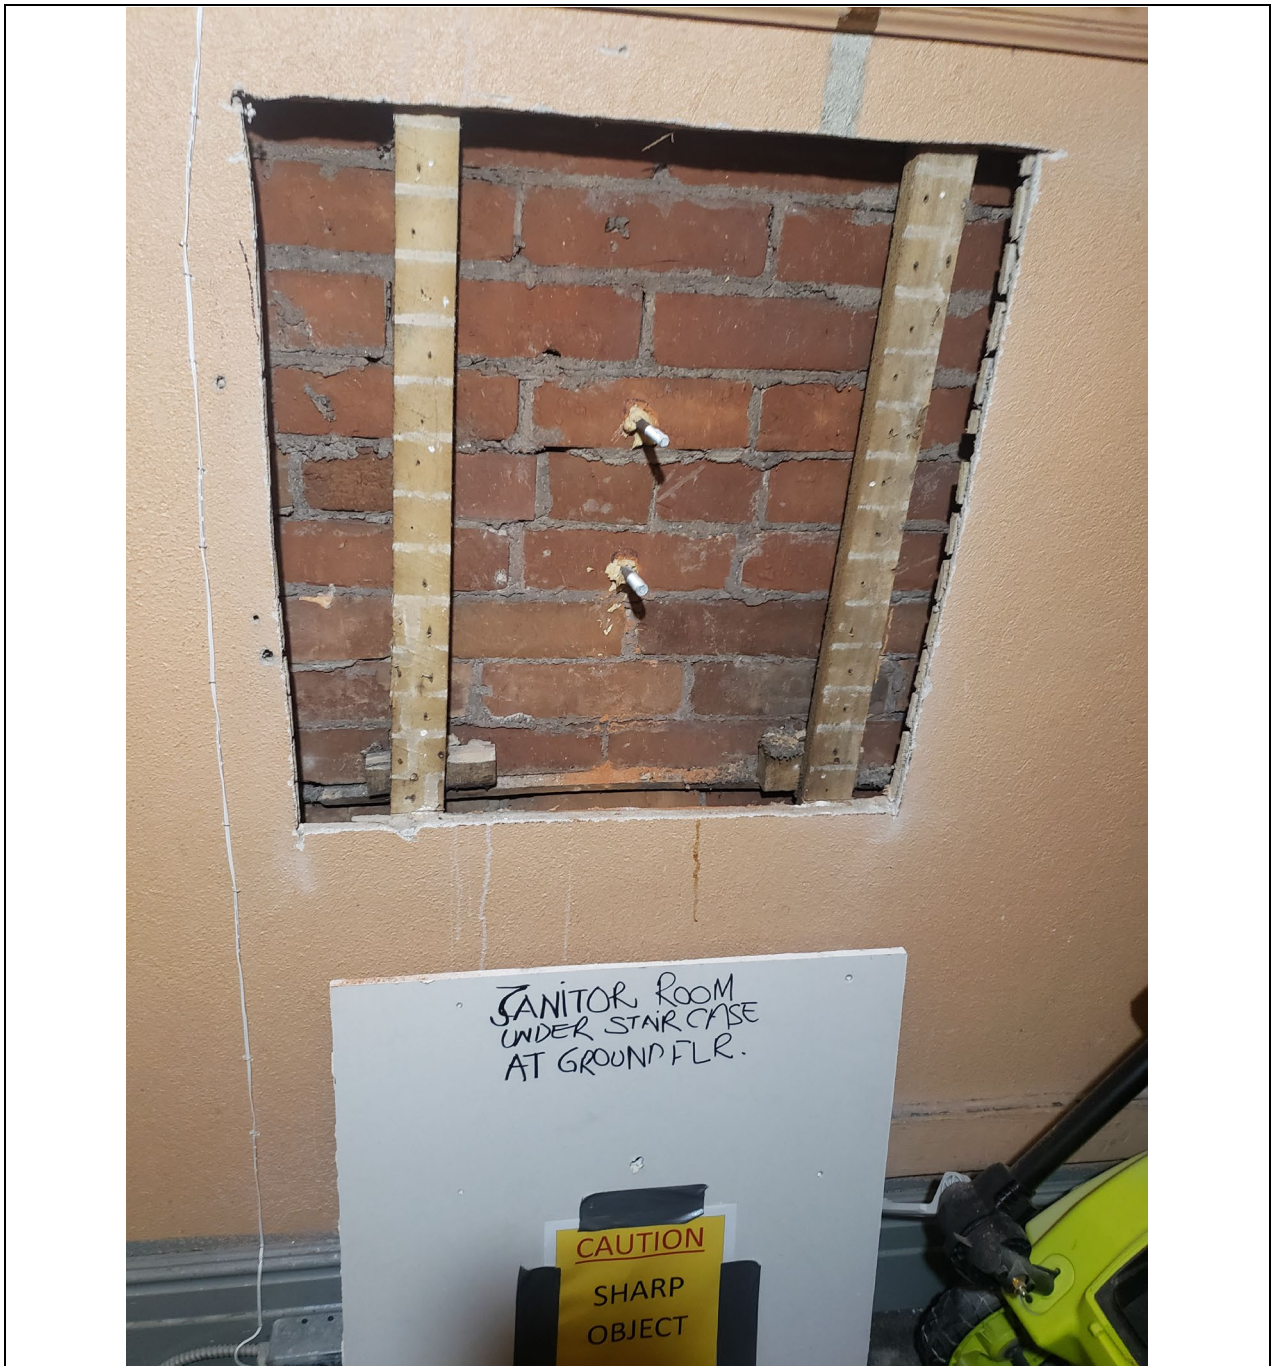
**Photograph No. 41,
showing anchor bolt installation for Anchor Pull-Out Location No. 4.**

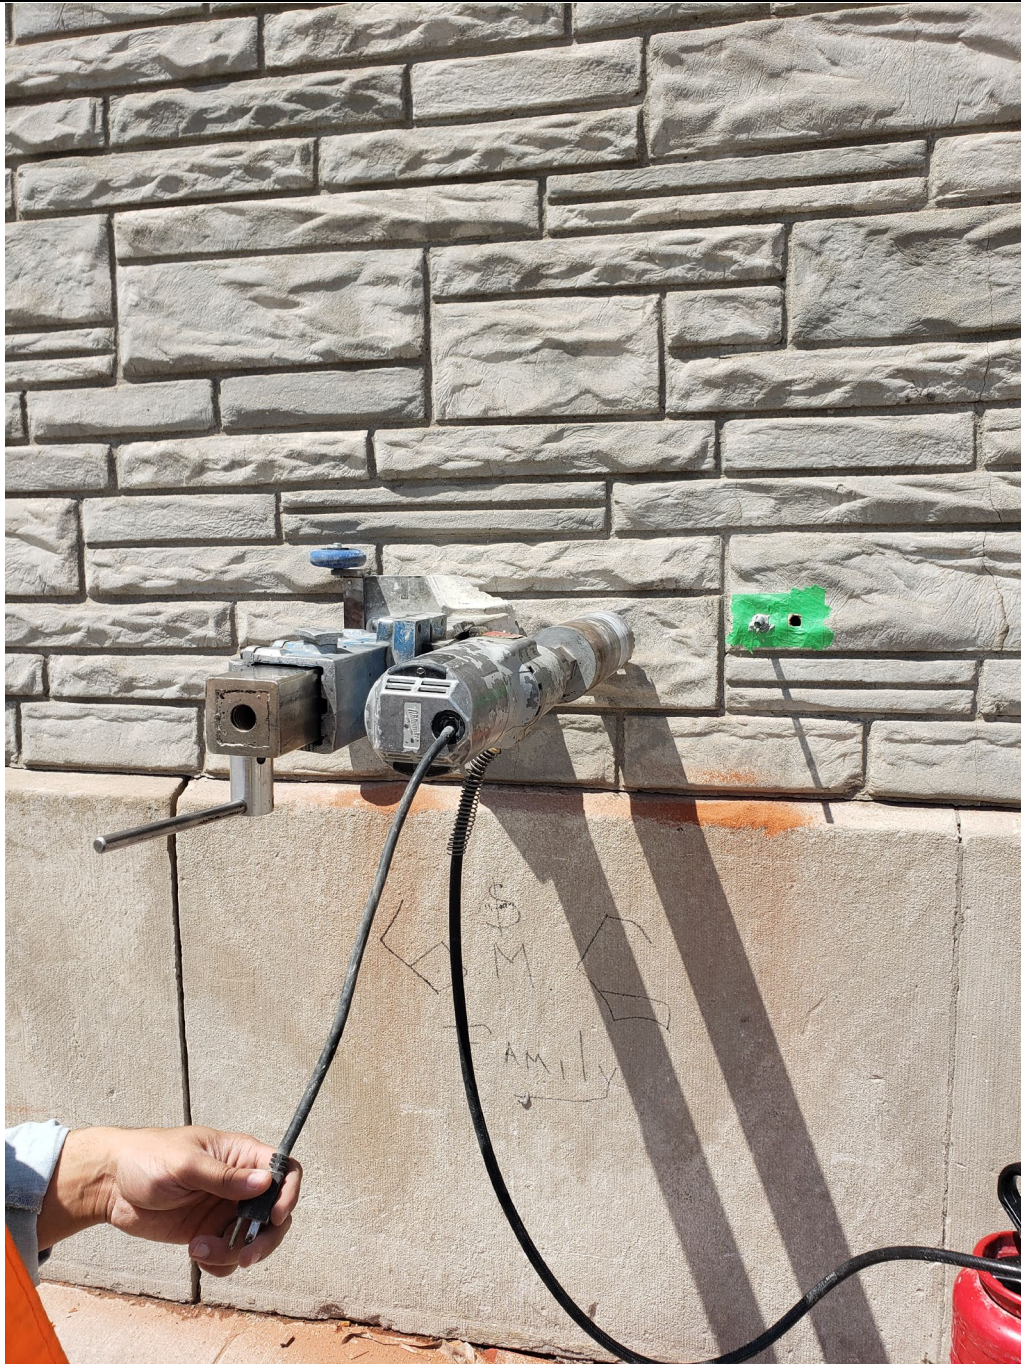
**Photograph No. 45,
showing a view of a typical drilling machine setup (Core No. 2).**

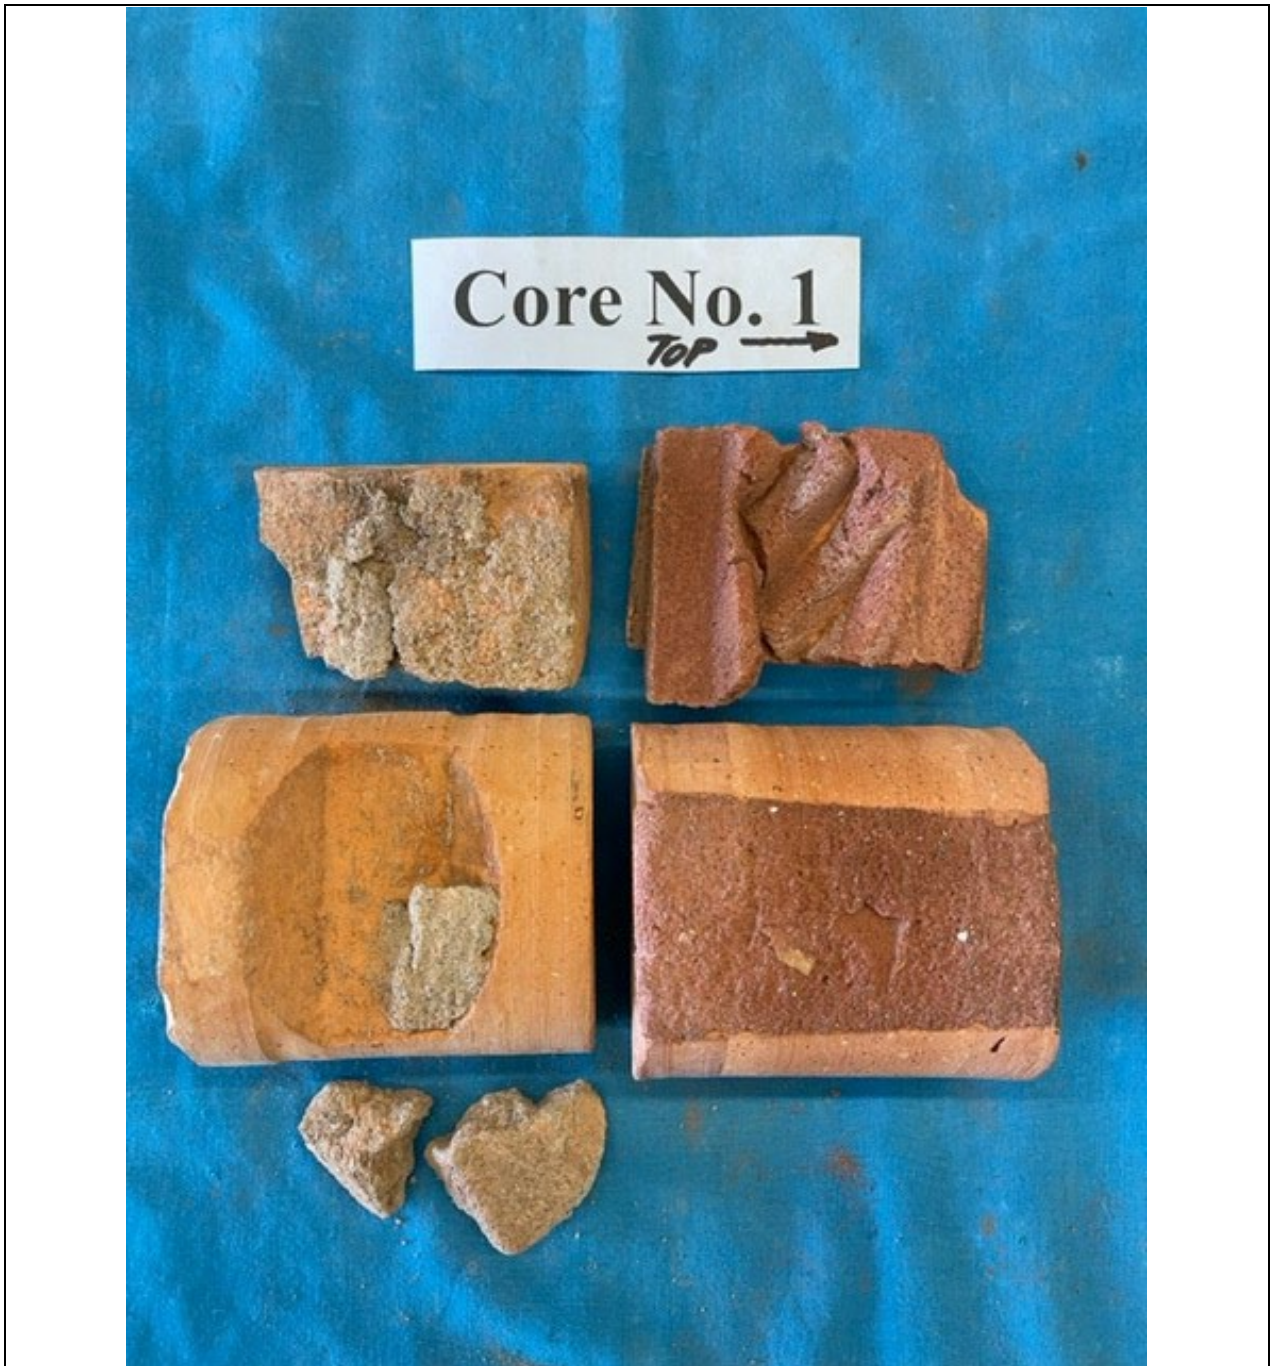
Photograph No. 47, showing an interior view of Core No. 1.

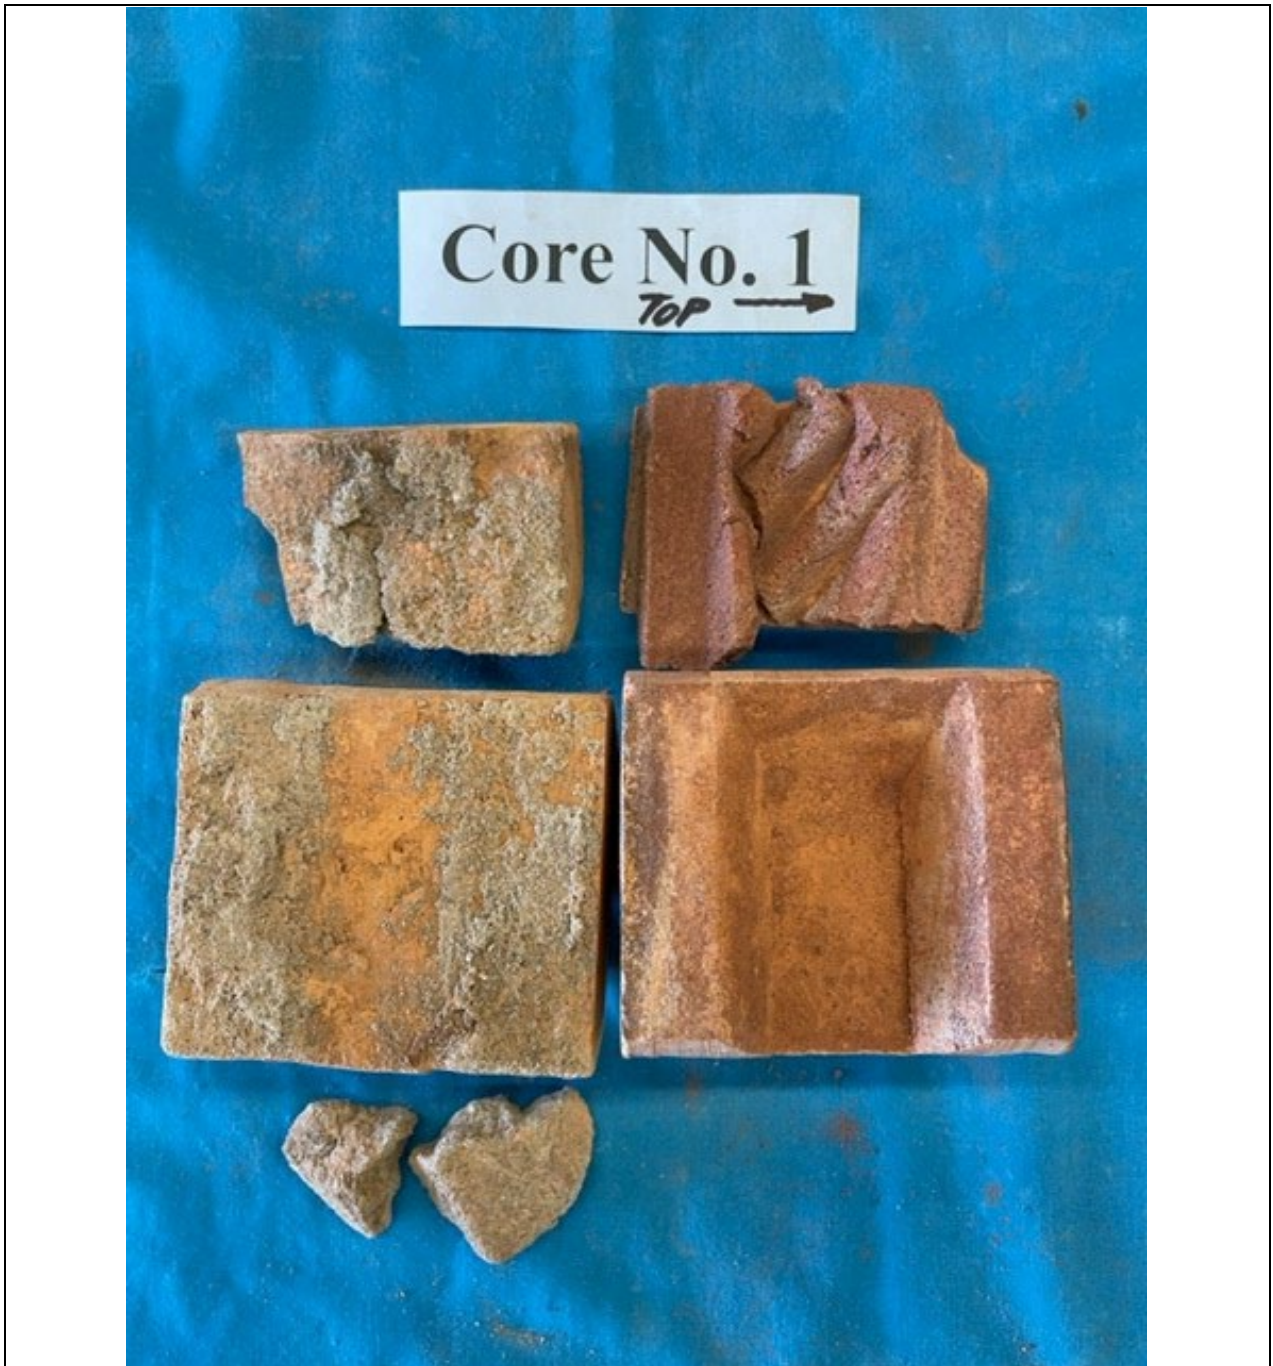
Photograph No. 48, showing the opposite interior view of Core No. 1.

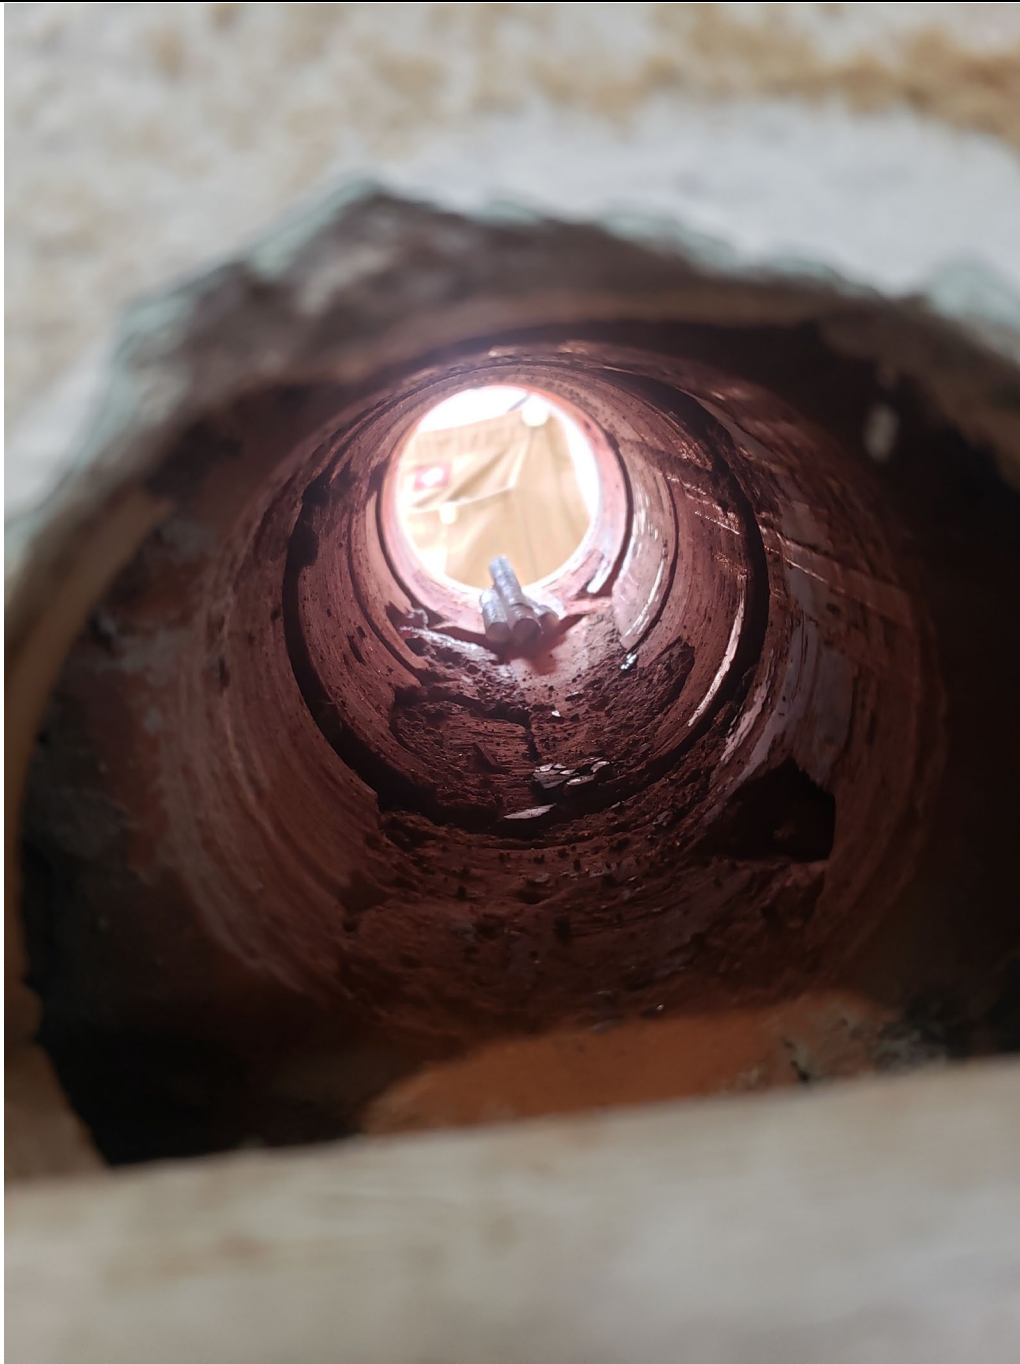
Photograph No. 50, showing an interior view of Core No. 2.

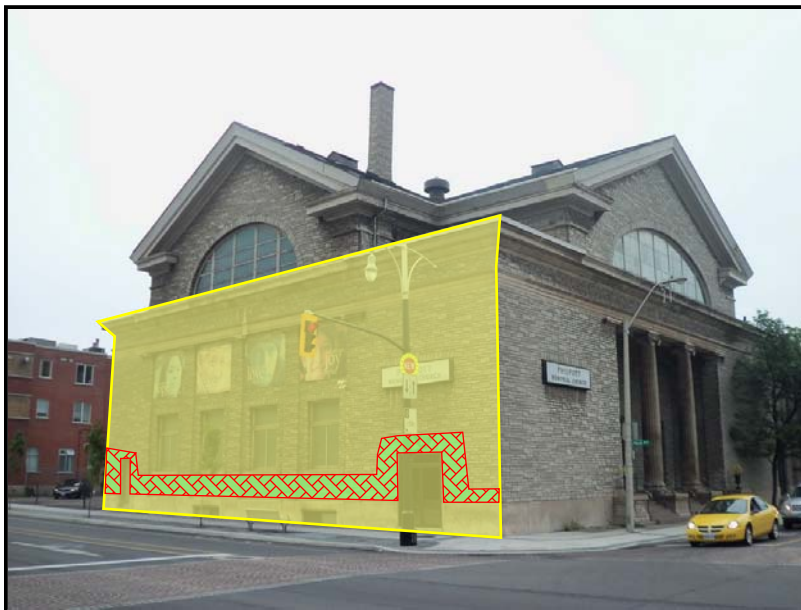
Photo No. 1: Southeast Corner

5. The cement-based mortar is delaminating from the face of the building and must be removed to ensure that portions of it do not spall away from the building and fall onto the sidewalk.

6. The cement-based mortar has severely degraded the exterior face of the entire exterior wythe of masonry (see SK-1, yellow portions). Further degradation has resulted in approximately 15-20% of the bricks likely needing replacement/repair (see SK-1, green portions).

100 % REMOVAL OF MORTAR AND 100%
REPLACEMENT OF EXTERIOR WYTHE

REBUILDING/REPOINTING (APPROXIMATELY
15-20% ANTICIPATED)
