TO:	Mayor and Members City Council
DATE:	December 6, 2022
SUBJECT:	City Hall Pedestrian Access Walkway (Wishbone Structure) Repairs Communication Update (Ward 2) (EFFM22-02)
WARD(S) AFFECTED:	Ward 2
SUBMITTED BY:	Craig Murdoch Acting Director, Energy Fleet & Facilities Maintenance Public Works Department
SIGNATURE:

**RE: Structural review of Existing Concrete Entrance Structure at the rear of the Building Located at 71 Main St. W, Hamilton, ON
Our Project No. 2022-JPS-101**

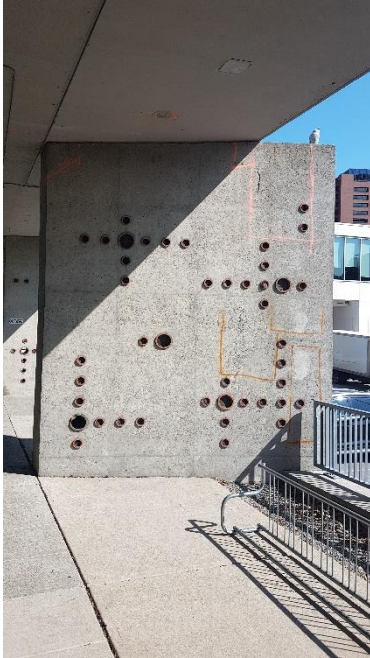
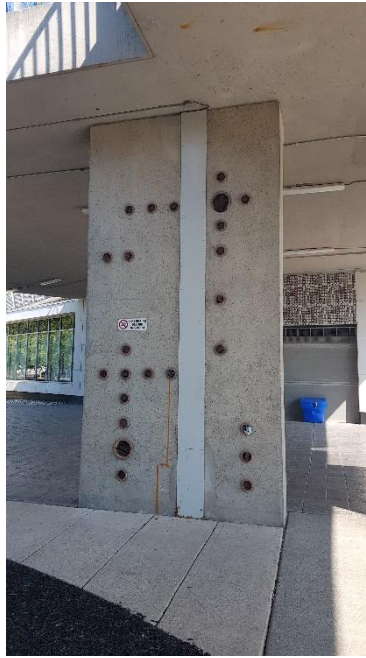
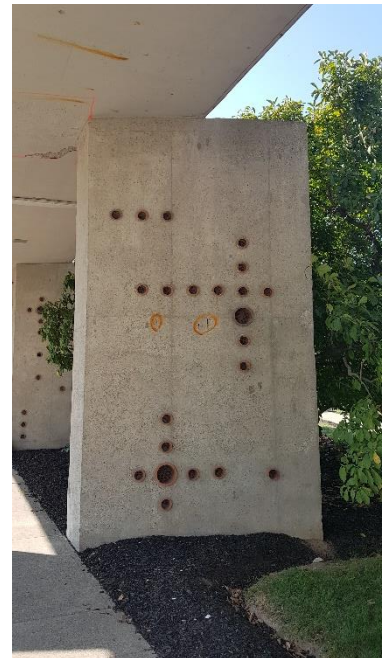
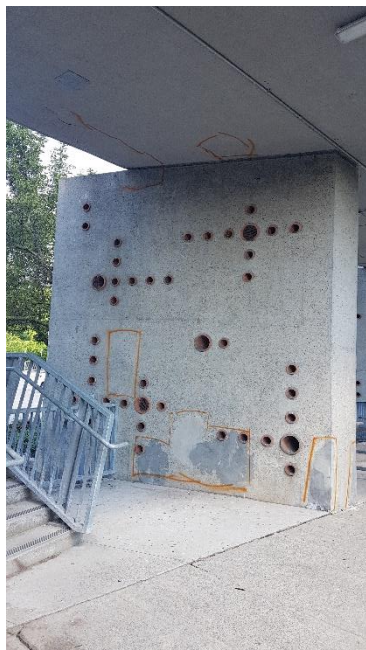
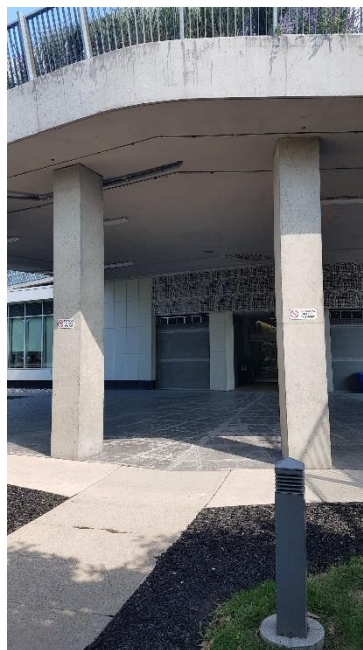
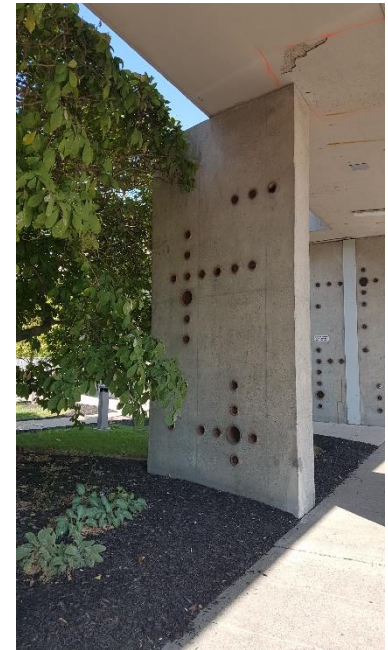
Appendix A: Additional site photos

We performed a visual review of the slab soffits, columns and other areas of concern that were visible at the time of our site walkthrough. The structure was also surveyed for any obvious signs of damage in the form of abnormal cracks, displacements, and signs of deterioration where readily visible during our walk-through. A few pictures are included below identifying the structural damage to the elements of the entrance structure.

- The portion of the structural elements and areas identified in the attached drawings need to be repaired immediately as they may lead to a catastrophic structural damage and also are safety hazards.
- Barricades and adequate caution signage should be provided and not removed until concrete repairs identified in the drawings are undertaken.
- The deteriorated slab soffits are an immediate safety hazard and tenant/pedestrian access should be prohibited until repairs are completed.
- To prevent any catastrophic structural failures and to prevent injuries, it is our recommendation that concrete repairs should begin immediately in conjunction with the application of permit to perform the concrete repairs.
