TO:	Mayor and Members City Council
DATE:	February 1, 2024
SUBJECT:	Longwood Road Bridge (Bridge 282) Upcoming Reconstruction (ENG24001) (City Wide)
WARD(S) AFFECTED:	City Wide
SUBMITTED BY:	Jackie Kennedy Director, Engineering Services Public Works Department
SIGNATURE:

Appendix "A" to Communication Update ENG24001: BRIDGE 282_2020_OSIM

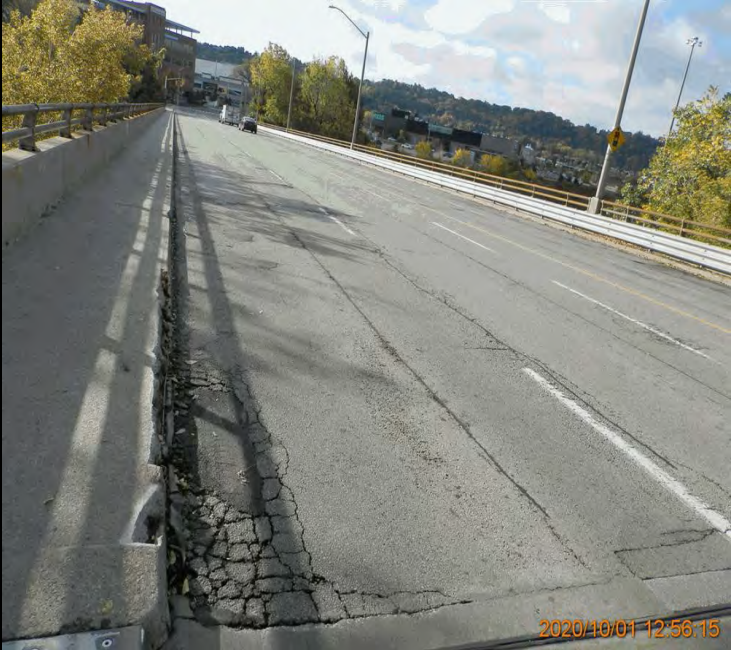
Description Bridge Deck From Northeast Corner		
	Elem Grp/Class Elem Type Sub Element Material Type Locator Defect Descript1 Defect Descript2 Defect Other	Decks/Wearing surface Asphalt	
File Name	05 Bridge Deck From Northeast Corner.JPG

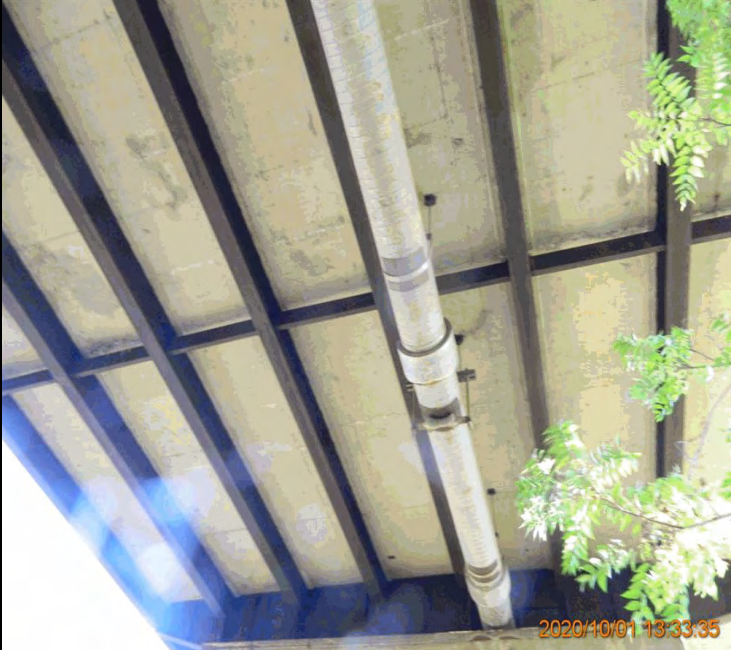
Description Interior Soffit and Girders at Pier 6, Looking South. Note: Local wet areas and N-M stained cracks.		
	Elem Grp/Class Elem Type Sub Element Material Type Locator Defect Descript1 Defect Descript2 Defect Other	Decks/Soffit - Thin Slab Interior Cast-in-place concrete General Poor condition Cracks	
File Name	17 Interior Soffit and Girders at Pier 6, Looking South.JPG

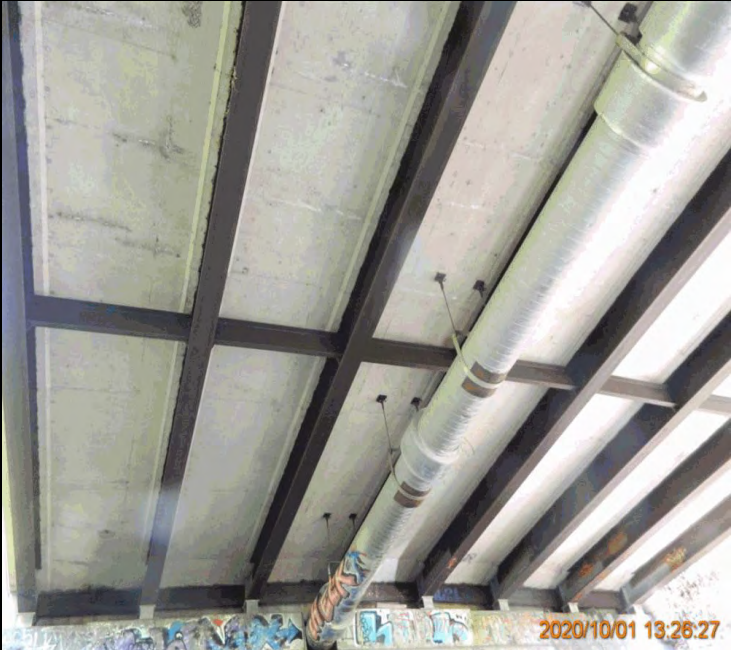
Description Interior Soffit and Girders at Pier 7, Looking North. Note: N-M stained cracks on soffit.		
	Elem Grp/Class Elem Type Sub Element Material Type Locator Defect Descript1 Defect Descript2 Defect Other	Decks/Soffit - Thin Slab Interior Cast-in-place concrete General Poor condition Cracks	
File Name	18 Interior Soffit and Girders at Pier 7, Looking North.JPG

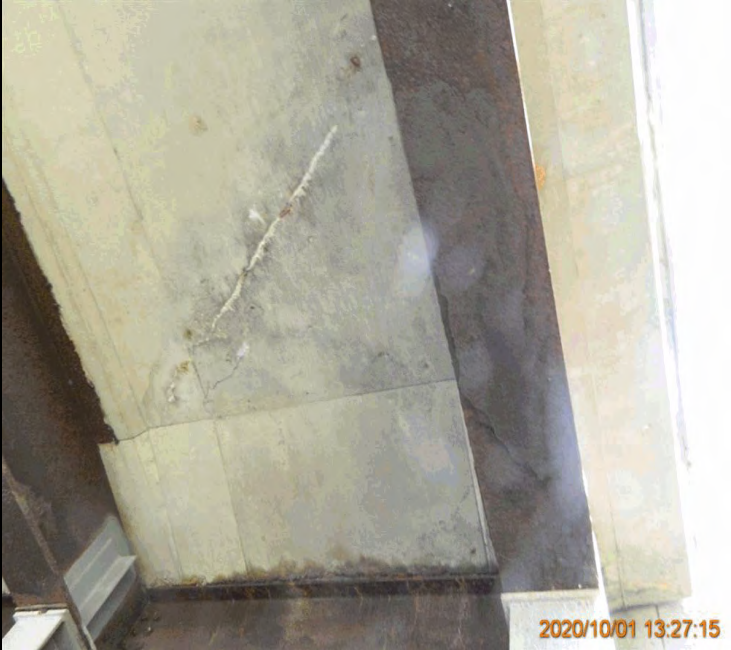
<p>Description N-M Wet Stained Diagonal Crack @ SW Corner of Soffit</p>

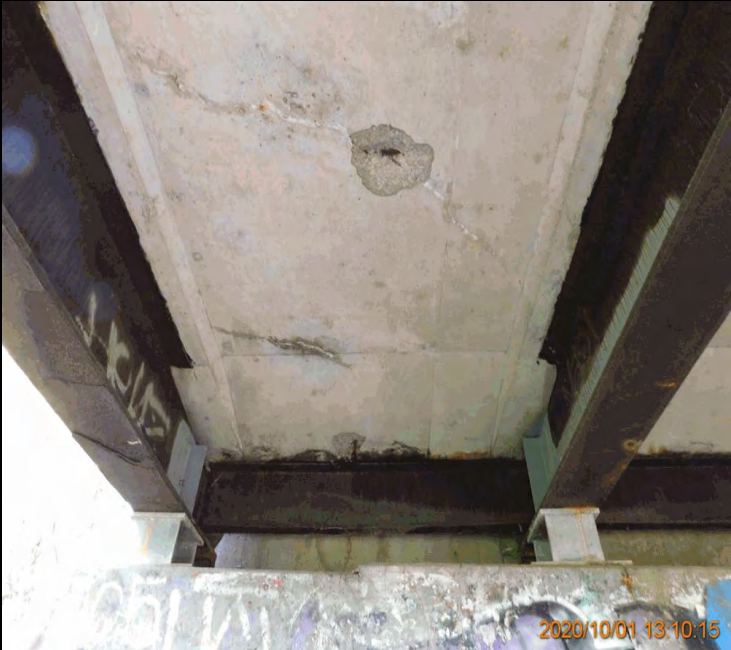
<p>Description Light Spall & N-M Stain Crack @ NW Corner of Soffit in Span 7</p>

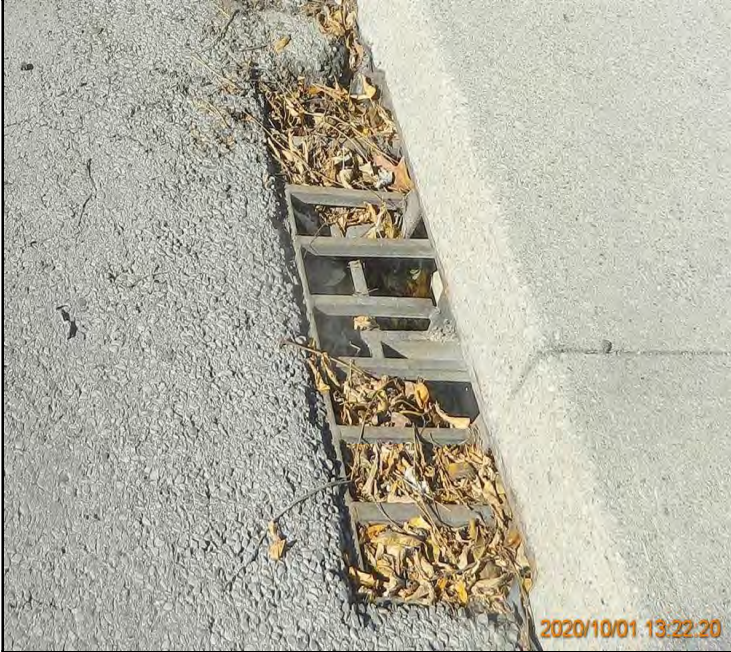
<p>Description</p> <p>Deck Drain with Basin at Deck Surface at Span 5, East Drain Shown. Note: Debris filled in deck drain.</p>

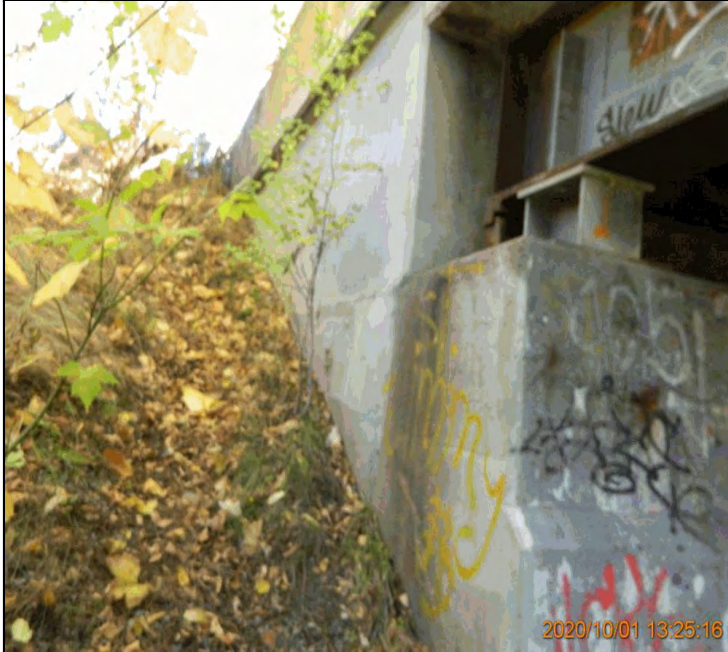
Local wet staining and few narrow to medium stained vertical cracks on wingwalls. (Ref Photos: #66-68).

Description Northwest Wingwall. Note: Wet staining and graffiti markings.	
Elem Grp/Class	Abutments/Wingwalls
Elem Type	Reinforced concrete
Sub Element	
Material Type	Cast-in-place concrete
Locator	General
Defect Descript1	Fair condition
Defect Descript2	
Defect	Staining
Other

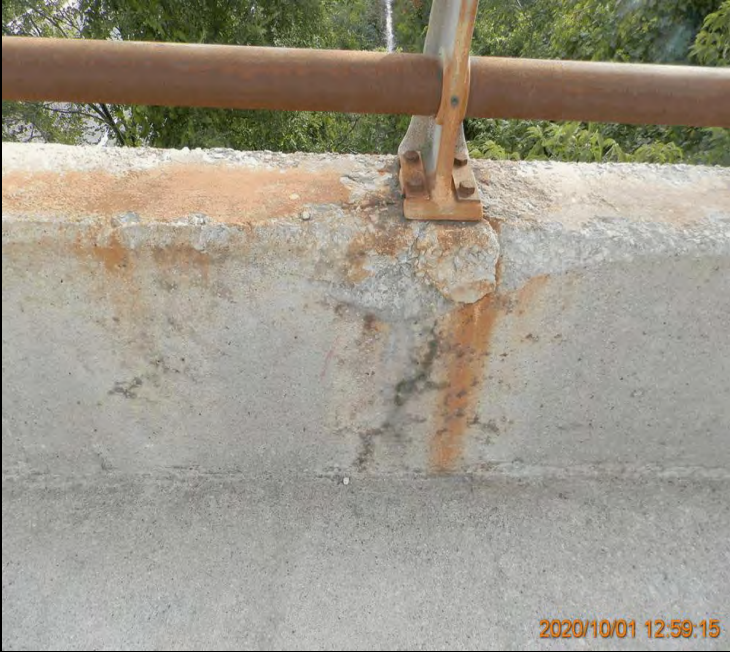
Severe spall & delam on east wall in span 3. W crack & severe delam @ top section of E wall @ N approach. S delam & W crack on top face of W Wall behind Thrie-Beam. Local areas of L-M scaling. (Ref Photos: #31-38).

Description L-M Scaling on East Wall Near South End of Deck		
	Elem Grp/Class	Barriers/Barrier/Parapet Walls	
Elem Type	Parapet Wall with two rails		
Sub Element	Interior		
Material Type	Cast-in-place concrete		
Locator			
Defect Descript1	Fair condition		
Defect Descript2			
Defect	Scaling		
Other			
File Name	36 L-M Scaling on East Wall Near South End of Deck.JPG

Recommended Work	Category	Timing	Quantity	Unit Cost	Total Cost (\$)
CO201 Repair Concrete (sqm)	Major Rehab	1 - 5 year	12.000	780	9360

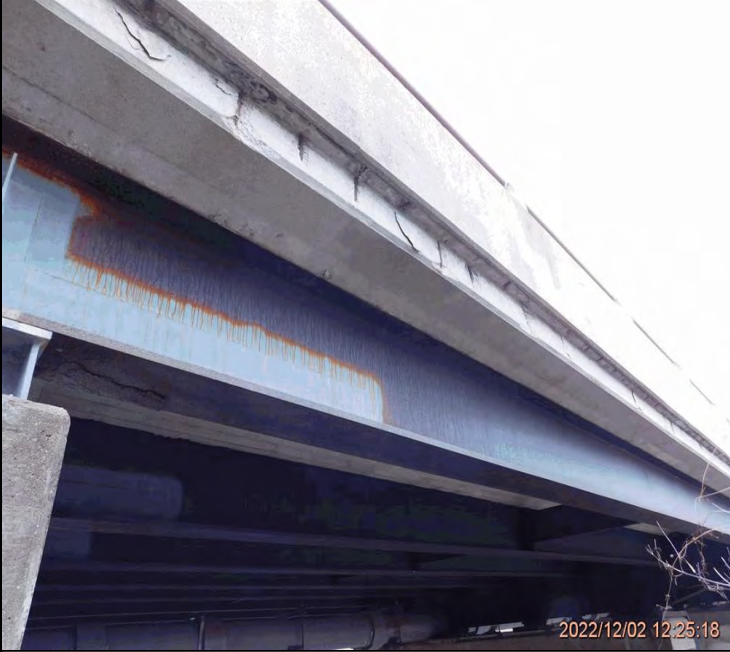
Description Local Delamination & Spalls on South Section of East Fascia

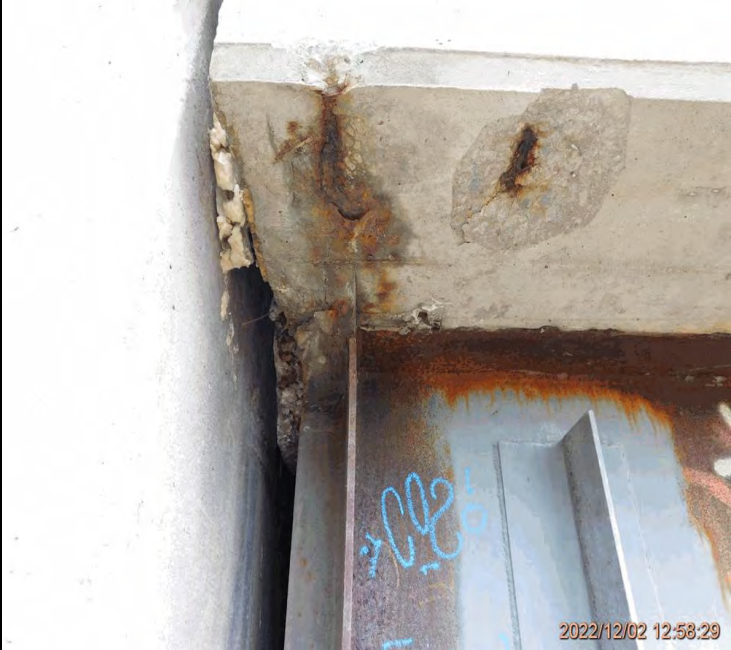
Description		
	Local Spalls at NW Corner of North Span Soffit		
Elem Grp/Class		Decks/Soffit - Thin Slab	
Elem Type		End	
Sub Element		Cast-in-place concrete	
Material Type		Cast-in-place concrete	
Locator		North	
Defect Descript1		Poor condition	
Defect Descript2			
Defect		Spalling	
Other			
File Name	21 Local Spalls at NW Corner of North Span Soffit.JPG

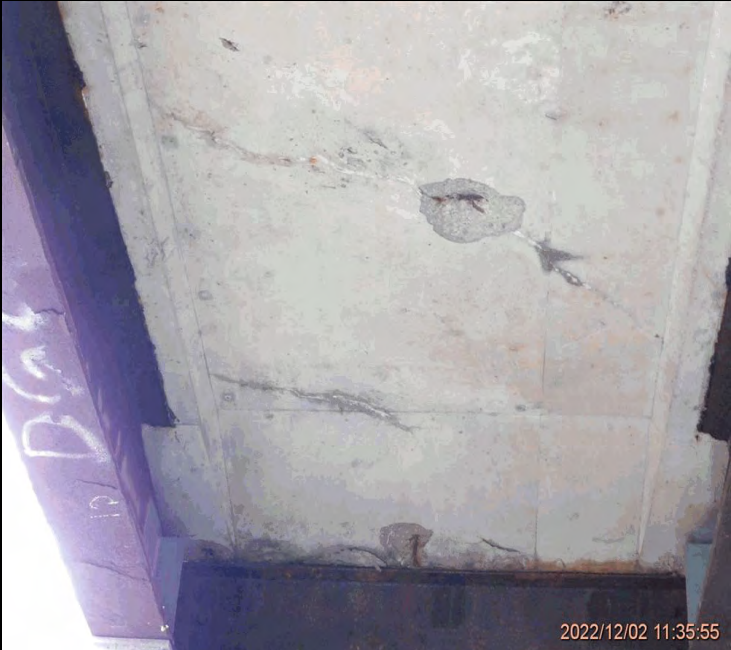
Description		
	Local Delam, Spalls, and Narrow-Medium Stained Cracks on NW Section of North Span Soffit		
Elem Grp/Class		Decks/Soffit - Thin Slab	
Elem Type		End	
Sub Element		Cast-in-place concrete	
Material Type		Cast-in-place concrete	
Locator		North	
Defect Descript1		Fair condition	
Defect Descript2			
Defect		Crack	
Other			
File Name	22 Local Delam, Spalls, and Narrow-Medium Stained Cracks on NW Section of North Span Soffit.JPG

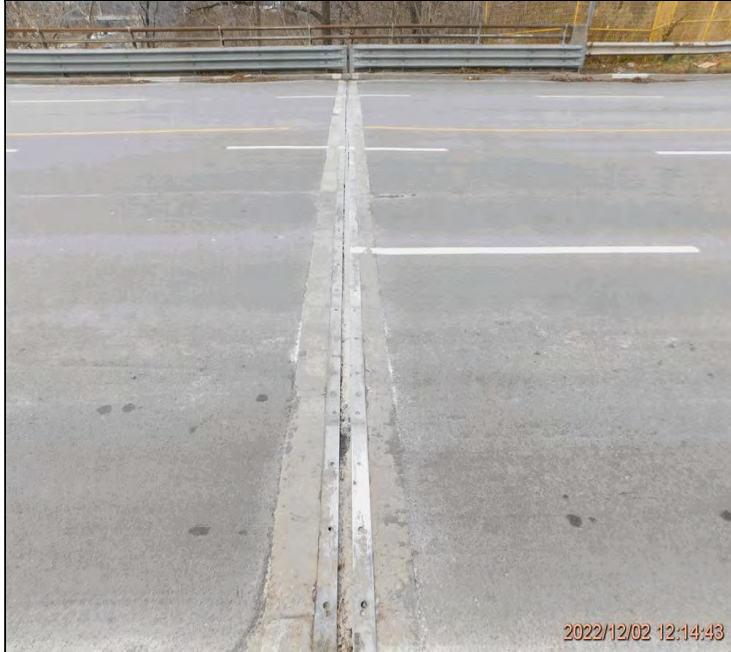
File Name 27 North Expansion Joint, looking West.JPG

Description
North Expansion Joint, looking West

Elem Grp/Class	Joints/Armoring/retaining device
Elem Type	
Sub Element	
Material Type	Steel
Locator	North
Defect Descript1	Excellent condition
Defect Descript2	
Defect	
Other

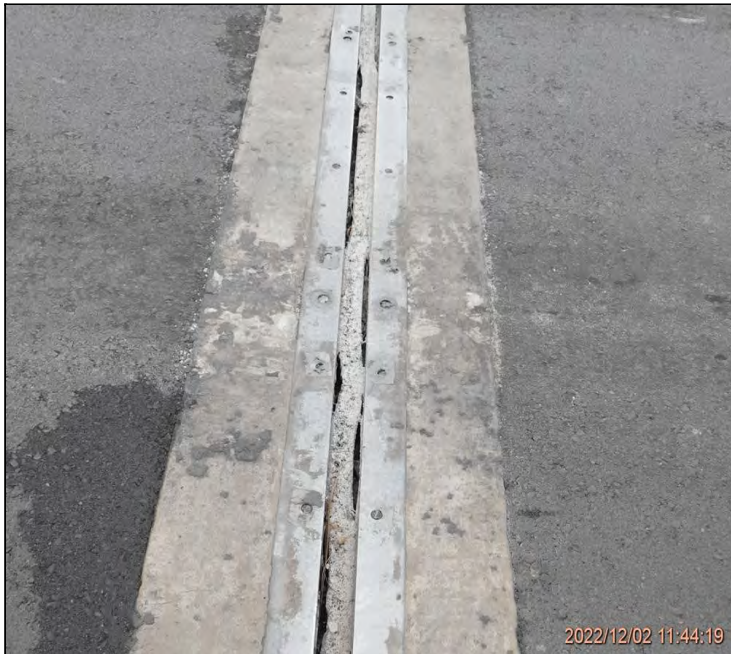
Description
South Expansion Joint, Gaps from Debonded Caulking atop Joint Seal (TYP)

Elem Grp/Class	Joints/Seals/sealants
Elem Type	Other
Sub Element	
Material Type	
Locator	South
Defect Descript1	Good condition
Defect Descript2	
Defect	
Other

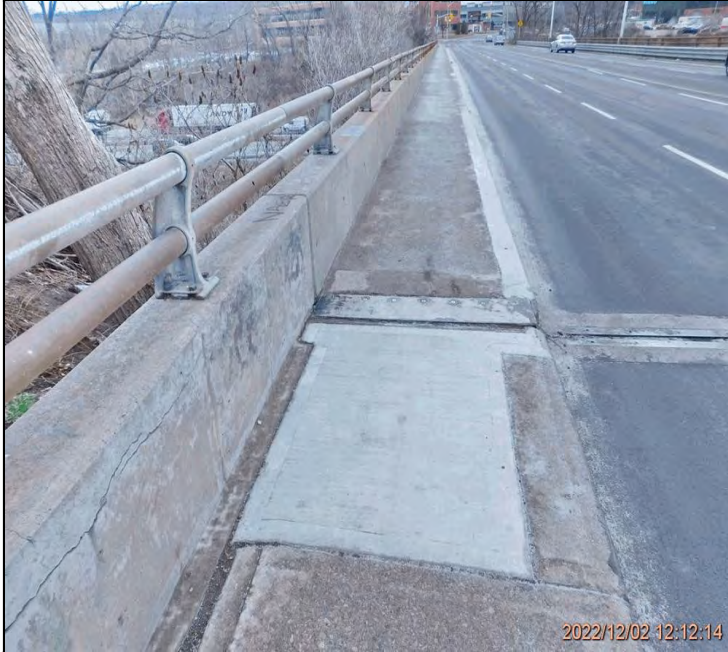
File Name 35 Large Patched Area on East Sidewalk at North Expansion Joint (TYP).JPG

Description Large Patched Area on East Sidewalk at North Expansion Joint (TYP)	
Elem Grp/Class	Sidewalks/curbs/Curbs
Elem Type	
Sub Element	
Material Type	Cast-in-place concrete
Locator	North
Defect Descript1	Good condition
Defect Descript2	
Defect	
Other

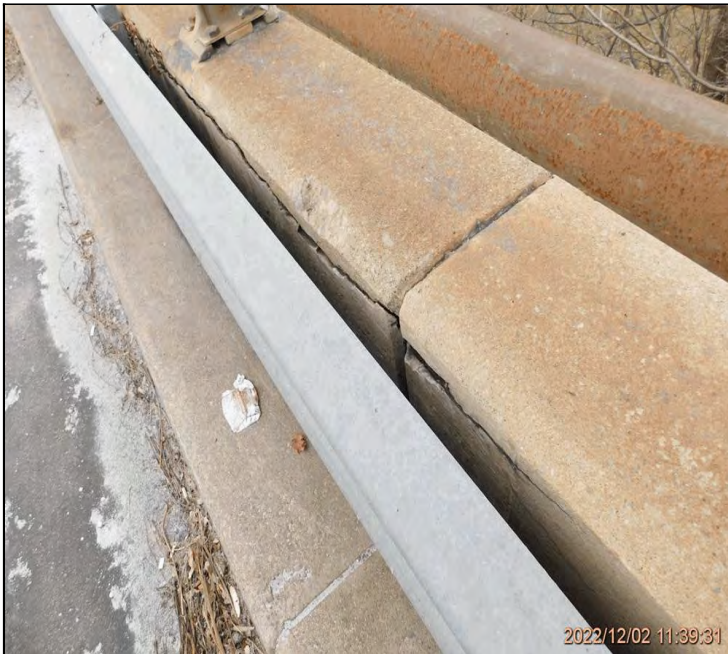
File Name 36 West Parapet Wall, Severe Delamination on Wall behind Thrie-Beam Guardrail.JPG

Description West Parapet Wall, Severe Delamination on Wall behind Thrie-Beam Guardrail	
Elem Grp/Class	Barriers/Barrier/Parapet Walls
Elem Type	Parapet Wall with two rails
Sub Element	Interior
Material Type	Cast-in-place concrete
Locator	West
Defect Descript1	Poor condition
Defect Descript2	
Defect	Delamination
Other

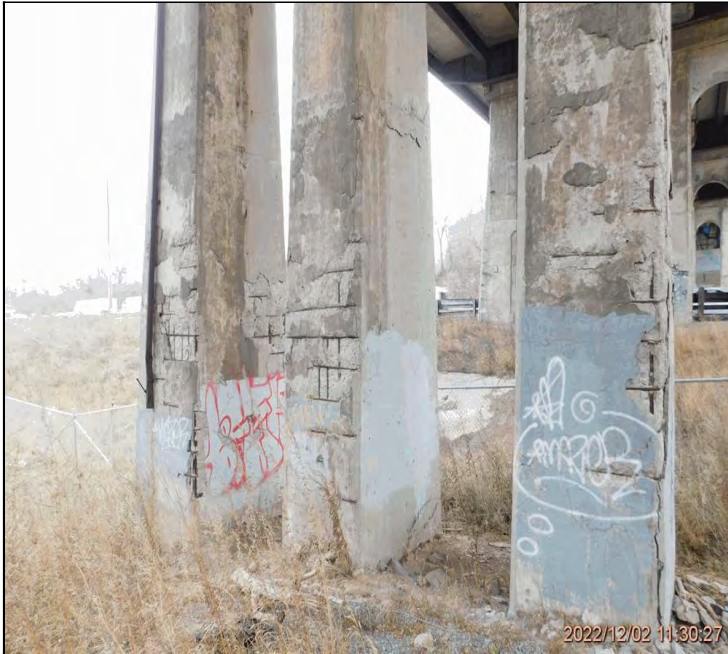
File Name 45 Pier 4, Severe Delam & Spalls on Columns at Pier, looking East.JPG

Description Pier 4, Severe Delam & Spalls on Columns at Pier, looking East	
Elem Grp/Class	Piers/Shfts/columns/Pile Bent
Elem Type	Conc rectangular columns with
Sub Element	
Material Type	Cast-in-place concrete
Locator	Bottom
Defect Descript1	Poor condition
Defect Descript2	
Defect	Spalling
Other

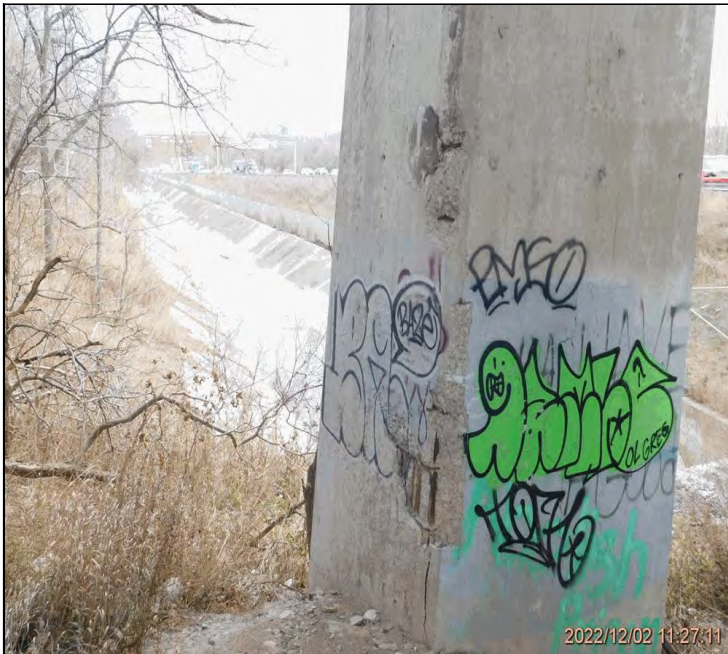
File Name 46 Pier 5, Severe Delamination & Spalls on Bottom Section of East Column.JPG

Description Pier 5, Severe Delamination & Spalls on Bottom Section of East Column	
Elem Grp/Class	Piers/Shfts/columns/Pile Bent
Elem Type	Conc rectangular columns with
Sub Element	
Material Type	Cast-in-place concrete
Locator	Bottom
Defect Descript1	Poor condition
Defect Descript2	
Defect	Delamination
Other

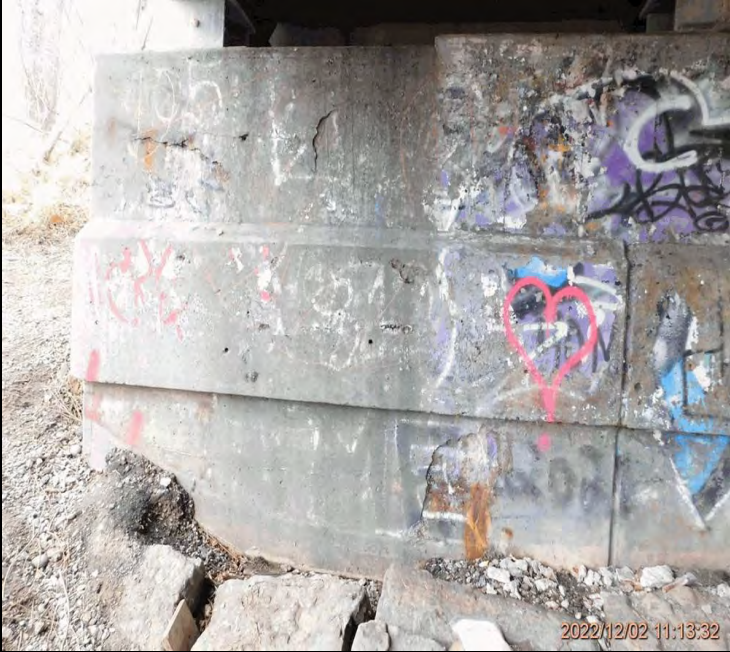
Description North Abutment, Severe Delam on West Section		
	Elem Grp/Class Elem Type Sub Element Material Type Locator Defect Descript1 Defect Descript2 Defect Other	Abutments/Ballast walls Cast-in-place concrete North Poor condition Delamination	
File Name	53 North Abutment, Severe Delam on West Section.JPG

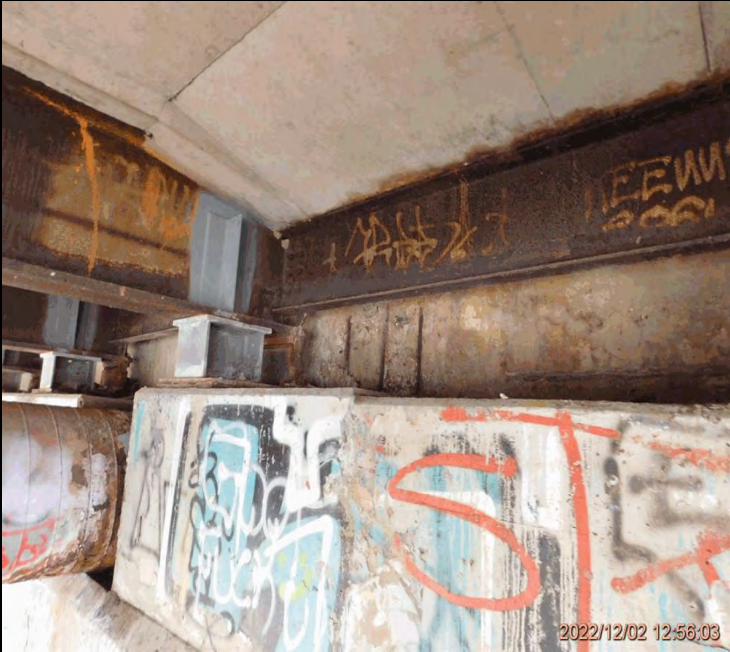
Description Local Severe Spalls on North Ballast Wall at Central Section of North Abutment		
	Elem Grp/Class Elem Type Sub Element Material Type Locator Defect Descript1 Defect Descript2 Defect Other	Abutments/Ballast walls Cast-in-place concrete North Poor condition Spalling	
File Name	54 Local Severe Spalls on North Ballast Wall at Central Section of North Abutment.JPG

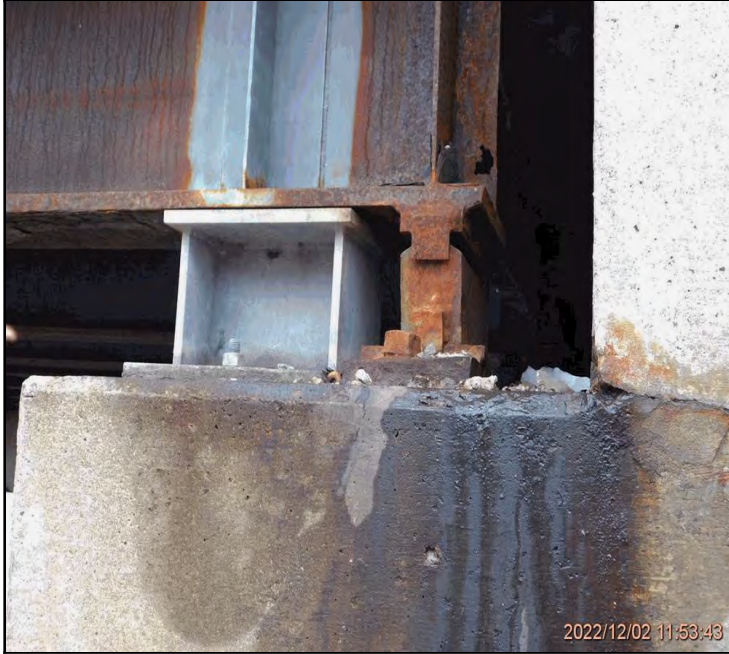
File Name	55 Typical Bearings at Abutments, West Bearing at South Abutment Shown.JPG
------------------	--

Description Typical Bearings at Abutments, West Bearing at South Abutment Shown	
Elem Grp/Class	Abutments/Bearings
Elem Type	Rocker
Sub Element	
Material Type	
Locator	South
Defect Descript1	Fair condition
Defect Descript2	
Defect	
Other

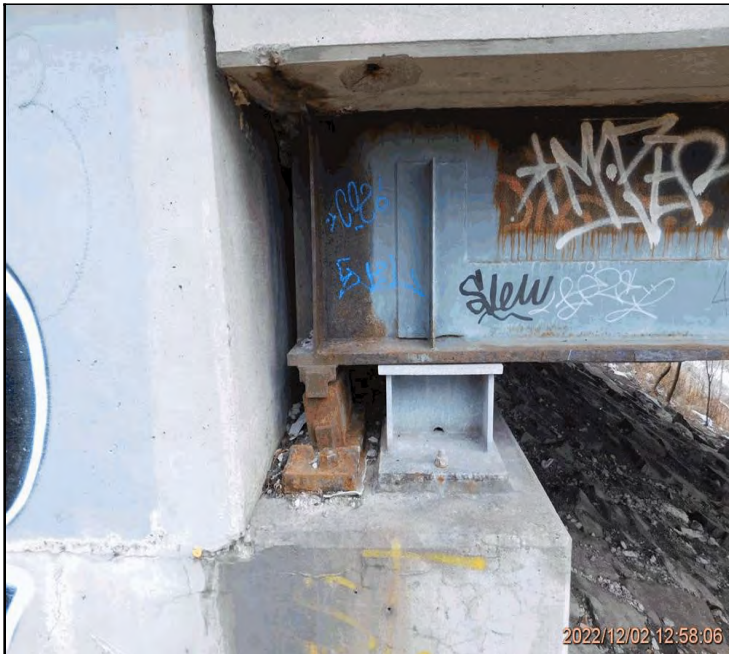
File Name	56 Typical Bearings Abutments, West Bearing at North Abutment Shown.JPG
------------------	---

Description Typical Bearings Abutments, West Bearing at North Abutment Shown	
Elem Grp/Class	Abutments/Bearings
Elem Type	Rocker
Sub Element	
Material Type	
Locator	North
Defect Descript1	Fair condition
Defect Descript2	
Defect	
Other

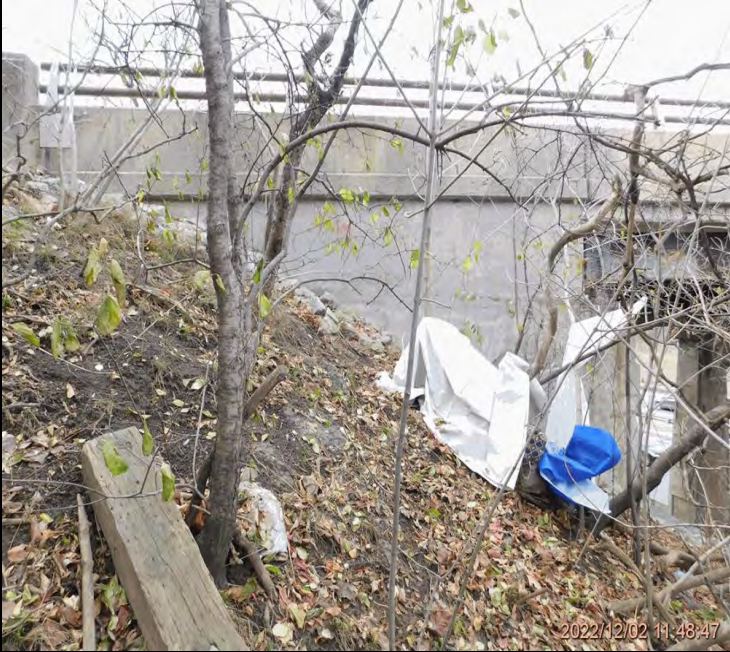
Description		
	Southeast Wingwall		
	Elem Grp/Class	Abutments/Wingwalls	
	Elem Type	Reinforced concrete	
	Sub Element		
	Material Type	Cast-in-place concrete	
	Locator	South	
	Defect Descript1	Good condition	
	Defect Descript2		
	Defect		
	Other		
File Name	57 Southeast Wingwall.JPG

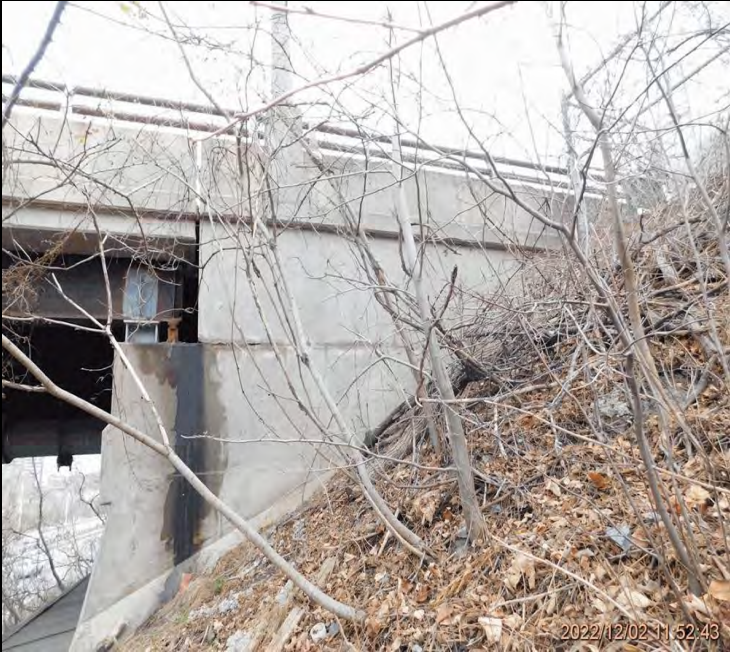
Description		
	Southwest Wingwall		
	Elem Grp/Class	Abutments/Wingwalls	
	Elem Type	Reinforced concrete	
	Sub Element		
	Material Type	Cast-in-place concrete	
	Locator	South	
	Defect Descript1	Good condition	
	Defect Descript2		
	Defect		
	Other		
File Name	58 Southwest Wingwall.JPG

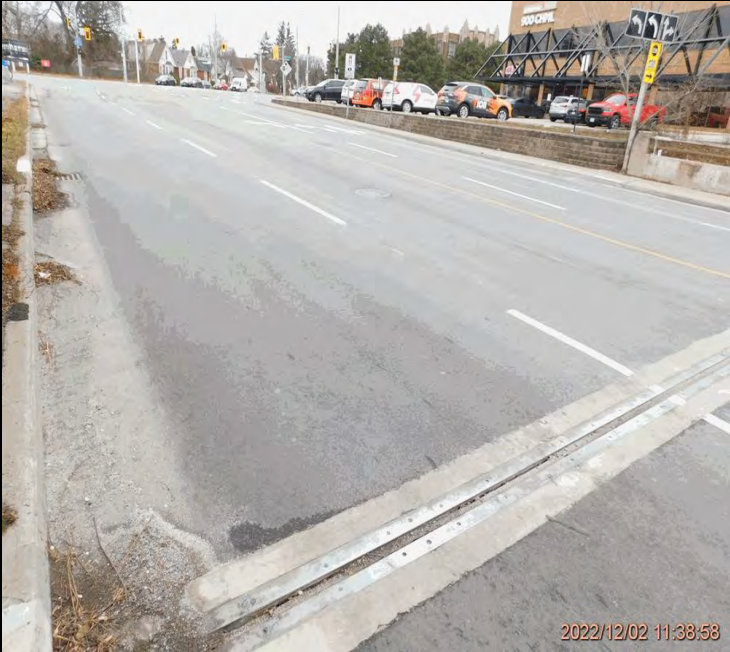
Description North Approach, looking North		
	Elem Grp/Class Elem Type Sub Element Material Type Locator Defect Descript1 Defect Descript2 Defect Other	Approaches/Wearing surface Asphalt North Excellent condition	
File Name		64 North Approach, looking North.JPG
