TIVOLI THEATRE | CULTURAL HERITAGE IMPACT ASSESSMENT

September 30, 2024

CULTURAL HERITAGE IMPACT ASSESSMENT | TIVOLI THEATRE

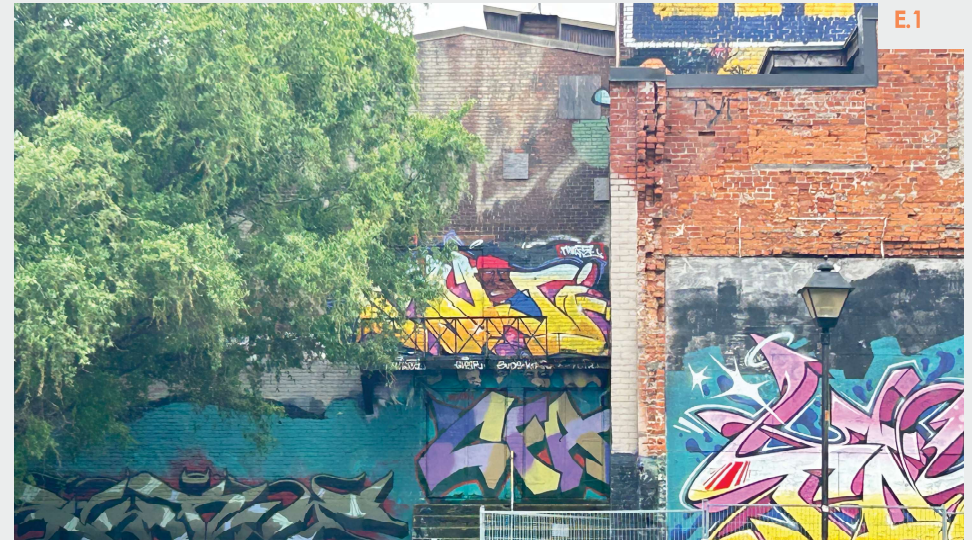
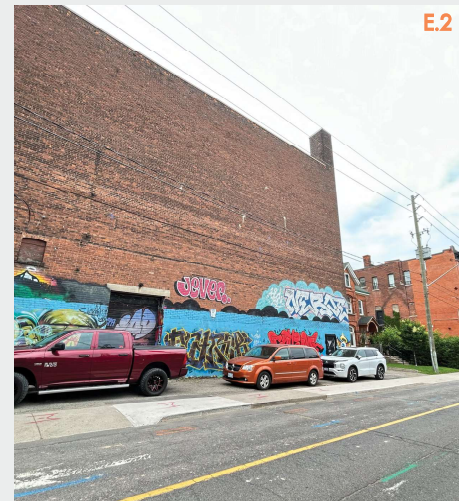
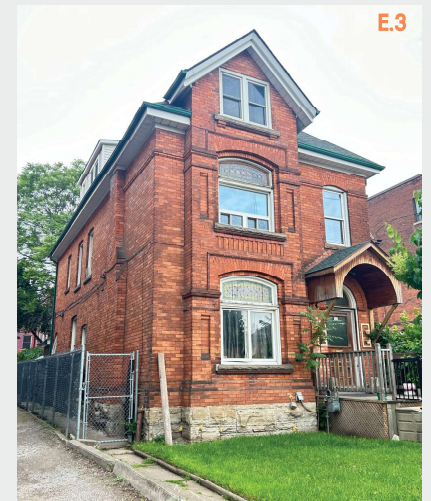
Exterior images [Source: +VG Architects]

- Exterior brick and clay tile walls are significantly deteriorating on both the interior and exterior sides.
- The roof structure is comprised of gypsum-based roof deck panels which loses structural integrity when it becomes wet, and heavy moisture is evident. Portions of the roof are collapsing and there is shoring in place to sustain the loads. The roof will need to be rebuilt.
- The plasterwork indicates moisture in the walls as evidenced by the peeling paint and plaster.
- Floor framing would require removal of damaged members and reinforce the floors to meet current day loading requirements.

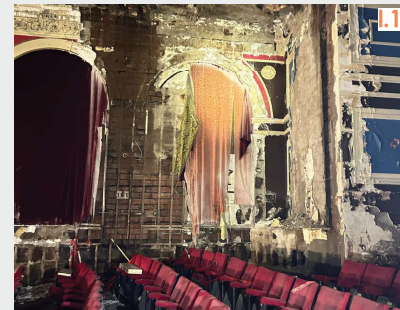
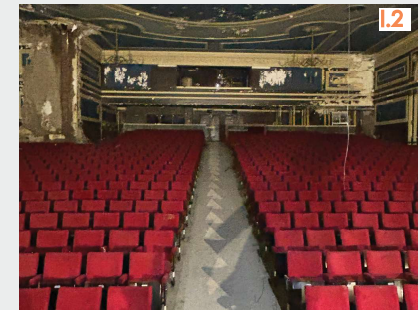
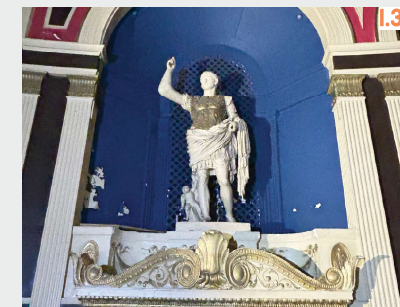
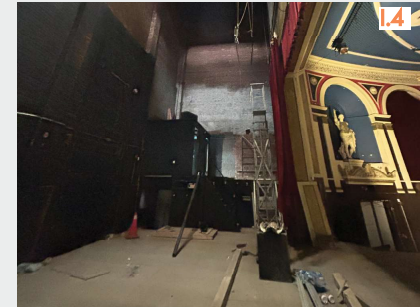
Interior images [Source: +VG Architects]

The condition of the asbestos-containing plaster throughout the building is noted to be extremely poor with widespread damage. All building surfaces are recommended to be treated as contaminated with asbestos fibres.

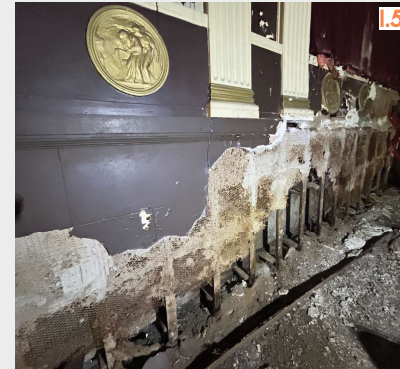
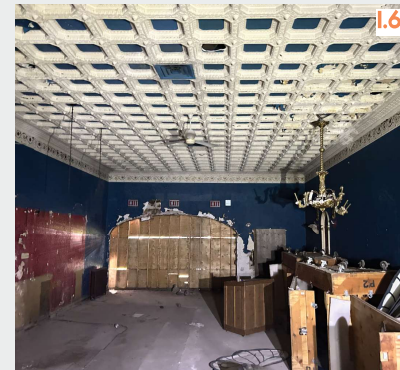
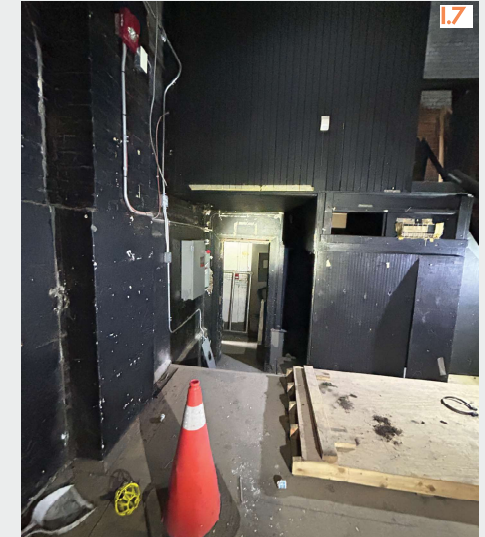
Various paint and surface coatings were tested by Reveal Environmental Inc. in April 2017 and found to have varying concentrations of lead. Access presumes that untested paint and surface coatings also contain lead, and report their deteriorating condition of extensive peeling and flaking and debris on surfaces. Lead is also presumed to be present in:

Interior images [Source: +VG Architects]

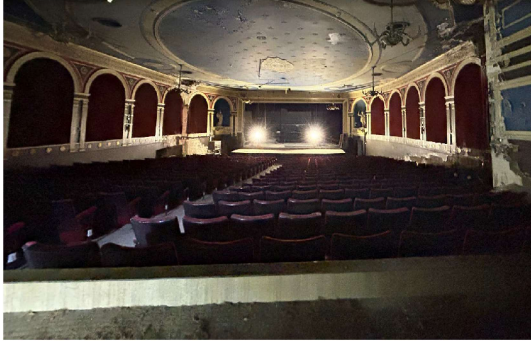
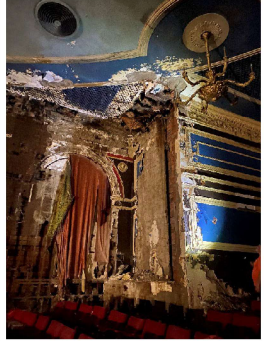
HERITAGE ATTRIBUTE	LOCATION	CONDITION	CURATION/ REUSE RECOMMENDATION	IMAGES	
3 Decorative plaster cornice & frieze below	House ceiling perimeter.	<p>General Condition: Good in most areas, however severely damaged or missing in others.</p> <p>Plasterwork is constructed on metal lath which is rusting in areas of the auditorium walls. Ornamental plaster is also failing in many areas. The cycle of moisture, freeze-thaw contribute to continuing deterioration.</p> <p>The area on the southwest corner of the auditorium is severely damaged from water due to the roof breach. Water falls into the auditorium further deteriorating the lower plaster wall.</p>	<p>Documentation: Detailed scanning, drawings and descriptions.</p> <p>Ornamental plaster requires careful documentation of the designs, spacing, scale, and location.</p> <p>Note: Two environmental reports identify designated substances and hazardous building materials found throughout the building. Specific to plaster and interior finishes are asbestos and lead paint. Due to deteriorated conditions of the interior, asbestos fibers are noted as having widespread on the interior. Abatement methods may be detrimental to the historic features and further study is required.</p>

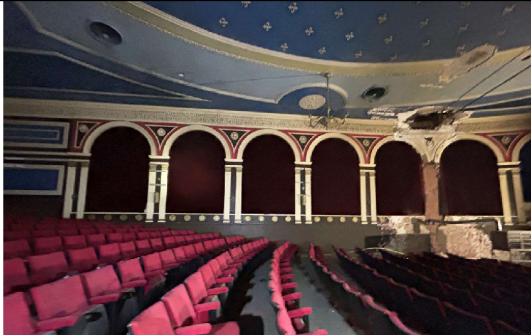
4 Wall colonnades each w five round arches sprung from coupled pilasters.	On the long walls of the auditorium.	<p>General Condition: Good in most areas, however severely damaged or missing in others.</p> <p>The wall colonnades each have six round arches plus the recessed arch with statutory beside the proscenium.</p>	<p>Documentation: Detailed scanning, drawings and descriptions.</p> <p>Ornamental plaster requires careful documentation of the designs, spacing, scale, and location.</p> <p>Note: Two environmental reports identify designated substances and hazardous building materials found throughout the building. Specific to plaster and interior finishes are asbestos and lead paint. Due to deteriorated conditions of the interior, asbestos fibers are noted as having widespread on the interior. Abatement methods may be detrimental to the historic features and further study is required.</p>

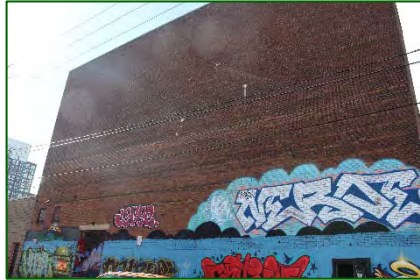
Area/Item Reviewed	Photograph
<p>Item 1.1 East Elevation</p> <p><u>Observation</u> East elevation of the building consists of brick. Brick has been parged over approximately 3m above grade. The brick is in fair condition. Some deterioration and staining of brick around existing window/door openings.</p>

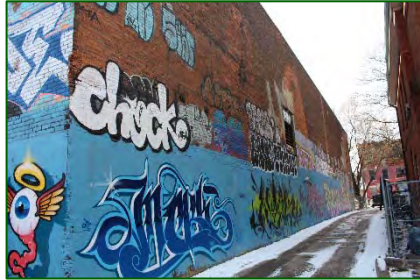
<p>Item 1.2 North Elevation</p> <p><u>Observation</u> North elevation of the building consists of brick and a parge coat approximately 3m above grade. Brick wall is in poor condition.</p> <p>Some deterioration of brick and cracking was observed.</p>

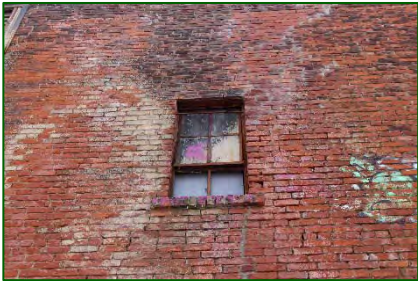
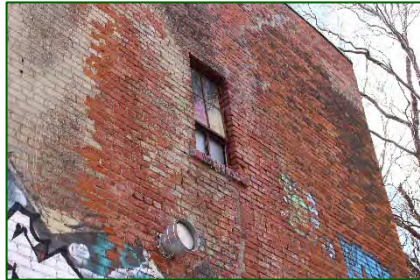
<p>Item 1.3 North Elevation</p> <p><u>Observation</u> Significant mortar loss at brick joints throughout wall. Significant staining throughout wall.</p>

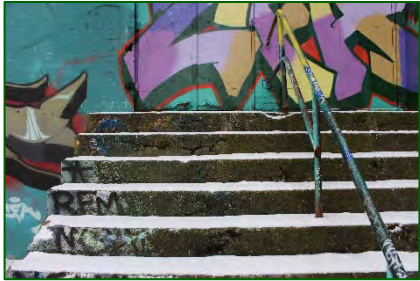
Area/Item Reviewed	Photograph
<p>Item 1.6 West Elevation</p> <p><u>Observation</u> Concrete steps deteriorating.</p>

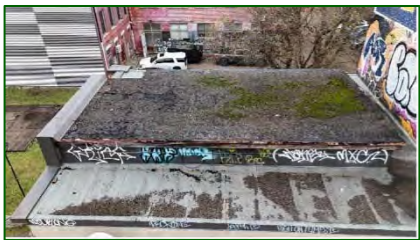
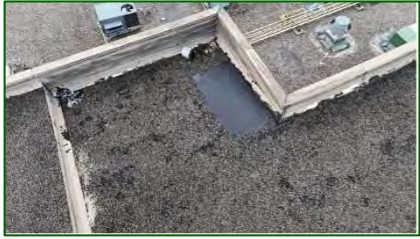
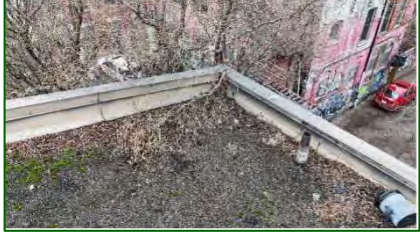
<p>Following the structural review several photos were shared by the building owner. Items from photos listed below.</p>	
<p>Item 1.7 Roof</p> <p><u>Observation</u></p> <p>Roof was not reviewed as part of this inspection. Photos of the roof were shared by owner. Roof is in poor condition, vegetation growth on roof suggest moisture problems.</p>

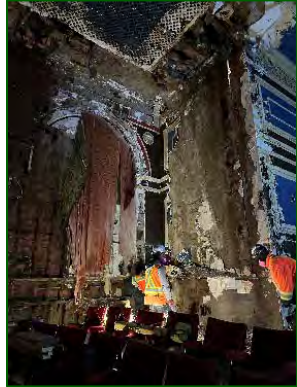
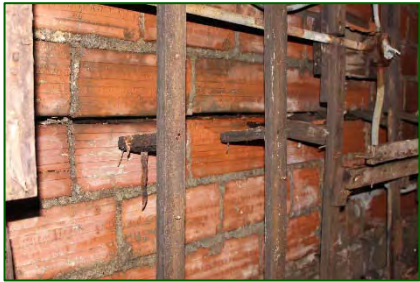
Area/Item Reviewed	Photograph
Item 2.1 Main Auditorium Walls <u>Observation</u> Brick and clay tile interior walls covered with plaster finish in most areas. Plaster is in poor condition; where visible, clay tiles and bricks are in poor condition.

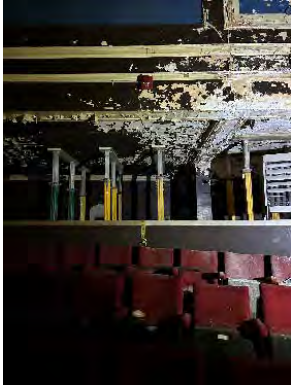
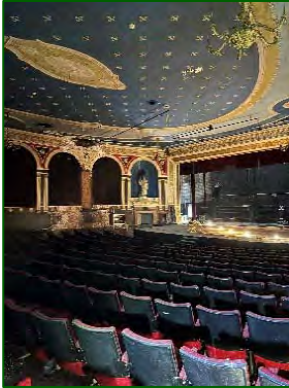
Area/Item Reviewed	Photograph
<p data-bbox="186 363 592 394">Item 2.2 Back of Auditorium</p> <p data-bbox="186 415 344 447"><u>Observation</u></p> <p data-bbox="186 449 906 514">Shoring installed at back of auditorium to support second floor and roof structure above.</p>

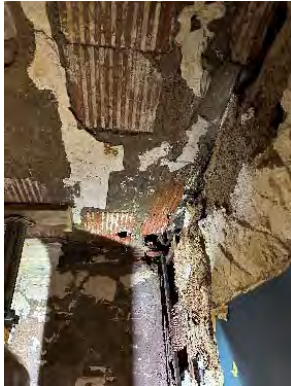
<p data-bbox="186 993 537 1024">Item 2.3 Floor Structure</p> <p data-bbox="186 1045 344 1077"><u>Observation</u></p> <p data-bbox="186 1079 636 1113">Clay tile ceiling at shoring locations.</p>

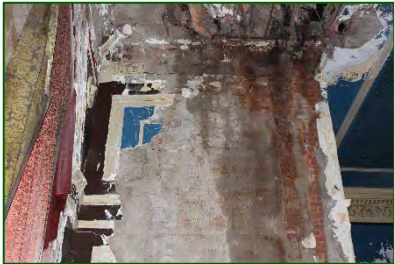
<p data-bbox="186 1440 407 1472">Item 2.4 Walls</p> <p data-bbox="186 1493 344 1524"><u>Observation</u></p> <p data-bbox="186 1526 505 1560">Moisture damage to wall.</p>

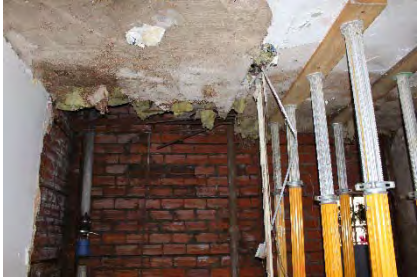
Area/Item Reviewed	Photograph
<p>Item 2.5 Roof Structure</p> <p><u>Observation</u> Shoring up to ceiling of roof structure. Ceiling has significant moisture damage and is on the verge of collapse. Shoring is installed but may not prevent collapse of moisture ridden gypsum panels.</p>

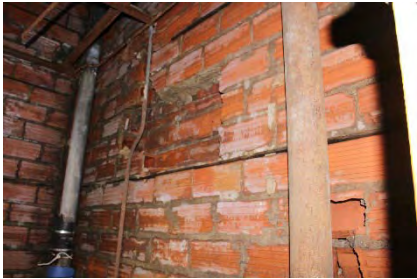
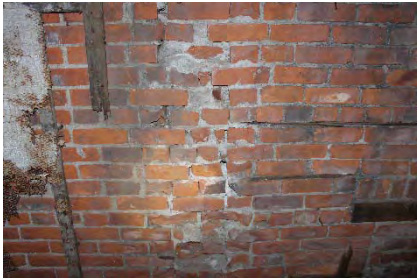
A photograph showing the interior of a roof structure. The ceiling is made of gypsum panels that are heavily damaged, with large areas of peeling and crumbling material. Several vertical metal shoring poles are installed to support the ceiling. The walls are made of red brick.
<p>Item 2.6 Walls</p> <p><u>Observation</u> Deterioration to clay tile and brick at inside of walls. Walls are in poor condition where viewed.</p> <p>Considerable cracking of brick walls was observed.</p>

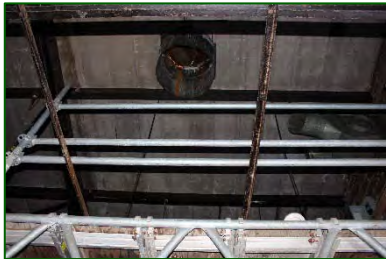
<p>Item 2.7 Roof Framing</p> <p><u>Observation</u> Siporex roof structure with damage at penetrations, several areas are stained suggesting moisture damage. Siporex roof structure loses significant structural integrity when wet.</p> <p><u>Action</u> Shore areas of damaged Siporex immediately.</p>

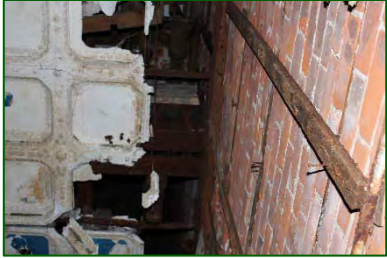
Area/Item Reviewed	Photograph
<p>Item 2.8 Walls</p> <p><u>Observation</u> Steel framing supporting brick wall above. Limited visibility. Previous report states steel trusses and channels used for roof framing.</p>

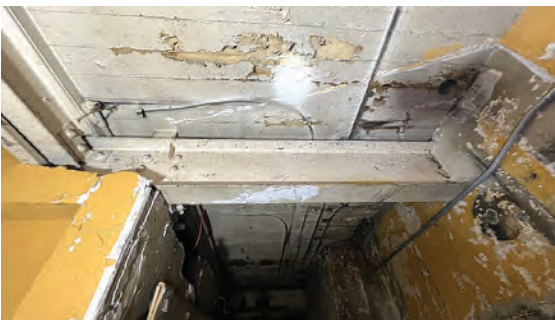
Photo 1: Example of peeling and flaking paint on wood ceilings below stage area.

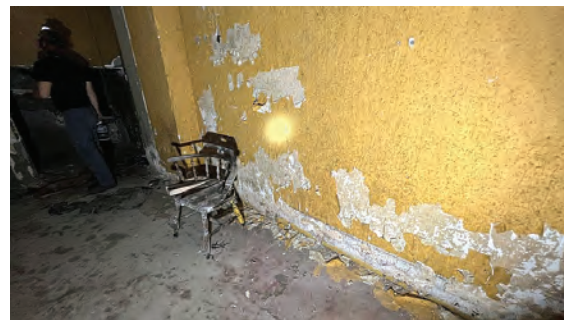
Photo 2: Example of peeling and flaking paint on plaster walls below stage area.

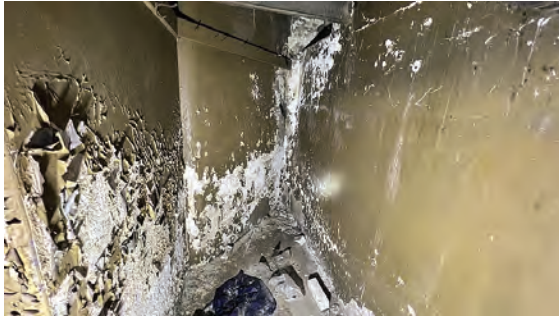
Photo 3: Example of peeling and flaking paint on plaster walls behind stage area.

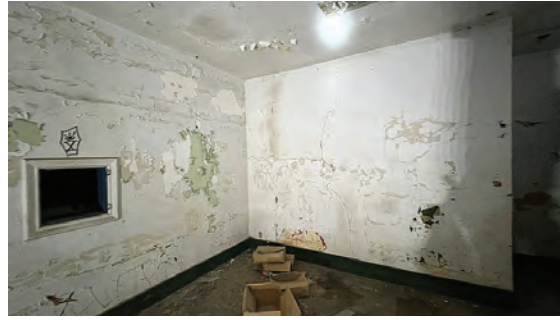
Photo 4: Example of peeling and flaking paint on plaster walls on second floor in the projection room.

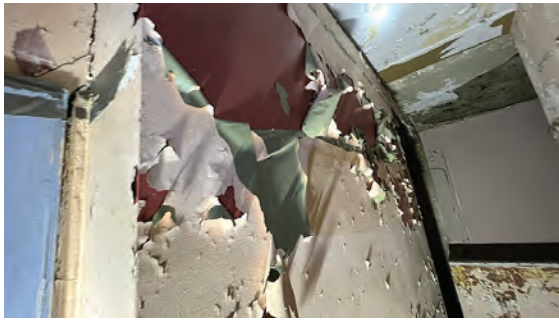
Photo 5: Example of damaged paint on plaster walls on second floor.

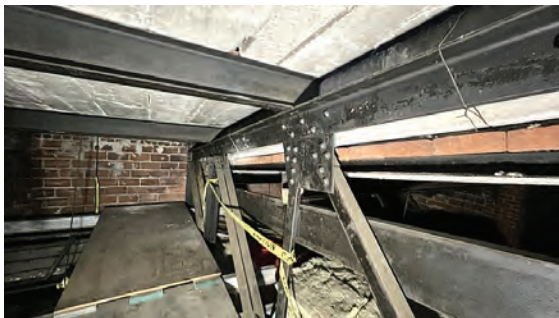
Photo 6: Example of suspected lead-containing primer on structural steel roof framing.

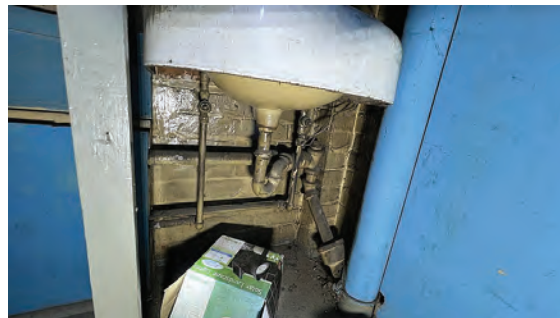
Photo 7: Example of suspected lead-containing pipes and joints.

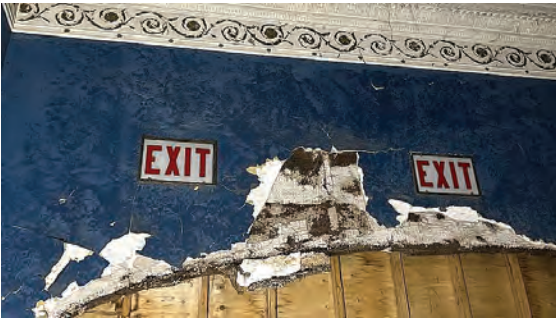
Photo 8: Example of exit signs suspected to contain lead acid batteries.

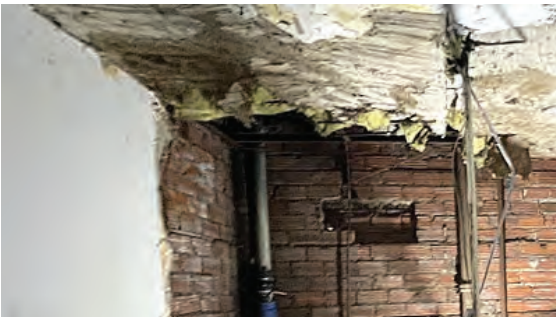
Photo 11: Water damage and mould growth in staircase area leading to projection room.

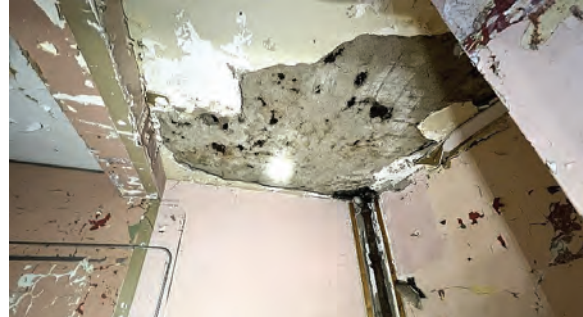
Photo 12: Water-damaged ceiling and mould growth on second floor.

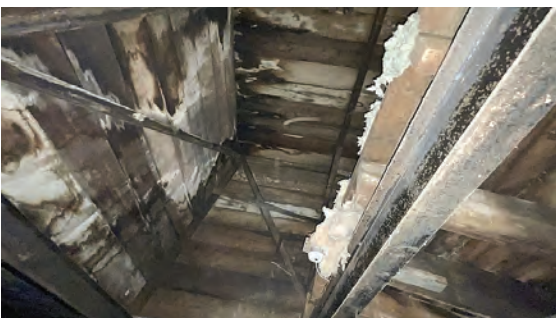
Photo 13: Water damage and mould growth on roofing above catwalk area.

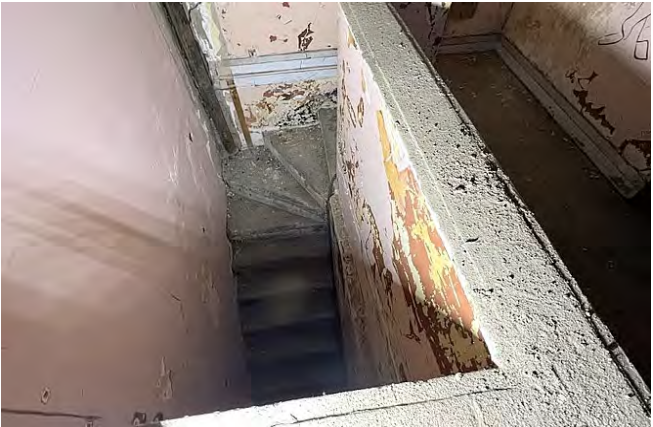
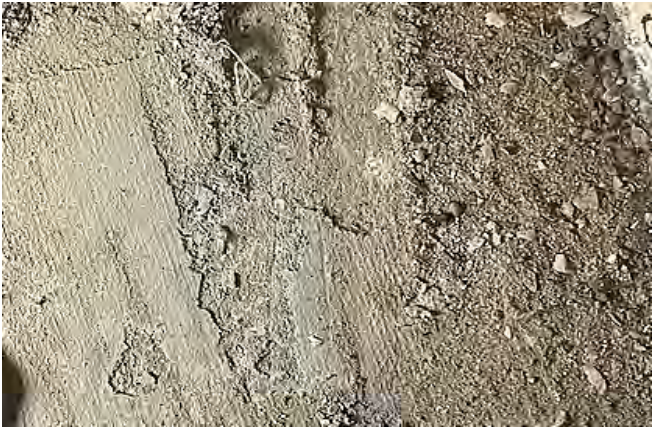
Lab Result: *None detected*

Comment: *Mastic tested does not contain asbestos.*

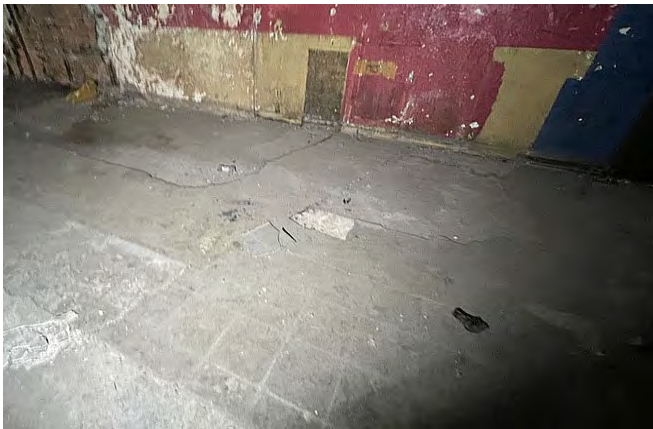
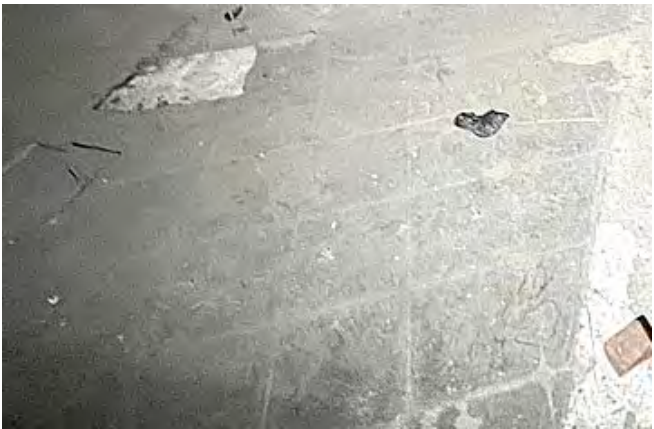
Samples: 014A.c)

Colour: *Black (tar)*
Brown (cementitious material)
Black, brown (mastic)

Friable: No

Lab Result: *1% Chrysotile*

Location #	Area Description	Quantity	Condition	Damaged	Qty.	Acc.	Vis.	Comments	Recommendation
L101	Front entrance	~ 50 sf	-	-	-	A	Yes	Exact location of mastic is difficult to determine and is likely present concealed elsewhere within the front entrance (L101).	Remove as part of the overall O. Reg. 278/05 Type 3 abatement operations within the building.

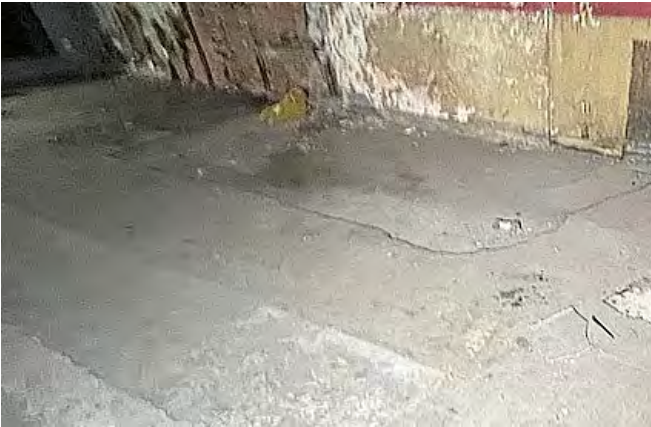
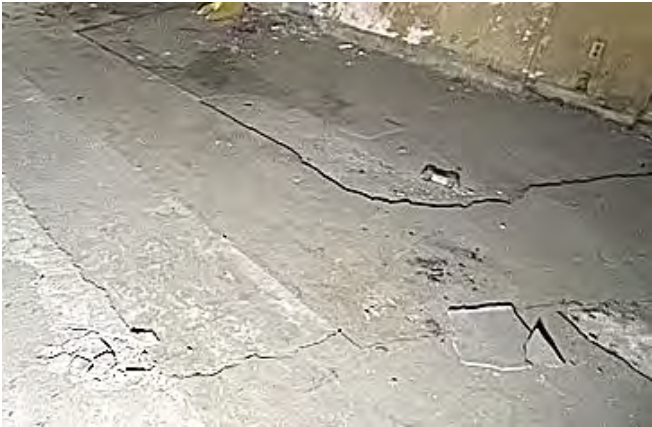
Lab Result: *None detected*

Comment: Floor levelling material tested does not contain asbestos.

Location #	Area Description	Quantity	Condition	Damaged Qty.	Acc.	Vis.	Comments	Recommendation
							Concealed asbestos levelling compound and mastics may be present.	Refer to BCM #12, BCM #13 and BCM #14.

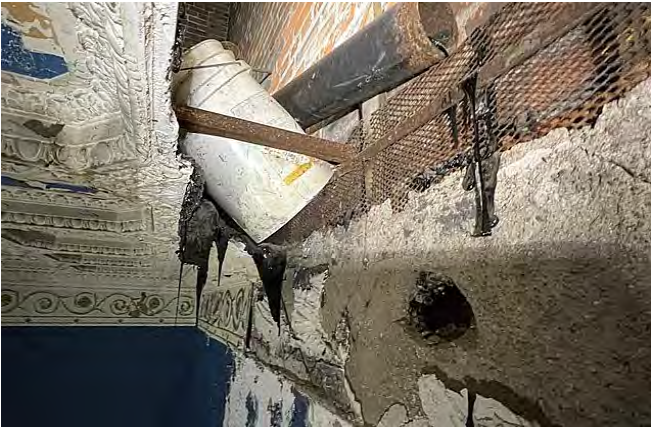
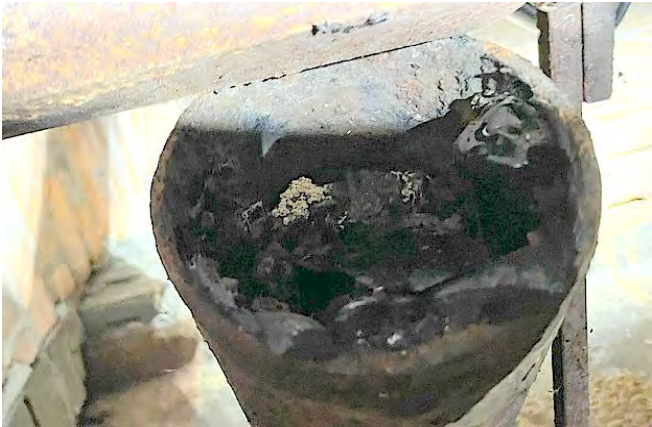
Colour: *Black*
Friable: *na*

Samples: *016A to C*
Lab Result: *None detected*
Comment: *Tar material tested does not contain asbestos.*

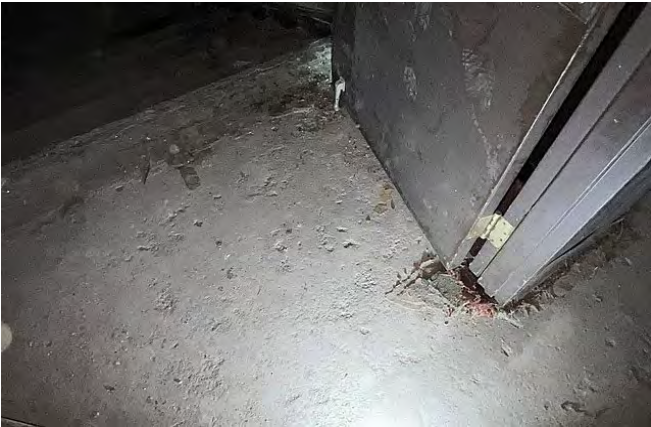
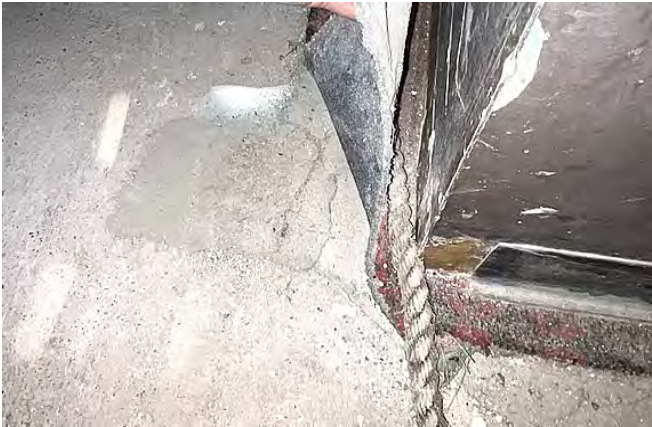
Colour: Grey
Friable: na

Samples: 017A to C
Lab Result: *None detected*
Comment: Carpet underlayment tested does not contain asbestos.

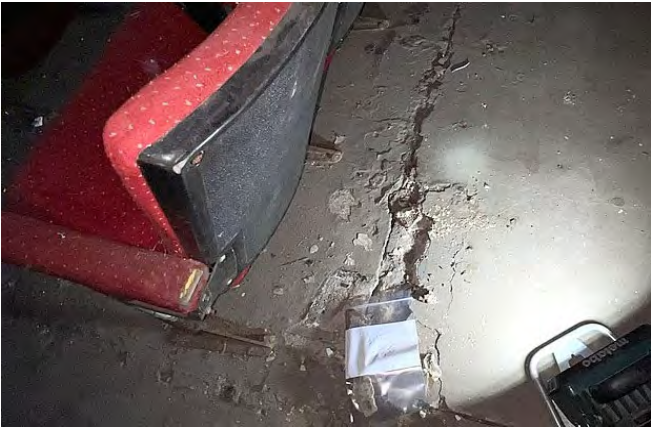
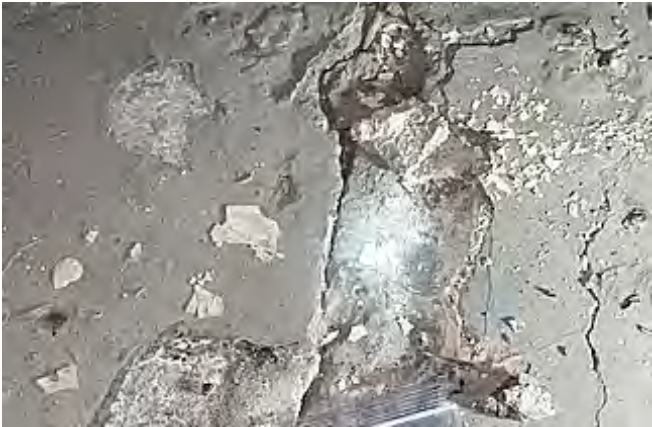
Colour: *Beige*
Friable: na

Samples: 018A to C
Lab Result: *None detected*
Comment: *Levelling compound tested does not contain asbestos.*

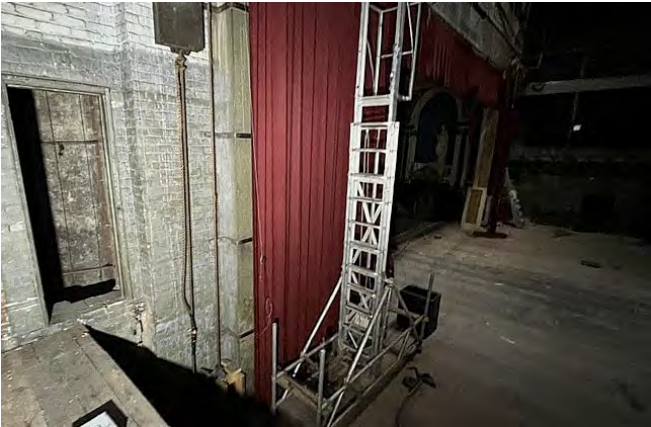
Lab Result: *None detected (Reveal Report)*

Comment: *Textile material does not contain asbestos (Reveal report).*

Location #	Area Description	Quantity	Condition	Damaged Qty.	Acc.	Vis.	Comments	Recommendation
							Textile fabric is likely contaminated by asbestos plaster debris.	Remove as part of the overall O. Reg. 278/05 Type 3 abatement operations within the building.

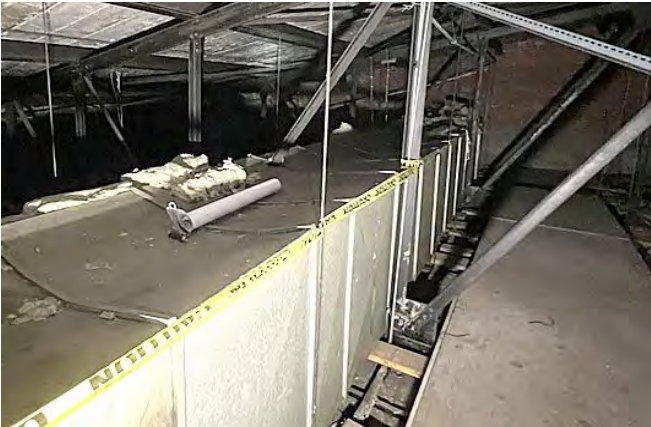
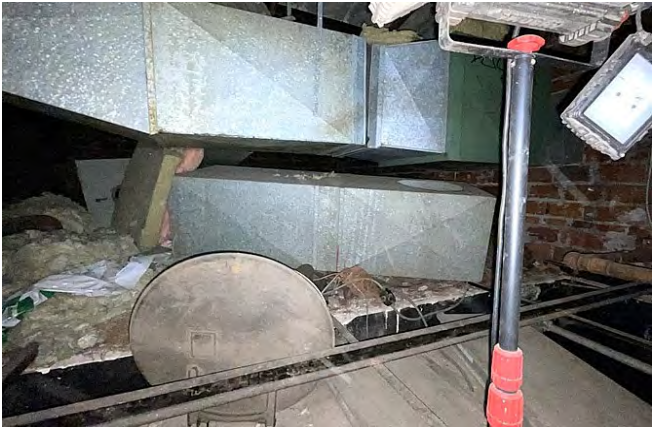
Colour: -
Friable: na

Samples: ns
Lab Result: *na*
Comment: *Ductwork is bare throughout subject area.*

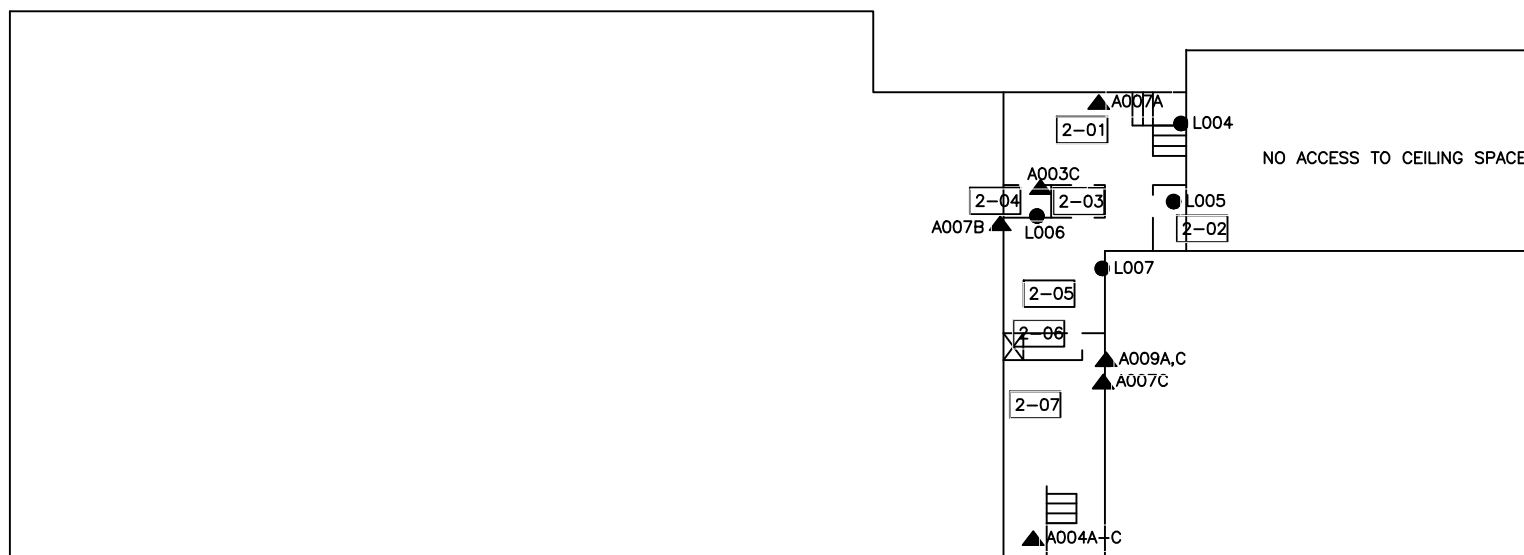
NOTE : ALL PLASTER FINISHES ON WALLS AND CEILINGS CONTAINS ASBESTOS.
