# City of Hamilton Heritage Committee

Meeting December 13, 2024

108 James Street North,  
111-115 Hughson

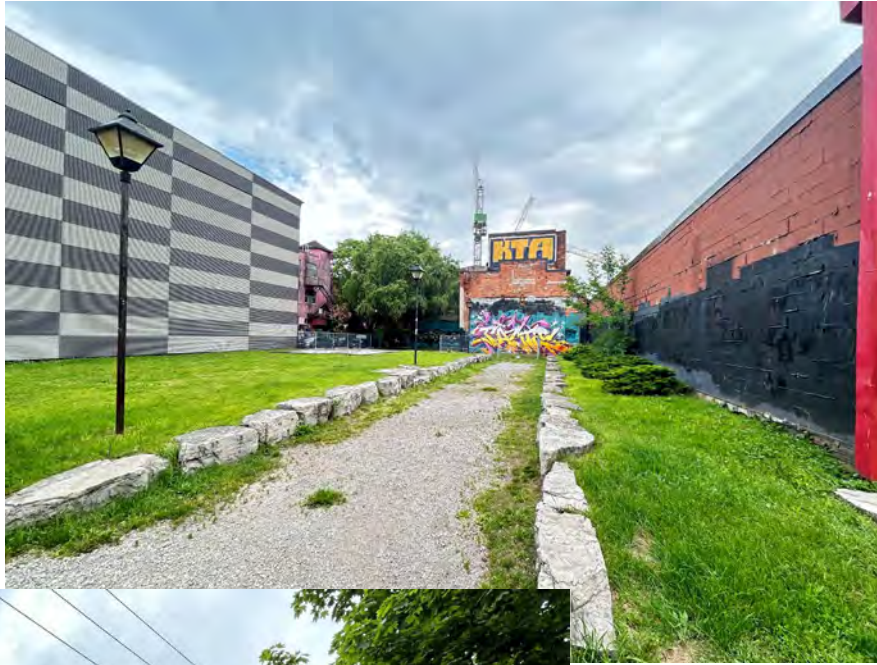
View of lobby from  
James St N

The scope of the application for a heritage permit includes demolition of the remaining lobby and auditorium of the Tivoli Theatre.

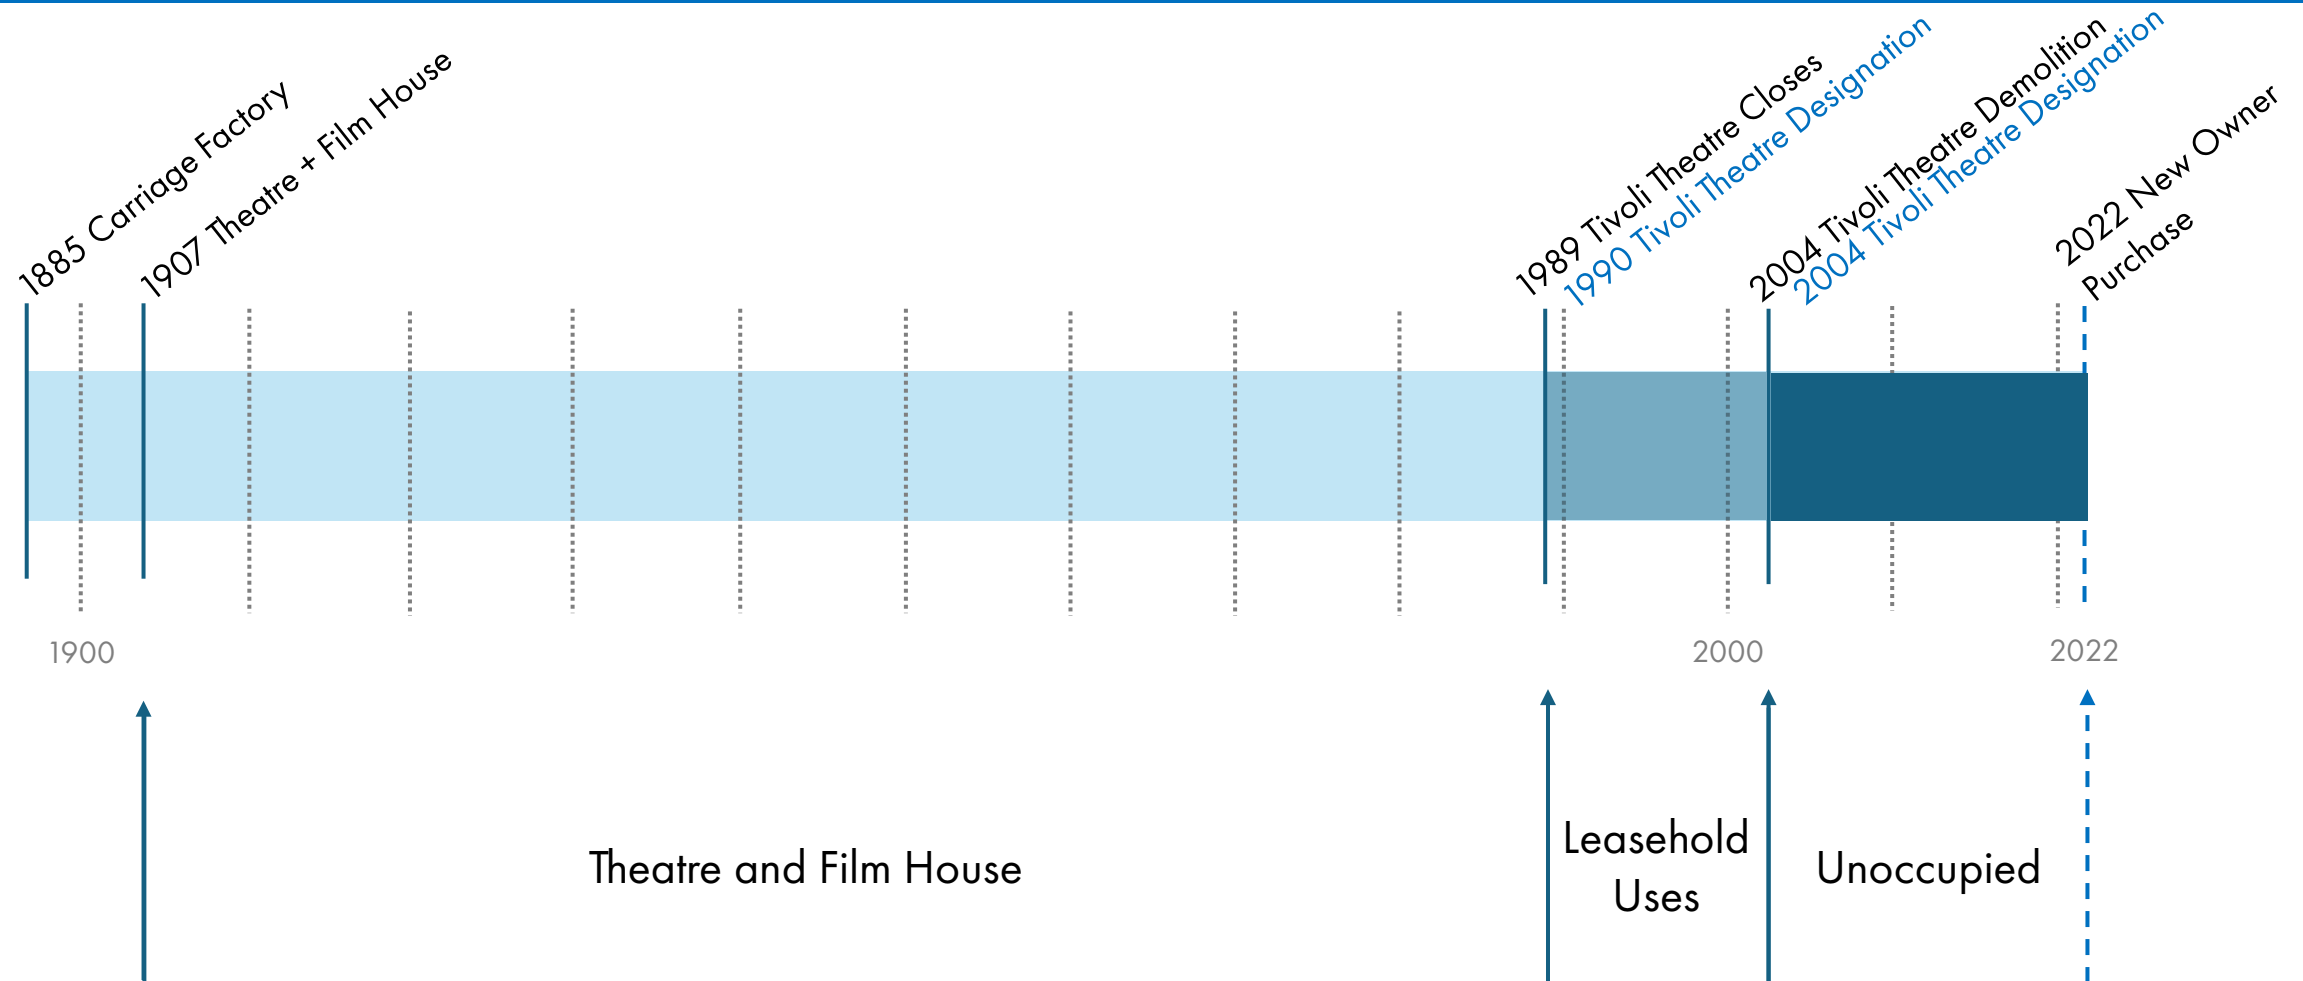
Tivoli Theatre Event Timeline showing extensive property deterioration since 2004.

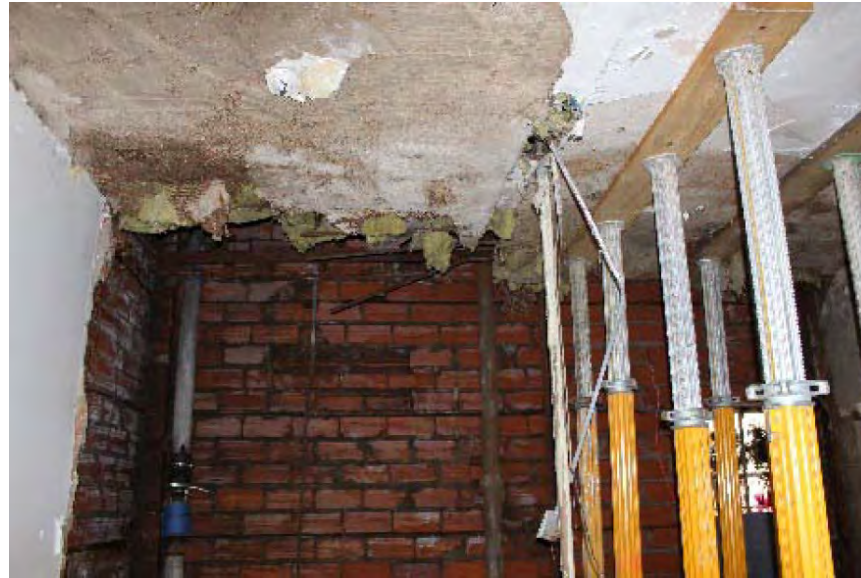
Observation: Shoring up to ceiling of roof structure. Ceiling has significant moisture damage and is on the verge of collapse. Shoring is installed but may not prevent collapse of moisture ridden gypsum panels.

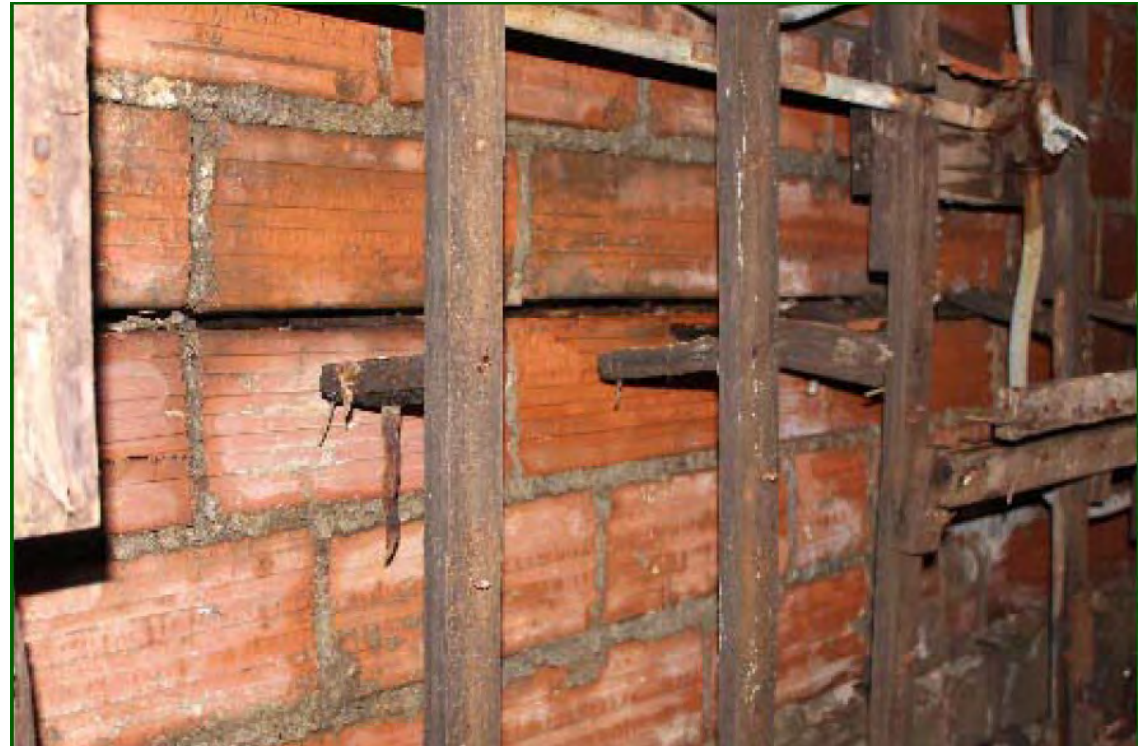
Observation: Brick and clay tile interior walls covered with plaster finish in most areas. Plaster is in poor condition; where visible, clay tiles and bricks are in poor condition.
