SUBJECT: Notice of Intention to Demolish 39 Wilson Street, Hamilton, ON L8R 1C6 (Unoccupied Manse Adjacent to Trinity Lutheran Church)

HERITAGE IMPACT ASSESSMENT

Trini Lutheran Church 37-39 Wilson E, Hamilton

10 JAN 2025

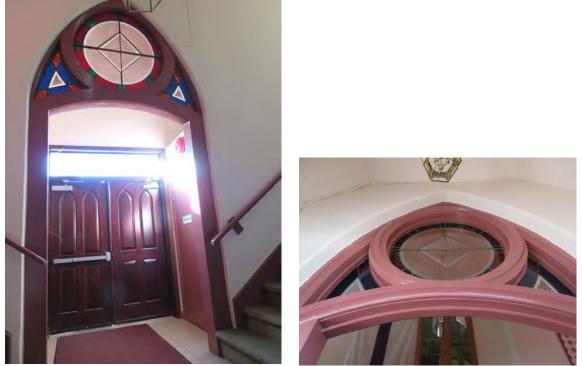
Church interior – small Vestibule inside the Front Entrance on Wilson Street – doorway and arched transom with stained glass – *arch and stained-glass transom are heritage attributes to be preserved *in situ*

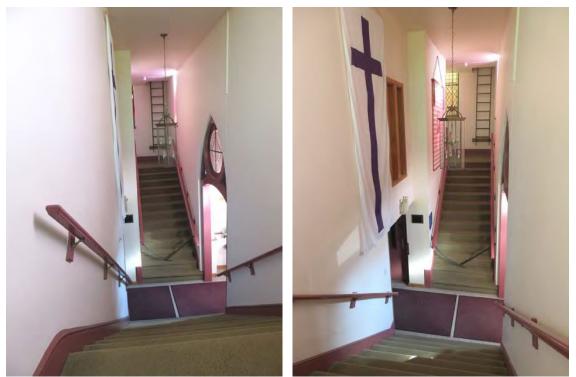
Church Interior - Corridor inside the Main Entrance on Wilson Street with two staircases up to the Gallery – the west stairs continue up into the tower

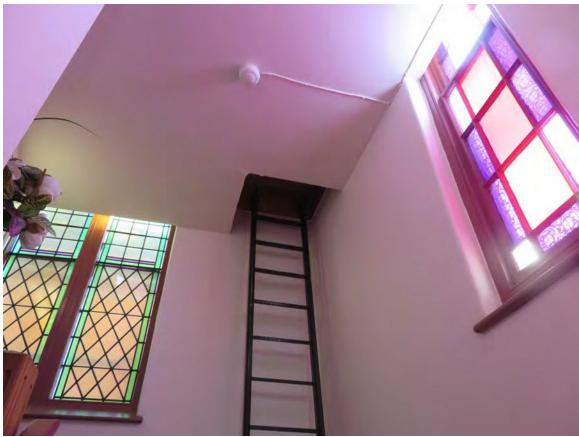
Church Interior – the Gallery overlaps the stained-glass window in Bay 1 on the east side elevation (left) and stained glass windows on the front elevation (right) – the front elevation has 1867 stained & etched glass windows

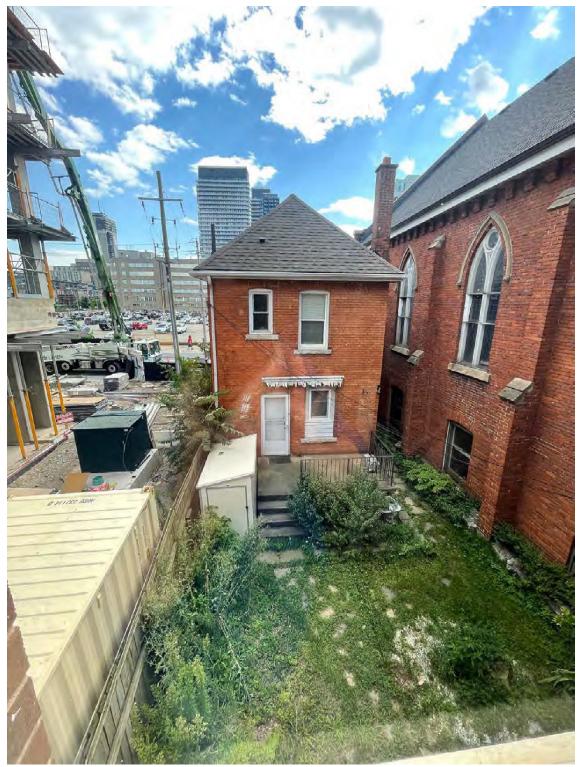
1902 Caretaker's House – view from the stairwell of the rear addition to the rear elevation and rear yard of the Caretaker's House – the east wall of the church is visible on the right – the new condo construction next door is visible on the left

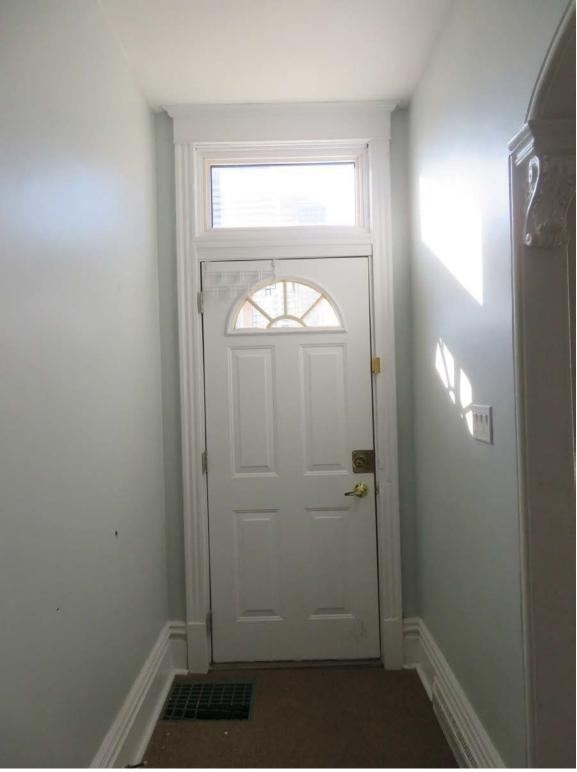
1902 Caretaker's House – interior – front door with transom above – replacement door

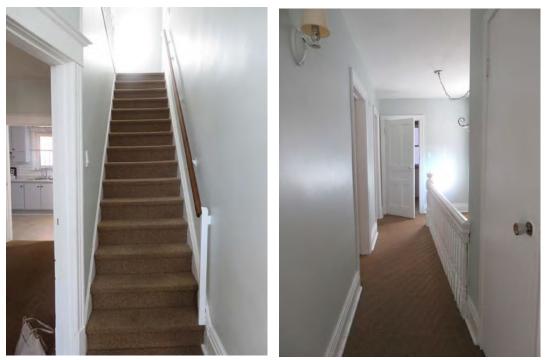
1902 Caretaker's House – interior – stairs to the 2nd floor

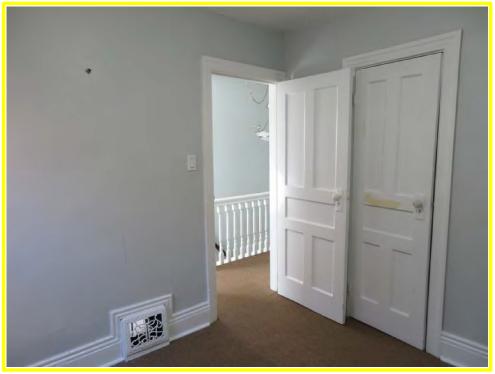
1902 Caretaker's House – interior – 2nd floor – original doors and vent covers

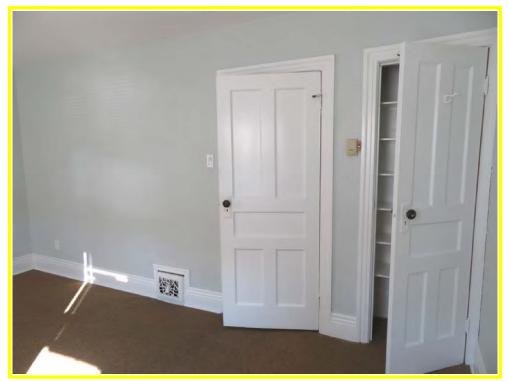
1902 Caretaker's House – interior – 2^{nd} floor – original doors and vent covers

POTENTIAL SALVAGE ITEMS: paneled wood doors

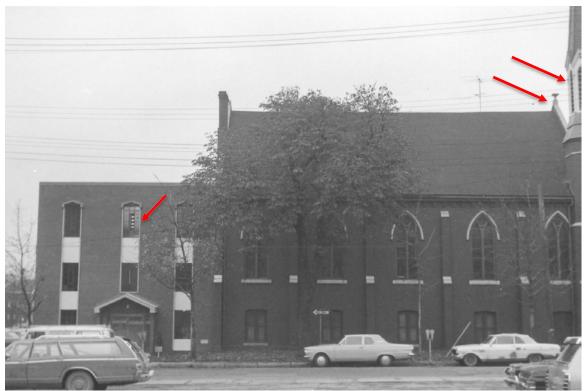
c.1969 PHOTO: Trinity Lutheran, Hughson Street North elevation – Sunday School addition that replaced the Old Manse {Lutheran Archives, WLU}

COMMENT: note the original geometric glazing pattern in the windows of the Sunday School Addition and stone framing details – note the original louvres in the Church steeple – note the original stone coping on the Church gable
