Feasibility Study for the Historic Barn at Battlefield National Historic Site

City of Hamilton

FINAL: June, 2016

SBA Project No. 15084

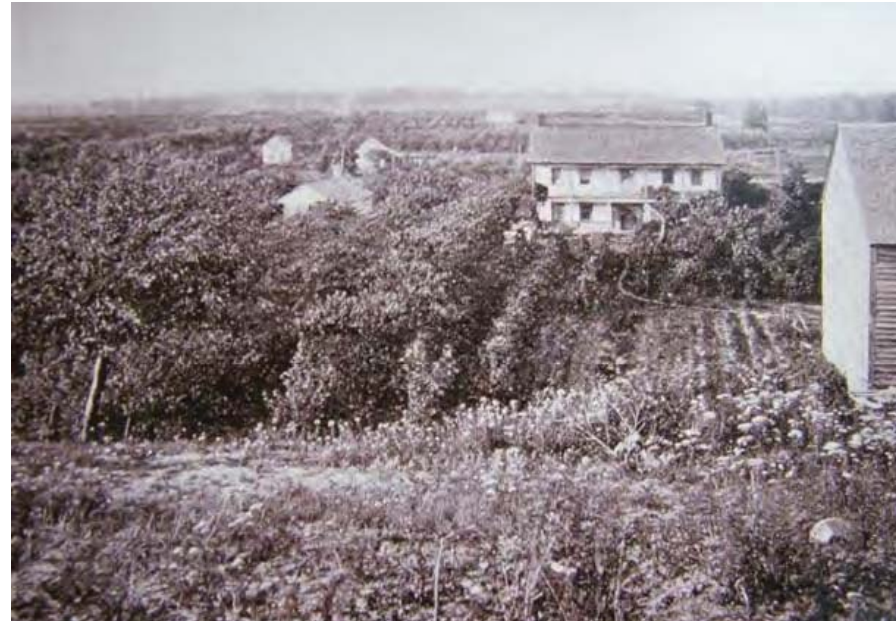
Figure 2: Gage House and Barn looking North circa 1900s (right side of photo)
Credit: Battlefield Park National Historic Site Master Plan, Jan. 2011, pg. 48.

The present analysis of the barn questions whether the barn shown in the early photo is indeed the same barn presently on site. Closer examination of the photograph and reconstruction (**Refer to Figures 2 and 3**) has led to the conclusion that the barn presently north of the Nash Jackson House is not the barn in the photograph of the Gage House.

The barn in the photograph has horizontal clapboard siding and it was analyzed quite closely to determine the dimensions of the barn in the photograph. The present barn has much of its original vertical board siding intact under the modern waferboard and board & batten. The type of siding installed on 19th century barns was determined when they were framed: barns to receive horizontal siding were framed with studs between the major timbers to directly receive the siding. **Refer to Figure 5.**

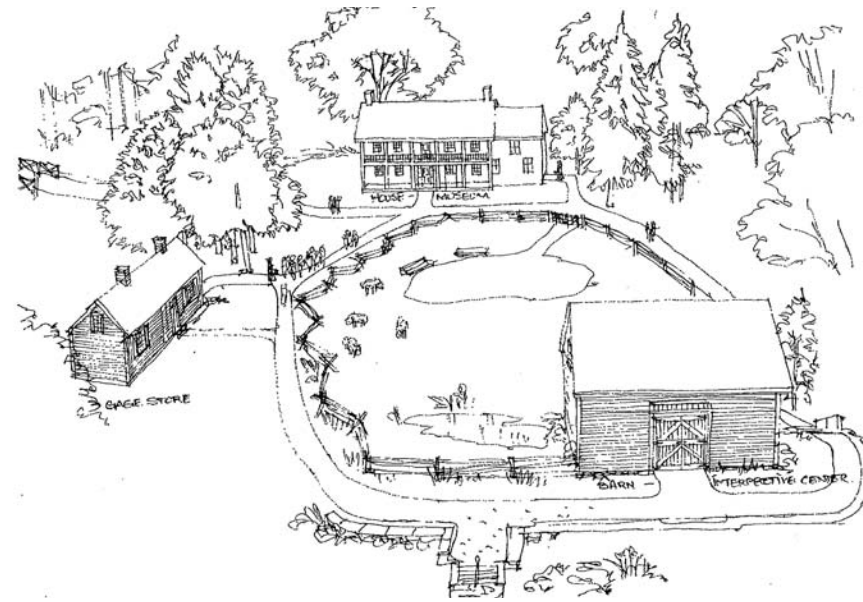
Figure 3: Proposed Restoration of Three Historic Buildings on Original Site
Credit: Battlefield Park Stoney Creek a Reconstruction c.1830, Jan. 2007, pg. 30.

In 2007, the restoration and creation of the Dunington-Grubb landscape at the base of the monument had not been completed as well it is suspected that it had not been envisioned at that point. Accordingly the 2007 analysis proposed the relocation of the historic barn to its original location south east of the Gage House and that the lost Gage Store be recreated as the third structure within the enclosed courtyard; thereby creating *additional opportunities to depict life at the Gage House in a complex context, with store and barn, fences, perhaps a blacksmith* (Murison, 2007, page 27). **Refer to Figure 3.**

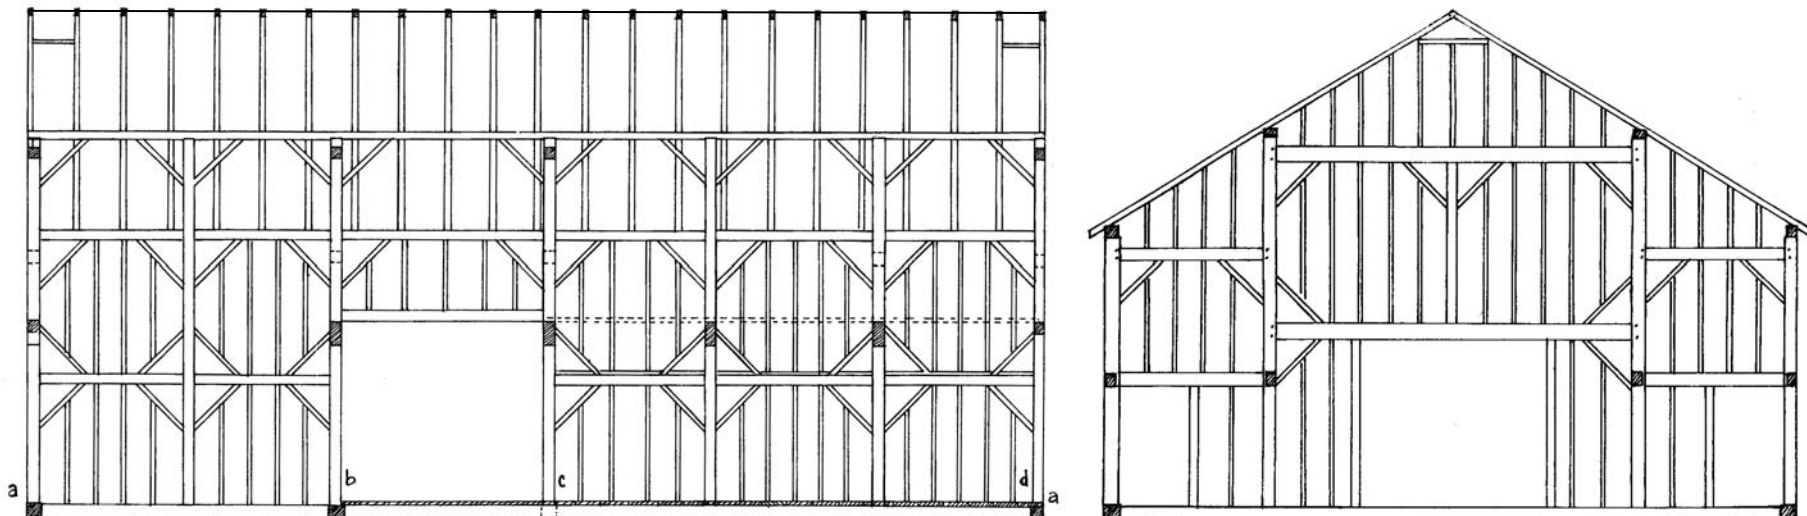
Figure 5: Typical Longitudinal Section (left) and Cross Section (right) of Horizontal Sided Barn
Credit: Arthur, Eric, *The Barn: A Vanishing Landmark in North American*, 1972, pg. 238,239.

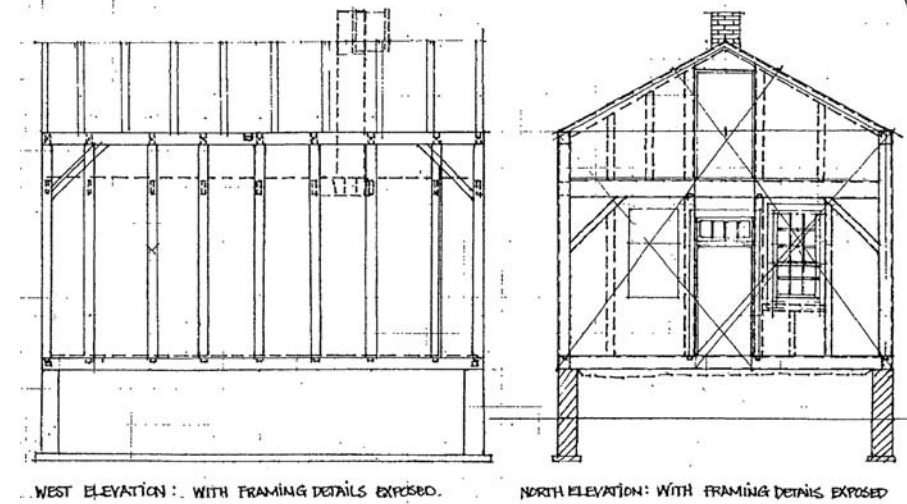
Figure 7: Construction Section details of older portion of J.Gage Store
Battlefield Park Stoney Creek a Reconstruction c.1830, Jan. 2007, pg. 25.

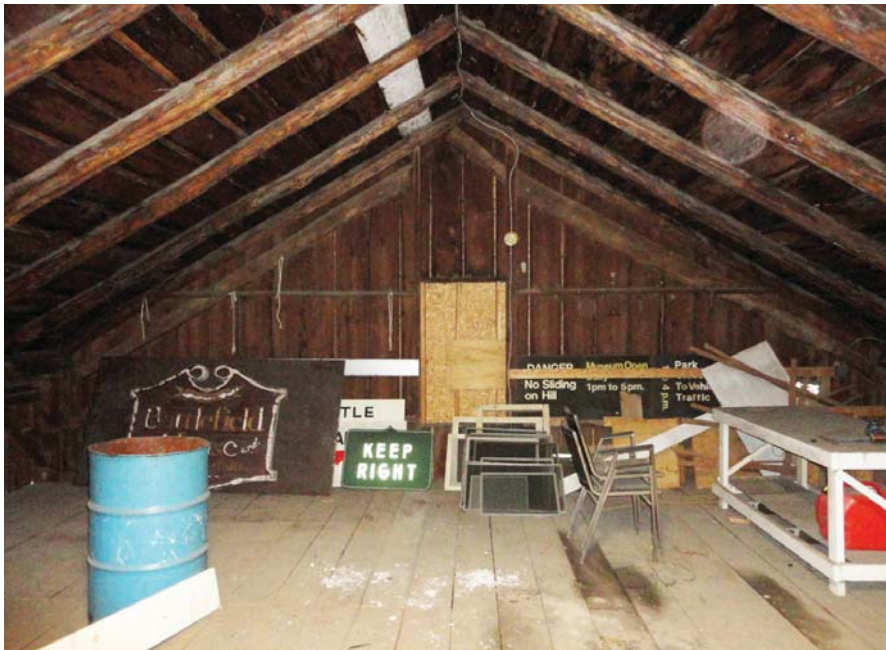
Figure 12: Attic looking North
Credit: SBA, 2015.

The approximate overall dimensions of the timber framed barn are 26'-5" wide by 36'-3" long by 13' high to the peak of the asphalt shingled gable roof. The original vertical boards, as noted earlier, can be seen from the attic, **(Refer to Figures 12 and 13)** and appear to have been clad in painted waferboard with vertical battens. The West Elevation has two overhead metal garage doors and a single metal man door. On the south gable an opening for a previous door within the Staff Room has been infilled with plywood and painted to match the remaining exterior. The east elevation is similarly clad however it is adorned with a Barn Quilt* which is signed by the Women's Art Institute of Hamilton.

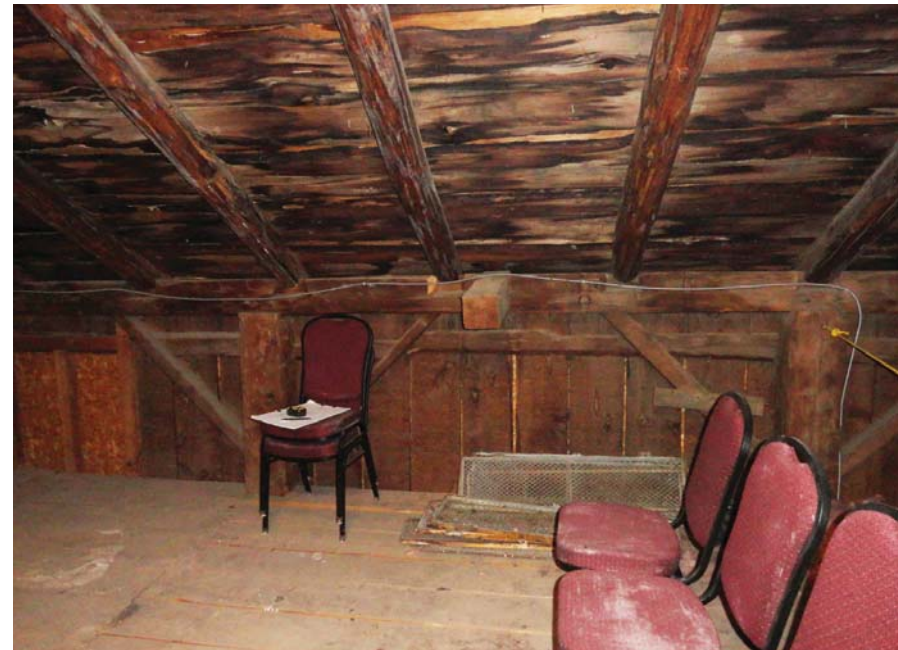
Figure 13: Attic looking East
Credit: SBA, 2015.

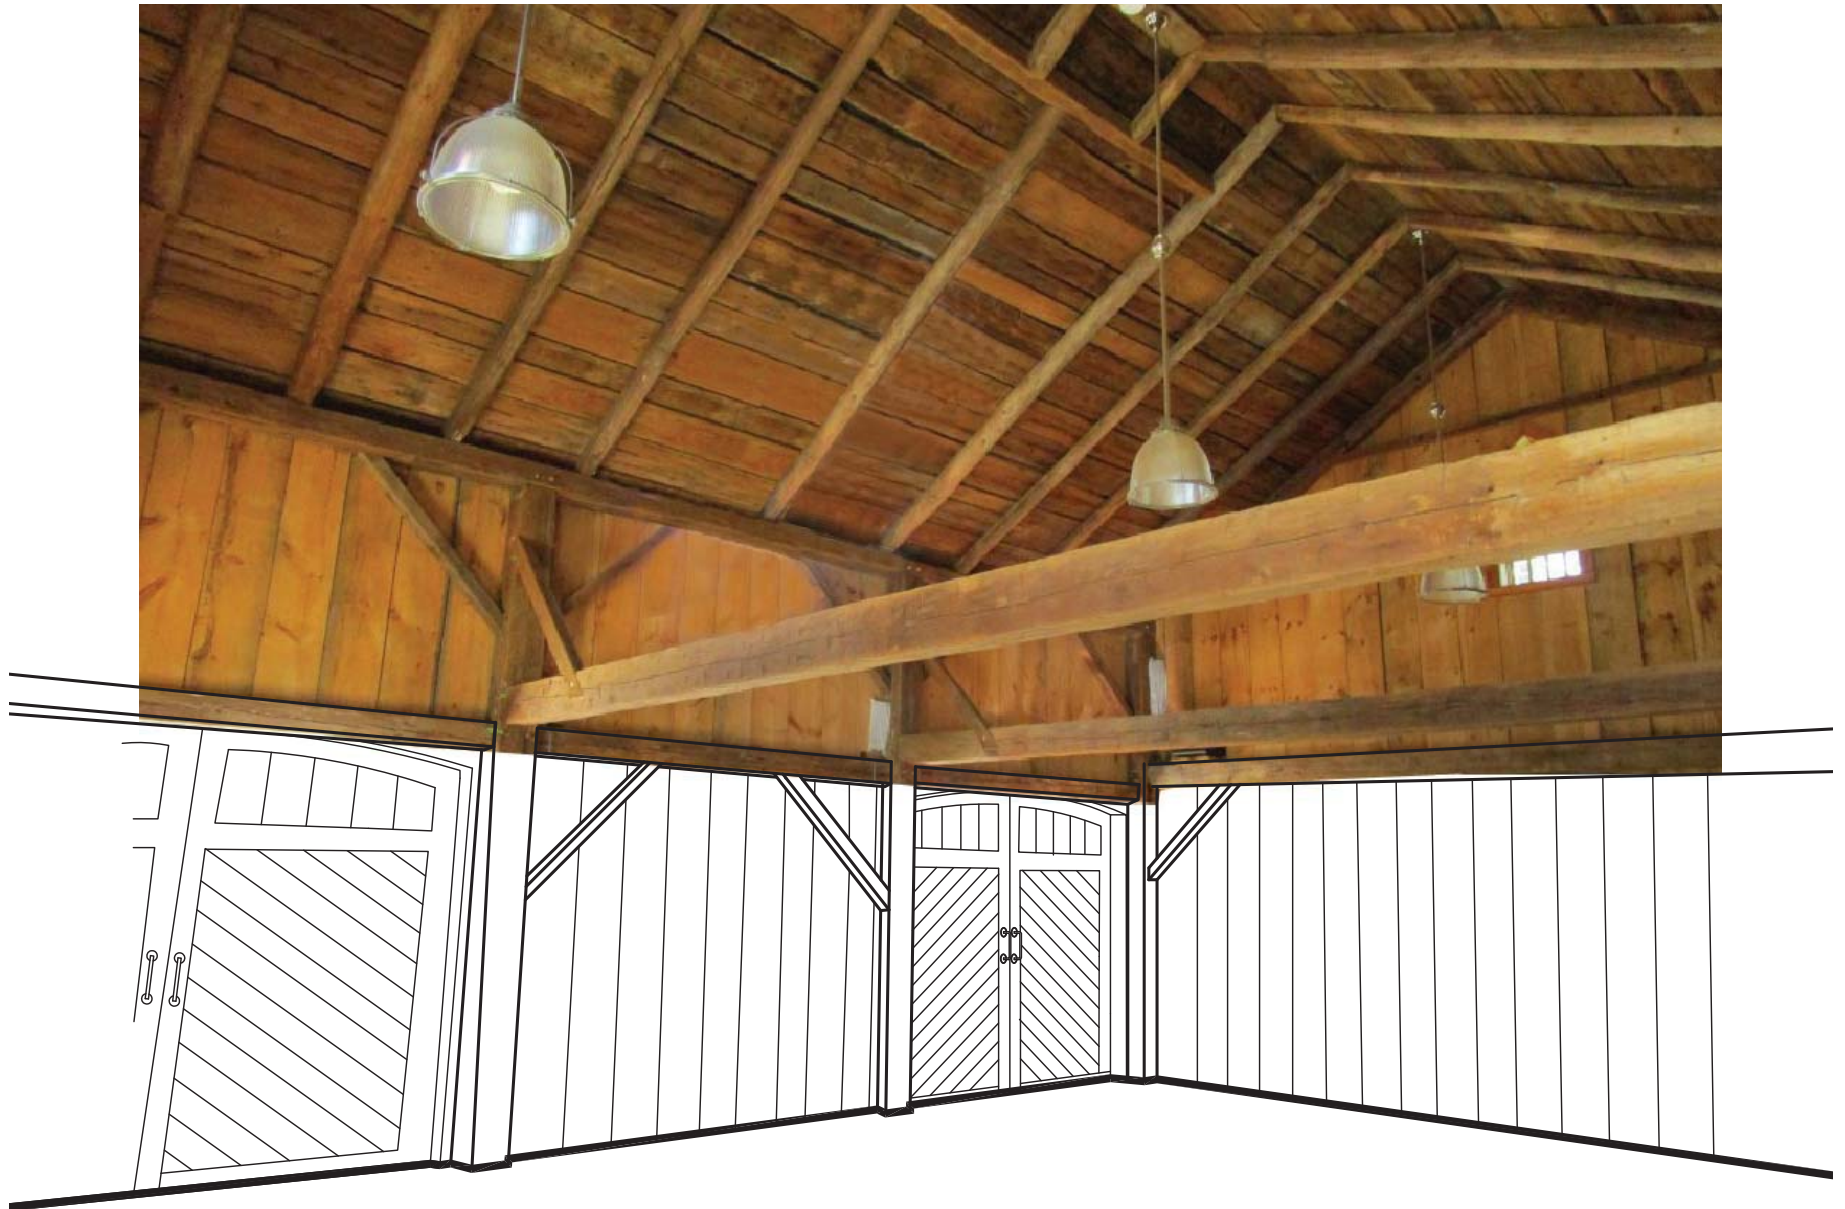
Figure 23: Interior of Exposed Timber Framed Barn
Credit: Mark Shoalts, 2016, Annotated by SBA 2016

There has been some discussion regarding the present openings framed within the gable ends. Both at one point may have been windows, though the one at the south end has been reframed at some point into a door. Though it is not believed that they are original, the thoughts are to include for new wood windows within the existing openings, in keeping with a simple barn, in order to address natural light into the barn and minimize the need for artificial lighting. **Figure 23** illustrates the concept of removing the existing, non-original ceiling, walls and stairs and exposing the original timber framing within a simple one storey space.

As discussed within Options 1 and 2 the barn will be moved or lifted within Option 3. All three options will require a new reinforced slab on grade foundation and the reinstatement of the previously lost timber sill plates. The option for the inclusion of a stone curb and new timber floor has been costed for all options. The intention is that the barn will primarily remain a three season structure with allocated allowances to address electrical and heating requirements.

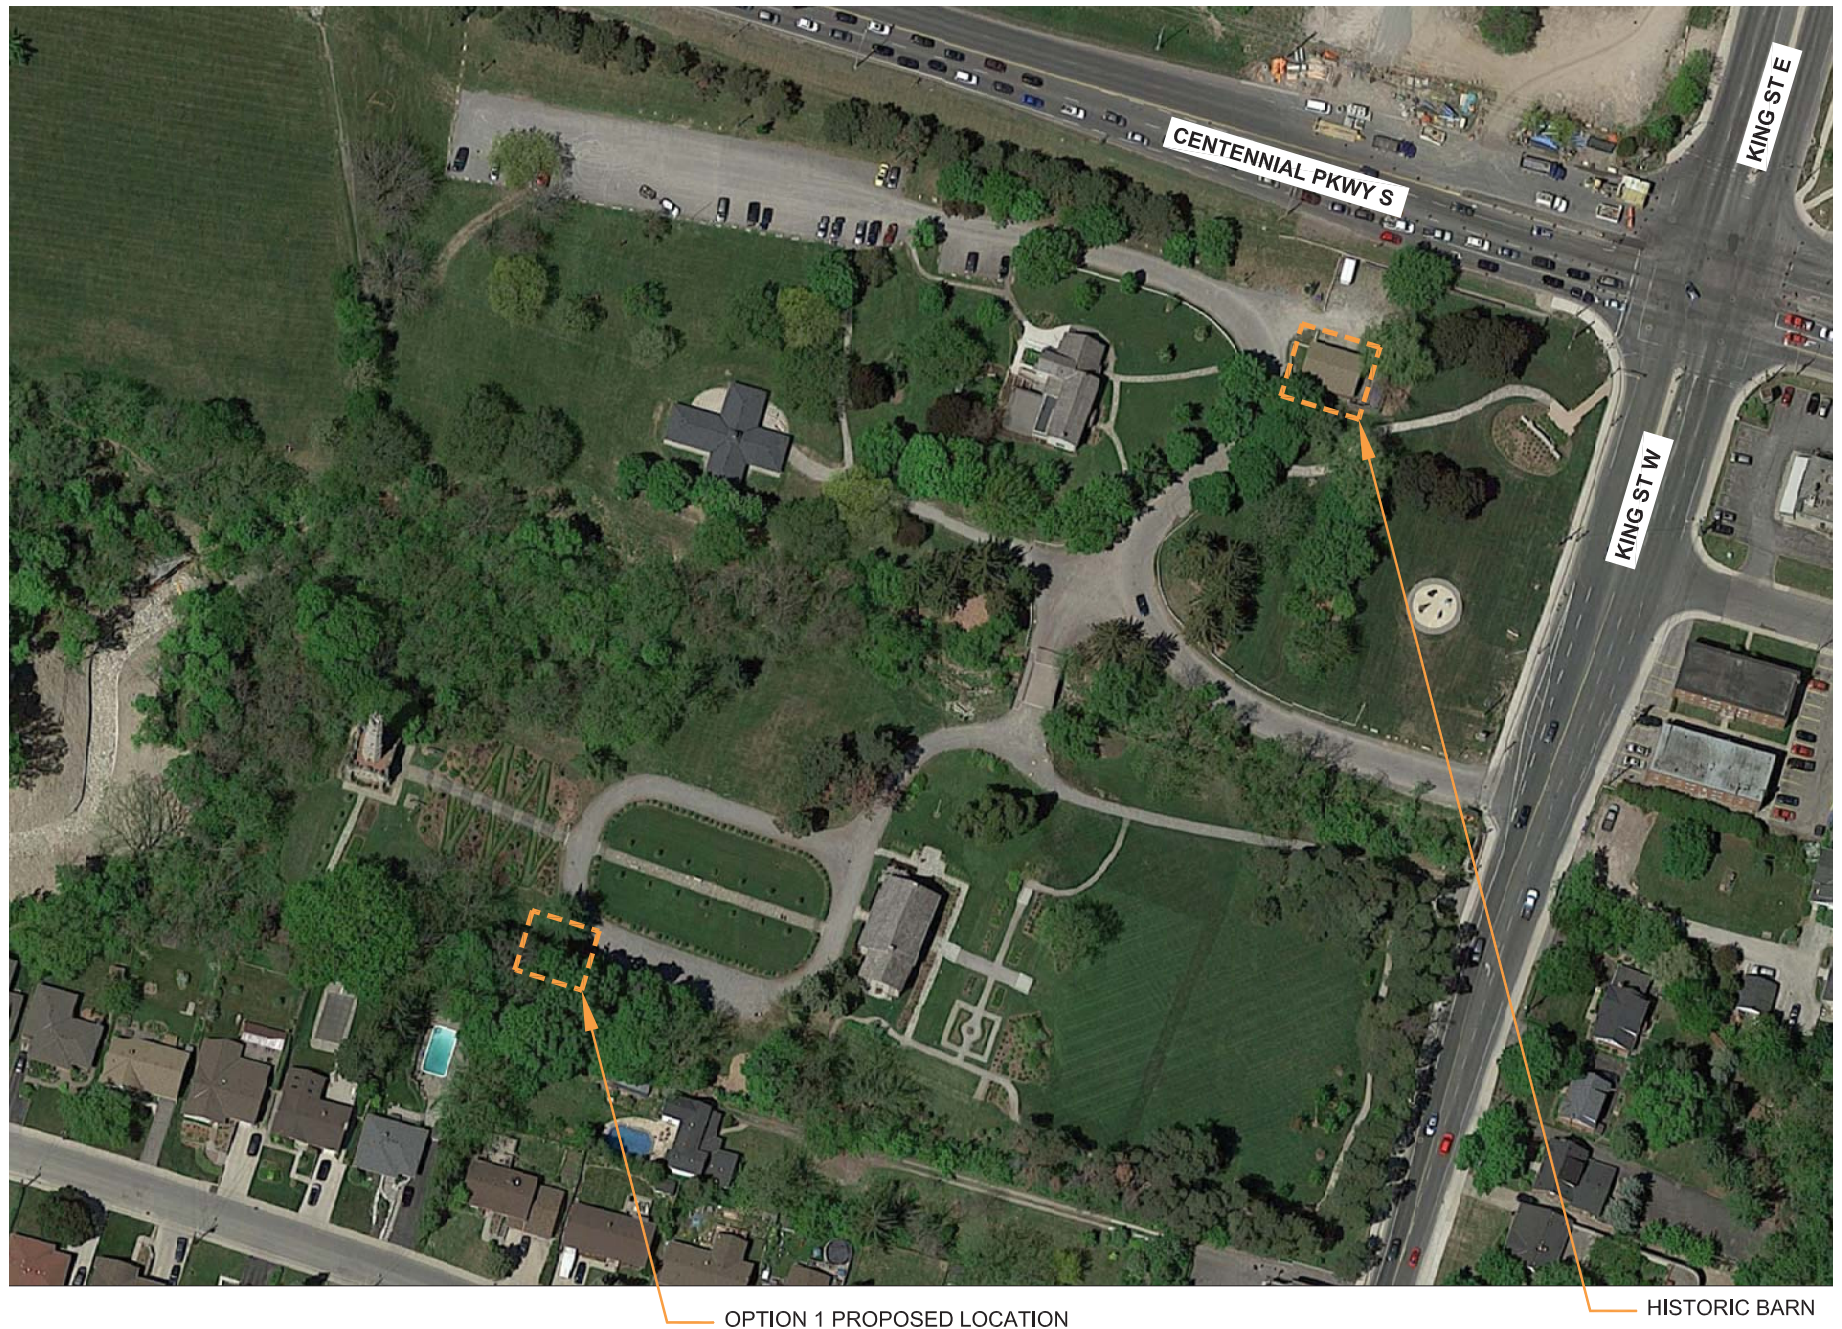
Figure 24: Option 1: Proposed Relocation of Barn as per 2007 Reconstruction Report
Credit: Google Maps, 2015, SBA Annotations, 2016.

Moving the existing barn would also be a structural challenge because of the loss of the original timber sill plates. The plates would have to be replaced in situ before moving the barn, or temporary plates and ties would be required. Temporary works tend to leave permanent scars on a building and should be avoided (timbers must be bolted to the existing posts to permit lifting of the building and to prevent spreading of the frame). Moving the barn should be considered as a last resort in order to save it, not as a desirable part of restoring it. Accordingly the proposed barn relocation would be questionable.

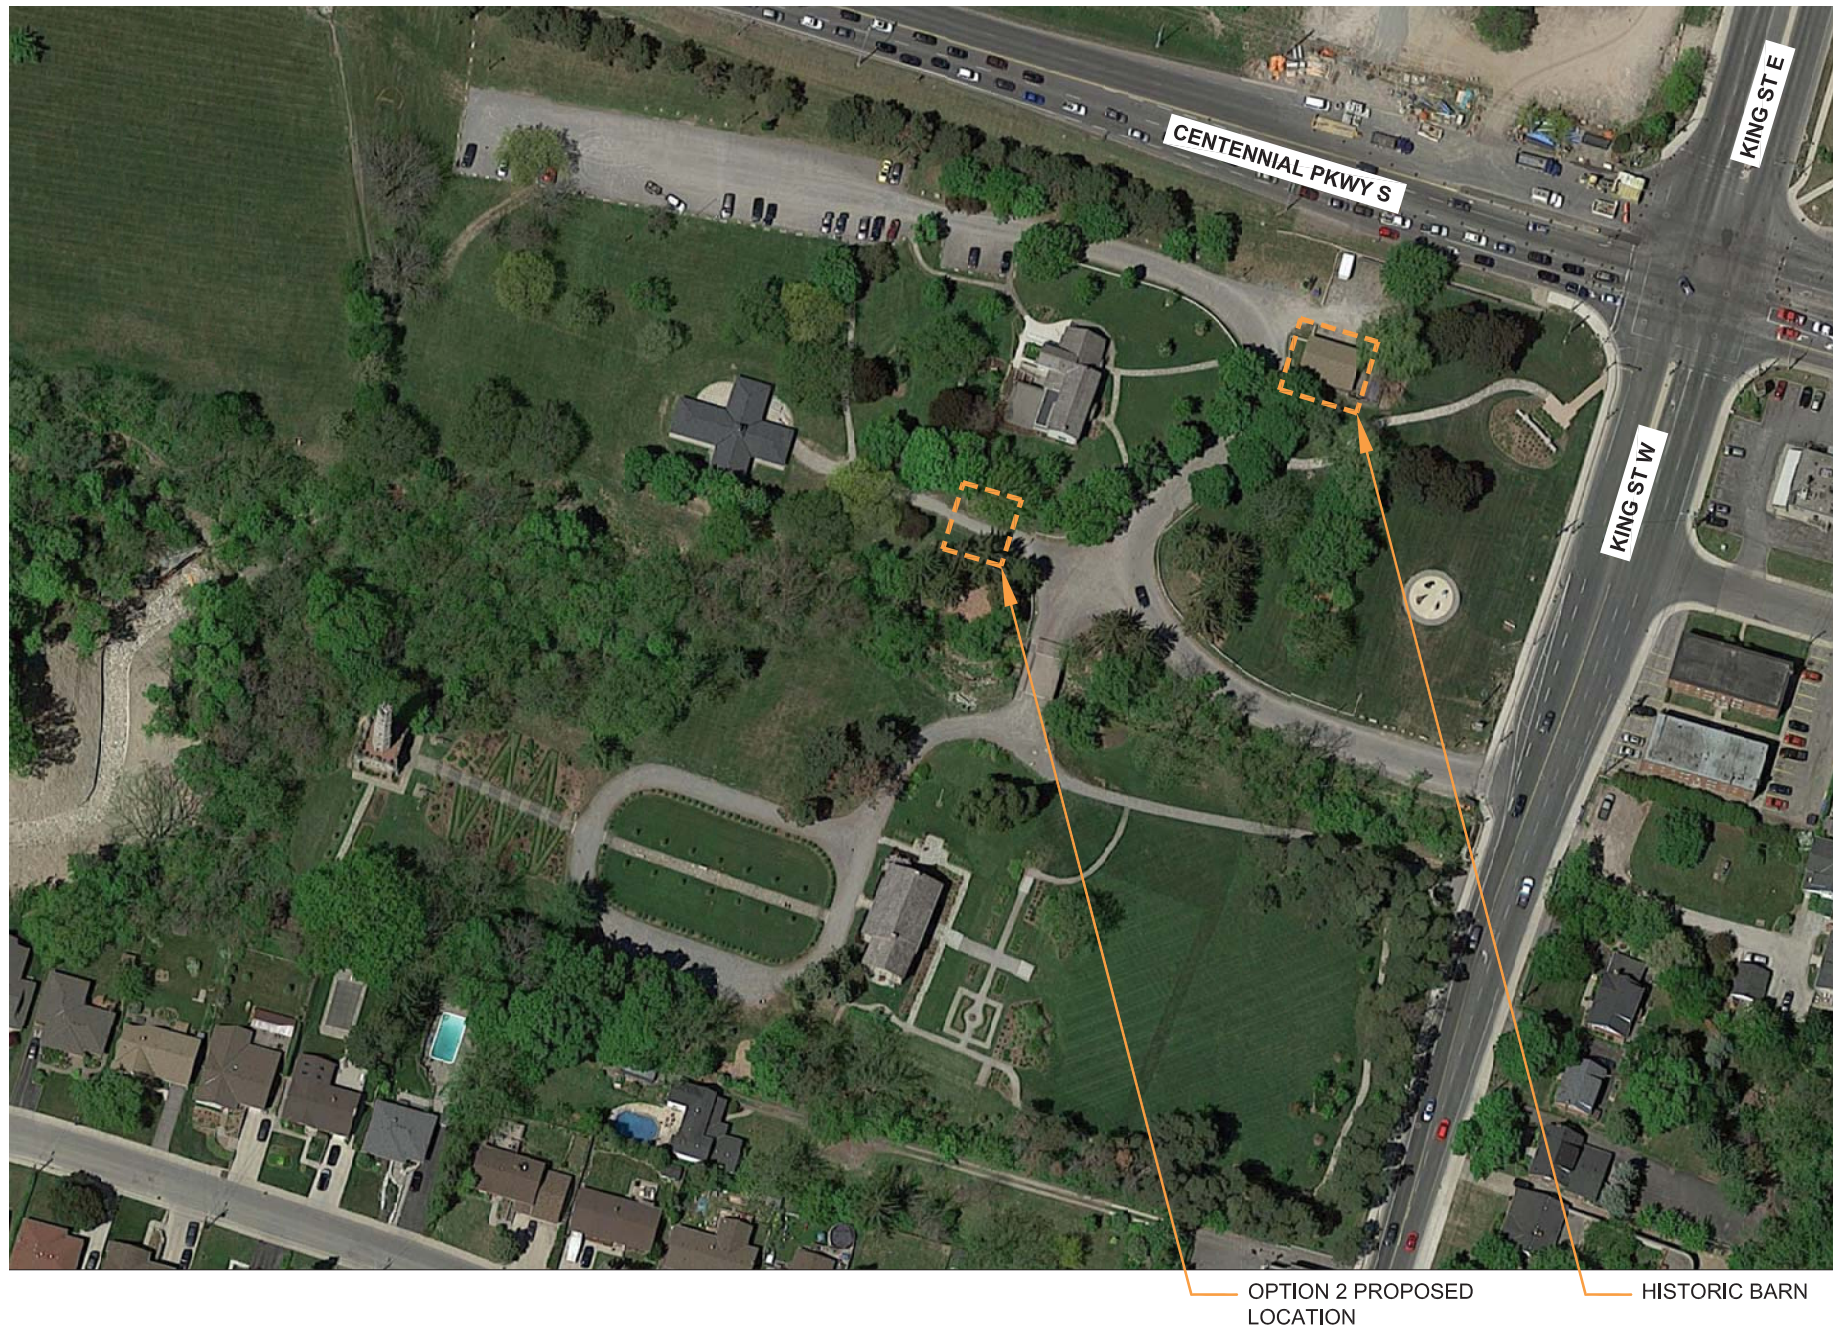
Figure 25: Option 2: Proposed Relocation of Barn as per 2011 Master Plan
Credit: Google Maps, 2015, SBA Annotations, 2016.

As noted in Option 1, moving the existing barn would also be a structural challenge because of the loss of the original timber sill plates. The plates would have to be replaced in situ before moving the barn, or temporary plates and ties would be required. Temporary works tend to leave permanent scars on a building and should be avoided (timbers must be bolted to the existing posts to permit lifting of the building and to prevent spreading of the frame). Moving the barn should be considered as a last resort in order to save it, not as a desirable part of restoring it. Accordingly the proposed barn relocation would be questionable.

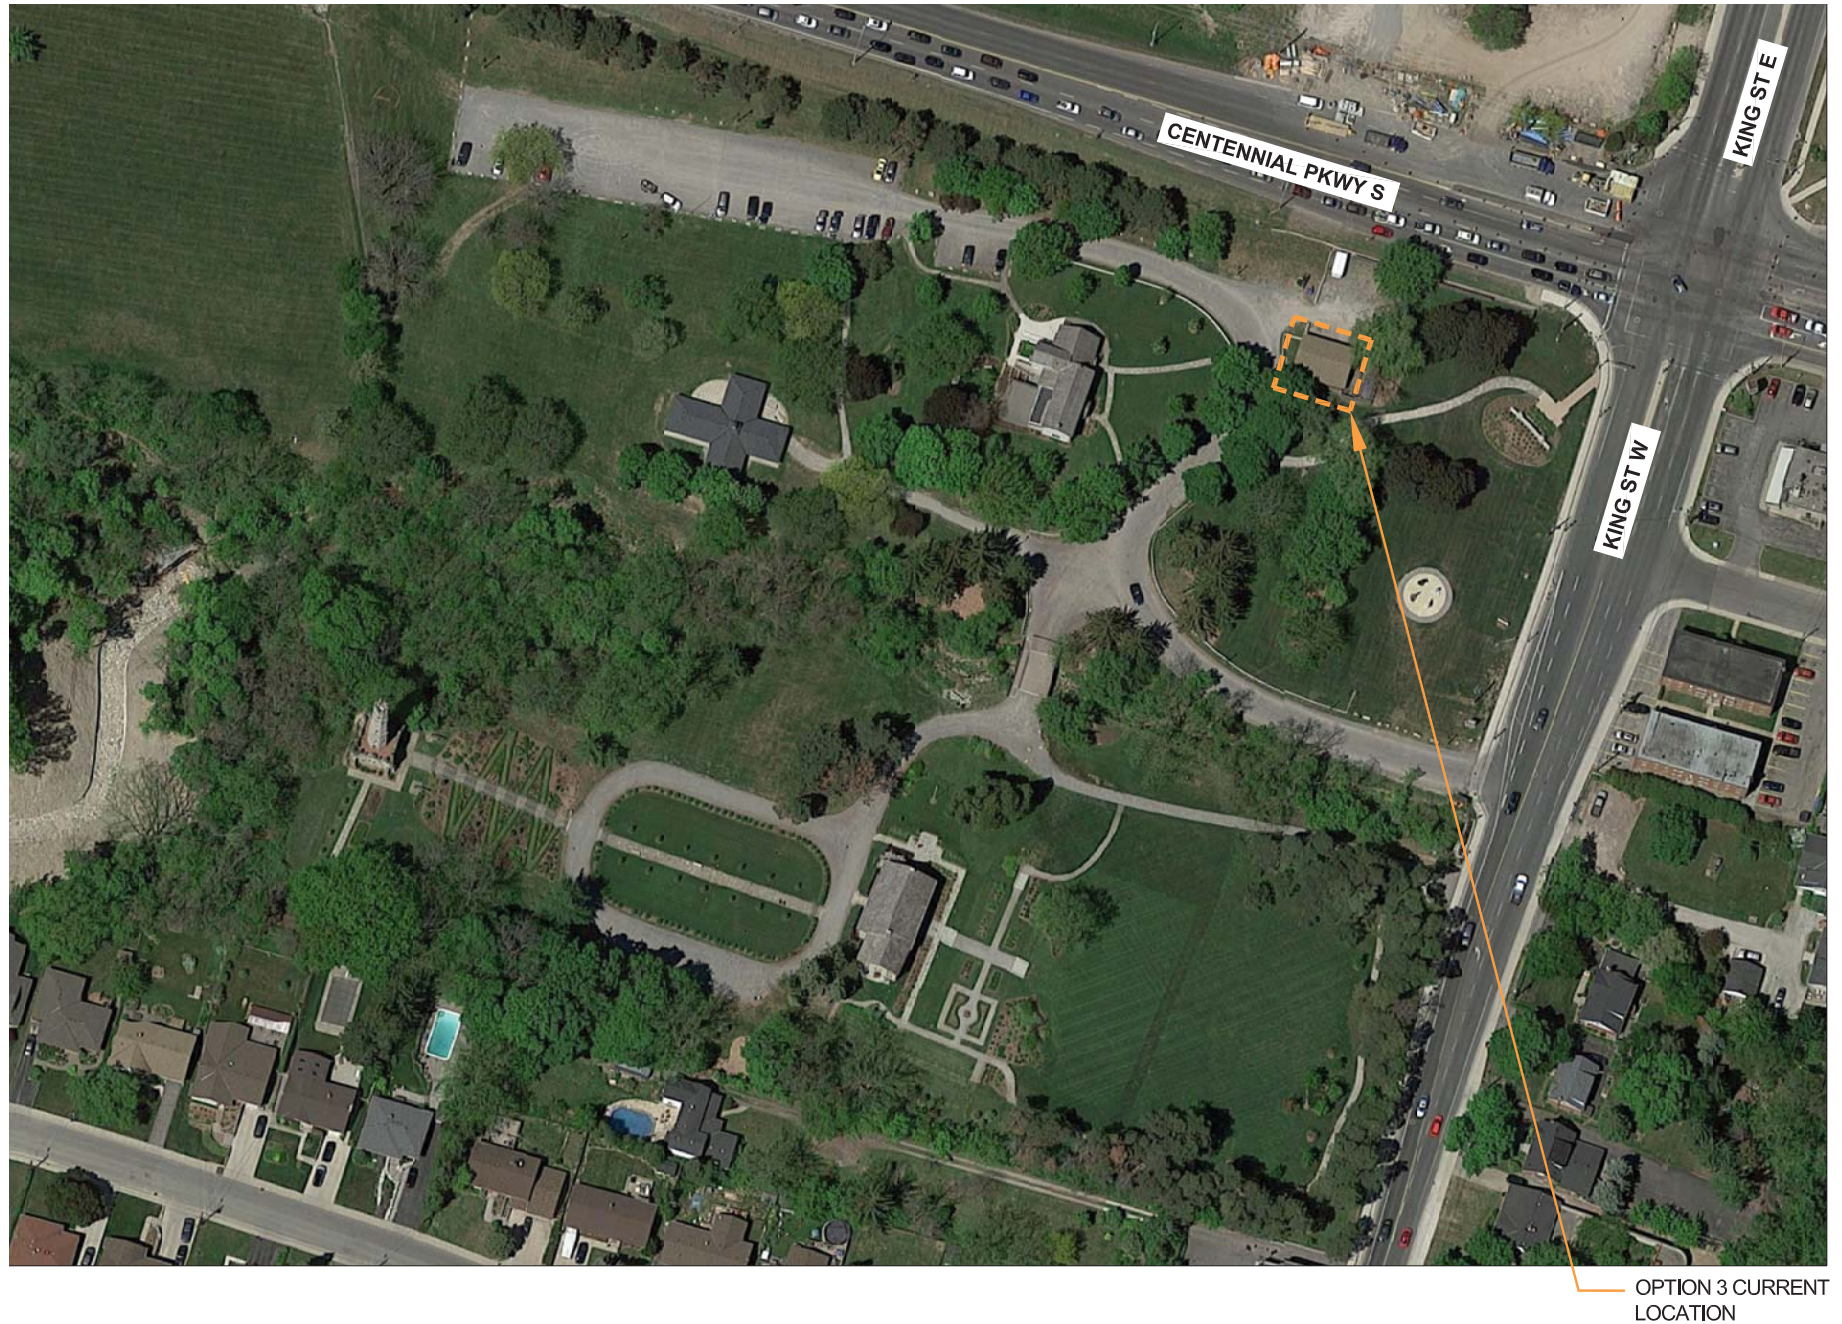
Figure 26: Option 3: Restoration of Barn in-situ
Credit: Google Maps, 2015, SBA Annotations, 2016.

As compared to the proposed relocation of the barn within Options 1 and 2 this option is desirable from the viewpoint of the building because there would be less stress on it and less potential for damage to the frame. Replacing the sill and either replacing the original wood floor or pouring a complete reinforced concrete floating slab are relatively easy to accomplish without moving the building. The building should be stripped down to only the materials to be retained prior to lifting. Cribbing and steel beams are required to lift the building straight up; the nature of a timber frame permits it to be supported at the loft level and the posts can hang below to be repaired before the sill is replaced. (Sill, plate, bottom plate, sill beam, and others are all used and are interchangeable terms). The tie beam between the top plates at the approximate centre of the building should be replaced after the building is sitting on its new foundation, however, it should be temporarily replaced with a nylon strap until that time to prevent splaying of the walls during the repairs.

The concerns, identified within both Options 1 and 2, regarding the structural implications required to move the structure given that the structure presently has no sill plates, was not robustly constructed and the siting of the barn would not be applicable within this option. The barn would remain in its present location. Accordingly the proposed restoration of the barn in-situ is desirable.

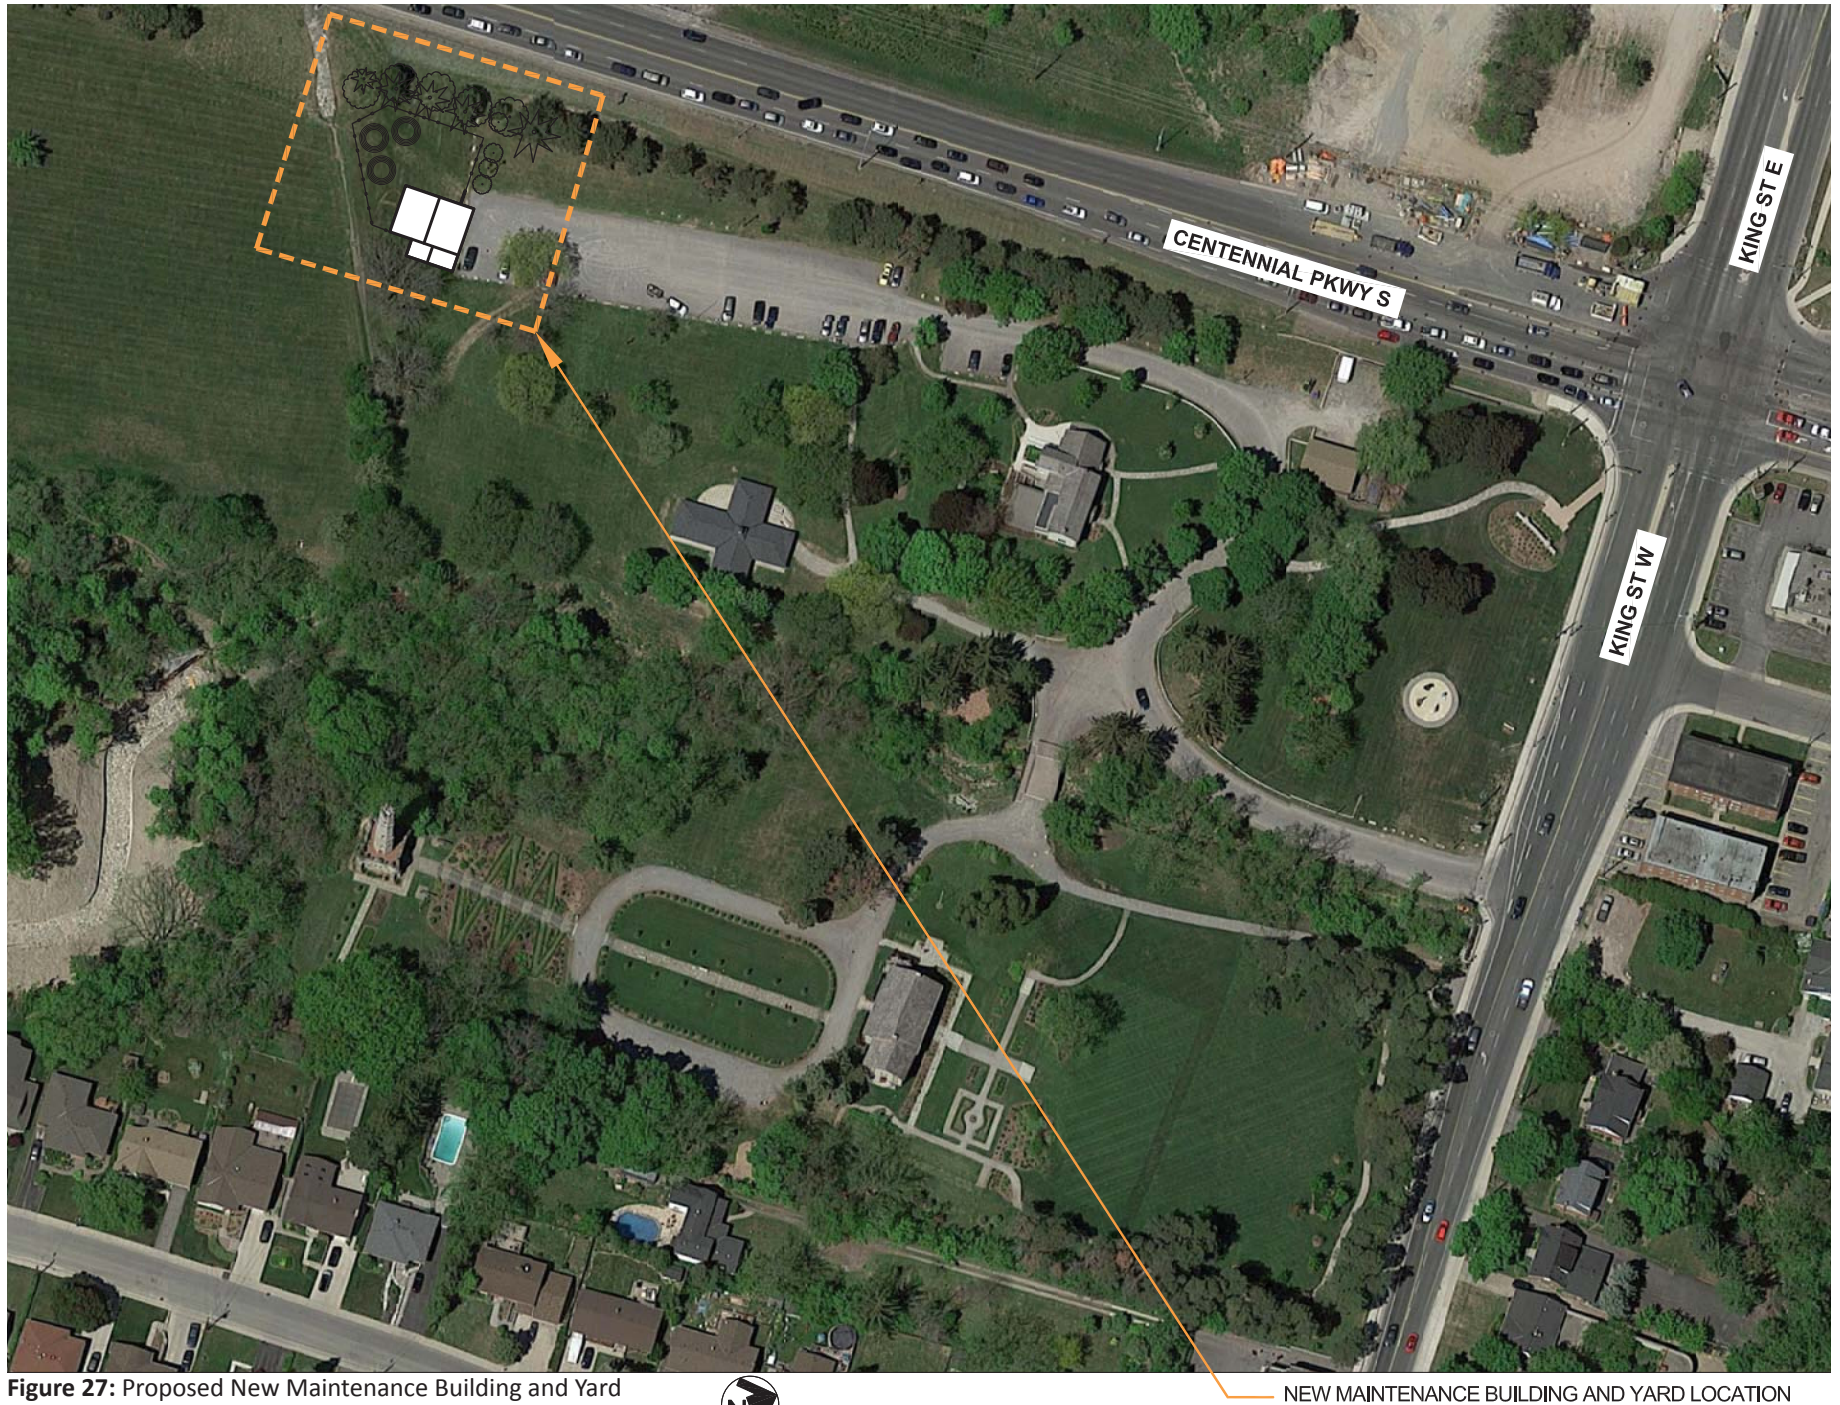
Figure 27: Proposed New Maintenance Building and Yard
Credit: Google Maps, 2015, SBA Annotations, 2016.

The concept is to break down the massing of the new wood framed facility into two elements/volumes according to their functional and spatial requirements. The staff facilities are proposed to be located along the east side within a smaller heated and air conditioned volume, complete with a single unisex washroom and staff lockers, in order to provide additional staff visibility of the site as well as take advantage of this smaller scaled element facing the park.

The unheated storage garage complete with 2 overhead doors is located in the larger volume along the west side and accessed directly through a locked gate and within the fenced in storage yard. Bulk exterior storage, inclusive of topsoil, mulch and bark, is easily accessible along the southern edge and may require additional consideration of the fencing and screening required along this side. A large roof overhang along the south roofline is proposed to address the need for covered storage and is envisioned as an area for the Museum's storage of pine poles and miscellaneous materials used for events.

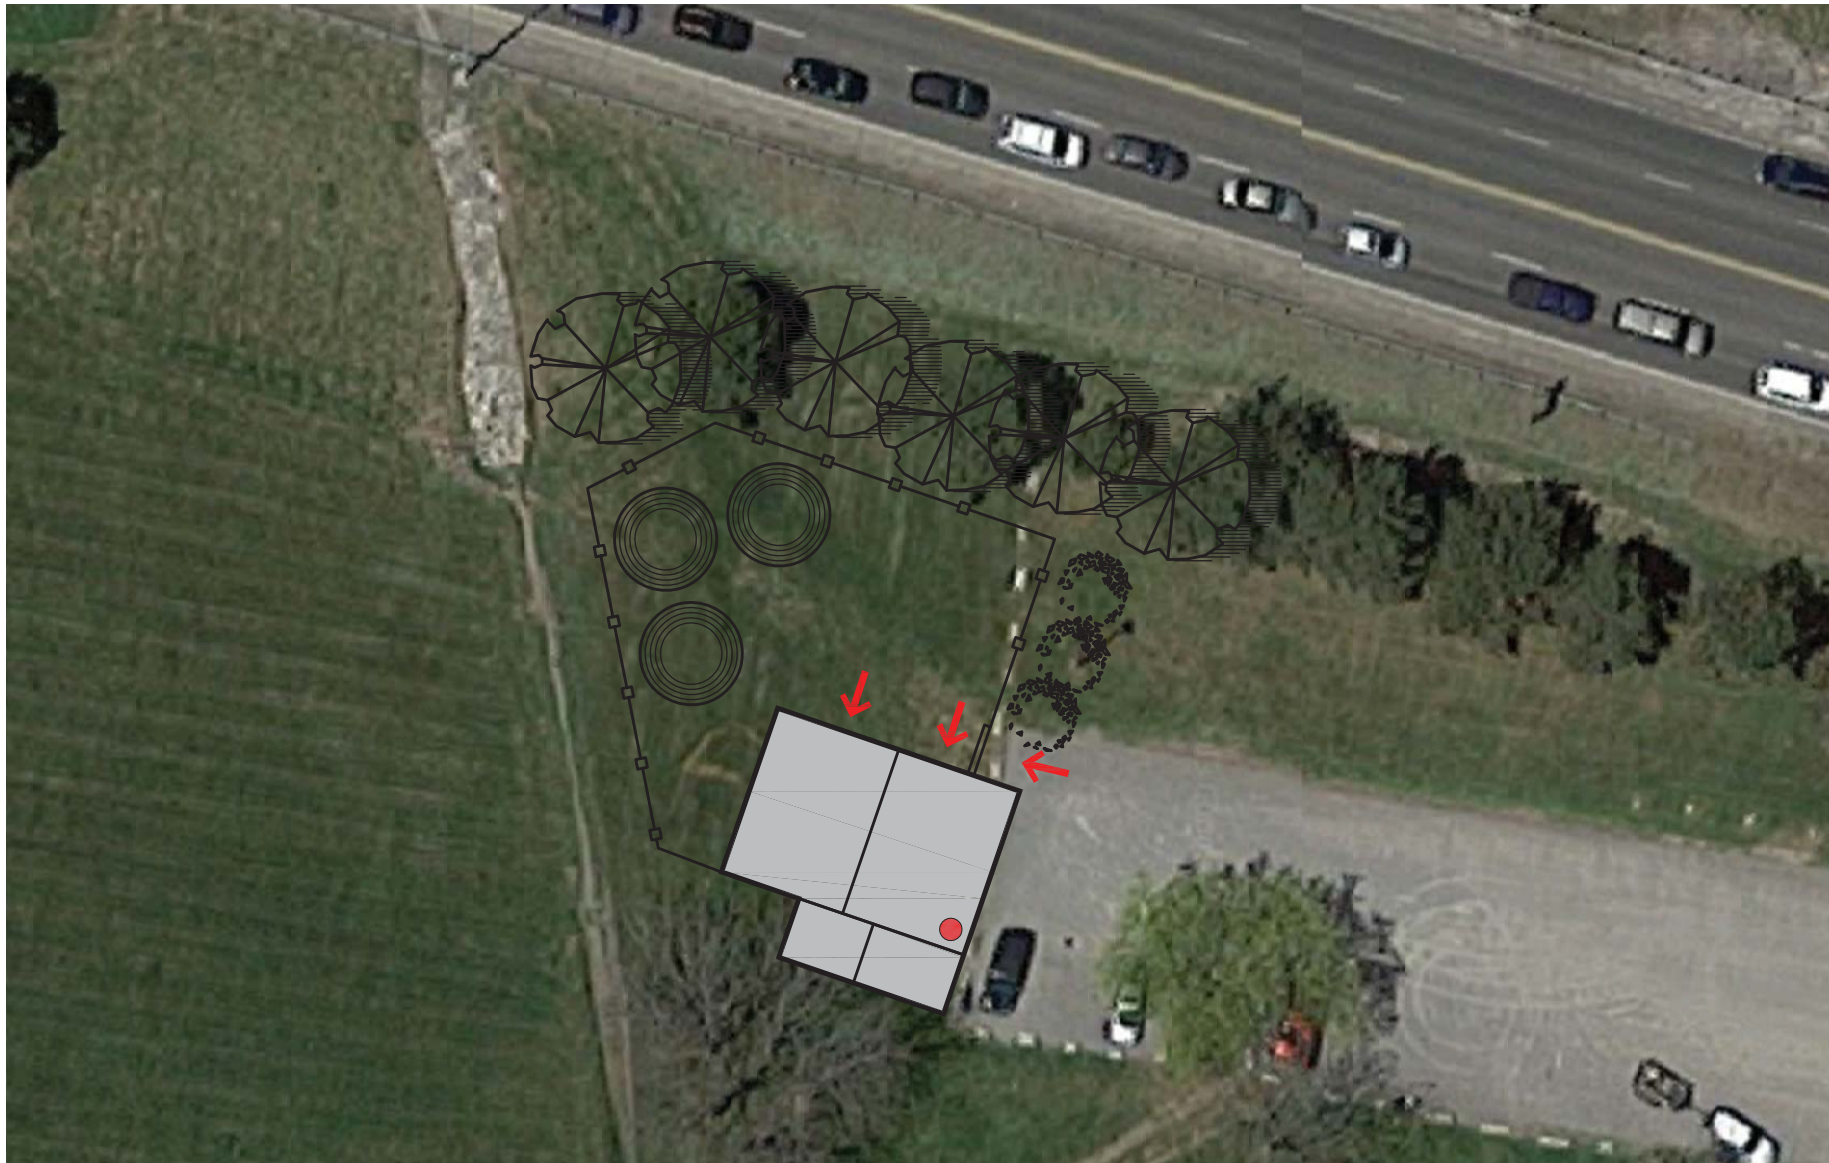
Figure 28: Proposed New Maintenance Building and Yard Site Plan (Not to Scale)
Credit: Google Maps, 2015, SBA Annotations, 2016.
