RE: UHOPA-20-012 and ZAC20-016
1107 Main Street West, Hamilton (Ward) 1
Objections to three-level underground parking garage
Inconsistency with PPS and lack of conformity to Growth Plan GGH and UHOP
Chedoke Creek Valley System subwatershed and the detrimental impact on
neighbouring residences and properties, and the forested slope of the CCVS

We, the undersigned residents in the immediate vicinity of the subject site, strongly object to the proposed development. Although there are many valid reasons for requesting that the two above captioned applications be denied, the specific concerns raised in this objection letter relate to the three-level underground parking garage and the detrimental impact that it will have on the neighbouring properties, the Chedoke Creek Valley System subwatershed, and the forested slope that separates the residences from the general open space and Provincial Highway 403.

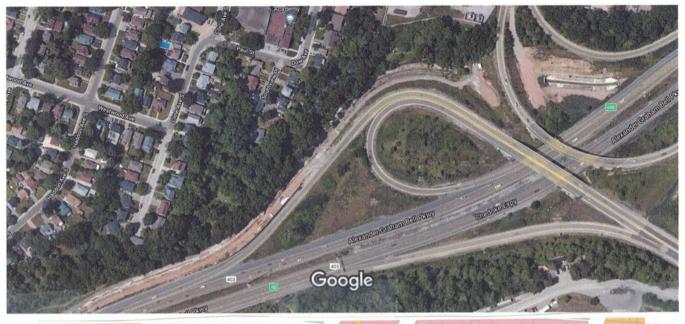
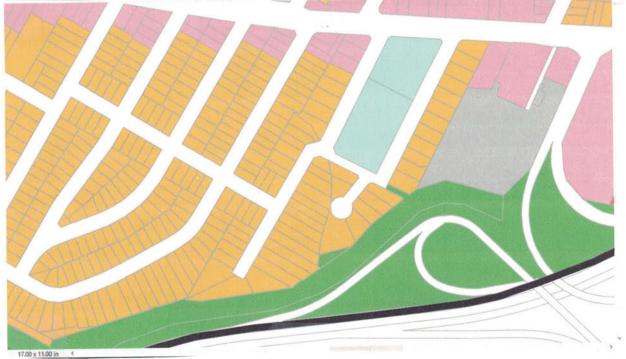
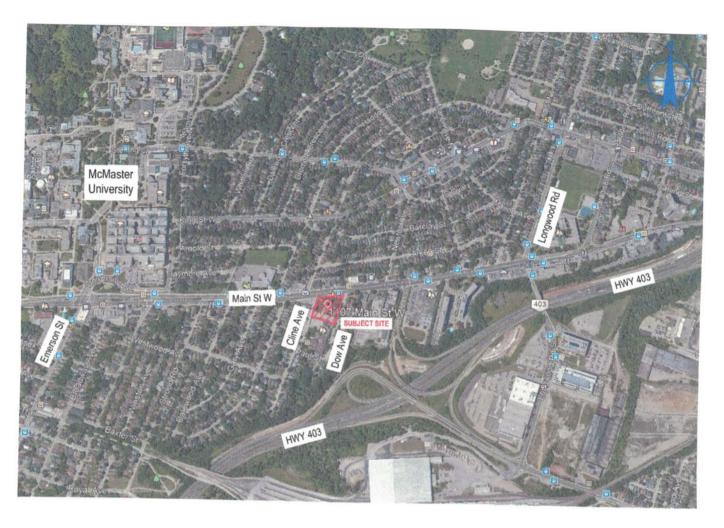
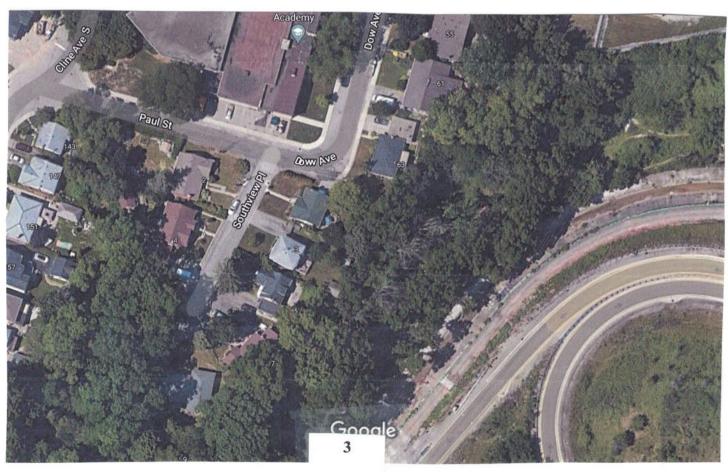
The description of these lands lying to the south, in comparison to the lands to the east, west and north of the subject site, can be visually appreciated in the following maps and pictures:

- 3) Google Satellite Map with Hwy 403;
- 4) Google Satellite May with close-up of the forest canopy on Dow Avenue, Southview Place and Cline Avenue South;
- 5) Map CH-9: Chedoke East Catchment of the Chedoke Creek Subwatershed as prepared by Hamilton Conservation Authority.

From these maps one can ascertain the valuable role the forested canopy of these lands has in the aesthetic beauty of the neighbourhood. But most importantly this natural landscape feature serves as a barrier in three distinct capacities, a visual barrier blocking the view of Hwy 403 from the neighbourhood, a noise barrier reducing the noise and decibel levels from the truck and motor vehicle traffic on Hwy 403, and; an air pollution abatement barrier absorbing by deposition some of the harmful vehicle emissions from Hwy 403.

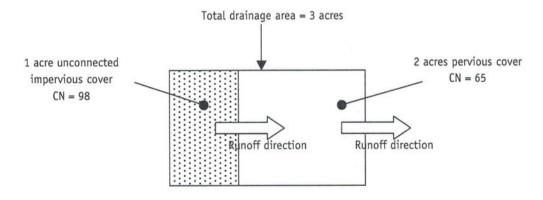
Pervious cover = mixture of lawn and woods pervious CN = 65 Impervious cover = asphalt impervious CN = 98

Note: All impervious area runoff sheet flows onto downstream pervious area

Impervious area S =
$$\frac{1000}{CN}$$
 - 10 = $\frac{1000}{98}$ - 10 = 0.20 inches

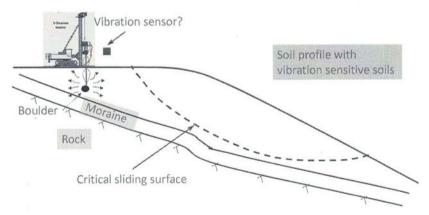
Figure 14. Vibratory sheet pile installation next to slope with vibration sensitive material. When the sheet pile hit strong materials like moraine or a boulder, vibrations in the soil can be become large. Driving-stop criteria can help avoiding large vibrations.

We have not been able to find examples in the literature about slope failures or landslides caused by sheet pile installation. However, vibratory sheet pile installation do induce large vibrations that cause settlements in sand, and can cause damage to buildings close to the installation locations (see e.g. [40], [41], [37]). This indicates that vibratory sheet pile installation can cause failure in vibration sensitive soils. Therefore, one should plan carefully for installation of sheet piles in the vicinity of slopes with vibration sensitive materials as shown in Figure 14.

When the sheet pile is driven through quick clay material very little driving force is necessary to install the pile and thus induced vibrations are not very large. The fact that quick clay loses its strength also means it cannot transfer stresses and vibrations in to the surrounding soil. On the other hand, when the sheet pile hits strong materials such as moraine or a boulder outside or beneath the quick clay, the induced vibrations in the

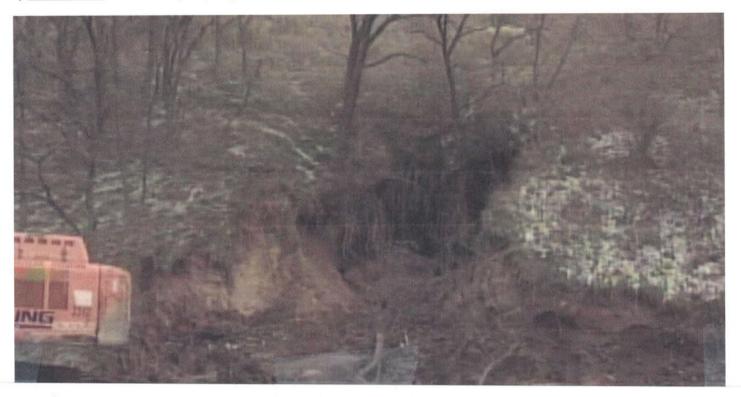
Work and delays continue after Hamilton 403 landslide

Crews were still working Saturday to repair the damage caused by a massive landslide Friday onto highway 403, triggered by a watermain break. It sent caused trees, mud and water sliding onto the highway just below York Boulevard, causing gridlock and chaos on Hamilton roads.

The 403 was closed for more than 10 hours and alternate routes were jammed. Saturday York Boulevard was still closed because of concerns the slope could collapse. City crews spent hours inspecting the hillside where the break happened.
