HAMILTON MUNICIPAL HERITAGE COMMITTEE ADDENDUM

Meeting #: 18-005
Date: May 10, 2018
Time: 12:00 p.m.
Location: Room 264, 2nd Floor, City Hall
71 Main Street West

BUILT HERITAGE INVENTORY FORM

Address 6 Webster's Falls Road, Flamborough Community Bullock's Corners
 Also known as Springdale Legal Description CON 1 PT LOT 11 FW FLM
 P.I.N. 174860146 Roll No. 251830216001600 Ward 14 Neighbourhood Bullock's Corners / Greensville

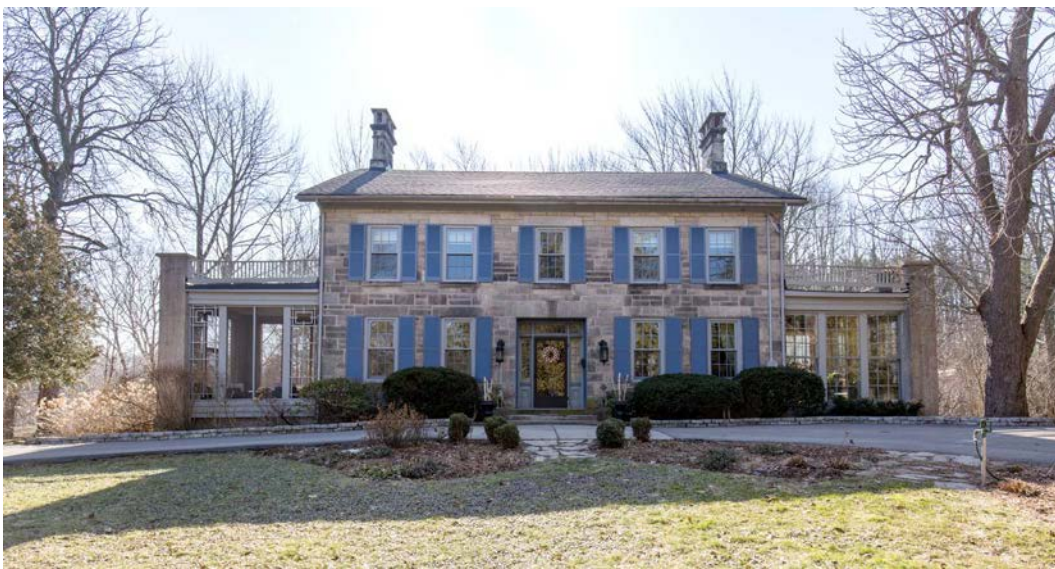
Figure 1: Front Facade of 6 Websters Falls Rd (Woolcott Realty, 2018)

The property comprises a large stone dwelling built in the ‘Wilderness Georgian’ style, with estimated construction dates ranging from circa 1810 to 1850. The property is currently listed in the City of Hamilton’s Inventory of Buildings of Architectural and/or Historical Interest, but is not designated under Part IV or V of the *Ontario Heritage Act*, and is not listed on the City of Hamilton’s Register of Property of Cultural Heritage Value or Interest. This report provides a preliminary evaluation of the dwelling using Ontario Regulation 9/06 – Criteria for Determining Cultural Heritage Value or Interest as outlined in the *Ontario Heritage Act*.

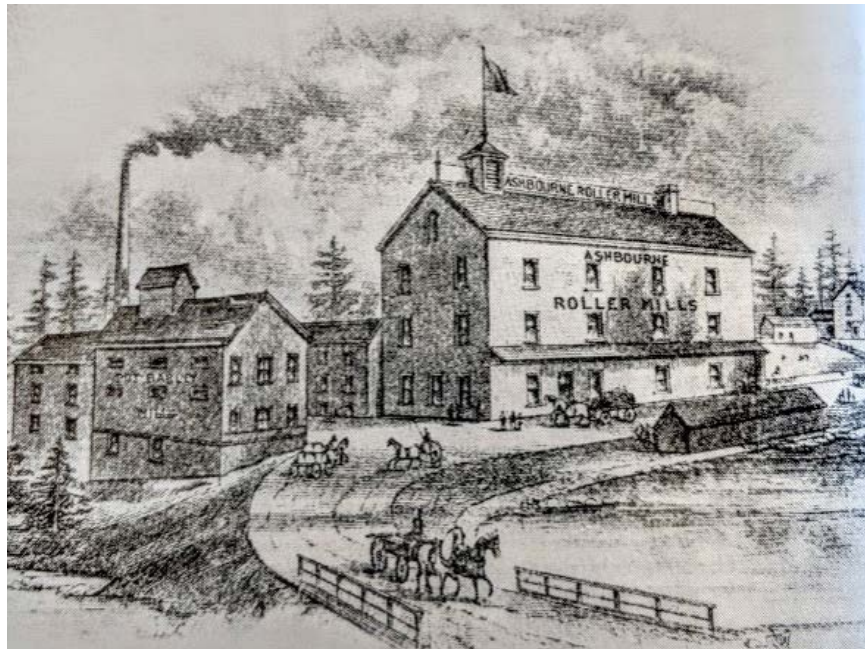
Figure 3: Illustration of Ashbourne Mills (Township of West Flamborough Centennial Celebration, 1850 - 1950)

Joseph Webster Jr. constructed a grist mill and rebuilt the distillery on the property soon after acquiring them from his father, calling it the “Ashbourne Grist Mills”. Webster Jr. added to the complex in 1842, adding a flour mill, barley mill, and oatmeal mill. Another addition followed in 1855 when a mill for cotton batting production and a cooper shop making flour barrels were constructed. At the time, the Ashbourne Mill was one of the largest operating in Upper Canada. Webster’s mills, along with those of William Bullock (the eventual namesake of Bullock’s Corners) led to an influx of residents and the establishment of Bullock’s Corners as a bustling commercial centre.

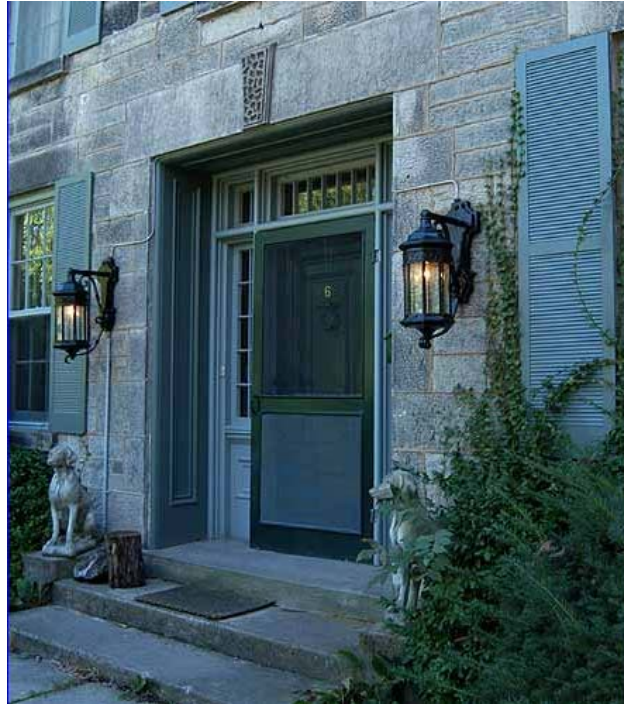
Figure 4: Front entrance to dwelling, showing transom, sidelights, lintel and quoins (Shannon Kyle, Ontario Architecture)

Local stone, presumably hand cut, makes up the front elevation while the rear and sides are composed of local rubble stone. This masonry style is known colloquially as a “Queen Anne Front, Mary Jane Back”, where the front’s luxe stone exudes wealth and power to visitors while the sides and rear, which they would never see, are comparatively quaint.

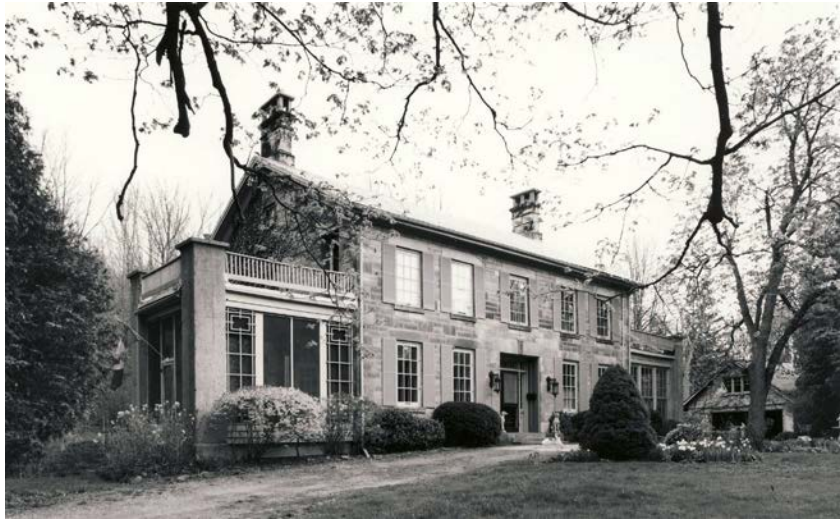
Figure 5: Front facade showing eastern addition (Flamborough Archives, 2002)

Identical additions, likely built in the early to mid-20th century, flank the east and west facades. The additions are each supported by what appears to be concrete pillars which complement the traditional style of the original dwelling. One addition serves as a sunroom, the other a screened in porch. A third addition at the rear, clad in light blue siding and built into the hill, connects to the western addition creating a lower third storey.

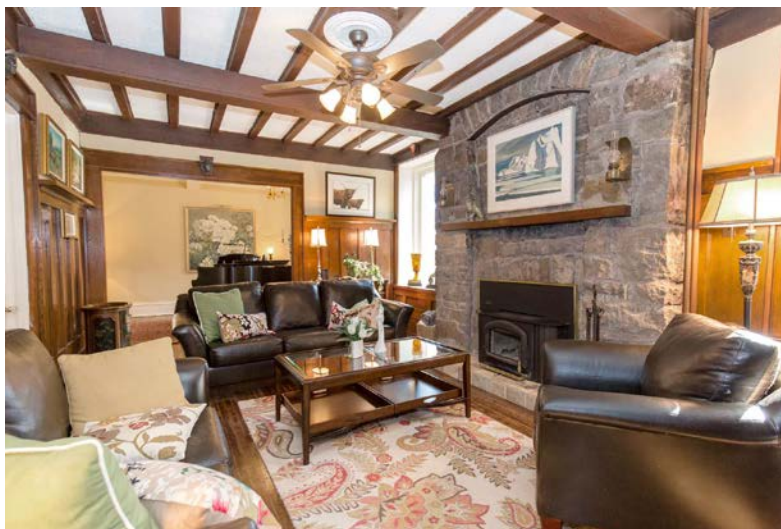
Figure 6: Sitting room, Stone fireplace, original wood floors, moulded wood panels visible (Woolcott Realty, 2018)

The interior of the dwelling is equally well maintained. Windows and doors feature elaborate moulding, reflecting the wealth of the original builder. Moulded recessed panels sit beneath the sitting room's windows, and a grand fireplace serves as a centre piece for both the sitting and dining rooms. Narrow plank maple hardwood runs through the home. The upstairs is less ornate, with plain baseboards and simple moulding, but still largely original. The basement features stone floors and moulded wood walls, and is almost church like in appearance. The beams throughout the house were likely added in the 1950s, but nonetheless suit the aesthetic of the home.
