City of Hamilton
AUDIT, FINANCE AND ADMINISTRATION COMMITTEE
AGENDA

8.1. Roads Value for Money Audit (AUD21006) (CityWide)

Roads Value for Money Audit

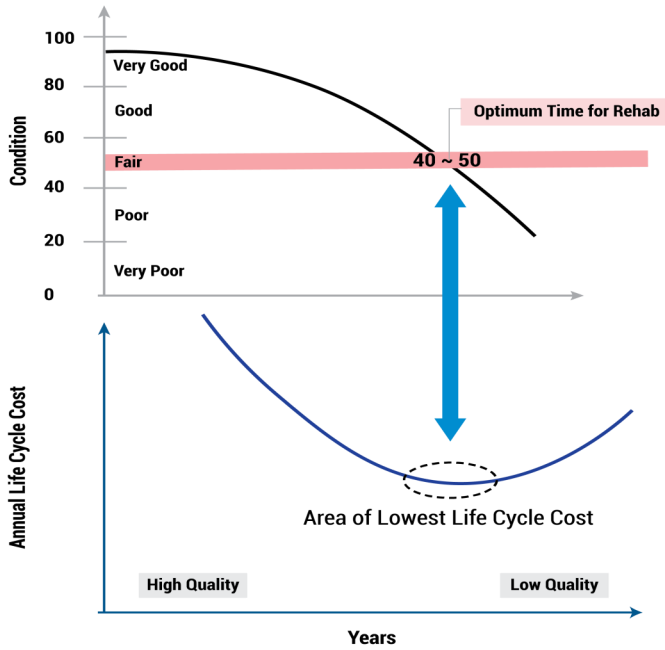
Box 1: The Concept of Optimizing to Lowest Life Cycle Cost

The first is identifying the deterioration point that is the optimum time for rehabilitation. This can be seen in the first diagram. Assume for illustrative purposes an optimum point in time for rehabilitation is identified through analysis and found to be when deterioration has reached a condition level of 45 (upper curve). This point will correspond to the point of lowest life cycle cost (lower curve). The reason an earlier rehabilitation is more costly is because the yield in pavement life is not as high. Later rehabilitation is more costly because beyond the optimal point deterioration results in more expensive repair.

Source: Washington State Department of Transportation.

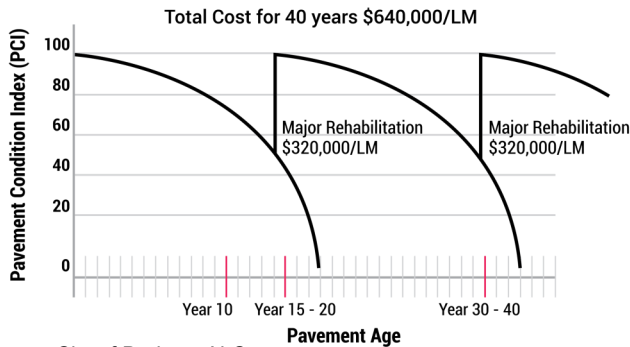
The second idea involves the use of preservation management. With no preservation management (second diagram) the roadway is allowed to deteriorate to condition level 45 and will end up being rehabilitated twice in 30 years at a total cost over life of \$640,000 per lane mile.

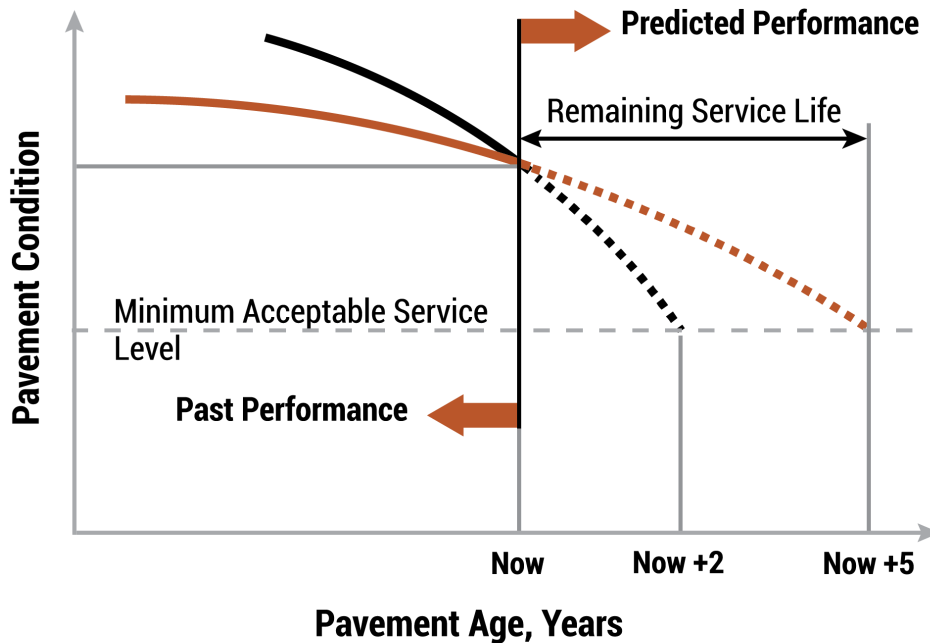
Fig. 3: Road Degradation Assumption vs. Timing of Maintenance/Rehabilitation

- 133 We concluded data is not collected frequently enough to adequately track road pavement performance, and the pavement deterioration does not map to the expected curve shape and presents risks that the model curves are not reflective of actual experience.
- 134 The reason these curves are so important to track in both predicted and actual form is the financial impact that deferral of maintenance has on the increased costs of future treatments. This can be seen in the generalized curve in Fig. 4 on page 34.
- 135 At a certain point, the cost of repairs accelerates such that any delay in intervention is very costly. Thus, for sound decision-making, planning and communications to stakeholders the City needs to have consistent, comparable methods, good data, frequent collection and effective predictive modeling.

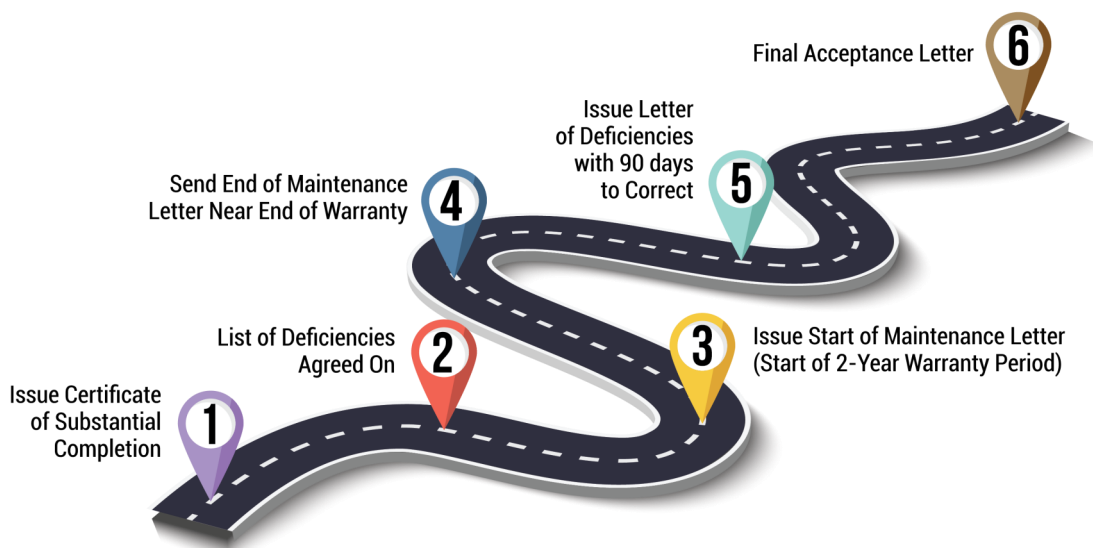
Fig. 5: Warranty and Final Acceptance Timeline

- 234 OCA had the following observations with respect to warranty administration.
- 235 In some cases, the End of Maintenance Letters are sent five or six months before the warranty period expires instead of 30 days. According to management this occurs when there are many deficiencies for the contractor to correct and management wants to provide the contractor with advance notice.

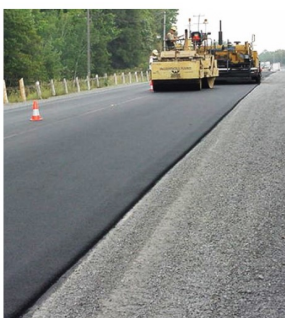
Seal Coat

The top course of the pavement can loosen over time because of weather conditions, gasoline/oil spills, and normal wear and tear. This causes erosion of the top layer allowing moisture penetration and subsequently asphalt cracking. The application of a seal coat over an old worn top course helps to restore and protect it.

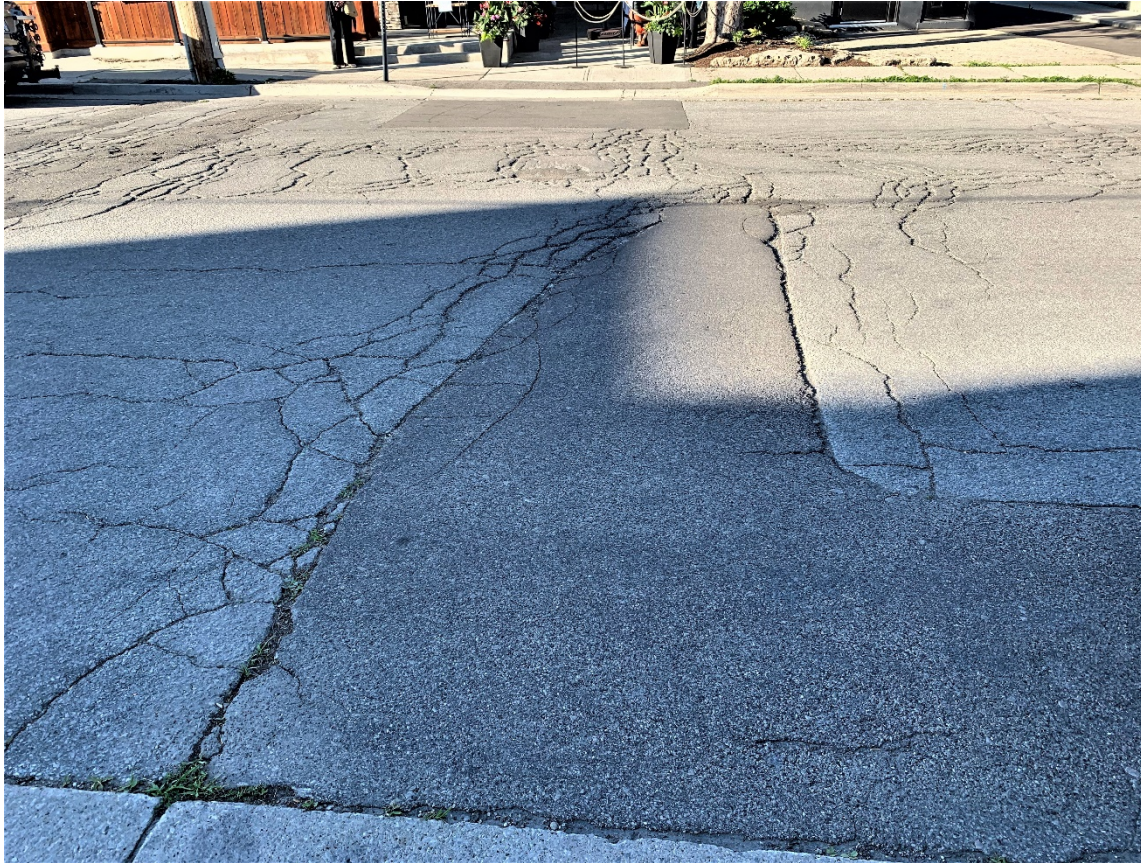
Pavement Condition Surveys

Scoring system out of 100

SI measures surface defects and RI ride smoothness

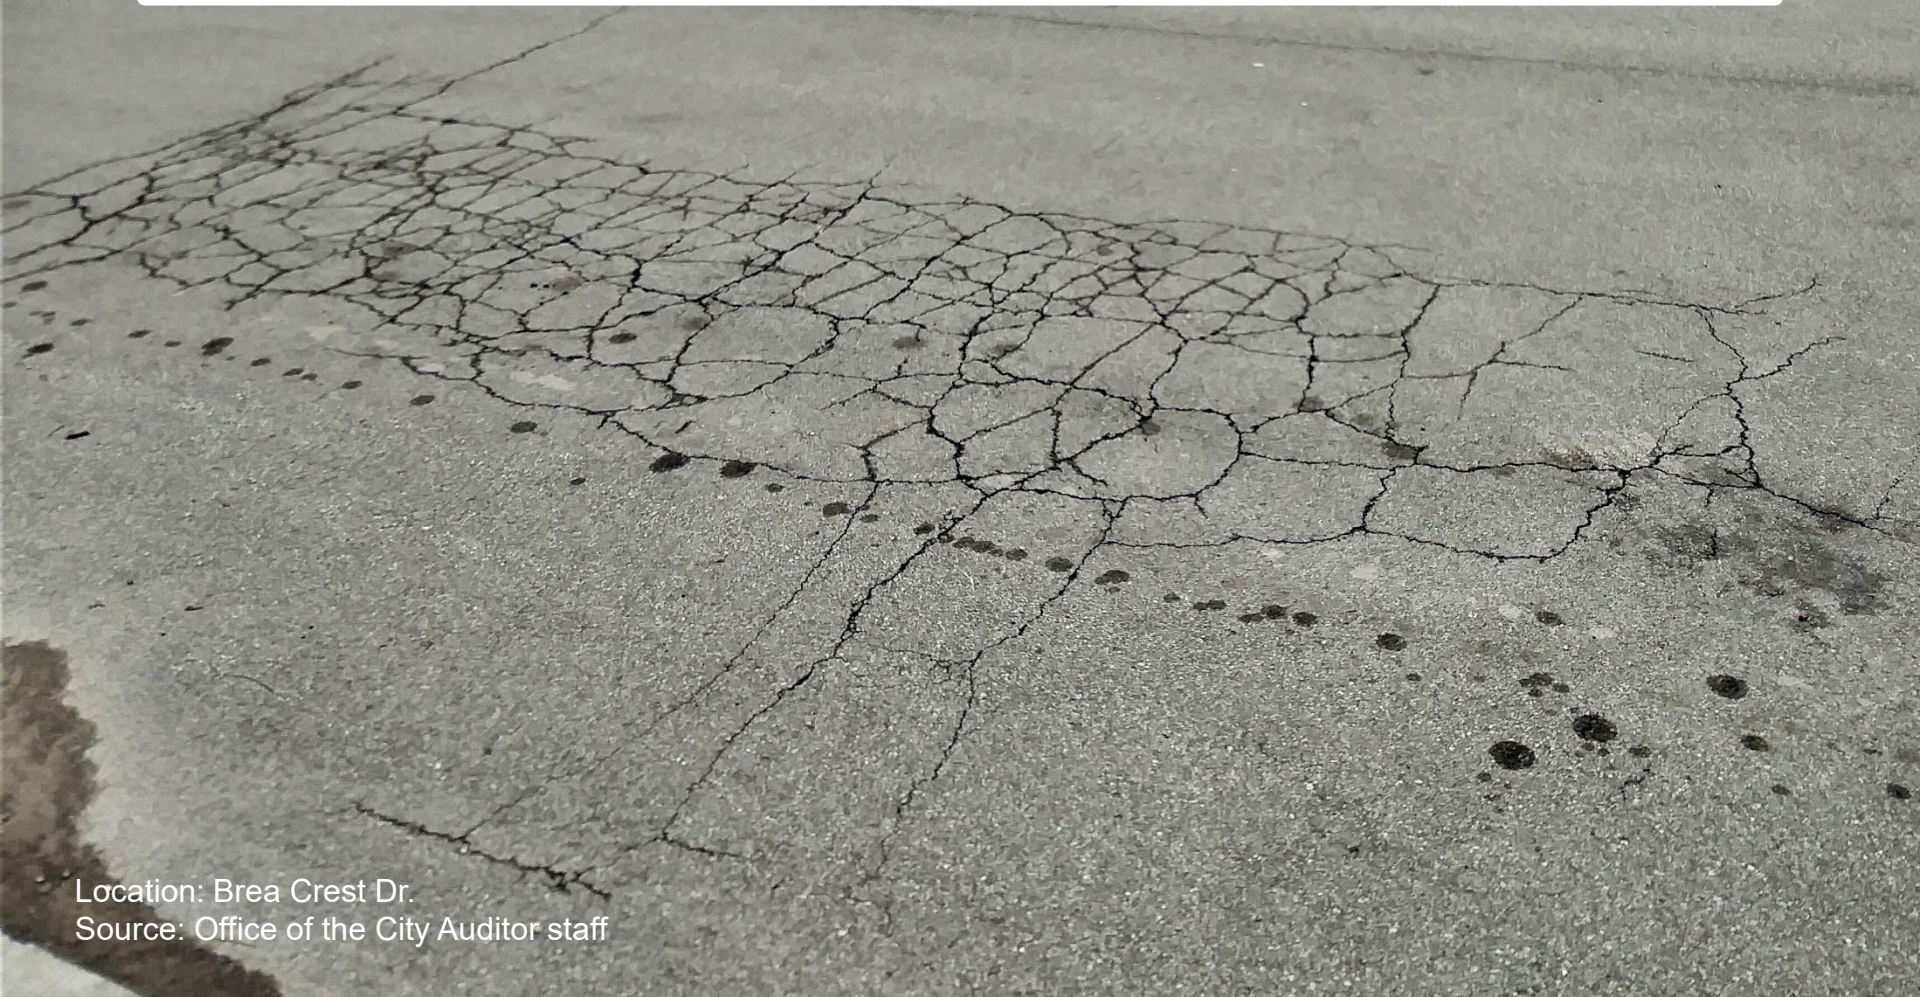
Location: Brea Crest Dr.
Source: Office of the City Auditor staff

Our audit found that for many years the City has had problems managing contractor performance and achieving the quality expected

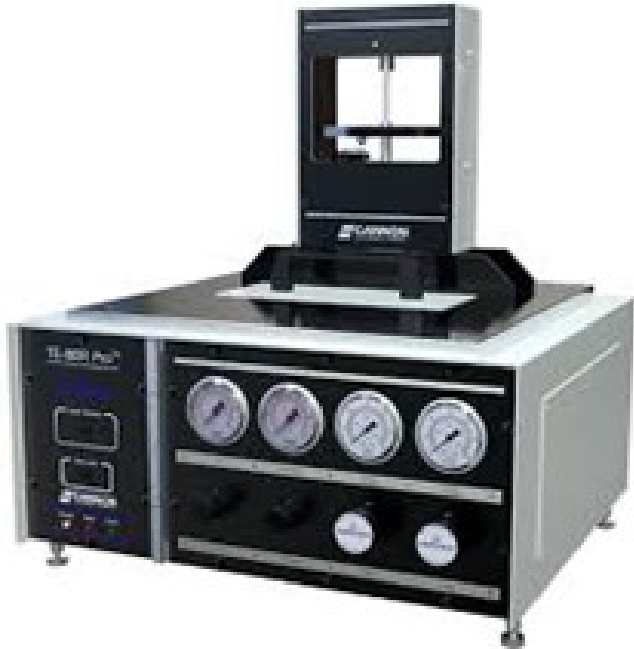
eBBR Testing

The BBR machine, which is used to test samples after 1, 24 and 72 hours of cold conditioning

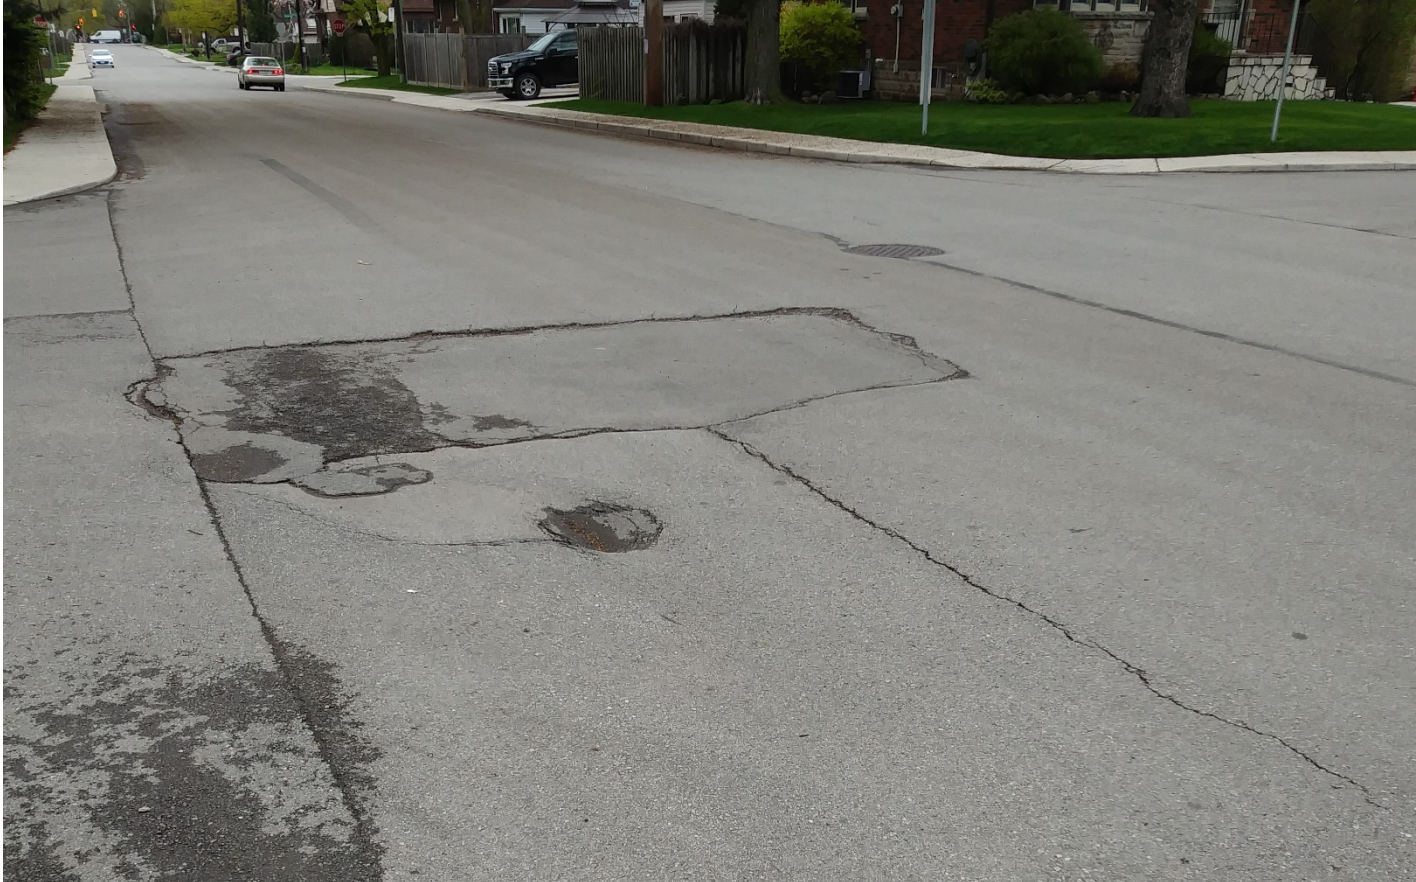
Location: Cameron Ave. S.
Source: Office of the City Auditor staff

No matter how well a road is repaired after a road cut, a certain amount of degradation is unavoidable.

- The City has a well defined process to ensure minimal damage, adequate inspection and recovery of costs
- Pavement restoration costs are recovered from the utilities (in 2019 over \$5M) plus administration surcharges of 15% plus degradation fees
- According to the FHWA (Federal Highways Administration) road cuts “increase pavement roughness...introduce discontinuities in the pavement structure. Both can cause the pavement’s expected lifespan to decrease”
- Studies confirm that utility trenching significantly shortens the overall lifespan of urban pavements causing reduction in asset value and serviceability

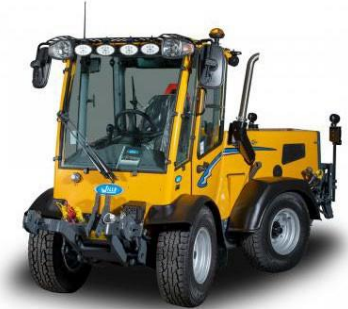
Trackless Sidewalk Tractor Comparison Chart				
Make/Model	Image	Demo Date(s)	Feedback	Additional Details
Wille 275

29-Nov-18	<p>A bit wider than our existing trackless machine (52 inches vs. 50.5 inches).</p> <p>Quite a bit shorter than our existing machine.</p> <p>Lower axle capacities wouldn't be able to operate the same as our existing units.</p> <p>Not compatible with our trackless attachments, the City would need to invest additional money to purchase the required attachments.</p>	Only available new from the manufacturer.

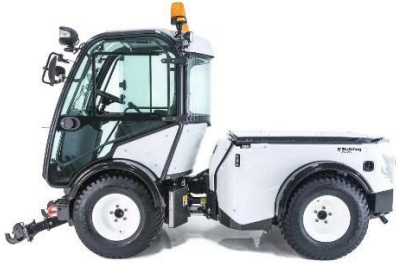
Trackless Sidewalk Tractor Comparison Chart				
Make/Model	Image	Demo Date(s)	Feedback	Additional Details
MultiHog CX 75

13-Mar-19	<p>A lot wider than our existing machines, would be too wide for the sidewalks (61 inches wide).</p> <p>Axle capacities are quite a bit smaller.</p> <p>Quite a large turning radius (124 inches).</p> <p>Not compatible with all our trackless attachments, the vendor said they could look into modifying but we weren't able to review any attachments at the demo.</p>	Only available new from the manufacturer.

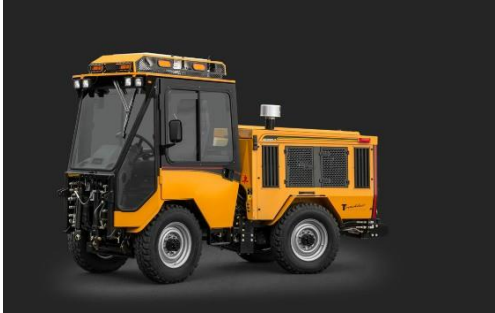
Trackless Sidewalk Tractor Comparison Chart				
Make/Model	Image	Demo Date(s)	Feedback	Additional Details
Trackless MT7(new) / MT57(re-man) Municipal Tractor

17-Apr-19	<p>User friendly.</p> <p>All existing attachments can be used without modification.</p> <p>Cost savings, no need to replace existing attachments.</p> <p>Currently the only sidewalk tractor the City operates meaning operator efficiency.</p> <p>Maintenance staff have experience working on these machines (less training required).</p>	<p>Available new or through a re-man program.</p> <p>Using the deep reduction gearbox and the auxiliary hydraulics, and they get incorporated into a new machine.</p> <p>Re-man program allows the City to get a trade in value which reduces the cost of the purchase of a new unit.</p>
