# HAMILTON MUNICIPAL HERITAGE COMMITTEE REVISÉ

**Meeting #:** 22-005

**Date:** May 13, 2022

**Cultural Heritage Assessment  
56 York Boulevard  
City of Hamilton, ON  
Part of Lot 15, Concession 2  
Geographic Township of Barton  
Former Wentworth County**

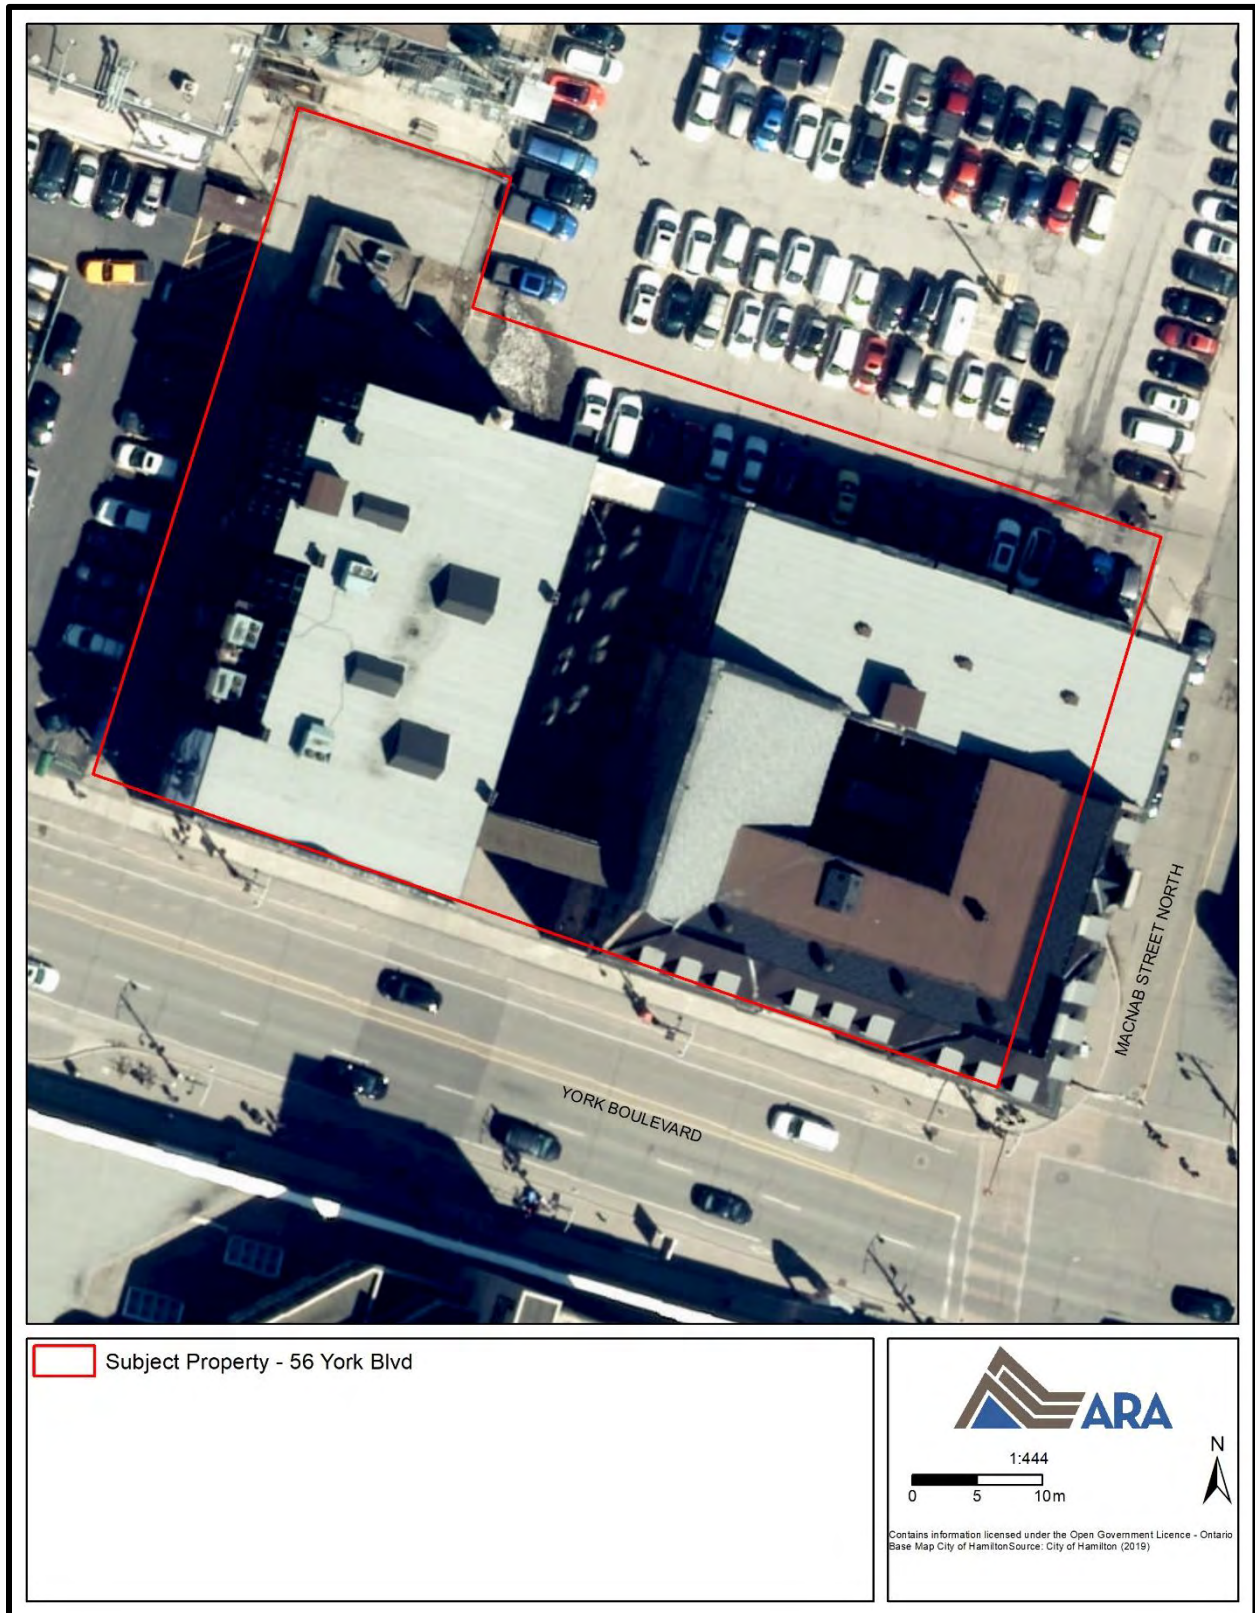
**Map 2: Aerial Image of Subject Property in City of Hamilton (Current)**  
(Produced under licence using ArcGIS® software by Esri, © Esri; City of Hamilton 2019)

The subject property is approximately 0.79 acres, rectilinear in shape and contains a three-storey stone commercial building and a four-storey brick commercial building situated on the same lot (see Map 2). The buildings are located at the northwest corner of York Boulevard and MacNab Street North in the core of downtown Hamilton. The surrounding area includes the Hamilton Farmers' Market and the Hamilton Central Public Library to the south, the First Ontario Centre (formerly Coppins Coliseum) to the southwest and a large parking structure to the east that connects through an enclosed pedestrian walkway to Jackson Square and the Hamilton City Centre to the southeast (see Figure 1).

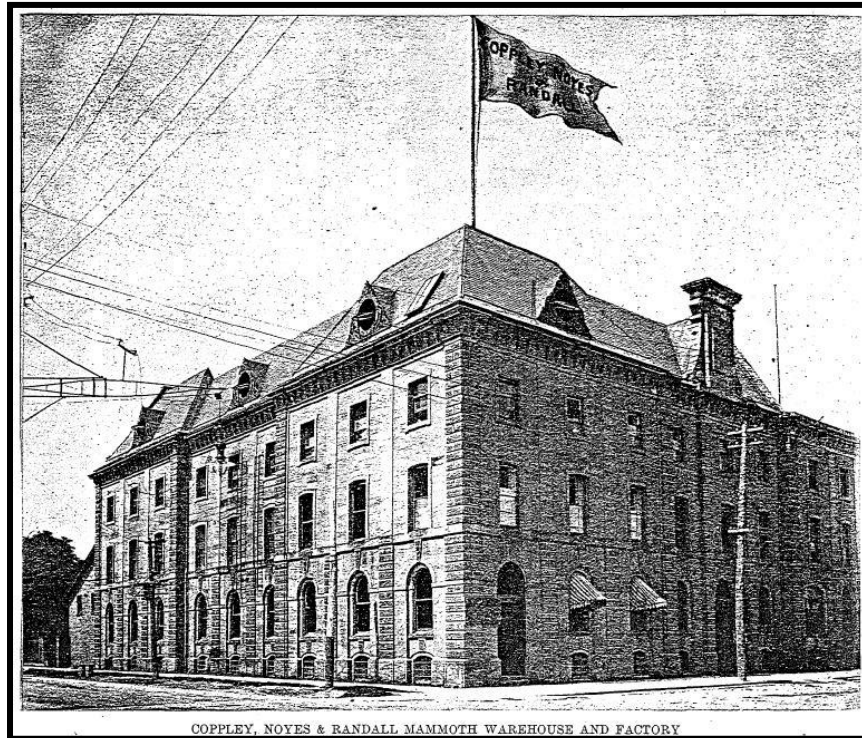
**Plate 3: Subject Property Stone Building Circa 1903  
(Adapted from Chapple and Moore circa 1903)**

The east elevation fronting MacNab Street was at one point used as the main entrance to the building according to imagery of the building's initial design and fire insurance plans (see Plate 3, Plate 10, Image 20 and Map 7). The south and central sections of the east elevation are three storeys plus a mansard storey and are part of the original building constructed in 1856. The northern part of the east elevation was constructed in 1881 and has three storeys (see Image 21). This elevation has nine bays and there are five dormers on the 1856 portion of the east elevation, each with a shed roof. The east elevation is finished with a similar massing as seen on the south facing front façade and includes the same decorative finishes as described on the front façade. These details include stone banding, vermiculated pilasters and keystones and arched window openings. A stepped entrance is located at the south end of the east elevation with an arched transom window that supports the design and rhythm of the openings on front façade and east elevation (see Image 22). A sign is affixed to the south of this entrance and reads, "COPPLEY NOYES & RANDALL LIMITED WHOLESALE CLOTHING" (see Image 22–Image 23).

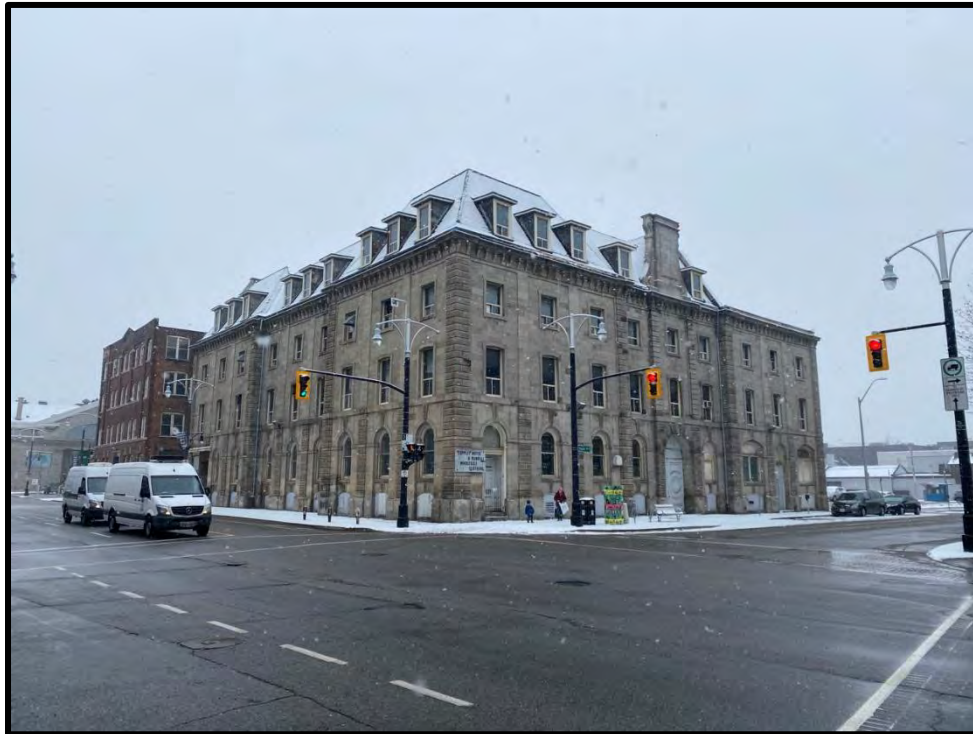
**Image 3: View of Subject Property**  
(Photo taken on December 8, 2021; Facing Northwest)

The nine-bay front façade has symmetrical massing (see Image 3). Stone pilasters separate each bay on the first storey of the front façade and extends to the second and third storeys. The pilasters feature vermiculated detailing on the first storey and ashlar on the second and third storeys (see Image 4–Image 6). A projecting stone band located in the approximate middle of the first storey extends the length of the front façade and wraps around the east elevation (see Image 7). A second projecting stone band delineates the space between the first and second storeys. The first storey window openings are framed by stone sills and round arches. Limestone keystones with a vermiculated finish decorate the arched window openings on the first storey and basement window openings which have a segmental arch (see Image 7–Image 8).

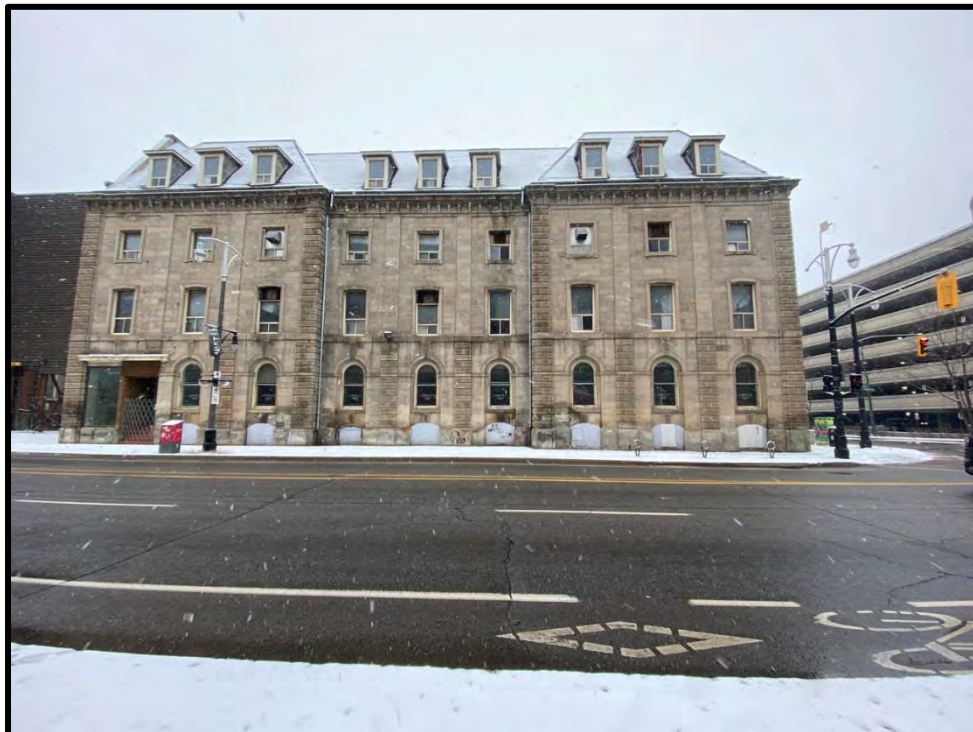
**Image 4: York Street Front Façade (South Elevation)**  
(Photo taken on December 8, 2021; Facing North)

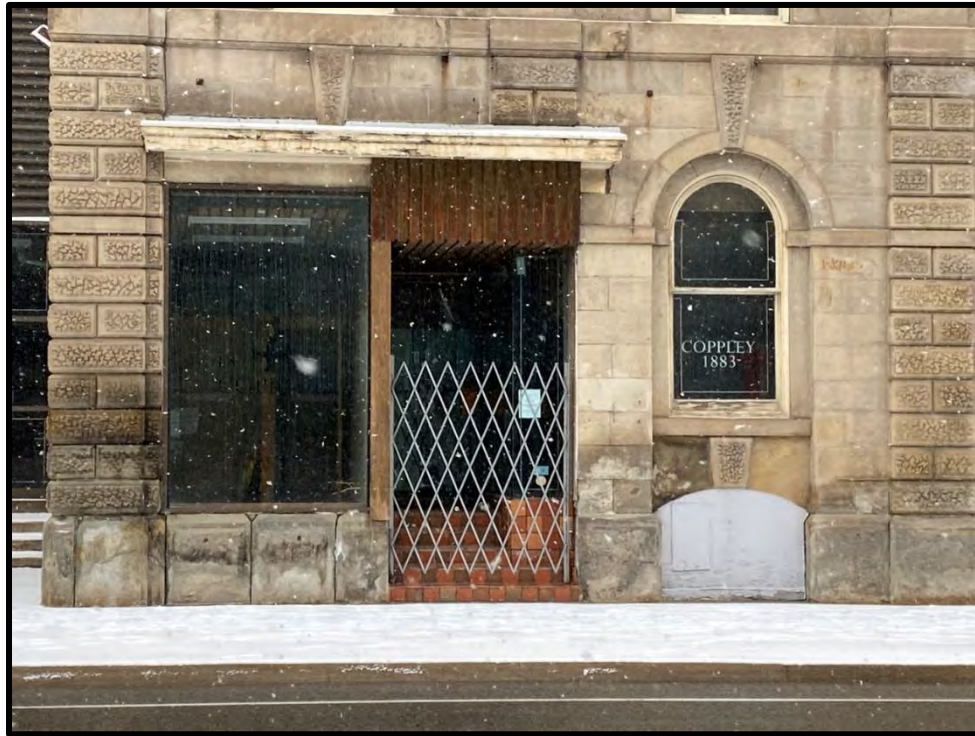
**Image 5: York Street Entrance – Detail**  
(Photo taken on December 8, 2021; Facing North)

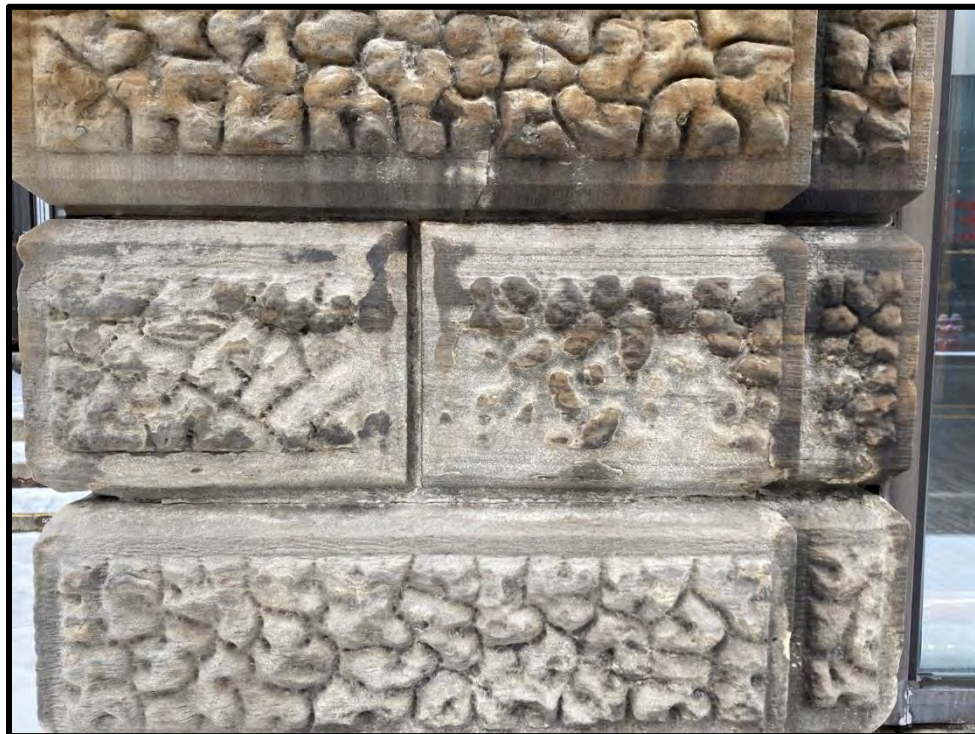
**Image 6: Vermiculated Stone Pilaster – Detail**  
(Photo taken on December 8, 2021; Facing North)

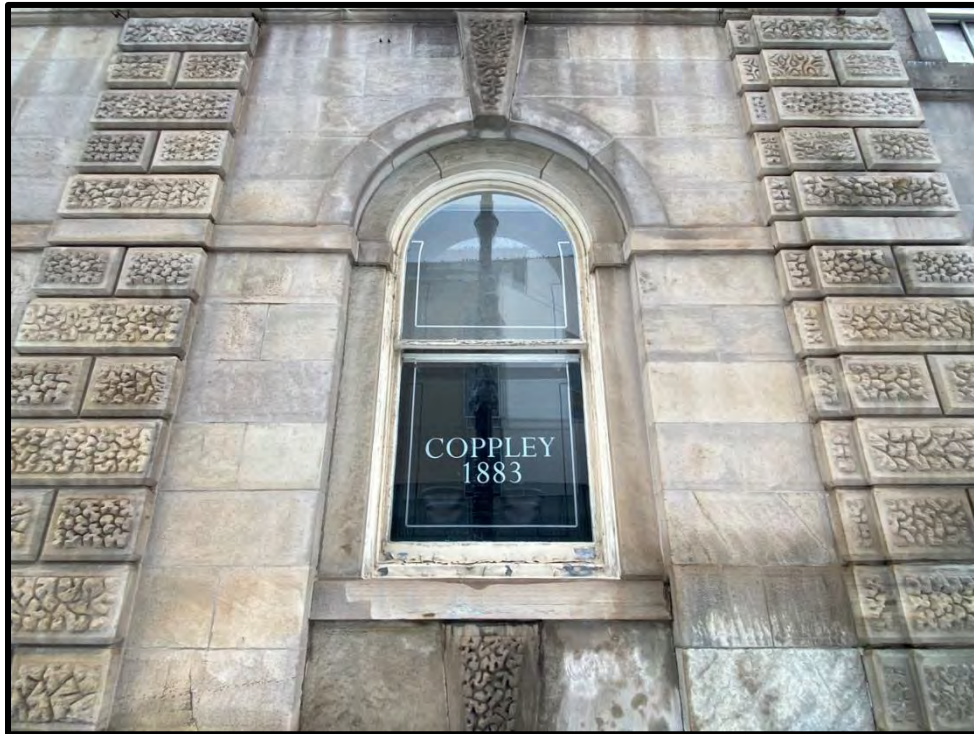
**Image 7: First Storey Window Opening and Vermiculated Ashlar Pilasters – Detail**  
(Photo taken on December 8, 2021; Facing North)

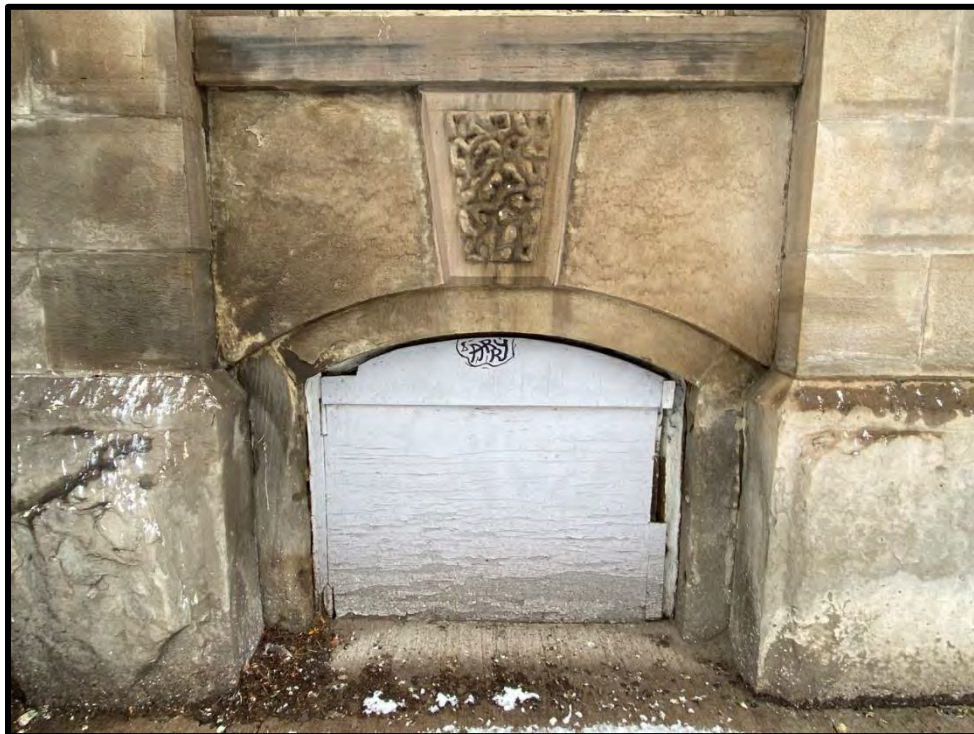
**Image 8: Detail of Basement Window Opening on York Street Front Façade**  
(Photo taken on December 8, 2021; Facing North)

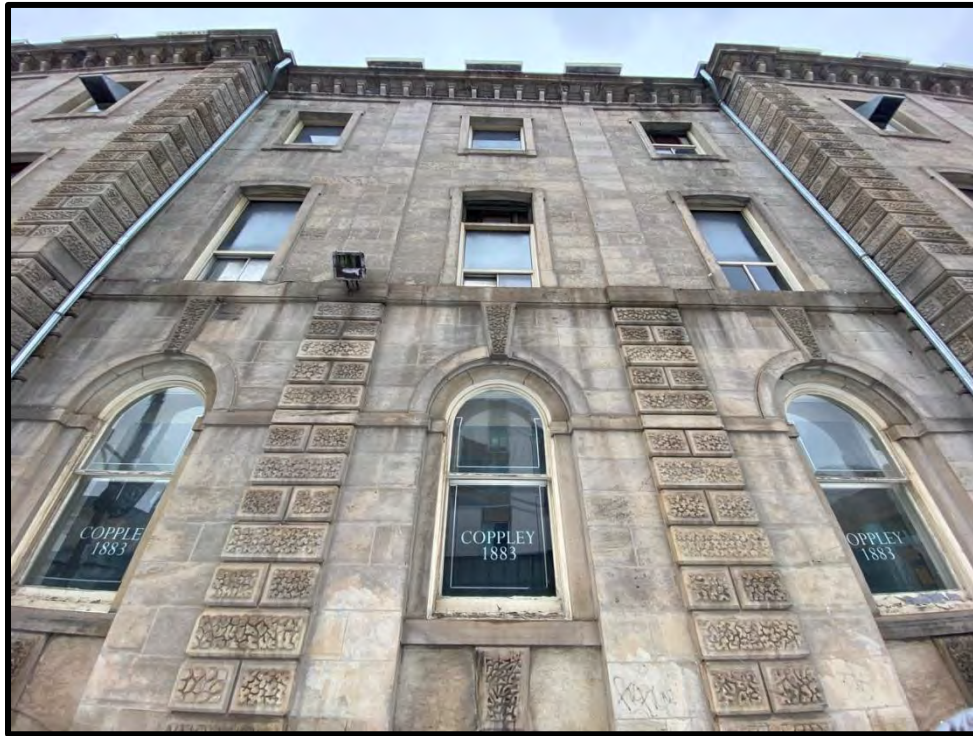
**Image 9: Detail of Central Section of York Street Front Façade**  
(Photo taken on December 8, 2021; Facing North)

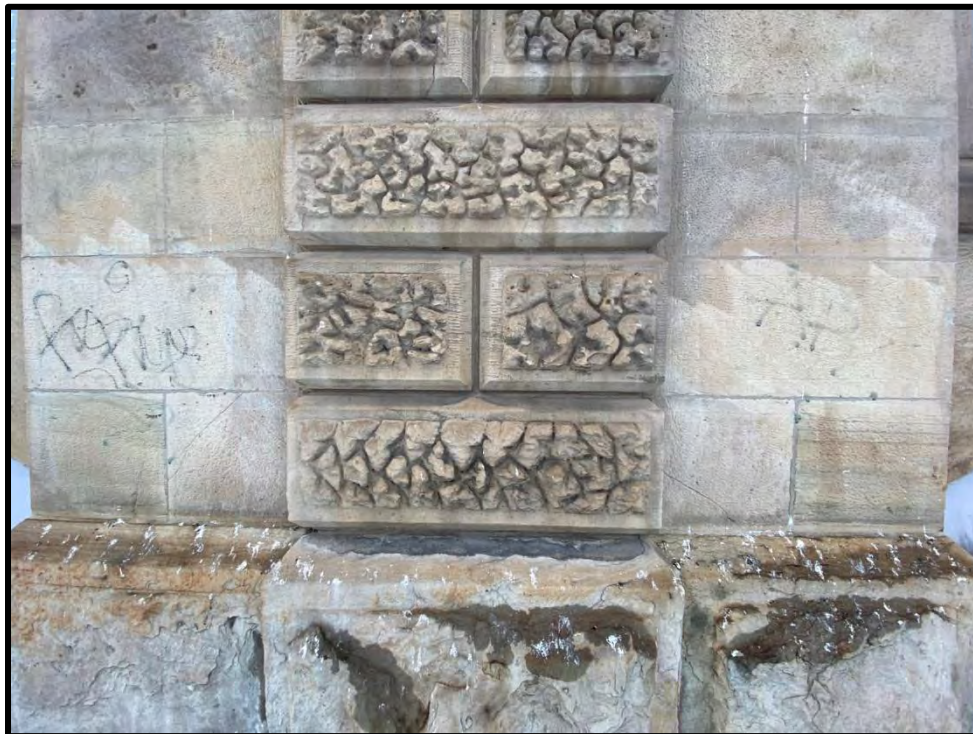
**Image 10: Vermiculated Stone Pilaster and Dressed Stone – Detail**  
(Photo taken on December 8, 2021; Facing North)

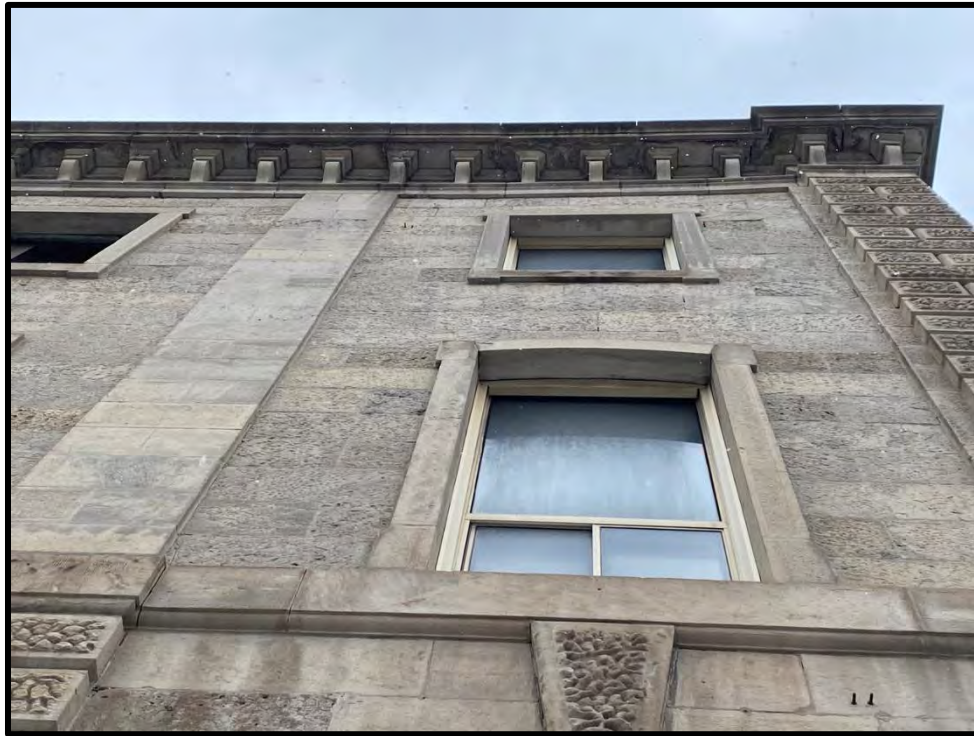
**Image 11: Second and Third Storey Window Openings and Brackets – Detail**  
(Photo taken on December 8, 2021; Facing North)

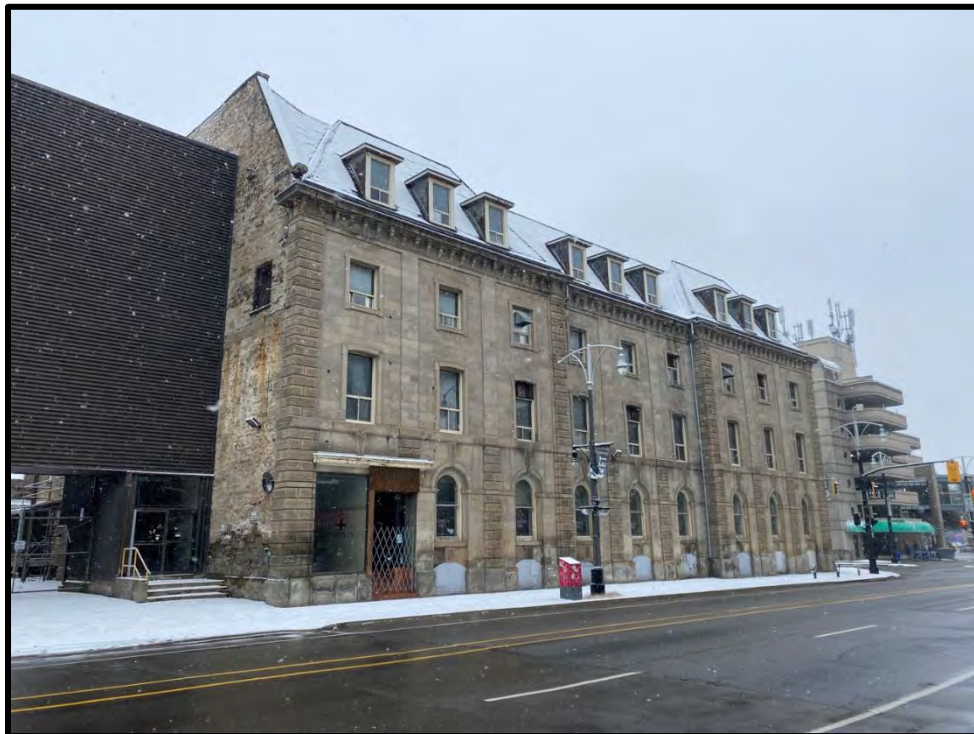
**Image 12: York Street Front Façade and Overhead Walkway at Left**  
(Photo taken on December 8, 2021; Facing Northeast)

However, the west elevation is finished in rubble stone and uncoursed masonry (see Image 12–Image 13).

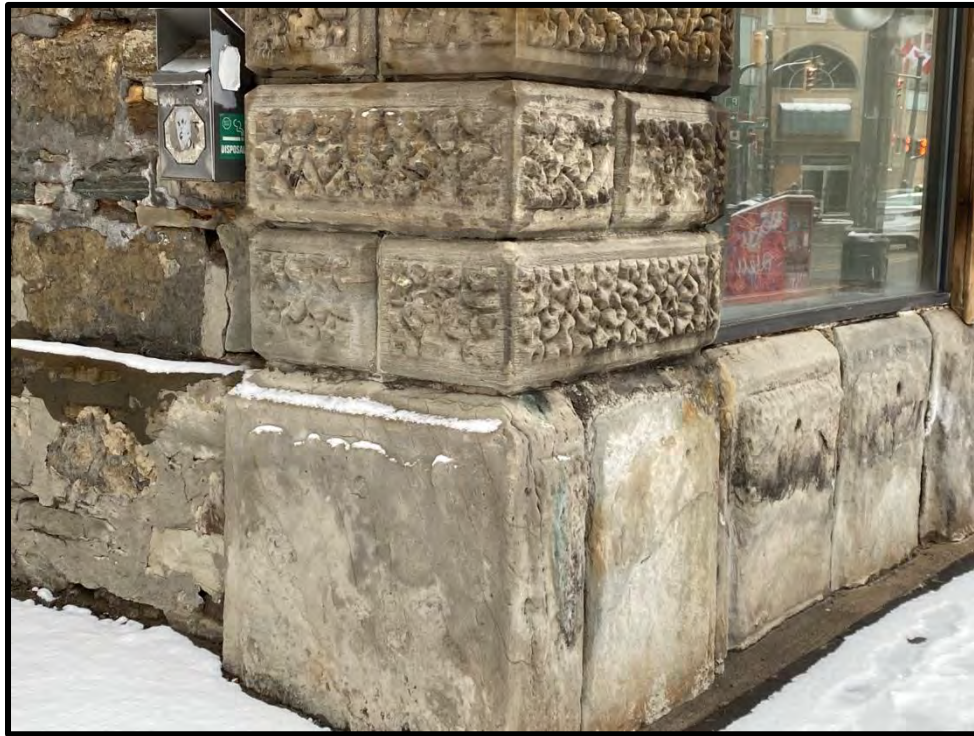
**Image 13: Detail of Corner at York Street Front Façade and West Elevation**  
(Photo taken on December 8, 2021; Facing Northeast)

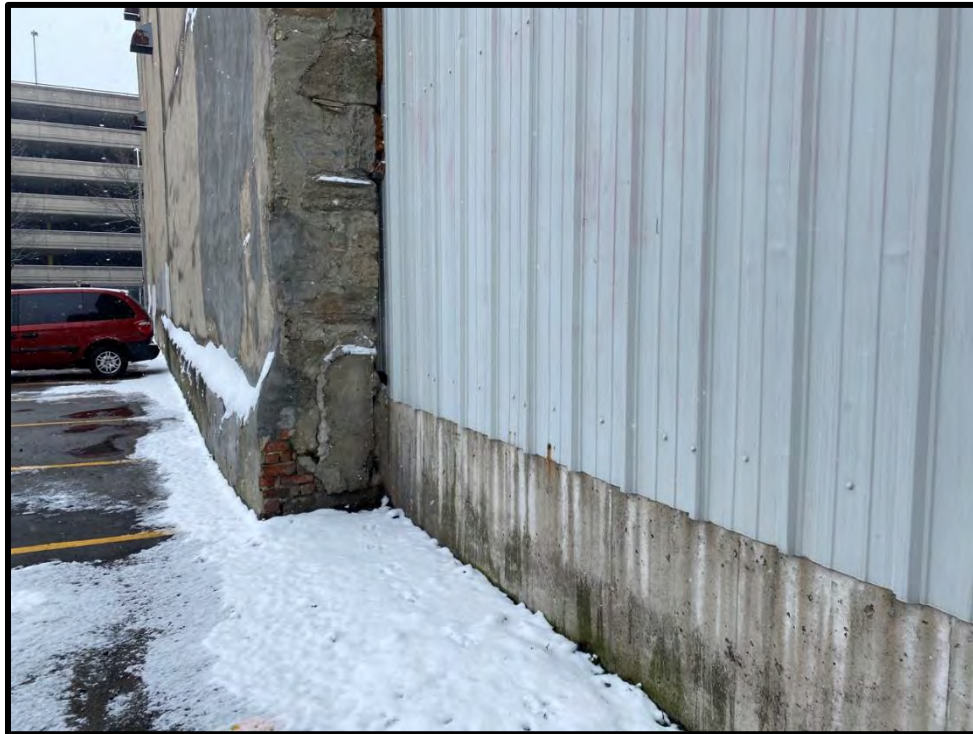
**Image 19: Foundation and Concrete Walkway – Detail**  
(Photo taken on December 8, 2021; Facing Southeast)

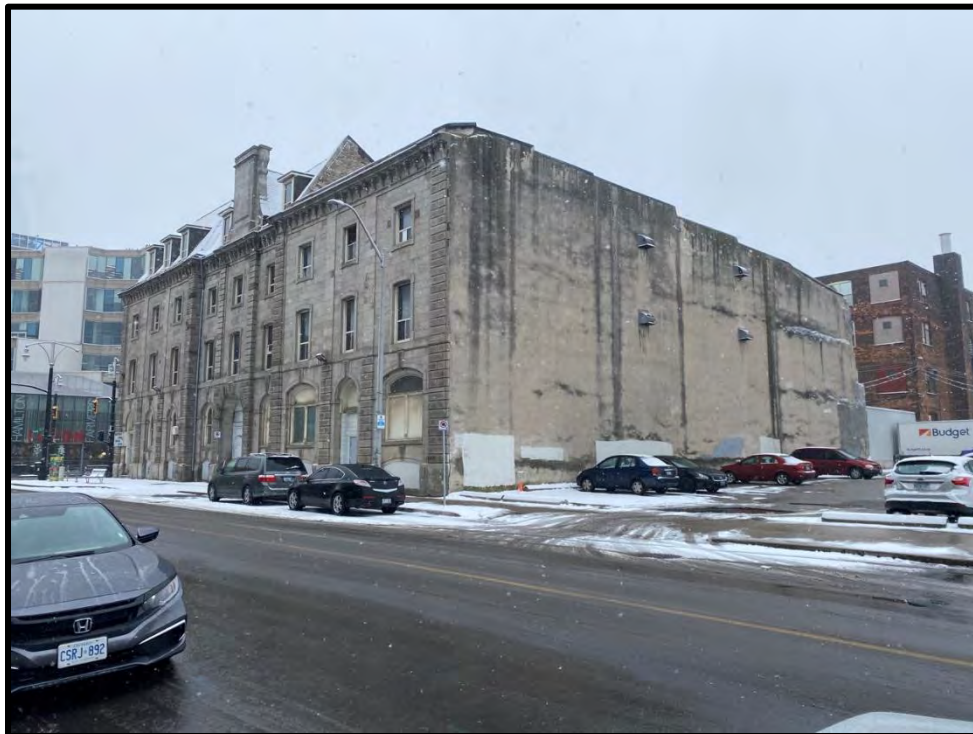
**Image 20: North and East Elevations**  
(Photo taken on December 8, 2021; Facing Southwest)

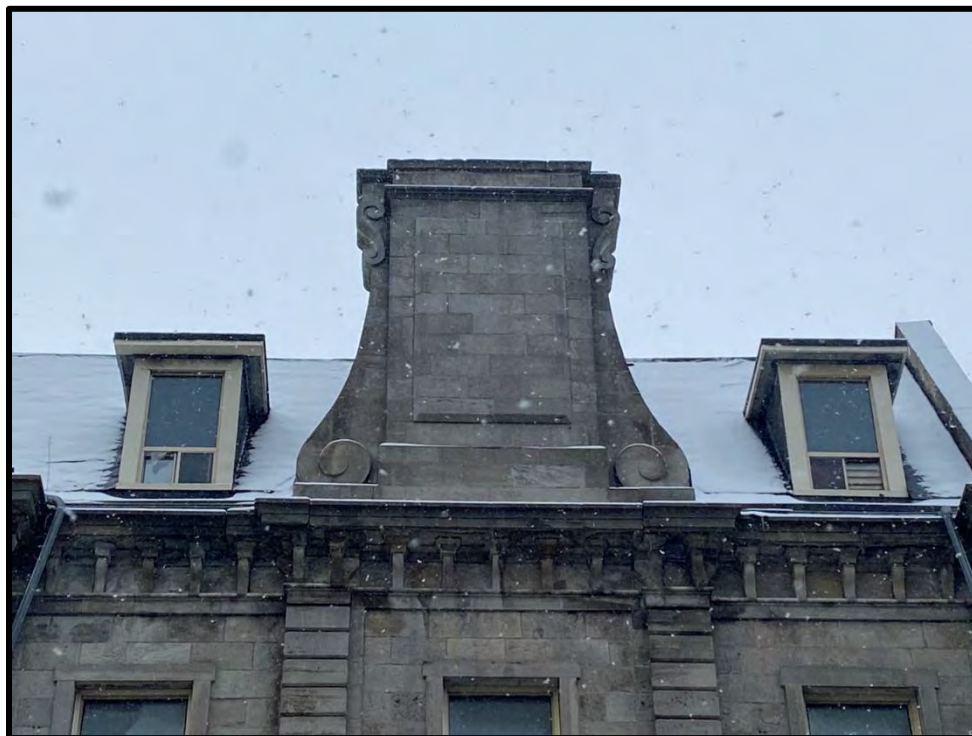
**Image 24: East Elevation Chimney, Brackets and Dormers Detail**  
(Photo taken on December 8, 2021; Facing West)

A prominent stone chimney with decorative stone scrollwork is located at the centre of the east elevation (see Image 24). The east elevation also contains a large, vermiculated arched door opening that provides access to the building's interior courtyard (see Image 25). The door enclosing the opening on at the central section of the east elevation is constructed of wood. The first storey windows on the east elevation match those seen on the front façade except for two wider window openings with segmental arches located on the northern part of the elevation that was constructed in 1881. While differing in dimensions, these window openings mimic the stone

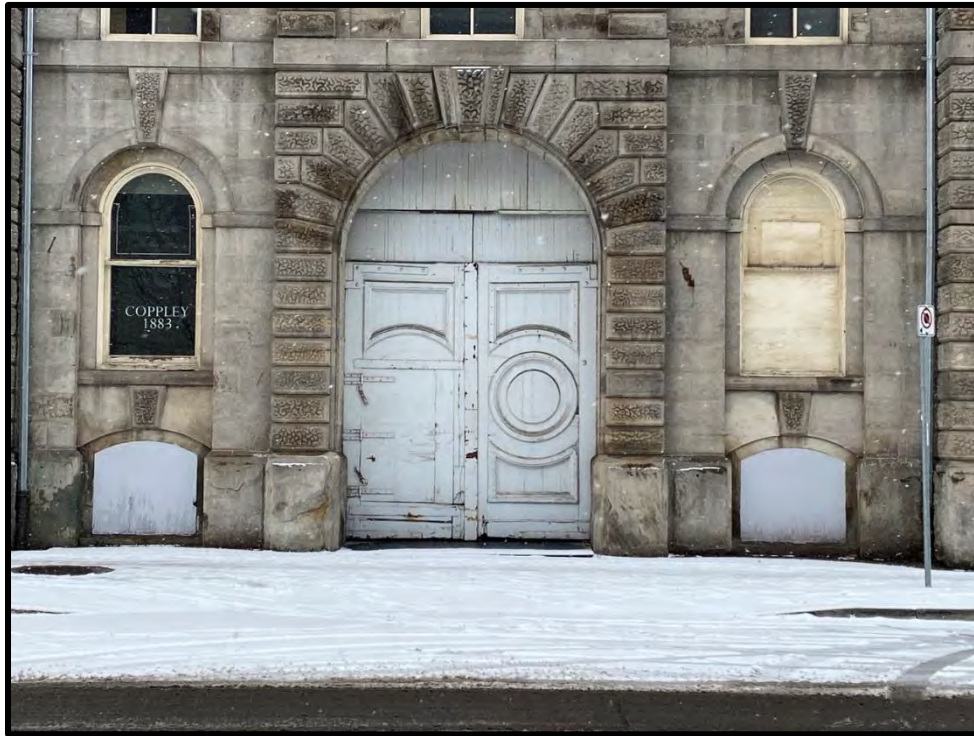
**Image 25: East Elevation Window Openings and Door Opening to Courtyard-Detail**  
(Photo taken on December 8, 2021; Facing West)

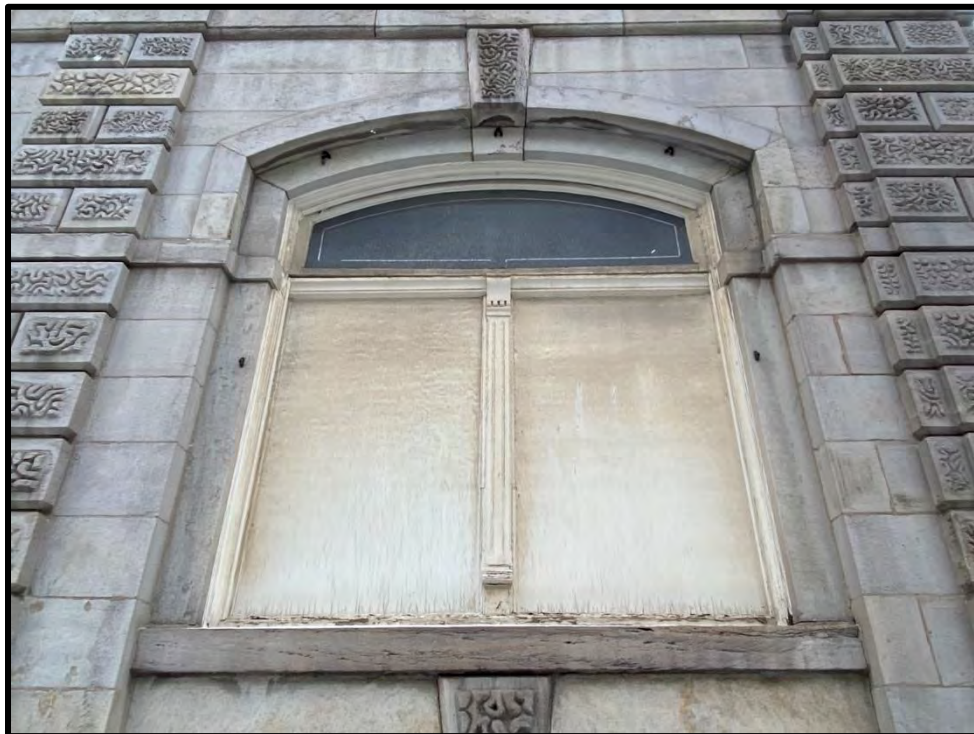
**Image 26: East Elevation Window Opening - Detail**  
(Photo taken on December 8, 2021; Facing West)

decorative finishes seen elsewhere on the first storey (see Image 26 and Image 27). Basement window openings on the east elevation have been covered with plywood and are recessed with vermiculated keystones (see Image 27).

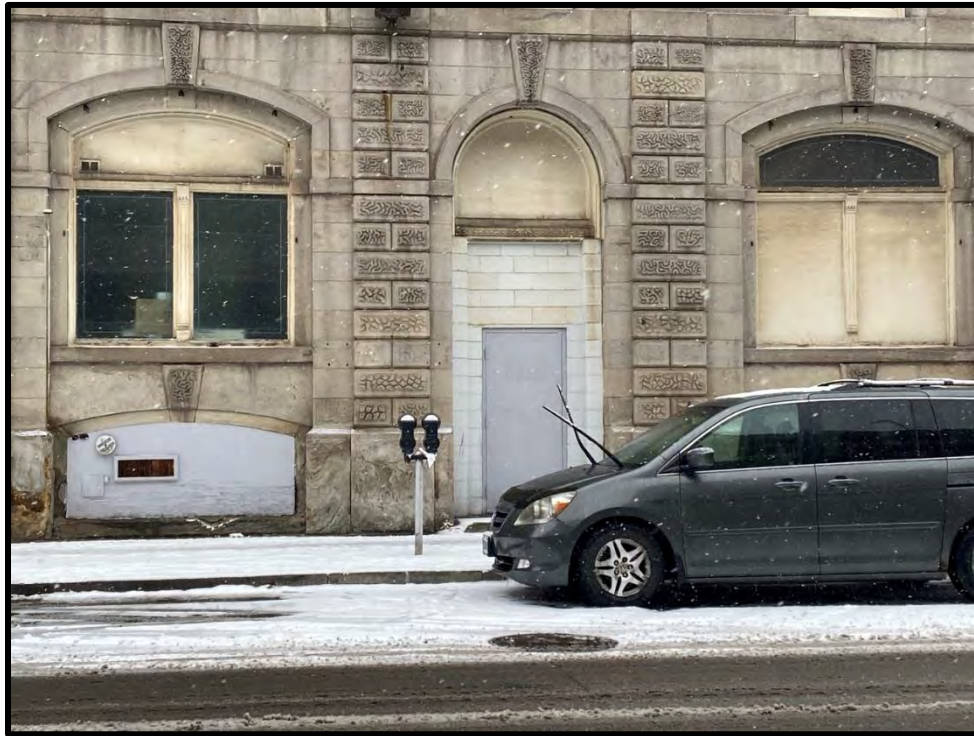
**Image 27: East Elevation Window and Door Openings - Detail**  
(Photo taken on December 8, 2021; Facing West)

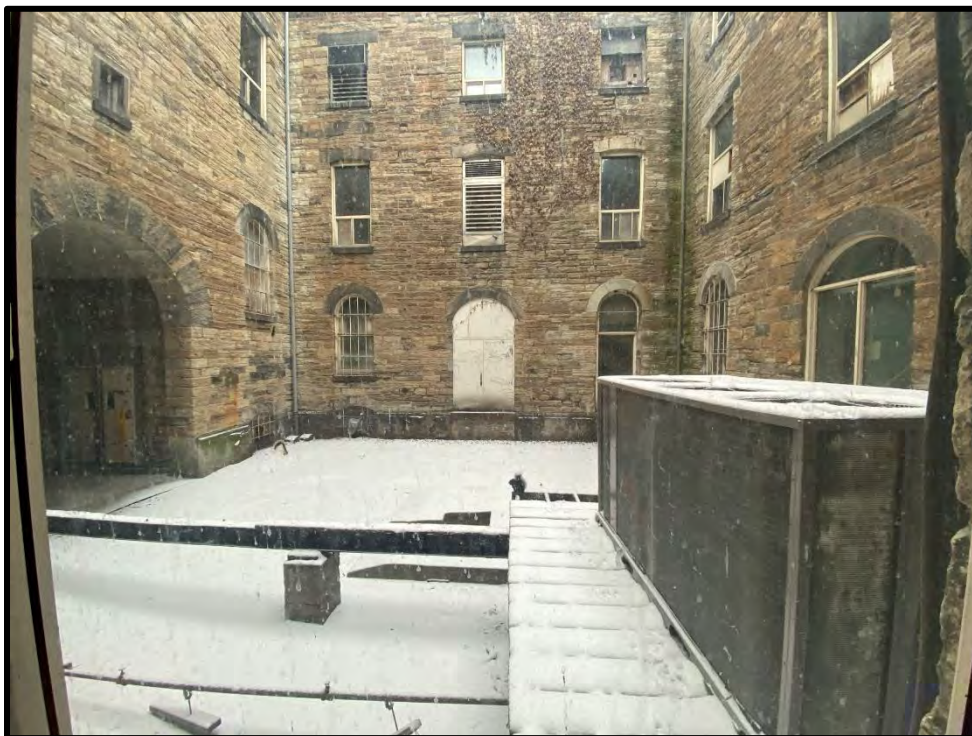
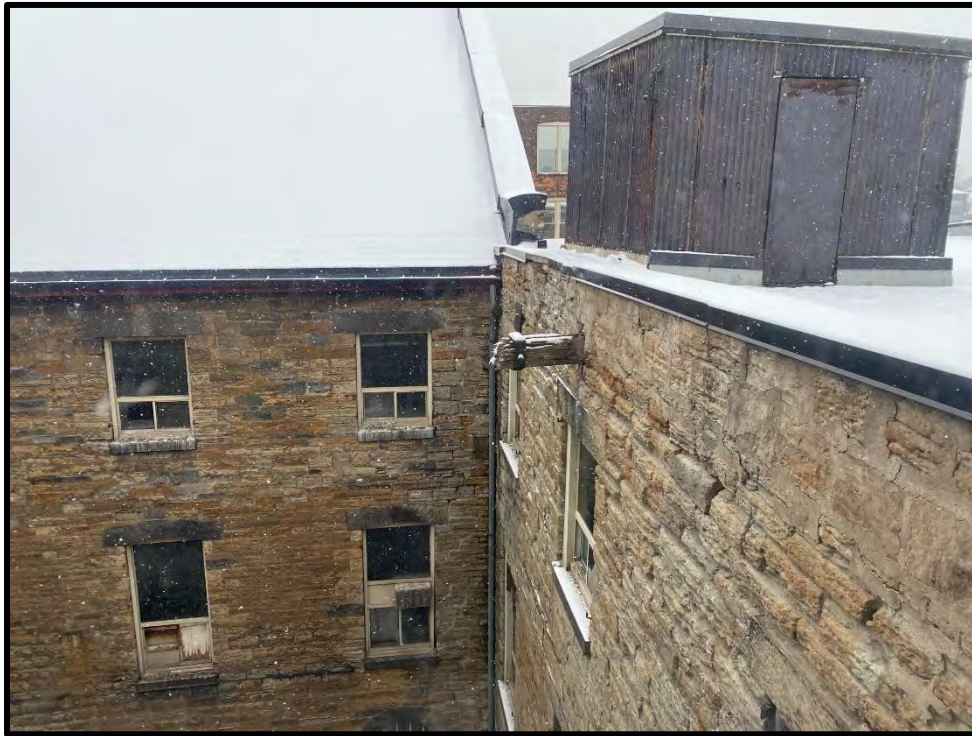
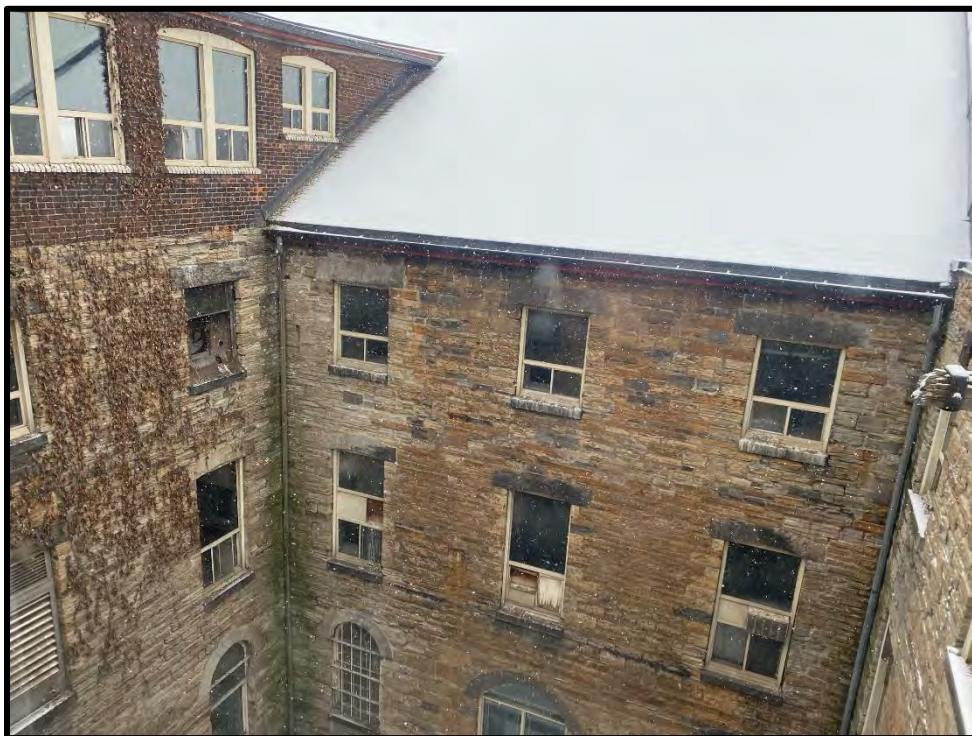
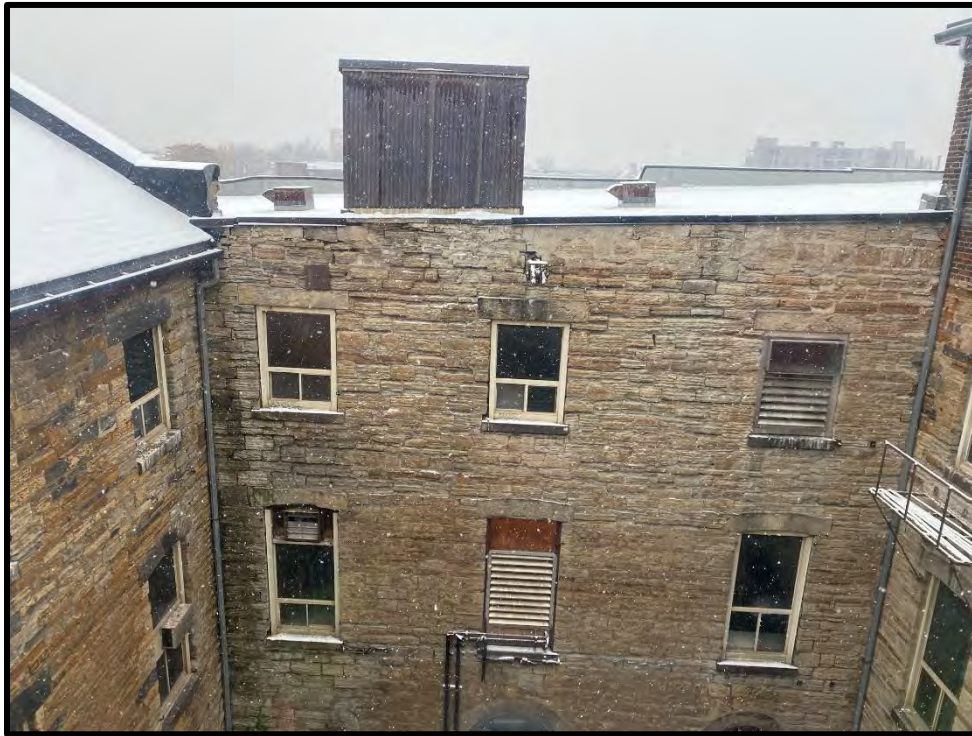
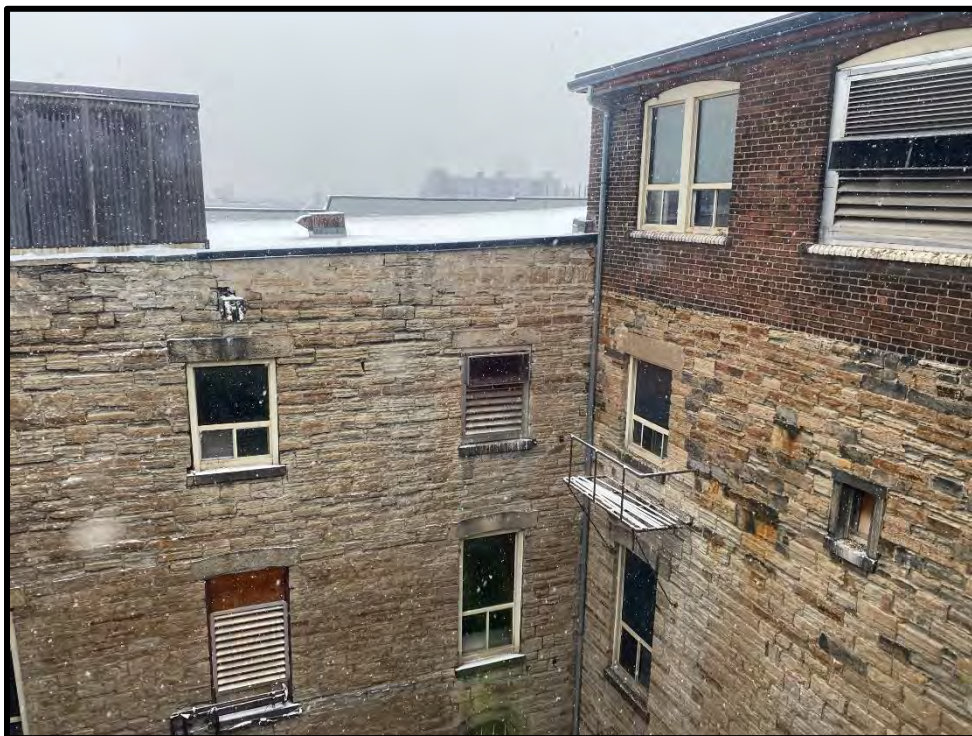
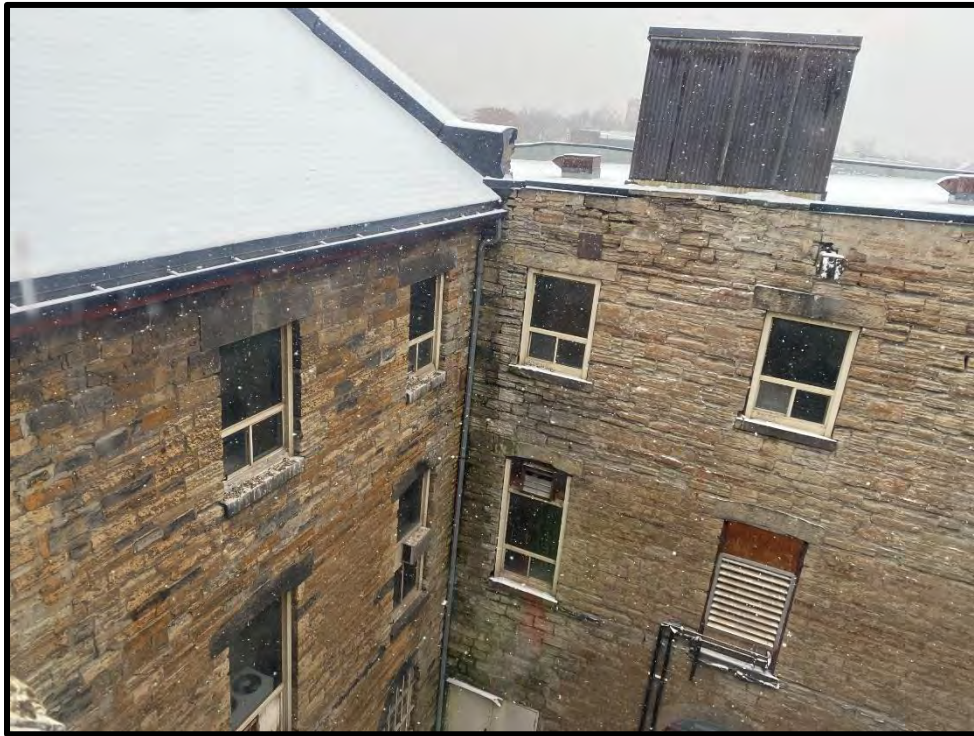
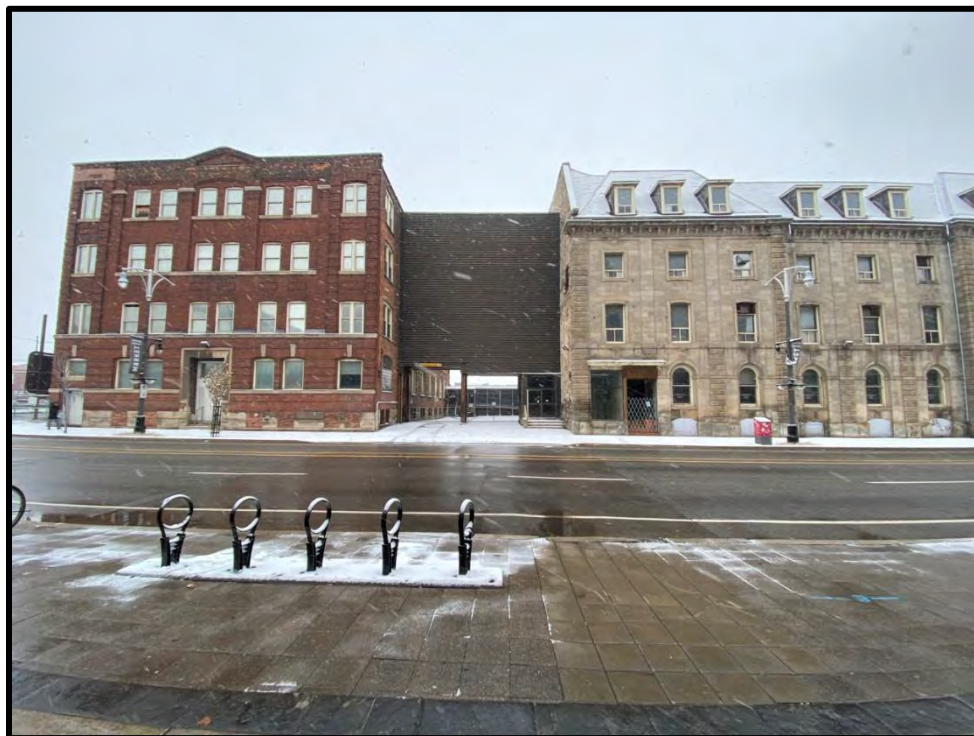
**Image 30: Courtyard**  
(Photo taken on December 8, 2021; Facing South)

**Image 31: Courtyard**  
(Photo taken on December 8, 2021; Facing West)

**Image 32: Courtyard**  
(Photo taken on December 8, 2021; Facing Southwest)

**Image 33: Courtyard**  
(Photo taken on December 8, 2021; Facing North)

**Image 34: Courtyard**  
(Photo taken on December 8, 2021; Facing Northeast)

**Image 35: Courtyard**  
(Photo taken on December 8, 2021; Facing Northwest)

**Image 36: York Street Front Façade Showing Entrance to Loading Area**  
(Photo taken on December 8, 2021; Facing North)

The stone building has a central courtyard that was enclosed with the construction of the north building in 1881 (see Map 10). The courtyard walls are constructed of cut stone masonry with the exception of the fourth storey of the north and west courtyard elevations that are constructed of brick masonry (see Image 28–Image 35). Basement window openings within the courtyard are small and covered with iron bars (see Image 28–Image 30). Window openings on the first storey of the courtyard are topped with round arches and several have iron bars affixed to the surrounding stone (see Image 28–Image 30). The large, round arched tunnel leads to the doorway on the east elevation (see Image 29).

The second and third storeys window openings are rectangular with stone sills and lintels (see Image 30–Image 35). The fourth storey of the north elevation is constructed of brick masonry has three large window openings with segmental arches evenly spaced and one small window opening at west end of the elevation. These openings are framed with brick voussoirs and brick sills (see Image 32).

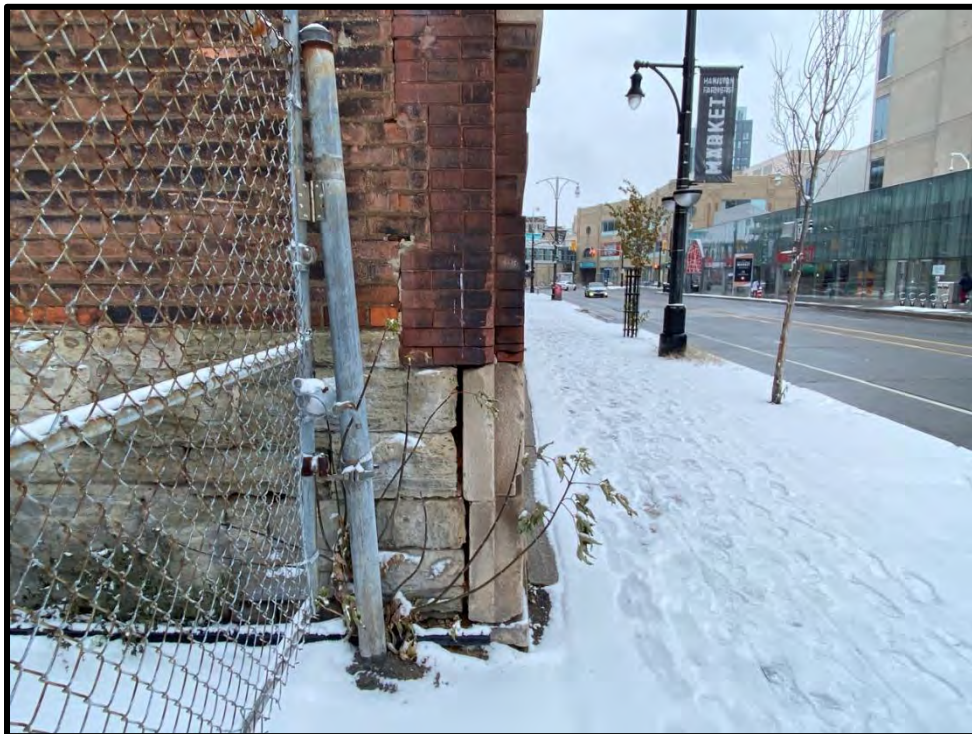
**Image 38: Detail of Front Façade Cladding**  
(Photo taken on December 8, 2021; Facing East)
