# HAMILTON MUNICIPAL HERITAGE COMMITTEE REVISÉ

**Meeting #:** 22-005

**Date:** May 13, 2022

**Cultural Heritage Assessment  
56 York Boulevard  
City of Hamilton, ON  
Part of Lot 15, Concession 2  
Geographic Township of Barton  
Former Wentworth County**

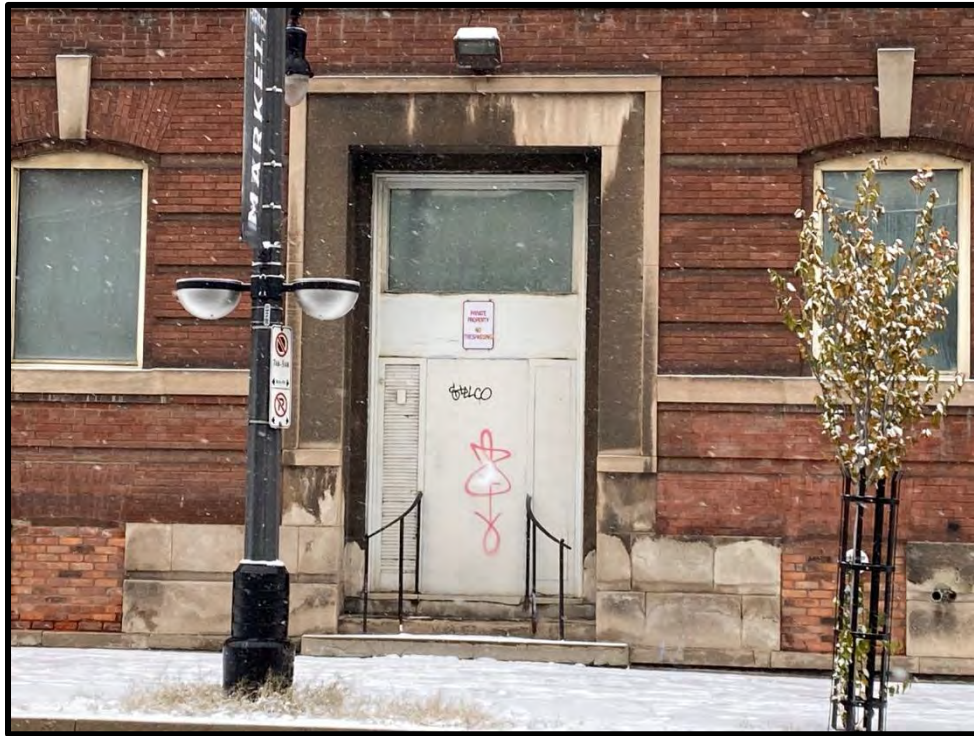
**Image 39: York Street Front Façade Door Opening Detail**  
(Photo taken on December 8, 2021; Facing North)

An entrance is located at the centre of the front façade on the first storey and is framed by an oversized dressed stone surround (see Image 39). Five window openings for the basement have been enclosed with brick and are separated by dressed stone with a tooled textured finish (see Image 40 and Image 41). Window openings on the first storey are framed with segmental arched brick voussoirs with a stone keystone. Similarly, the window openings on the second, third and fourth storeys have segmental arches with brick voussoirs. An unassuming door opening is located at the western extent of the front façade. The front façade has a parapet wall with a centred peak (see Image 42).

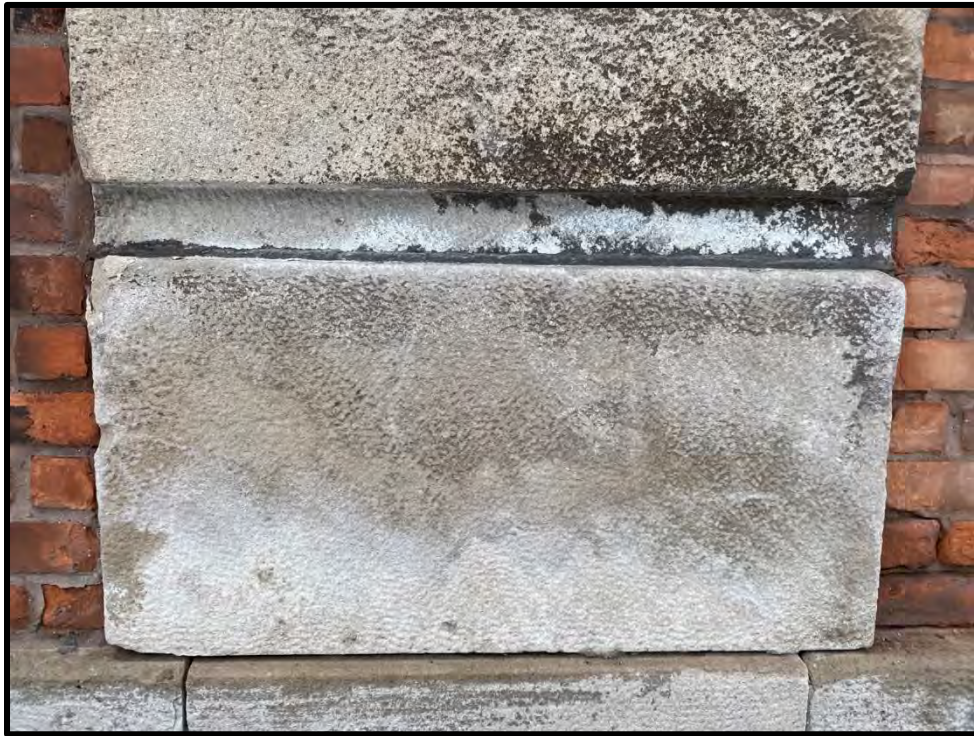
**Image 41: York Street Front Façade Rusticated Stone – Detail**  
(Photo taken on December 8, 2021; Facing North)

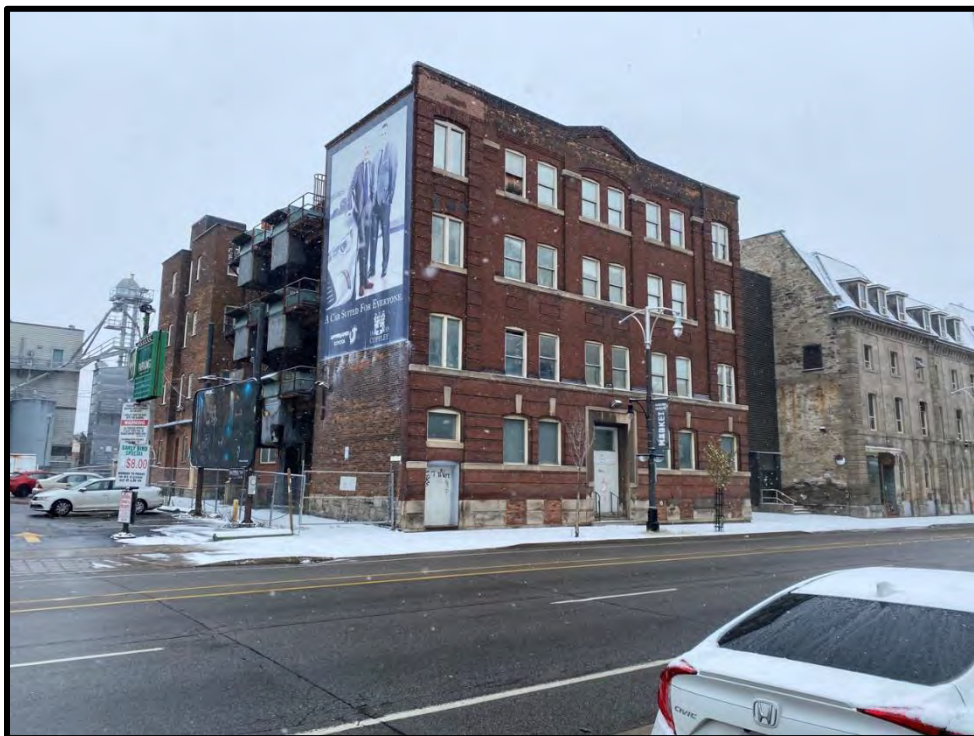
**Image 42: South and West Elevations**  
(Photo taken on December 8, 2021; Facing Northeast)

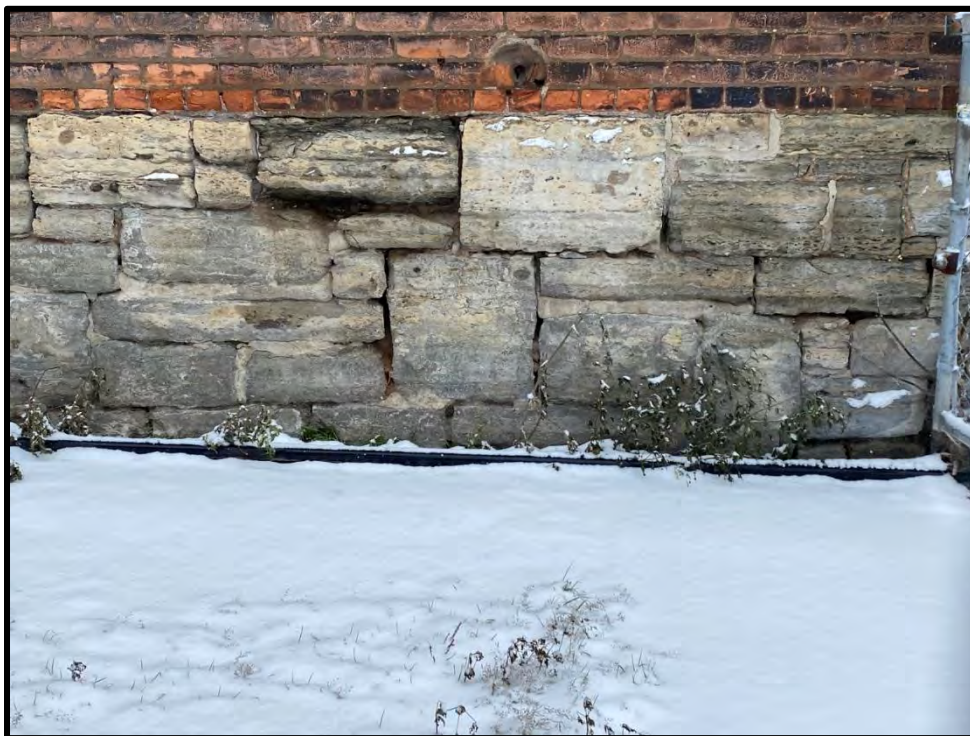
**Image 44: Detail of Stone Foundation Brick Coursing on West Elevation**  
(Photo taken on December 8, 2021; Facing East)

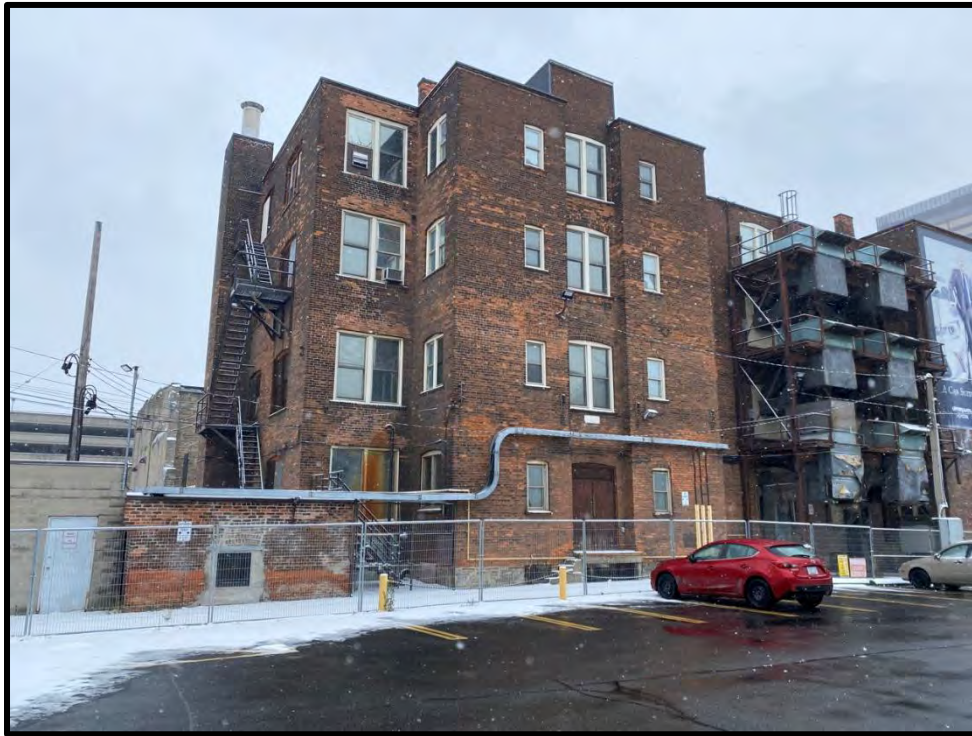
**Image 45: West Elevation Showing Elevator Shaft  
(Photo taken on December 8, 2021; Facing Southeast)**

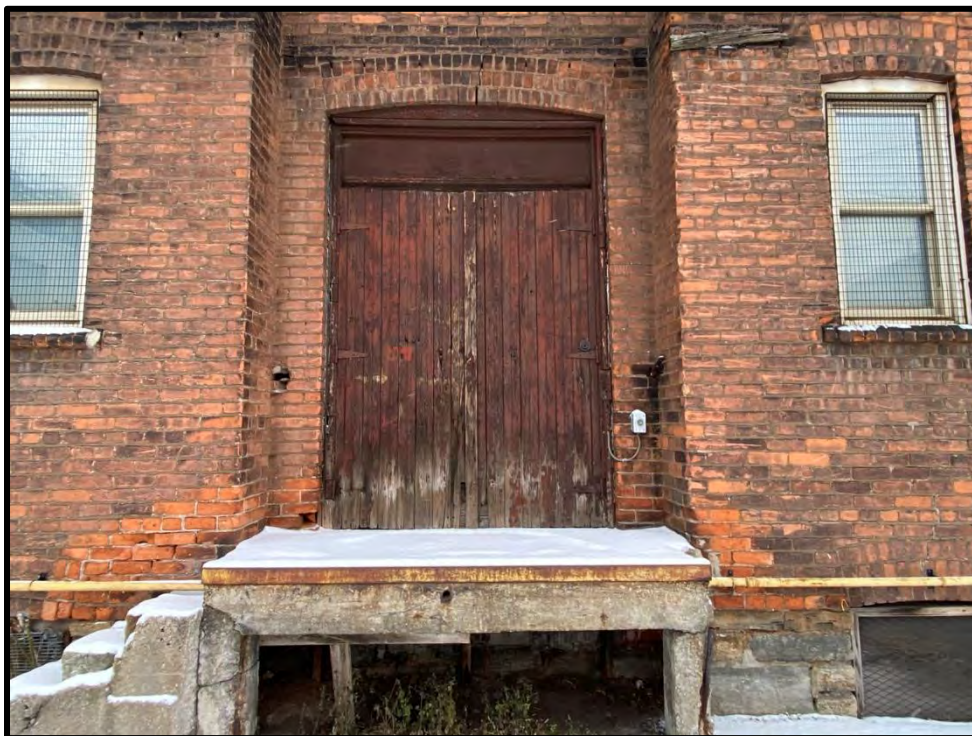
**Image 46: Detail of Door Opening on West Elevation  
(Photo taken on December 8, 2021; Facing East)**

elevation between the two projecting sections and partially or fully obscures the window openings (see Image 45). A wooden door is located on the first storey of the north projecting section (see Image 46). Basement window openings have stacked brick voussoirs laid in a segmental arch, with some openings enclosed and others with original glazing and metal mullions (see Image 47). There is a one-storey brick addition on the north elevation, with an enclosed square window opening and stacked brick voussoirs laid in a segmental arch (see Image 48). A one-storey cinder block addition connects to the north side of the one-story brick addition (see Image 49).

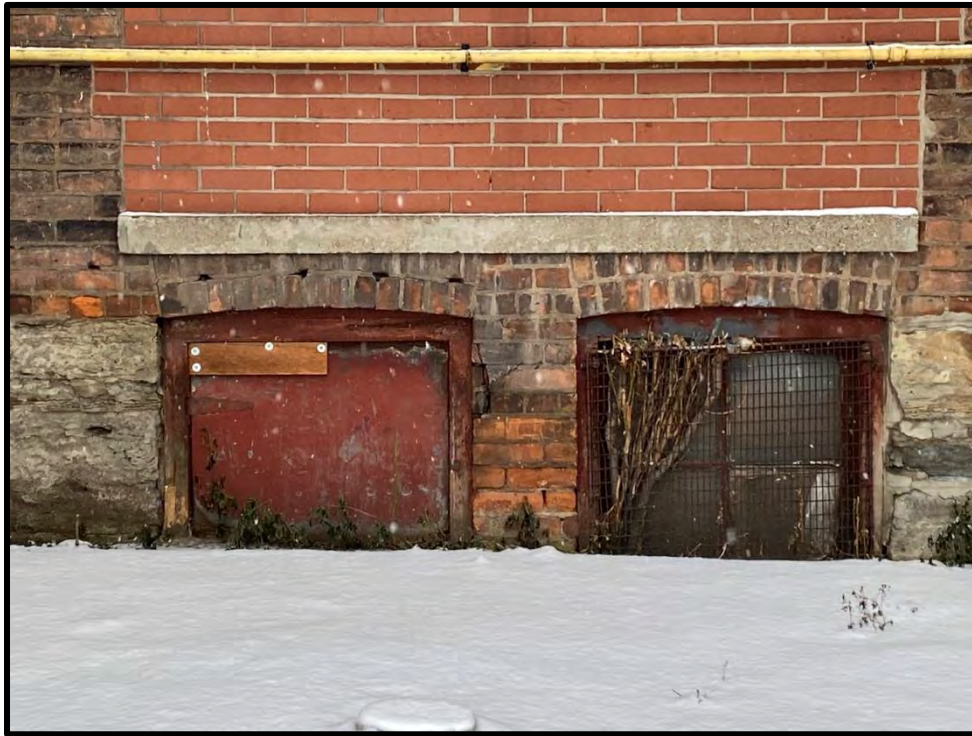
**Image 47: Detail of Basement Window Openings on West Elevation**  
(Photo taken on December 8, 2021; Facing East)

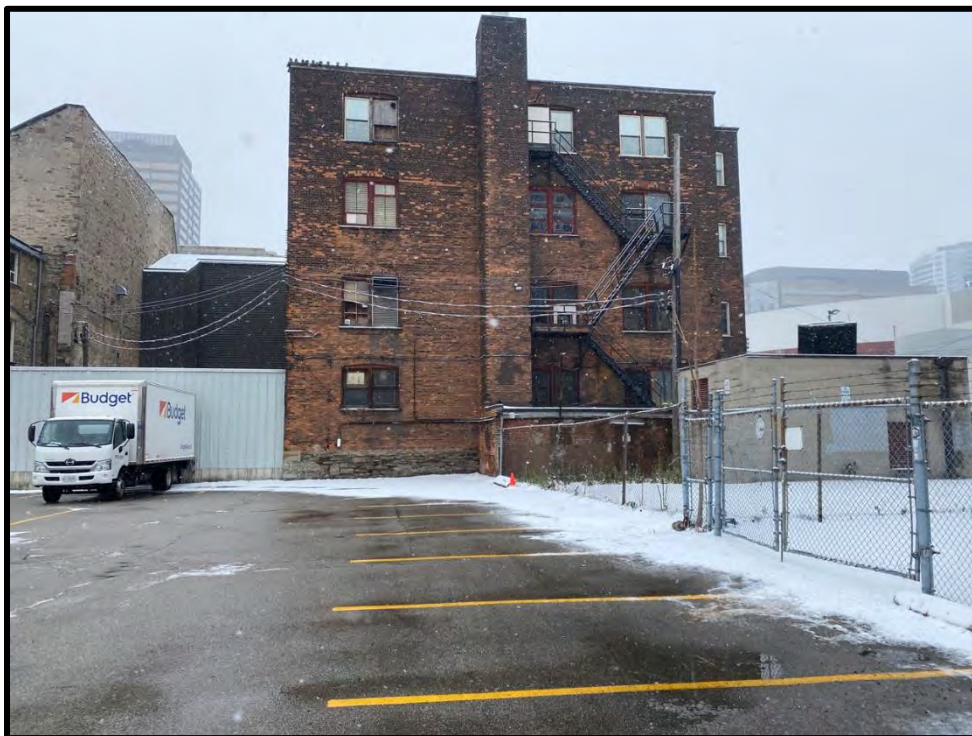
**Image 50: North Elevation**  
(Photo taken on December 8, 2021; Facing South)

The north elevation is the rear of the building (see Image 50). An exterior brick chimney is located at the centre of this elevation and extends from the one-storey brick addition on the north elevation (see Image 50). The window openings on this elevation are similar to those previously described with stack brick voussoirs laid in a segmental arch with brick sills (see Image 51). The stone foundation visible on this elevation is uncoursed (see Image 52).

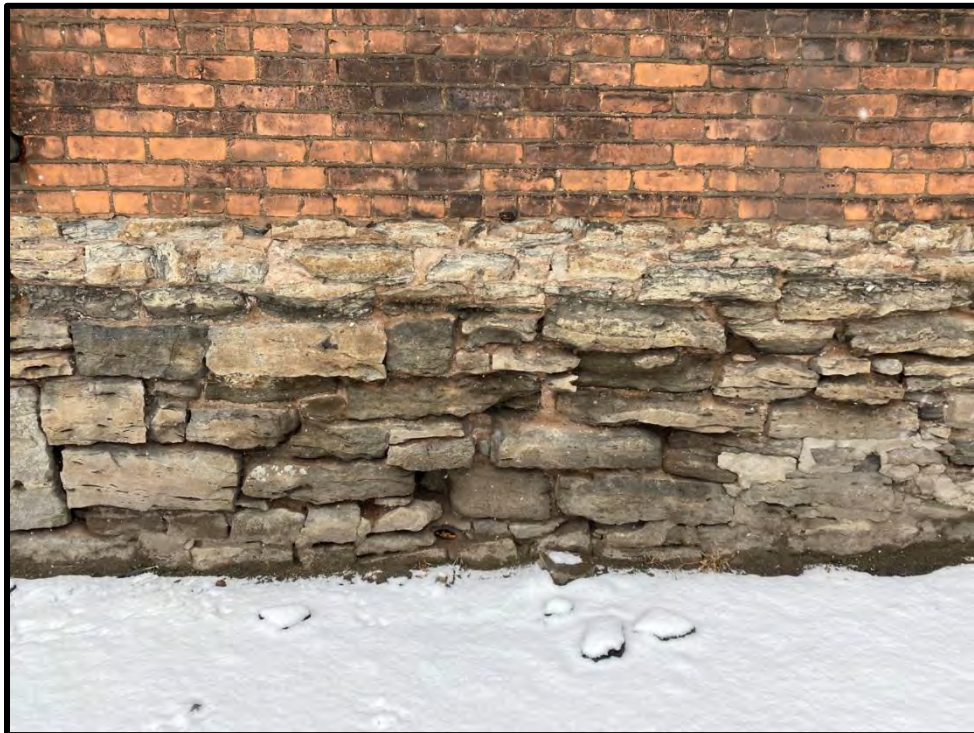
**Image 52: Common Bond Brick Coursing and Uncoursed Stone Foundation – Detail**  
(Photo taken on December 8, 2021; Facing South)

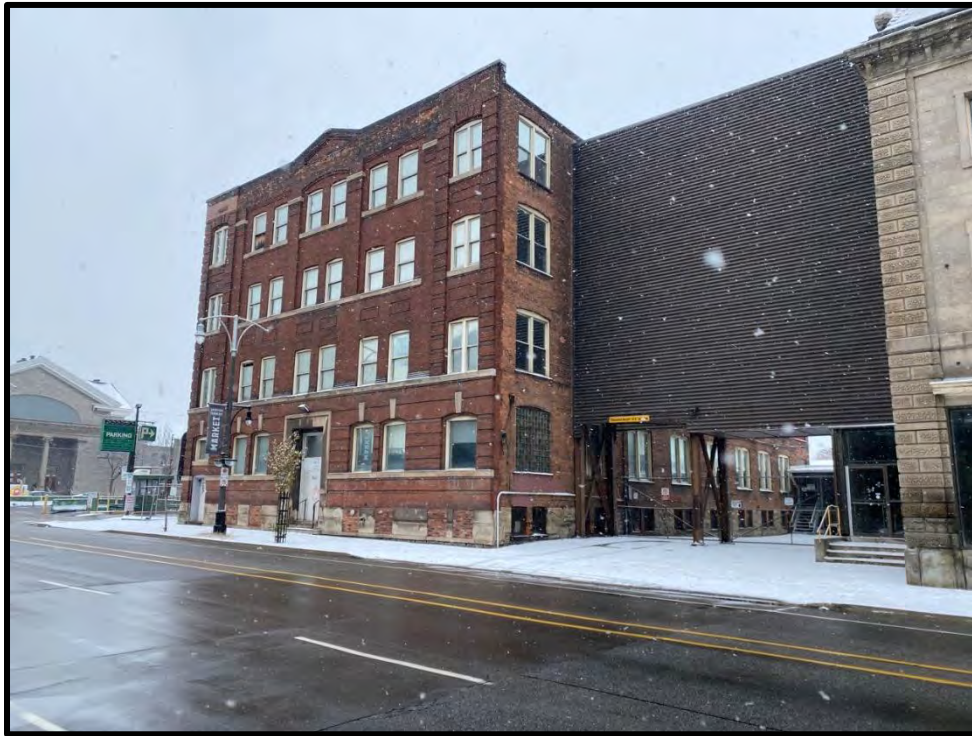
**Image 53: South and East Elevations**  
(Photo taken on December 8, 2021; Facing Northwest)

The east elevation is partially obscured from York Boulevard due to the elevated walkway (see Image 53). Openings along this elevation match the dimensions and finishes to those seen on the north and east elevation with stacked brick voussoirs laid in a segmental arch and brick sills (see Image 54). The first storey window opening at the south end of the east elevation is glazed with insulated glass block and the second and third storey openings just north of the southernmost window openings have been covered with the overhead walkway extending west from the stone building (see Image 54).

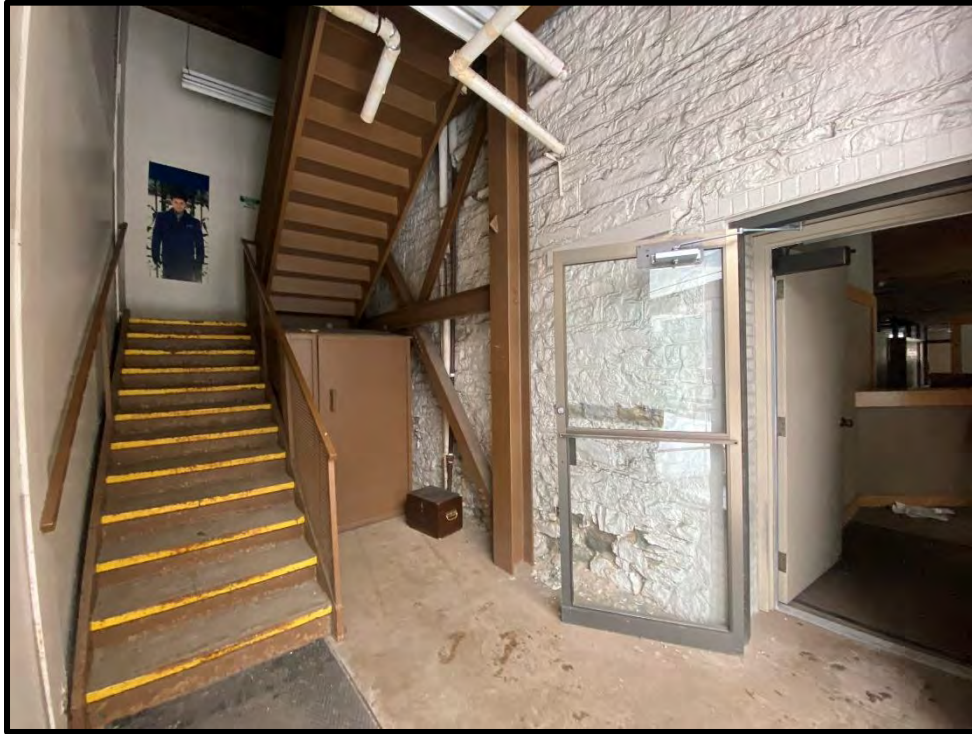
**Image 55: First Floor – Stairwell Addition and West Elevation Entrance**  
(Photo taken on December 8, 2021; Facing East)

The interior of the structure has been modified through its history to best suit the needs of the businesses within. The interior was accessed through the door opening at the west elevation (see Image 55–Image 56). The first floor has been heavily modified for use a commercial retail space and offices (see Image 56, Image 63, Image 71 and Image 72). Painted cast iron pillar with fluted shafts are spaced throughout the first floor of the original 1856 structure and feature an eight-sided plinth and capital. and the retail and office spaces have been finished with a more contemporary wooden dropped ceiling (see Image 57, Image 59–Image 60, Image 62, Image 69, Image 70 and Image 78–Image 80). At the north extent of the 1856 building along MacNab Street is a decorative chair rail that dates to an earlier period of use for the buildings and remains somewhat intact (see Image 64). The window openings on the first floor have wood sills (see Image 62–Image 63). The north building, constructed in 1881 is less decorative than the remainder of the first floor and has been modified since its previous use as an imported fruit warehouse (see Image 76–Image 80 and Image 84–Image 88). A vault is located on the first floor of the 1881 building (see Image 80–Image 83). A narrow corridor provides access to stairs to the second floor and is the location of a window opening and wainscoting (see Image 89 and Image 91–Image 92). A metal heat register indicates the method of heating the building through much of its history (see Image 90).

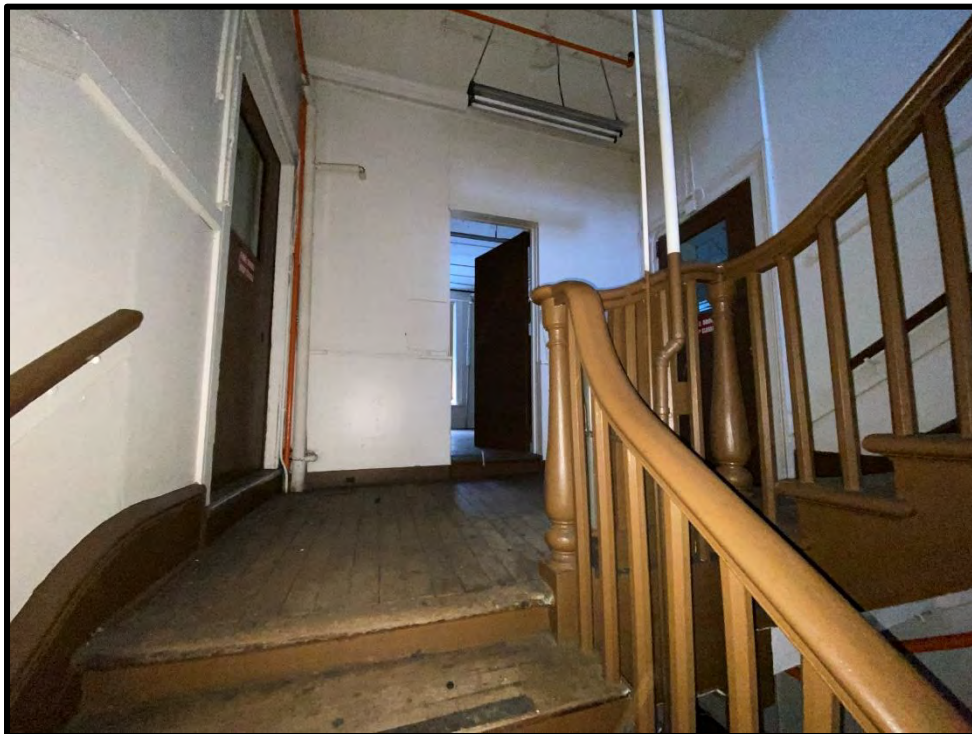
**Image 97: North Addition – Basement Entrance Alarm**  
(Photo taken on December 8, 2021)

Stair access to the basement is located at the east part of the building, with the stairwell clad in wood panelling and plaster (see Image 97 and Image 143). Cylindrical fluted pillars support the first floor and the basement flooring is almost exclusively hardwood (see Image 145). Various rooms have been created for storage within the basement as well as a boiler area (see Image 144–Image 153). A vault is located in a room in the basement which, upon closer inspection, has remnants of graffiti by way of names of previous employees such as "TOM MAR [??] /57; JAN 18 /57" (see Image 156).

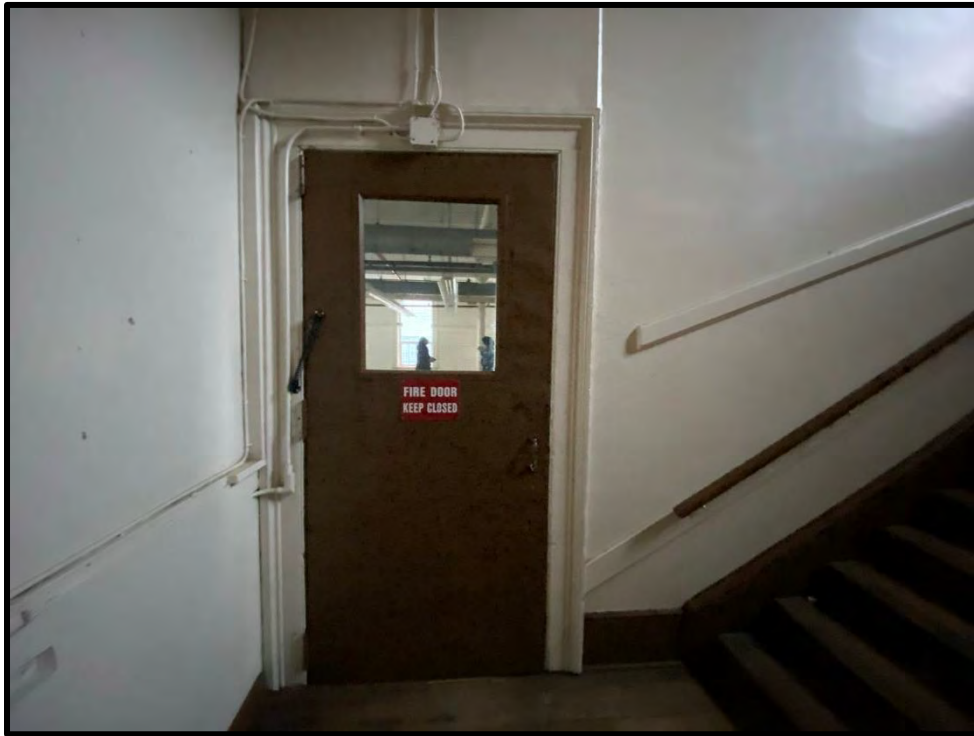
**Image 100: Second Floor Stone Building – Interior**  
(Photo taken on December 8, 2021)

(see Image 98 and Image 100–Image 101). Cast-iron pillars support the third storey and are decoratively the same as the iron pillars found on the first floor (see Image 102, Image 106, Image 108, Image 110–Image 112 and Image 114). The doorways allow for fluid movement around the second floor and a door opening covered by a retractable metal fire door leads to the second-floor walkway allowing travel from the stone building to the brick building (see Image 109). Walls on the second floor are clad in wood paneling, dry wall and plaster (see Image 109, Image 111, Image 113, Image 117 and Image 120). A vault is located on the second floor and evidence of modifications to the building's interior can be seen on the second floor with the presence of a stairwell behind a door opening (see Image 121–Image 122). Flooring materials on the second floor consisted of hardwood and vinyl tiles.

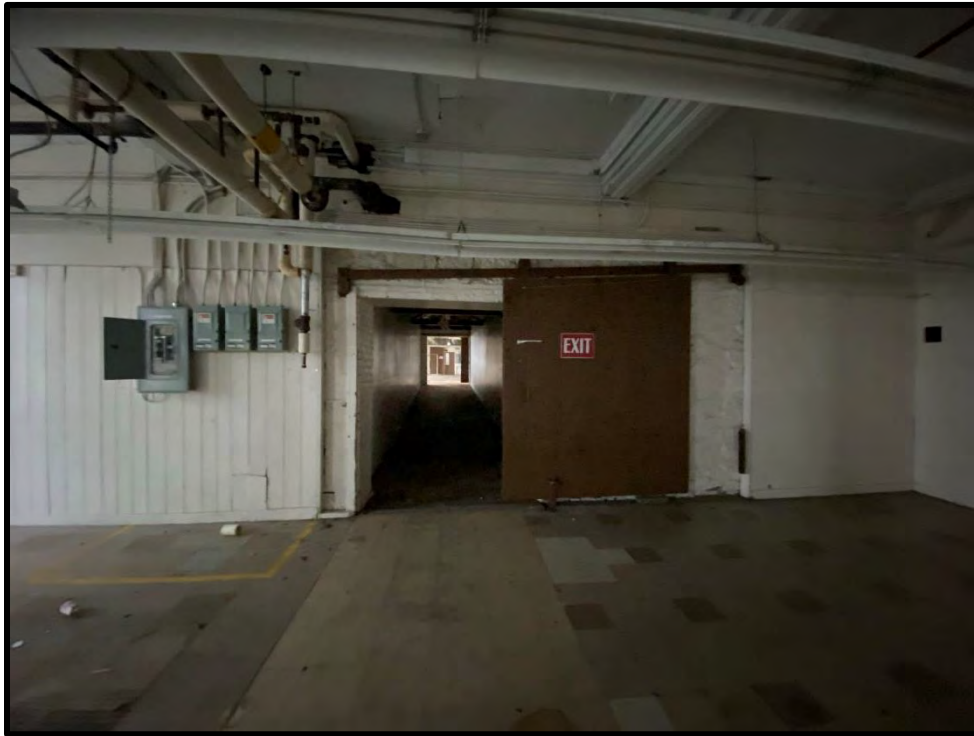
**Image 108: Second Floor Stone Building – Interior Showing Plank and Beam Construction**  
(Photo taken on December 8, 2021; Facing Northeast)

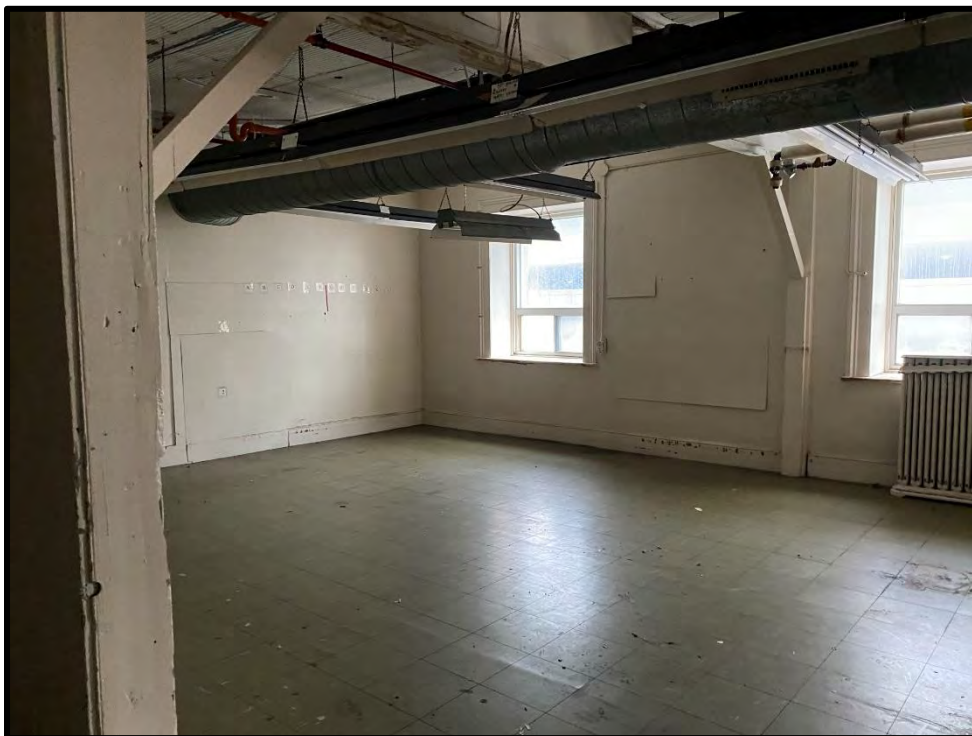
**Image 123: Second Floor North Addition Vault – Detail**  
(Photo taken on December 8, 2021; Facing Northwest)

The third floor is very similar to the second floor, although the vault on the third floor is not as elaborate (see Image 123). The support pillars on the third floor are relatively plain and mostly undecorated (see Image 124–Image 130 and Image 132). The stairwell hidden behind the door opening on the third floor leads to the fourth floor (see Image 133).

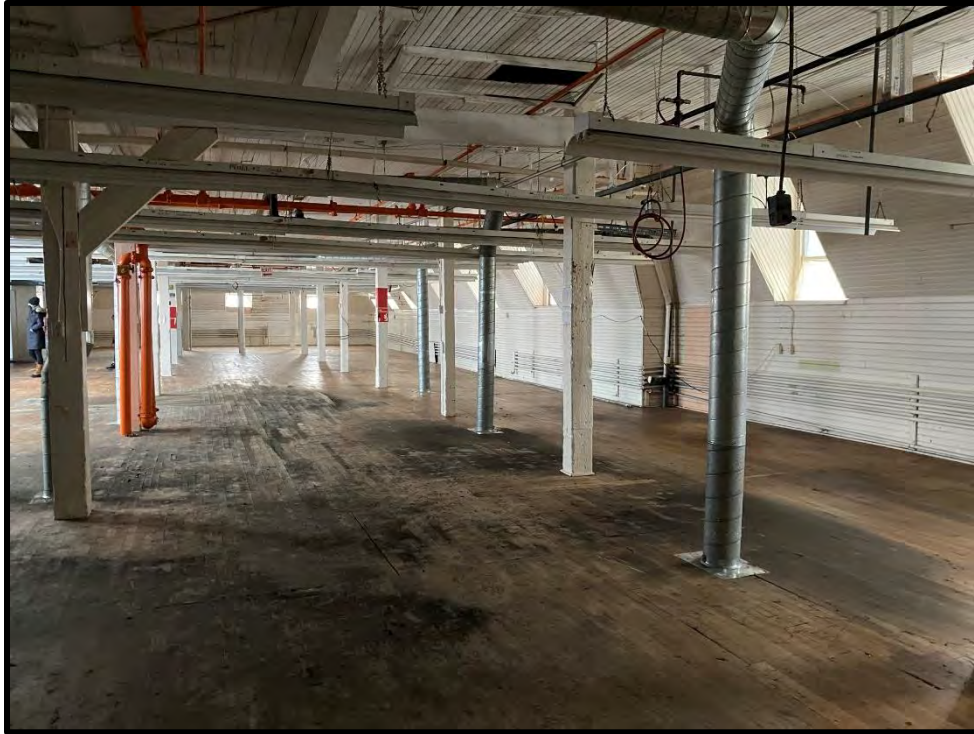
**Image 136: Fourth Floor Stone Building – Interior**  
(Photo taken on December 8, 2021; Facing West)

The fourth floor was accessed from the east side of the building and is supported by squared wooden posts and cast-iron pillars (see Image 135–Image 137). An opening to the north of the 1856 building leads to the half-storey central section of the west part of the building. The wall separating the central section from the south section of the building was constructed with red brick, while the west and north walls of the central section were built with stone. This section slants down from west to east and appears have functioned as a storage area. The dormer walls and ceiling are clad in painted beadboard (see Image 138–Image 139). A doorway at the south part of the west side of the building leads to an external staircase that was added to the property sometime in the 20<sup>th</sup> century (see Image 140). There is also a large opening to the walkway on the fourth floor that leads between the stone and brick buildings (see Image 141–Image 142).

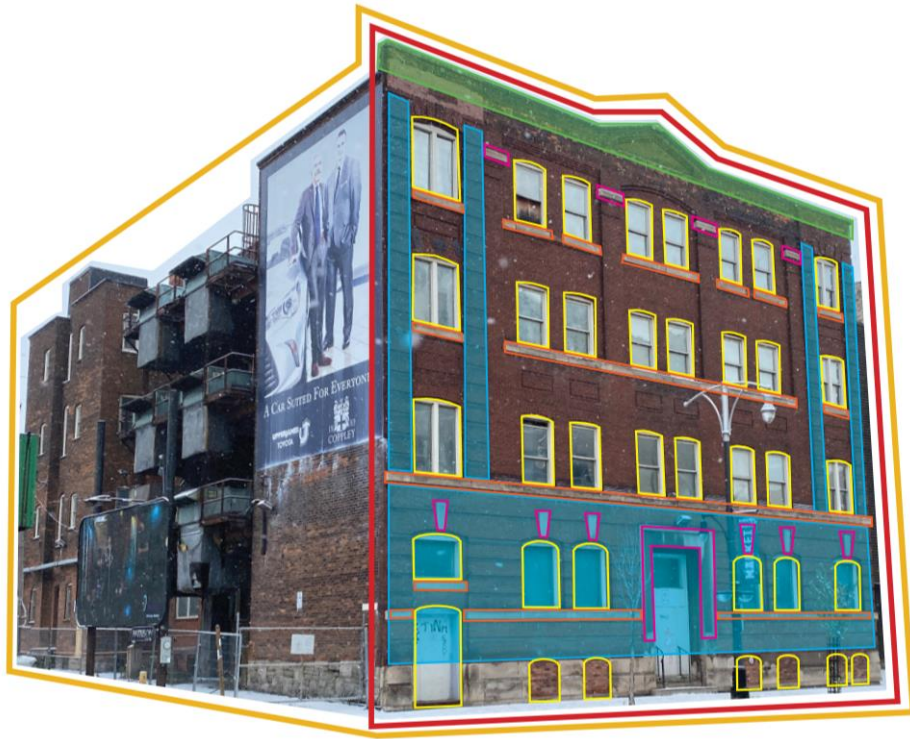
## Heritage Attributes Brick Building

- Balanced façade
- Brick masonry construction
- Brick banding or channelling on facade
- Parapet wall
- Stone trim and accents around openings
- Oversized stone architectural elements
- Segmentally arched fenestration on façade

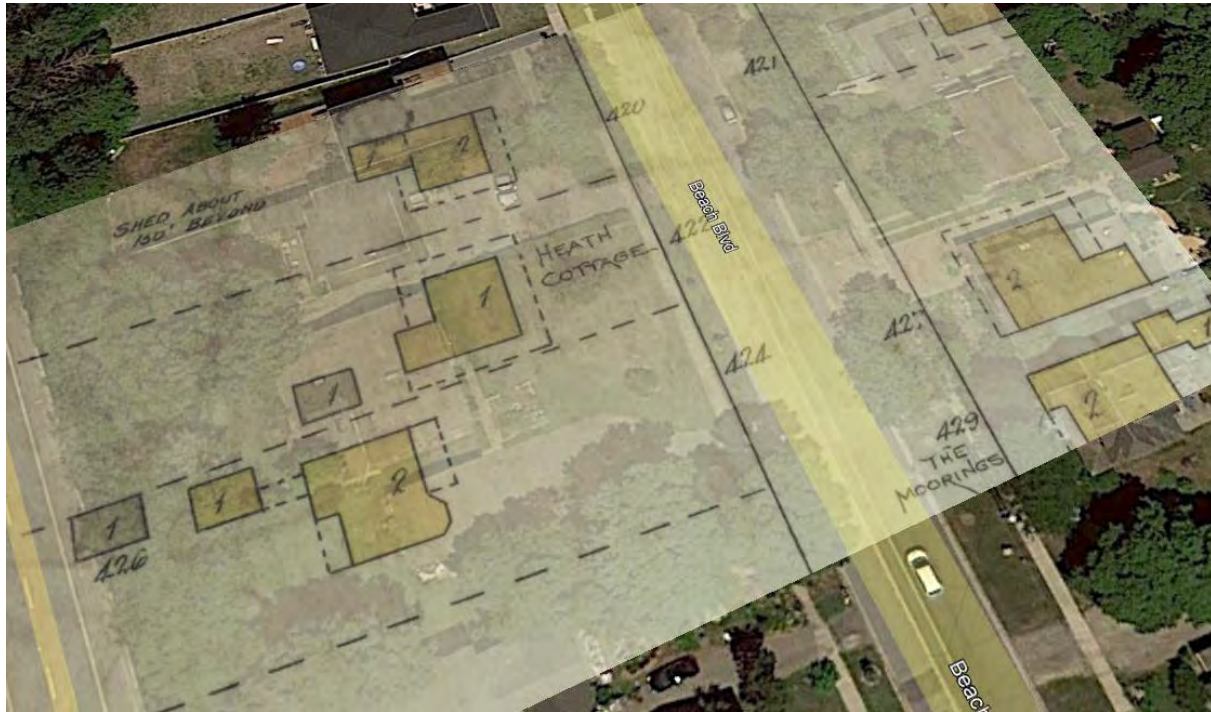
Figure 9: Overlay of 1900 Fire Insurance Plan over modern air photo.

Registered Plan 318, dated 19 March 1878, indicates that the Property is among a large parcel owned by John Brown. Prior to this, historic mapping shows little development in the vicinity of the Property, although several residences had been constructed along Beach Boulevard prior to 1875 (Figure 5). It is unclear when the Property was first subdivided and developed; however, the 1900 Fire Insurance Plan for Burlington Beach shows the Property as two separate parcels; lots 422 and 424.

In 1900, "Heath Cottage" a one-storey frame residence with a wrap-around porch and one storey outbuilding or shed is shown on the northern half of the Property, while a two-storey wood frame structure with two outbuildings is shown on the south half of the Property in the approximate location of the extant garage (Figure 9). Heath Cottage, appears to be the structure shown as late as 1934 on aerial imagery. The two-storey residence on the south half of the Property is not visible on the 1934 air photo (Figure 10).

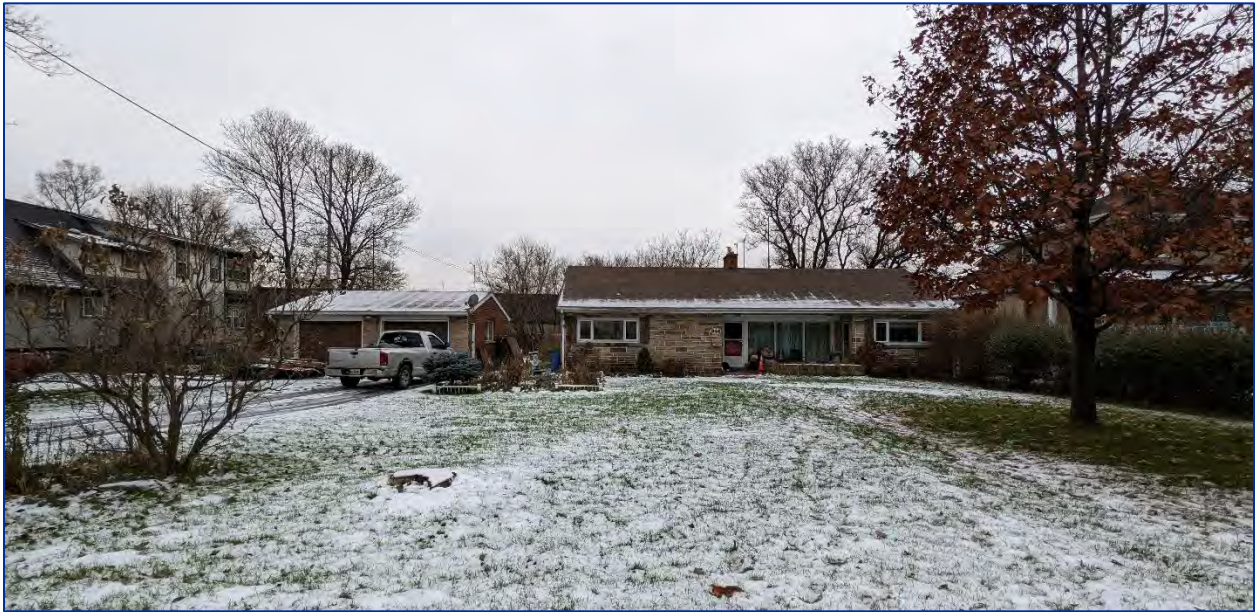
Figure 11: View of the east elevation of the residence

The property municipally known as 940-946 Beach Boulevard is comprised of a mid-century vernacular bungalow on a concrete foundation with a small gabled, rectangular rear addition on a cinder block foundation (Figure 11 and Figure 14) and a one-storey, rectangular detached garage with a concrete foundation (Figure 21). The property is accessed from Beach Boulevard by the circular driveway in front of the detached garage at the southern end of the property (Figure 25). The interior of the structure is modern in design; however, the design of the fireplace, the floor in front of it, the flooring in the front foyer, and the shower are uncharacteristic of modern design (Figure 17 and Figure 18).

The residence is constructed of red brick laid in running bond with cut stone cladding on the east elevation and a medium-pitch side gable roof with vinyl cladding beneath each gable, a central red brick chimney, and overhanging eaves (Figure 11 and Figure 12). The building can be accessed through a main, central contemporary door with an exterior glass and metal door located in the inset covered porch on the east elevation (Figure 11), a contemporary door with an exterior glass and metal door at the northern end of the inset covered porch on the east elevation (Figure 19), a central contemporary door with a large window and a wooden screen door on the west elevation (Figure 14), and a contemporary door adjoined to three windows with an exterior glass and metal door on the southern elevation of the rear addition. The rear addition's door windows are boarded up from the outside (Figure 13 and Figure 20). Windows are found on all elevations.

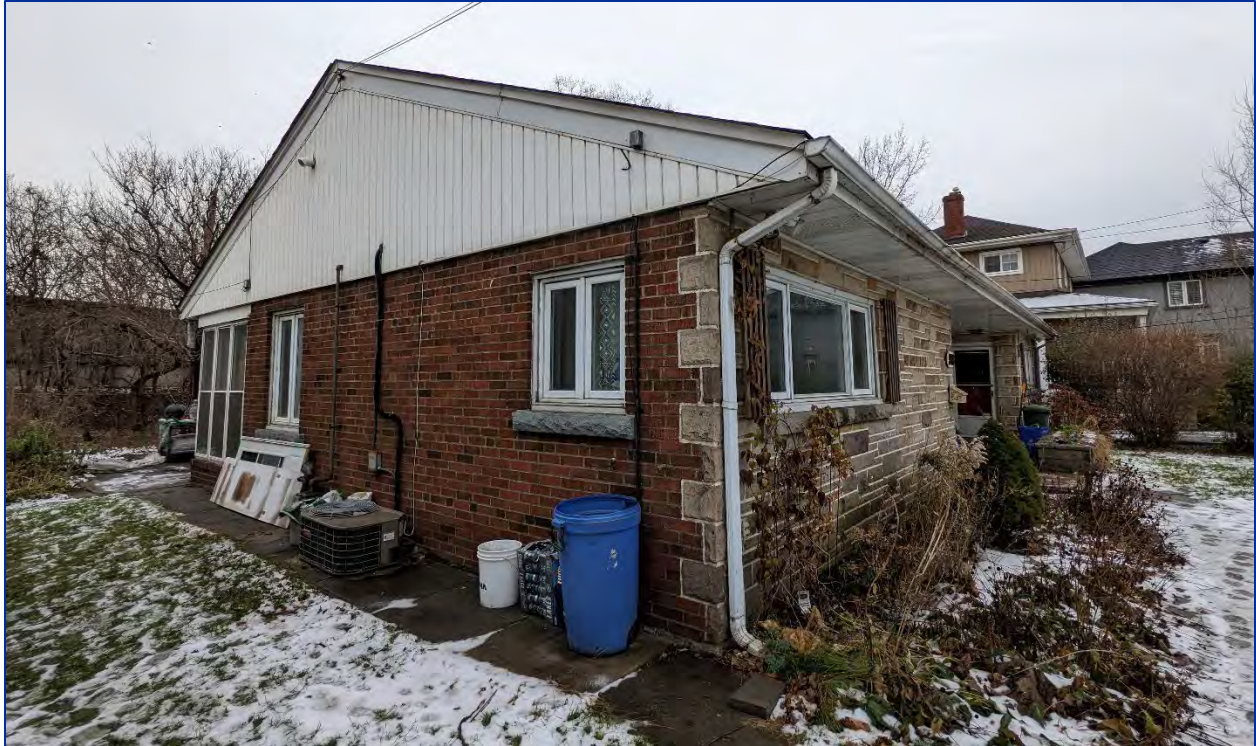
Figure 12: View of the south elevation of the residence

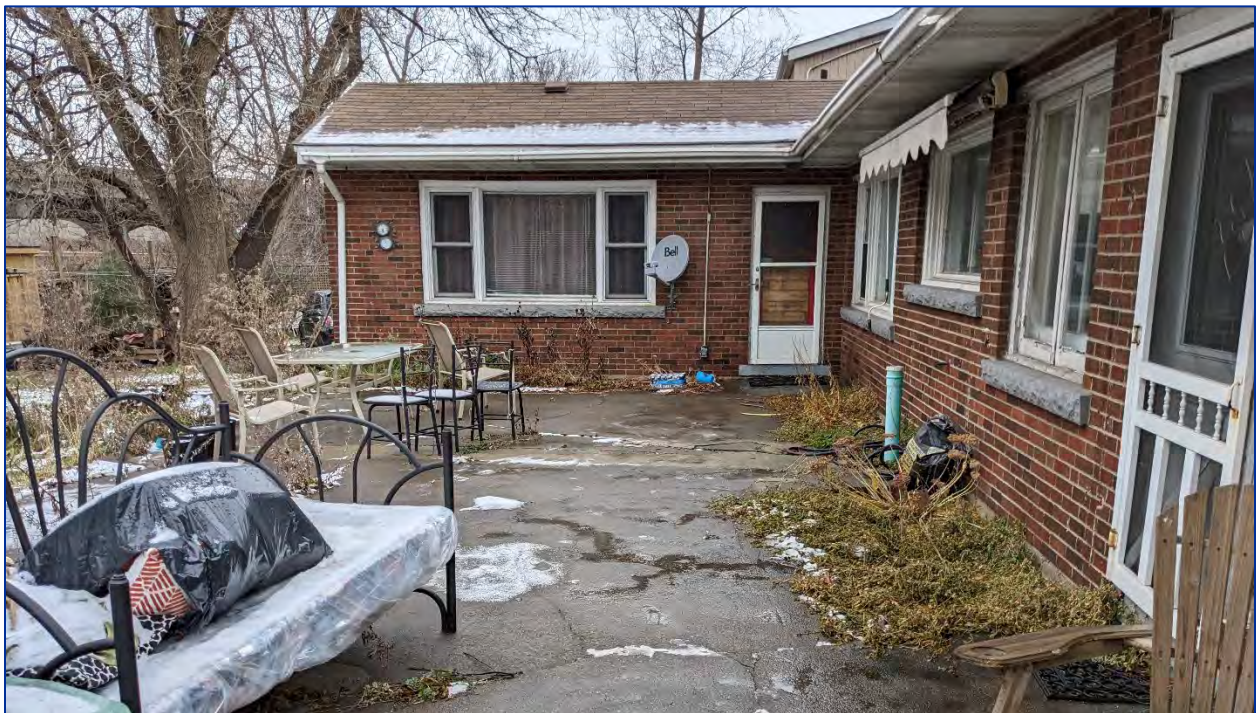
Figure 13: View of the south elevation of the rear addition

single hung sash windows and a stone lug sill on the south elevation (Figure 13), a long rectangular window divided into three sections with a central picture window flanked by two single hung sash windows and a stone lug sill on the west elevation (Figure 14), and a small, thin rectangular fixed window with a stone lug sill on the north elevation (Figure 15).

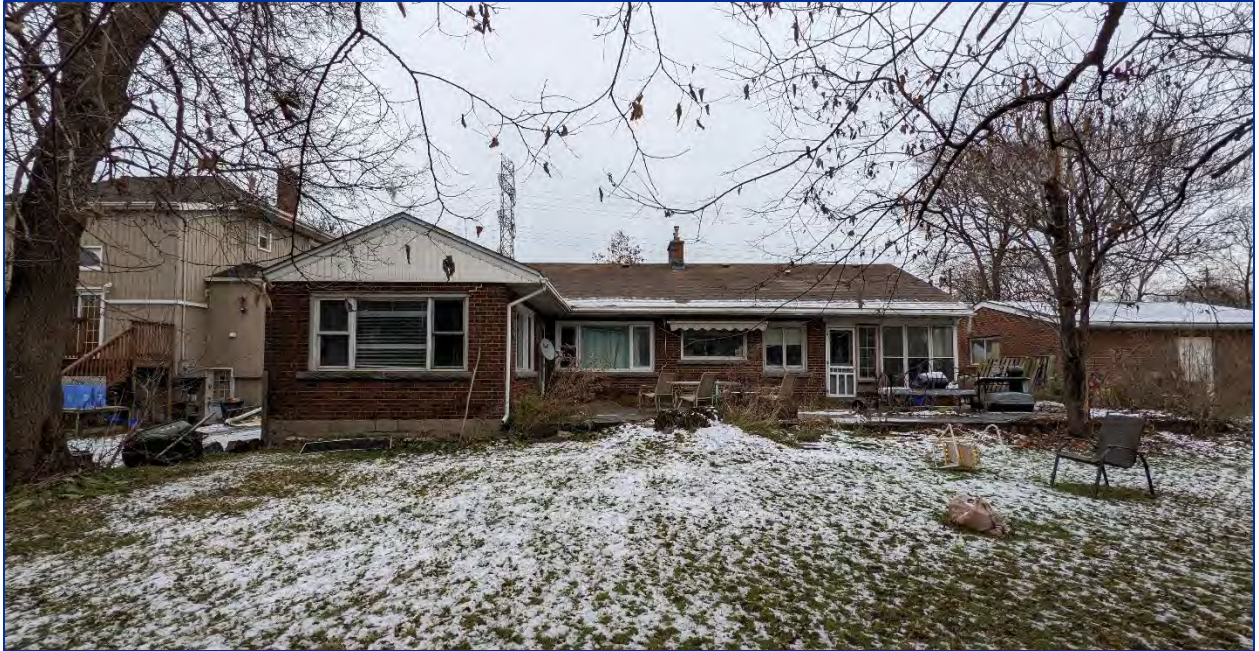
Figure 14: View of the west elevation of the residence and its rear addition

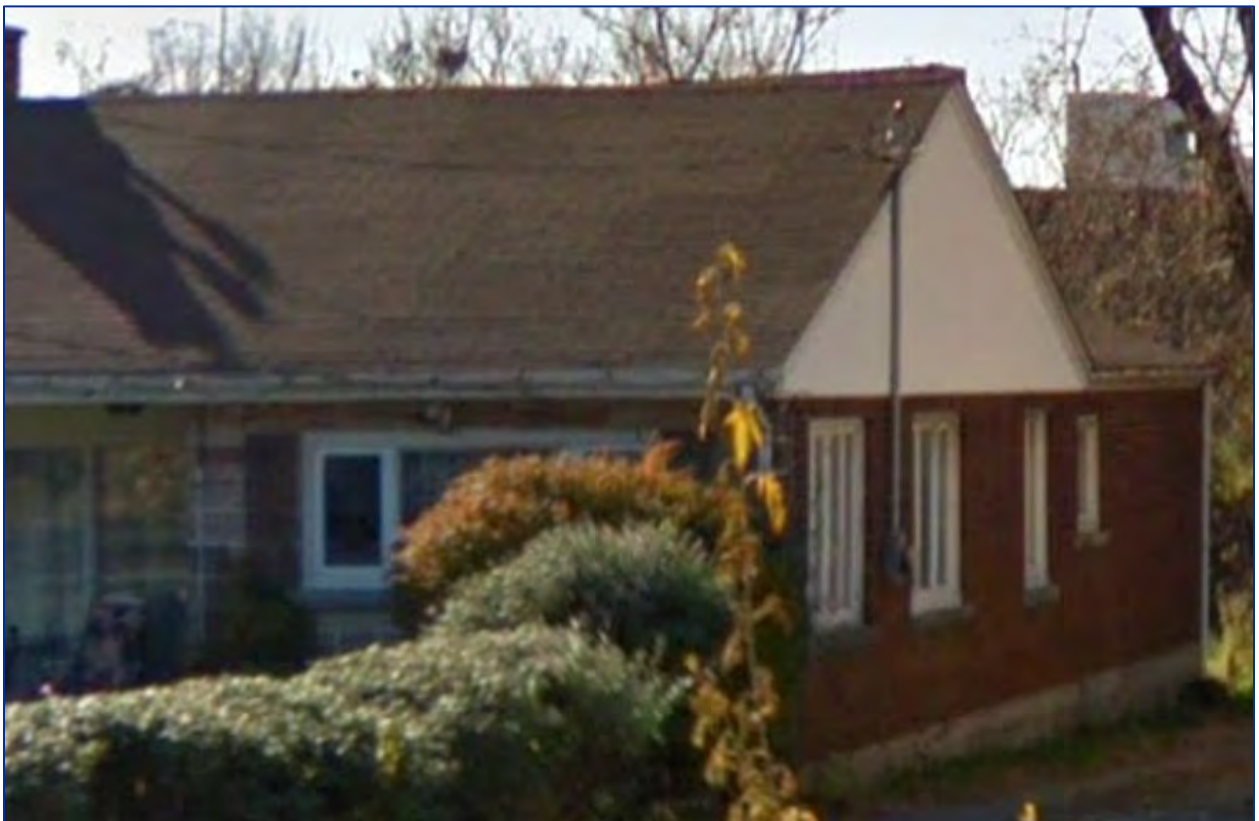
Figure 15: View of the north elevation of the residence and its rear addition; Source: Google Streetview November 2016

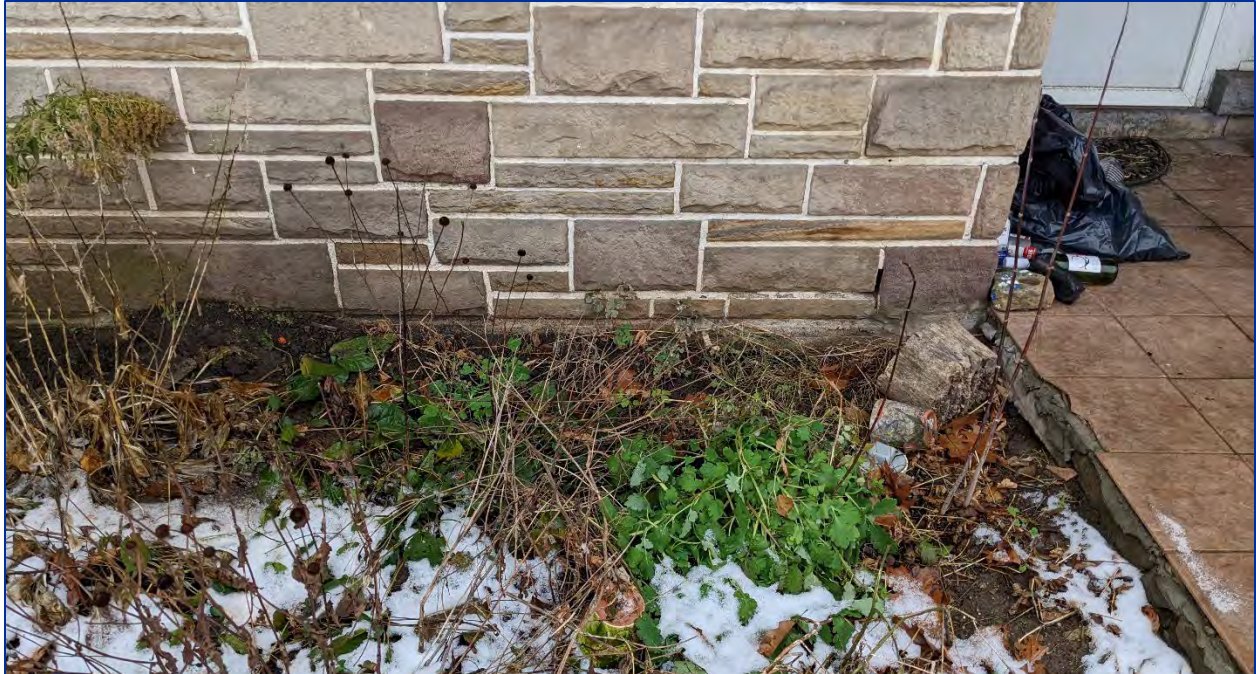
Figure 16: View of the residence's concrete foundation

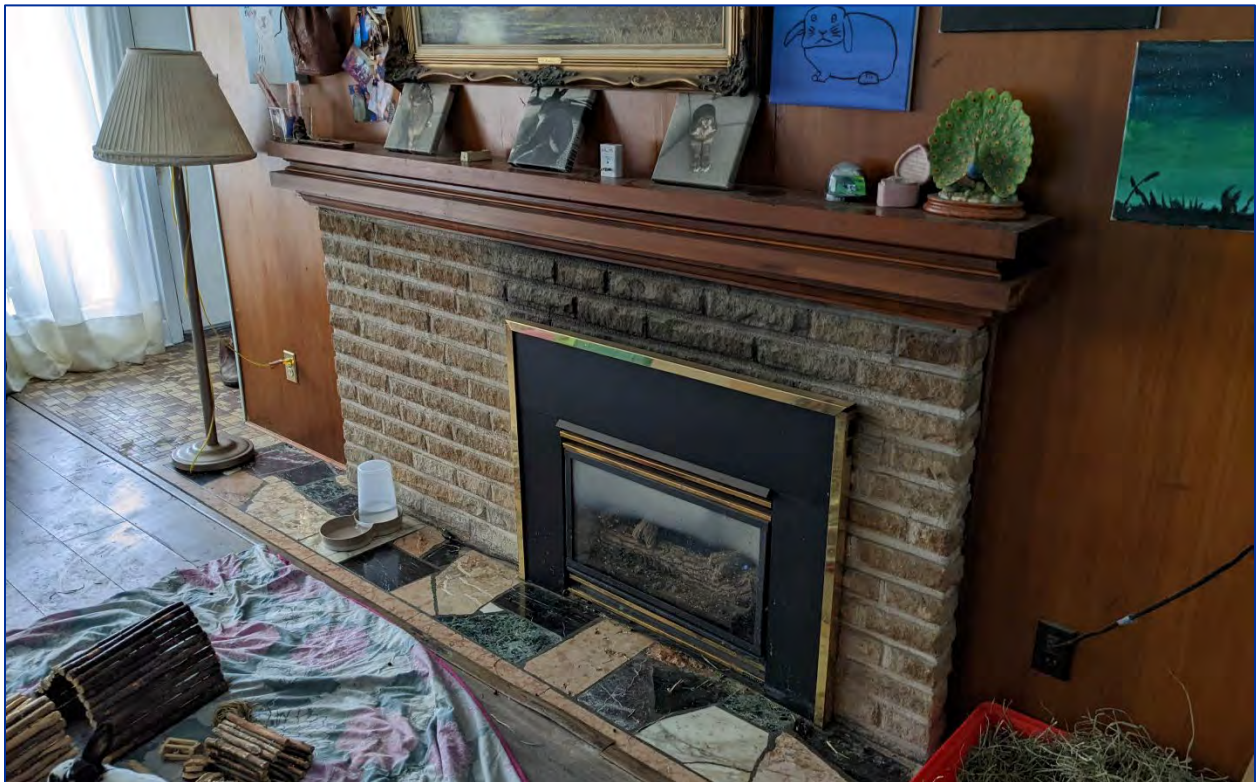
Figure 17: View of the fireplace and the front foyer floor
