# HAMILTON MUNICIPAL HERITAGE COMMITTEE REVISÉ

**Meeting #:** 22-005

**Date:** May 13, 2022

**Cultural Heritage Assessment  
56 York Boulevard  
City of Hamilton, ON  
Part of Lot 15, Concession 2  
Geographic Township of Barton  
Former Wentworth County**

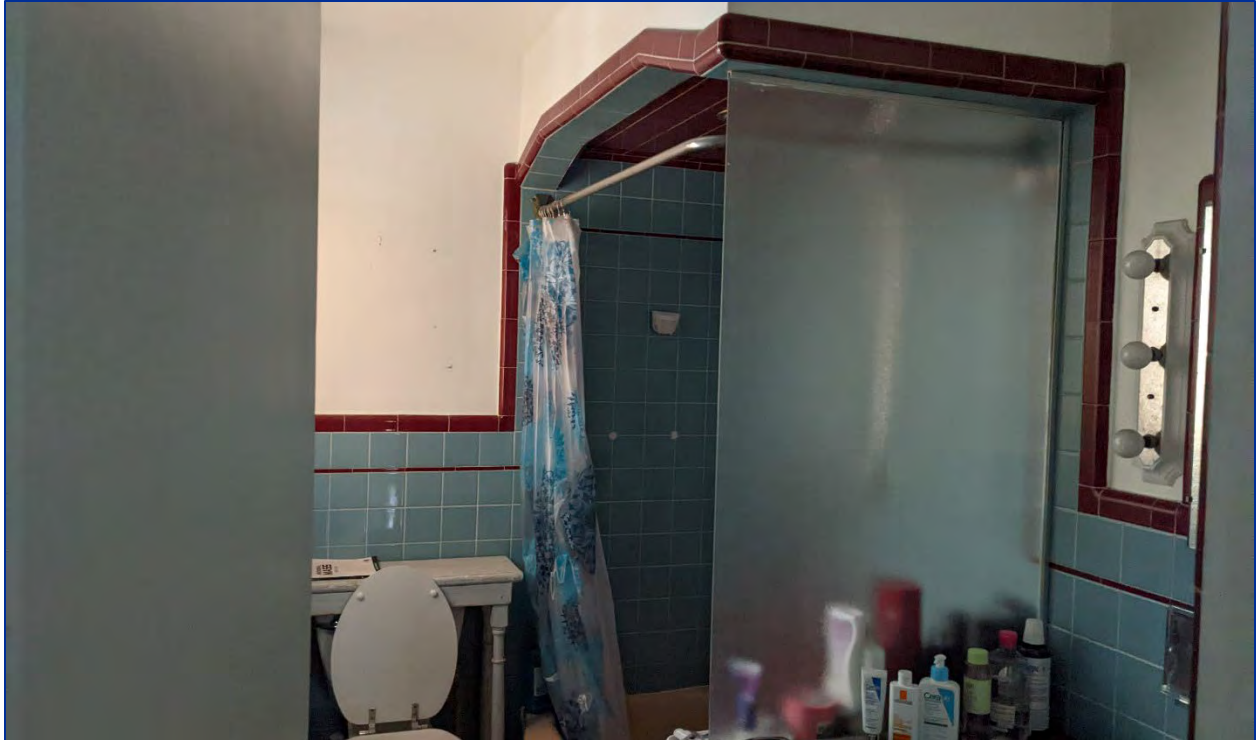
Figure 18: View of the shower

The property municipally known as 940-946 Beach Boulevard is comprised of a mid-century vernacular bungalow on a concrete foundation with a small gabled, rectangular rear addition on a cinder block foundation (Figure 11 and Figure 14) and a one-storey, rectangular detached garage with a concrete foundation (Figure 21). The property is accessed from Beach Boulevard by the circular driveway in front of the detached garage at the southern end of the property (Figure 25). The interior of the structure is modern in design; however, the design of the fireplace, the floor in front of it, the flooring in the front foyer, and the shower are uncharacteristic of modern design (Figure 17 and Figure 18).

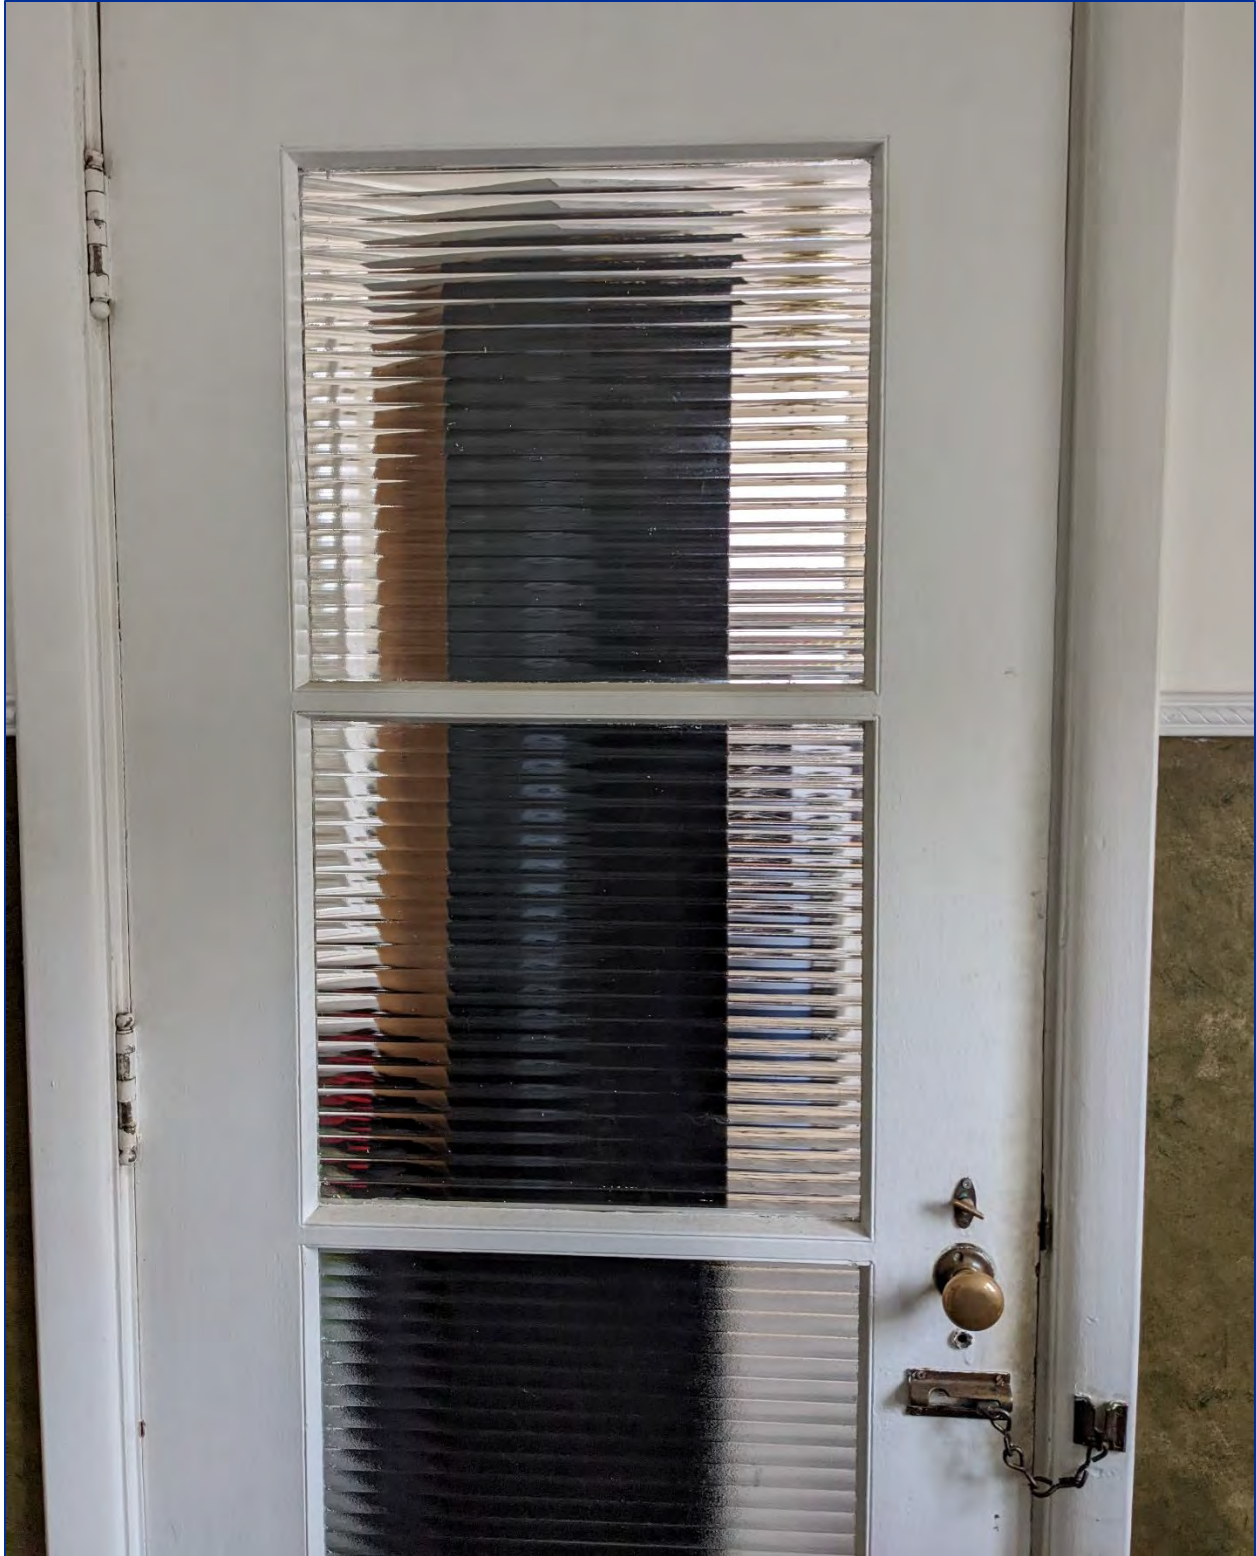
Figure 20: View of the interior of the boarded-up door

The residence is constructed of red brick laid in running bond with cut stone cladding on the east elevation and a medium-pitch side gable roof with vinyl cladding beneath each gable, a central red brick chimney, and overhanging eaves (Figure 11 and Figure 12). The building can be accessed through a main, central contemporary door with an exterior glass and metal door located in the inset covered porch on the east elevation (Figure 11), a contemporary door with an exterior glass and metal door at the northern end of the inset covered porch on the east elevation (Figure 19), a central contemporary door with a large window and a wooden screen door on the west elevation (Figure 14), and a contemporary door adjoined to three windows with an exterior glass and metal door on the southern elevation of the rear addition. The rear addition's door windows are boarded up from the outside (Figure 13 and Figure 20). Windows are found on all elevations.

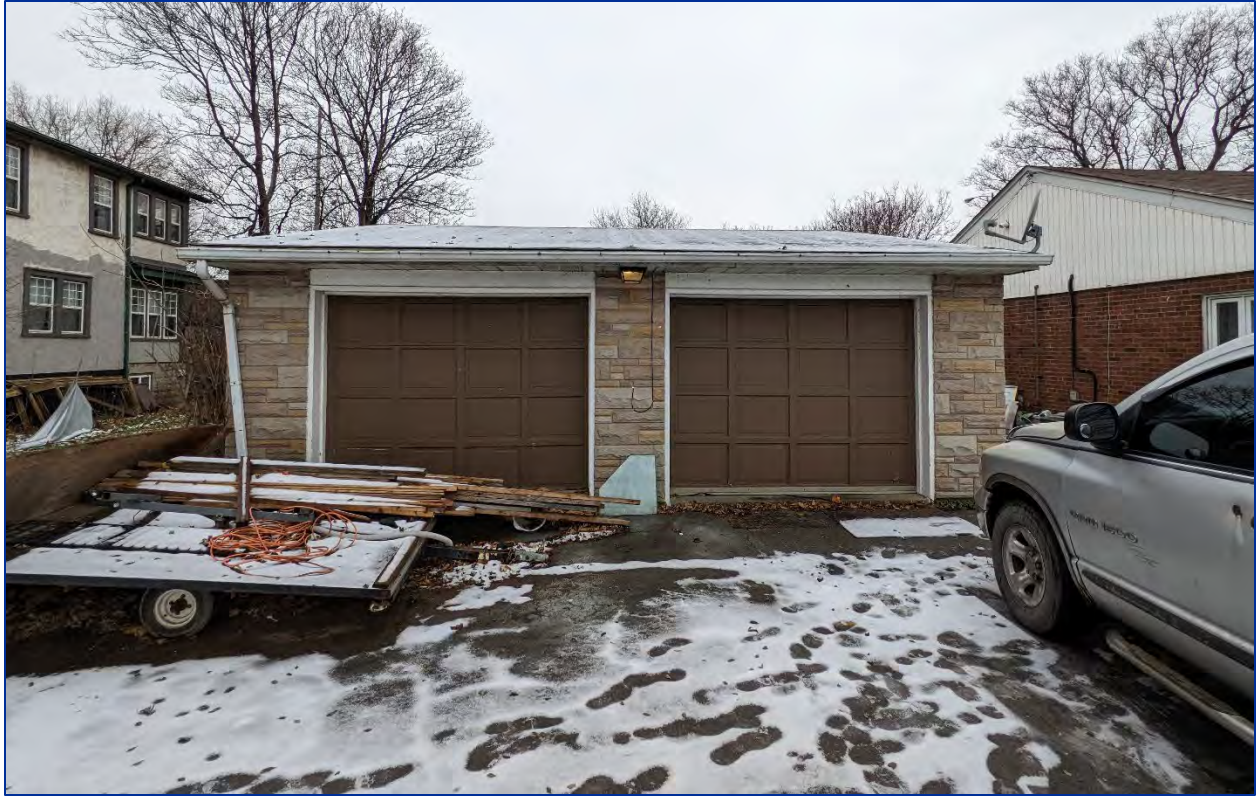
Figure 21: View of the east elevation of the detached garage

The detached garage is constructed of red brick laid in running bond with cut stone cladding on the east elevation and has a shallow pitch gable roof with overhanging eaves (Figure 21). The building can be accessed through the two garage doors on the east elevation, a contemporary door covered in plywood sheets on the west elevation, and a wood door with a window at the eastern end of the north elevation (Figure 21, Figure 23 and Figure 24). The north and south elevations each feature a central rectangular sliding window with stone lug sills (Figure 22 and Figure 24).

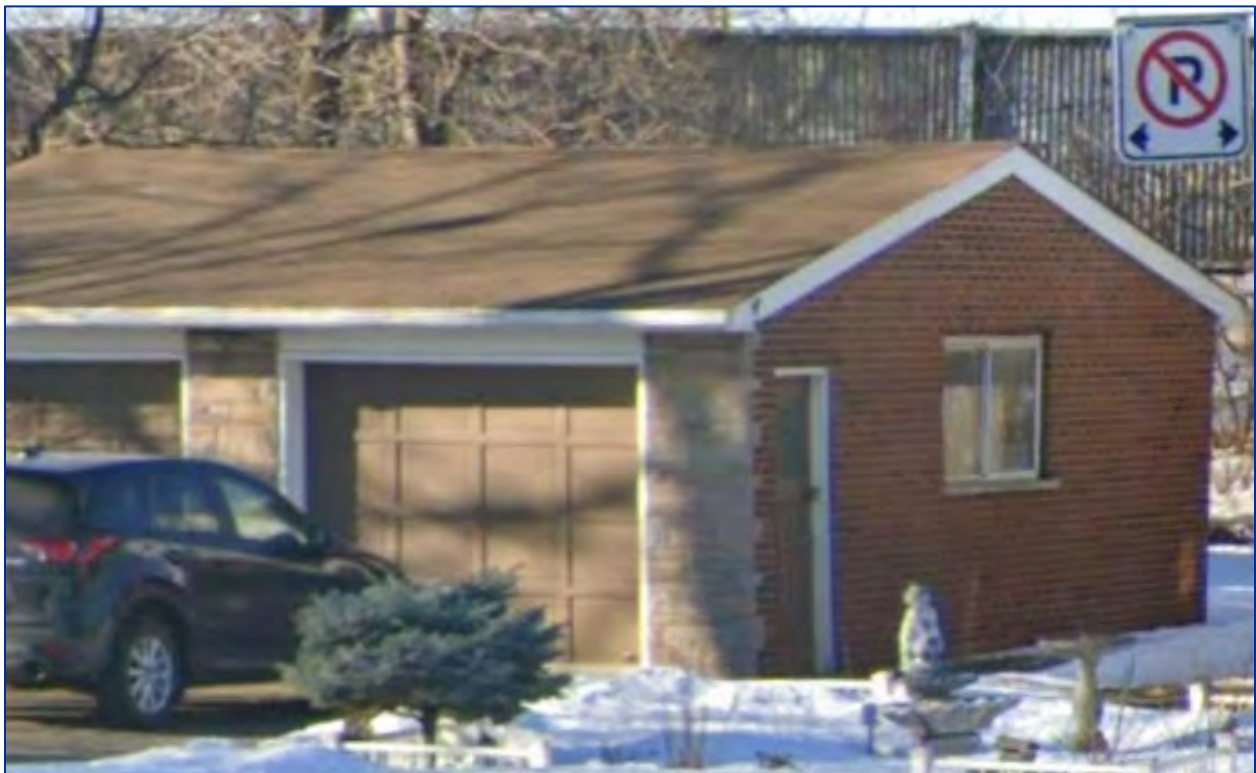
Figure 24: View of the north elevation of the detached garage; Source: Google Streetview February 2021

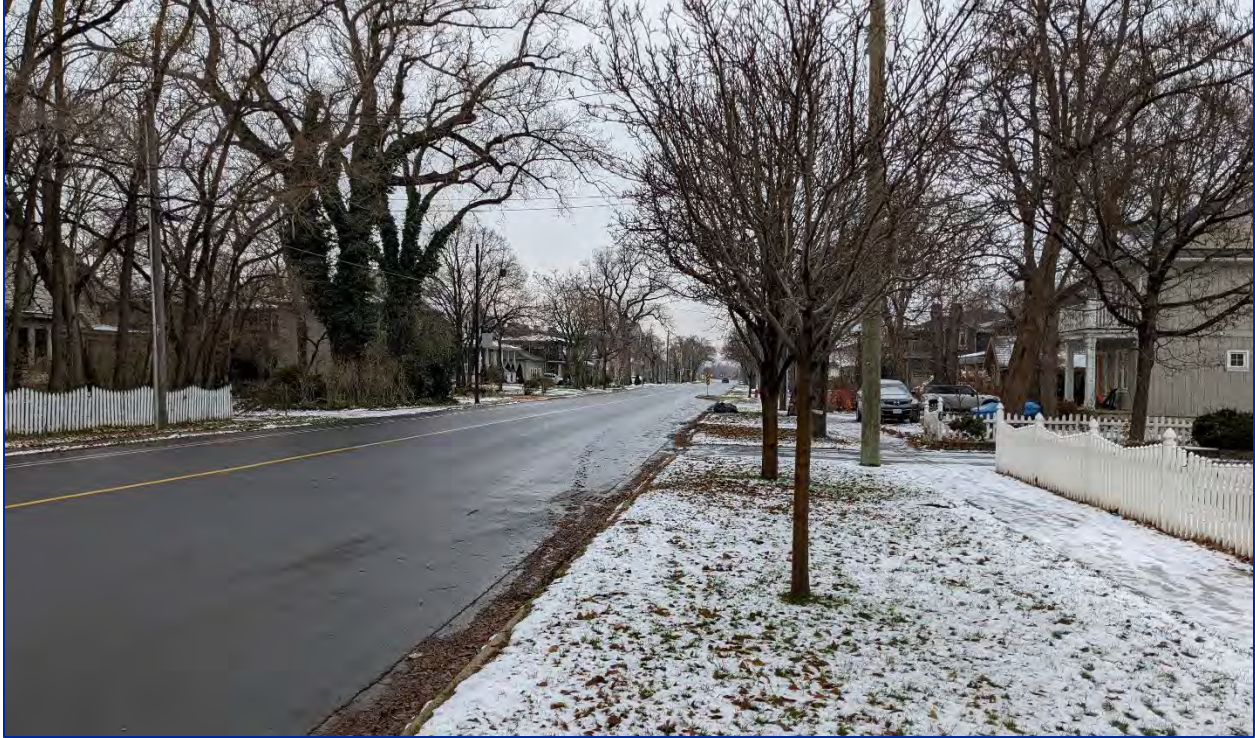
Figure 31: View north along Beach Boulevard from in front of 957 Beach Boulevard

The surrounding area is comprised of residential properties that are one to two storeys in height with shallow to moderate setbacks. Parcel lots are generally 13 m to 27 m wide and 44 m to 50 m deep. Building materials primarily consist of wood with some stone and brick, and some modern materials like vinyl siding (Figure 30 and Figure 31).

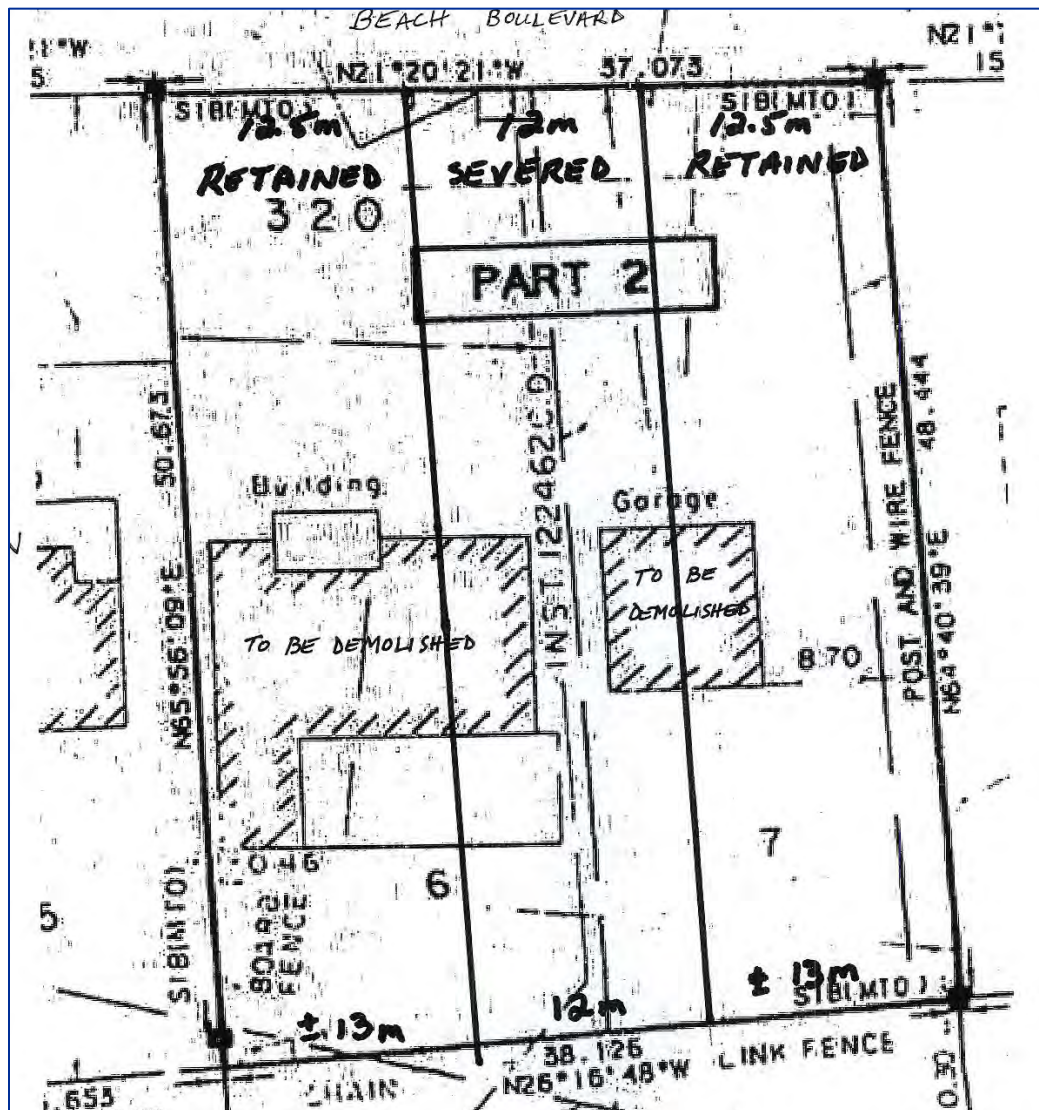
Figure 32: Detail of survey of the Property showing proposed severance

The current proposal seeks demolition of the extant structures with a view to constructing detached, single dwellings on the two retained parcel and the new severed parcel. Design of the new dwellings has not commenced.

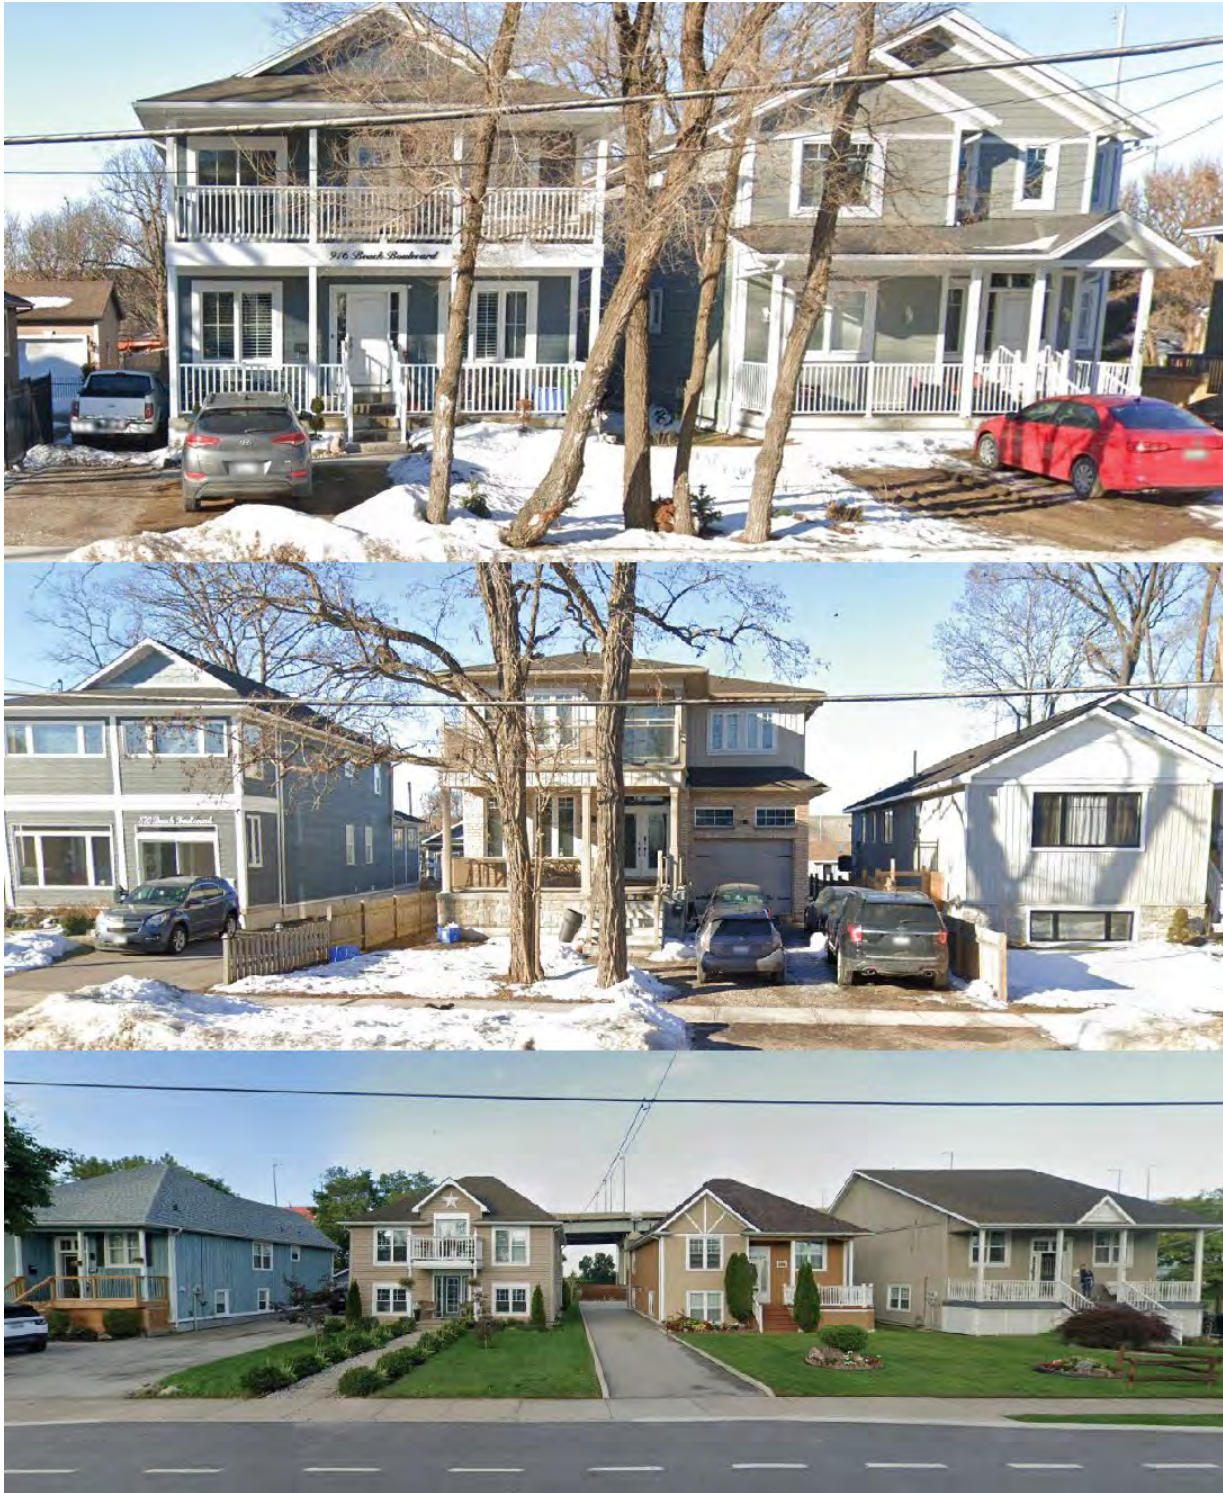
Figure 33: Examples of Compatible Infill along Beach Boulevard

The proposed demolition and severance are generally consistent with HCD guidelines. Design of new dwellings on the proposed lots must progress with HCD Plan guideline 5.3 in mind. The new single detached dwellings will be required to be compatible with the streetscape character. Design, massing, setback, and materials should take cues from the surrounding buildings, while avoiding replication (Figure 33).

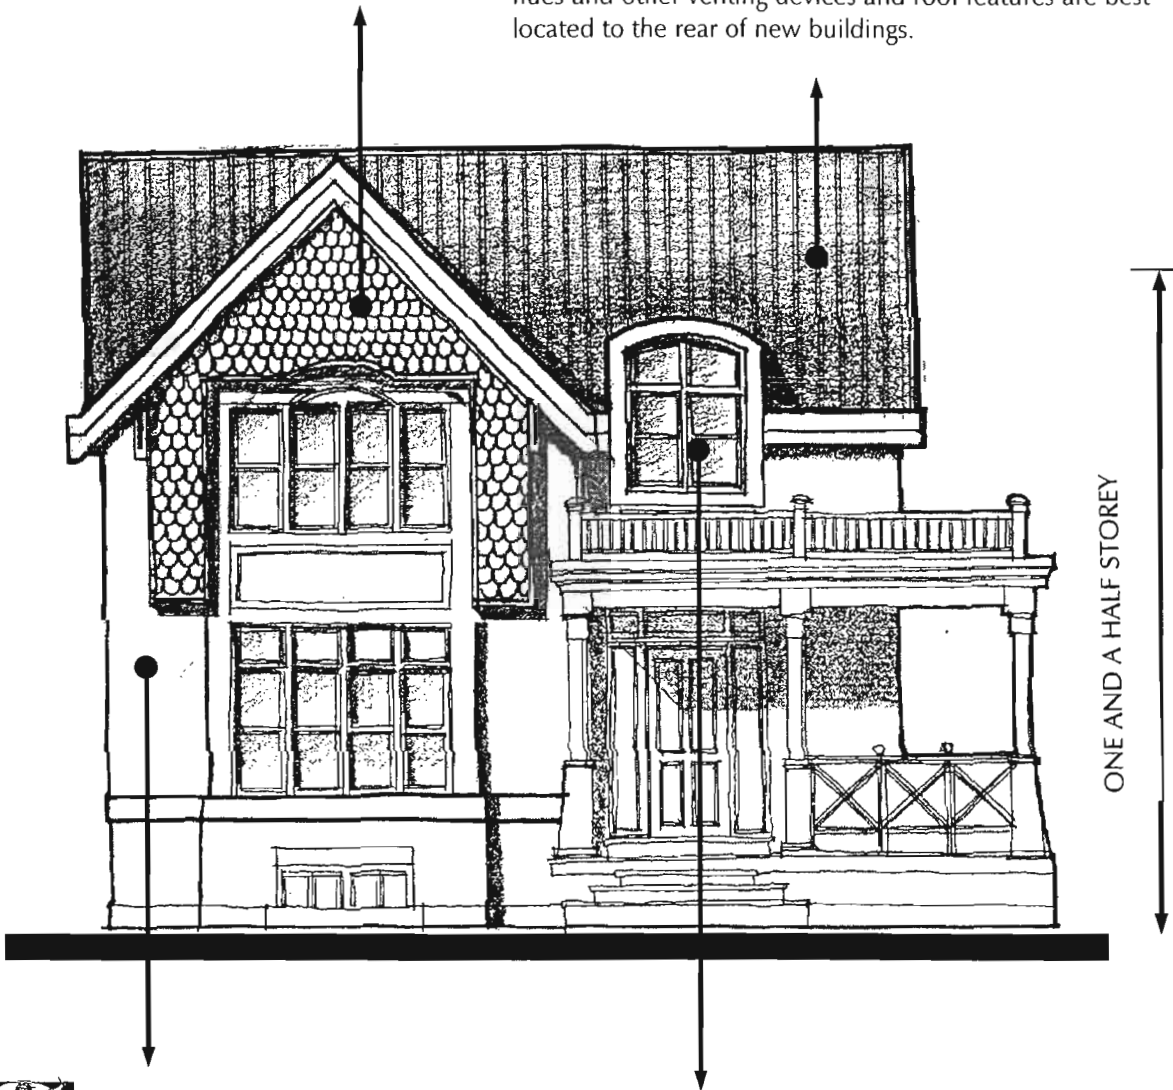
One of the roof types which is encouraged is cross-gable shown bellow. Roof vents, satellite dishes, chimneys, flues and other venting devices and roof features are best located to the rear of new buildings.

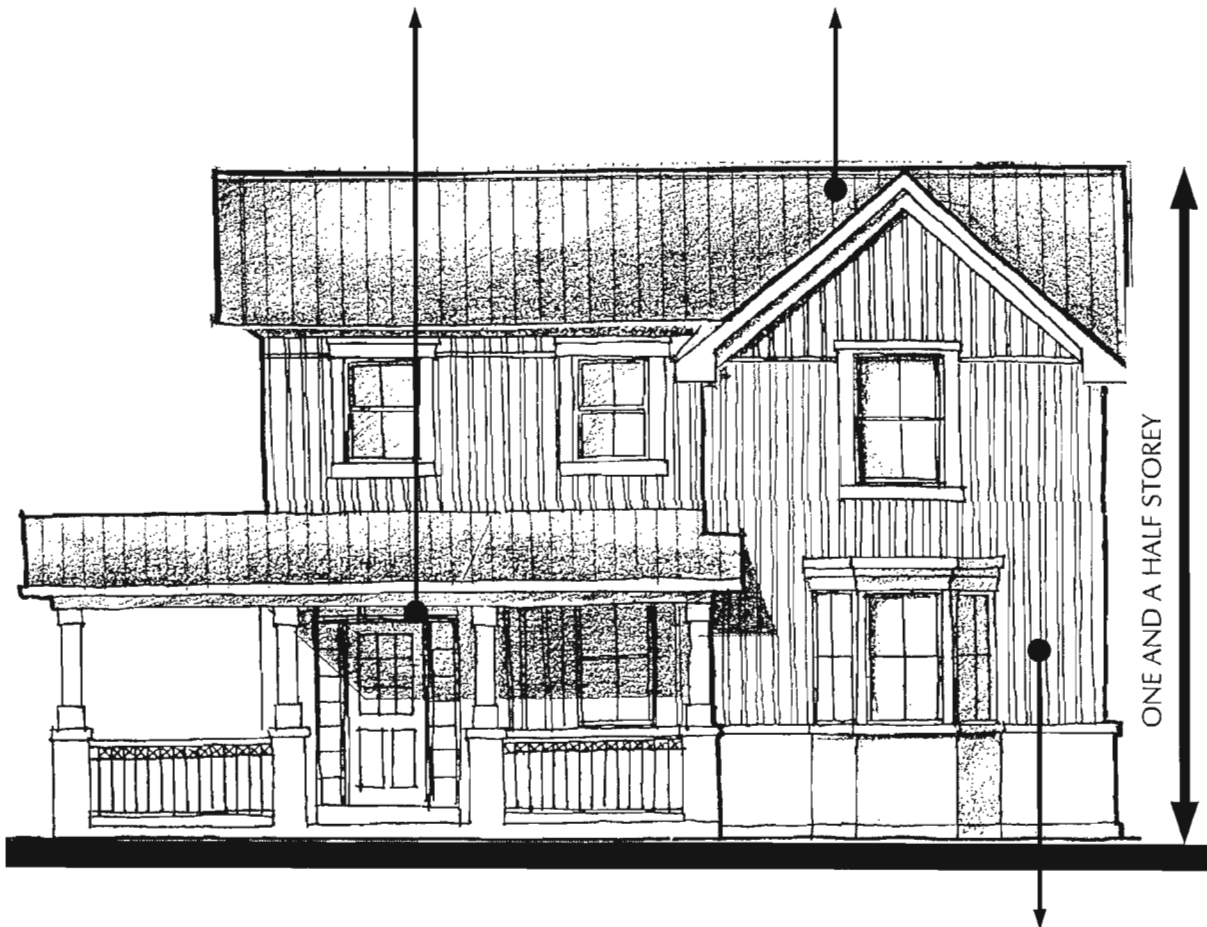
Cross gables with windows may be appropriate in front elevations on Beach Boulevard provided that they do not overpower the façade. Dormers should only be encouraged at the rear or side elevations. This example: asphalt shingles.

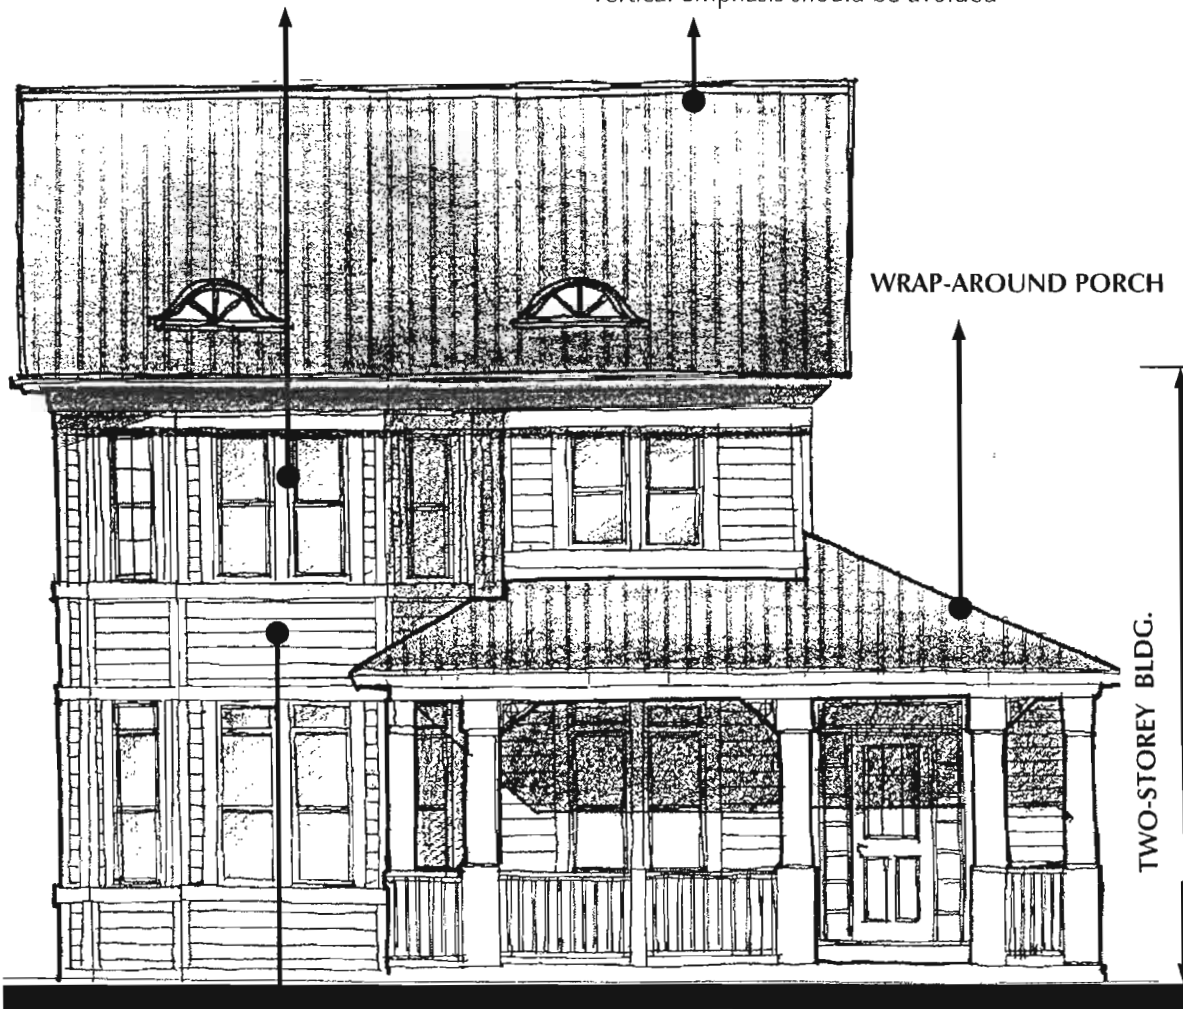
New infill should be developed with horizontal to square facades with three bays comprising an entranceway and two window bays. Facades with a vertical emphasis should be avoided

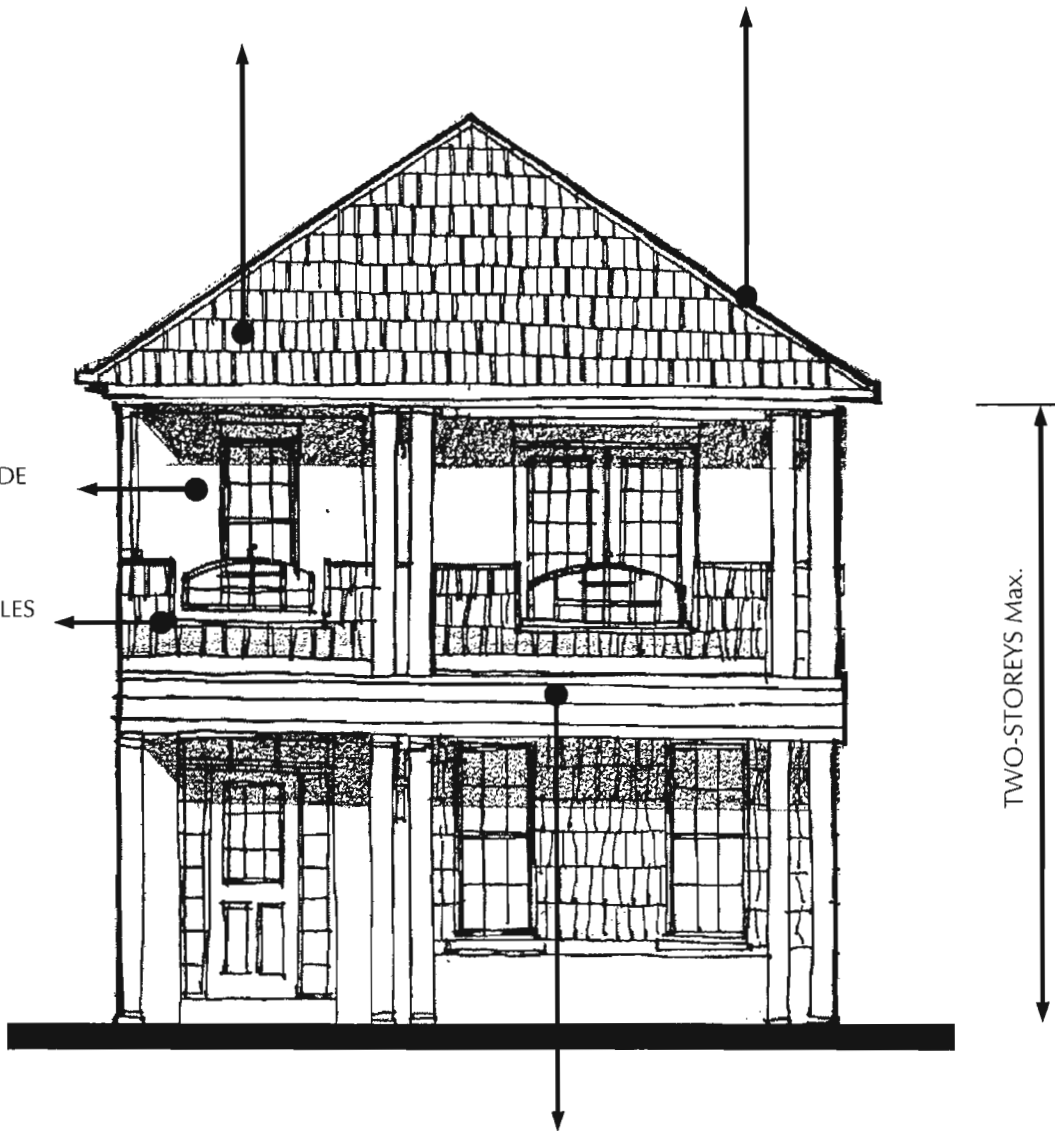
STUCCO FACADE

WOOD SHINGLES

TWO-STORIES Max.

#### TWO-STORY VERANDAH

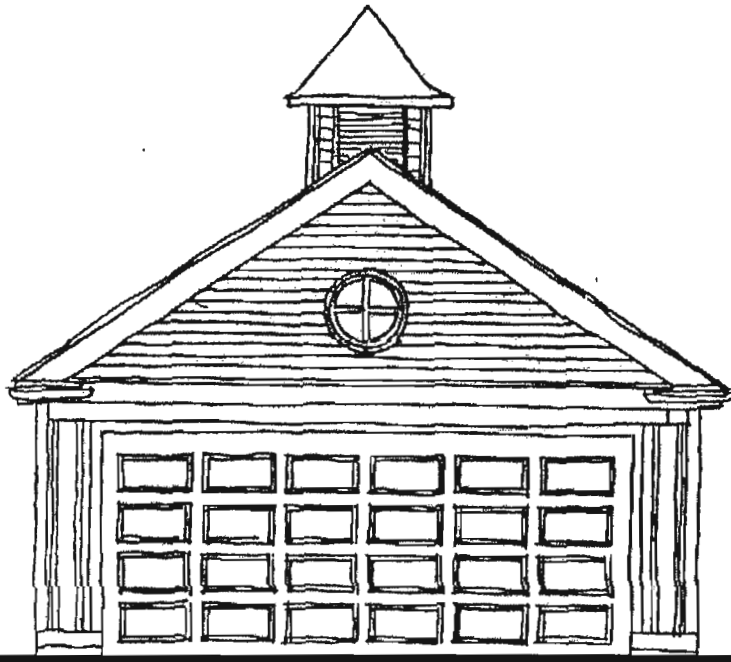
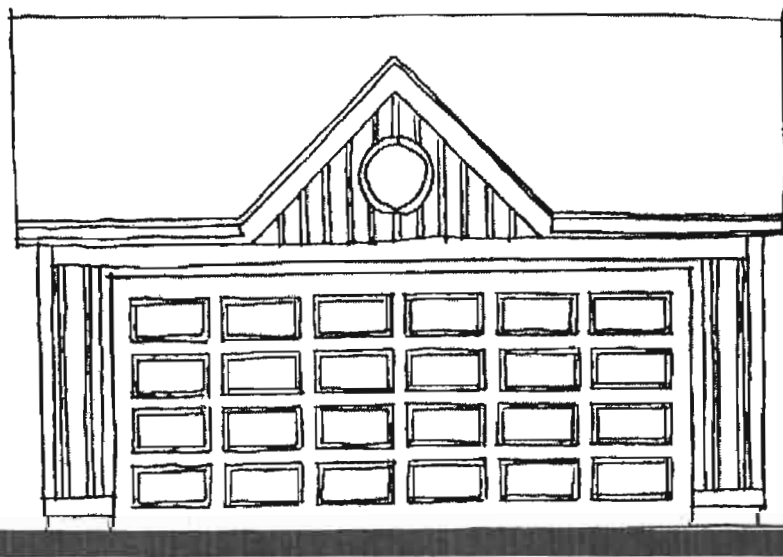
Garages and ancillary structures are best located away from the main façade and should be located in traditional areas for these functions, usually towards the rear of the lot. Garages, in particular, should not form part of the front façade of the main building.
