## 6 Websters Falls Road (Springdale)

Preliminary Cultural Heritage Assessment – March 2018

Prepared by Greg MacPherson

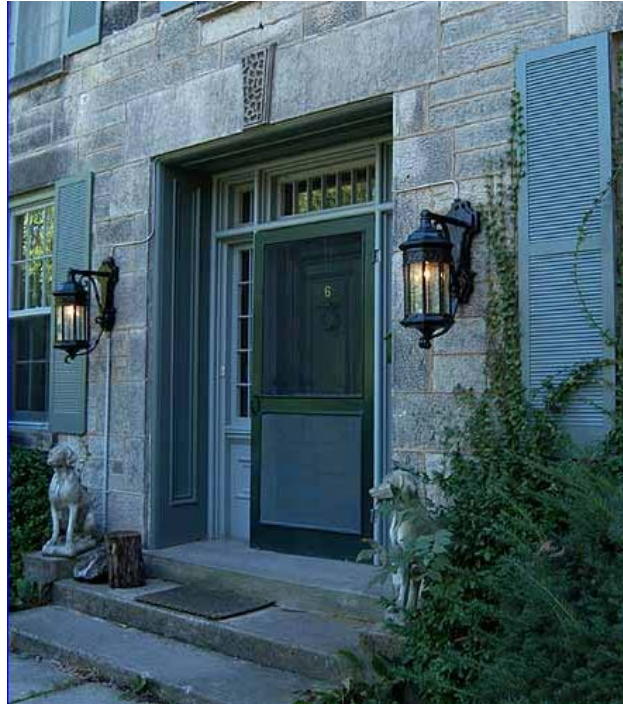
**Figure 4:** Front entrance to dwelling, showing transom, sidelights, lintel and quoins (Shannon Kyle, Ontario Architecture)

The home's two-storey front façade displays classic 5-bay Georgian proportions. Nine double hung, six-over-six windows, each topped with a stone lintel and flanked by wooden shutters, surround a centrally located entrance. A plain stone lintel with a wormed, flared keystone caps the front door, itself surrounded by an original wood trim transom and sidelights to either side. Large stone quoins, the same material as the façade, surround the front entrance. Two large stone chimneys sit at the far left and right sides of the side gabled roof.

The dwelling is utilitarian but subtly elegant, displaying a high degree of craftsmanship. Stone lintels top each window along the front façade, as well as the front entrance. An original transom and moulded sidelights surround the front entrance, itself topped with a lintel and decorative keystone and encircled by stone quoins the same material as the façade.

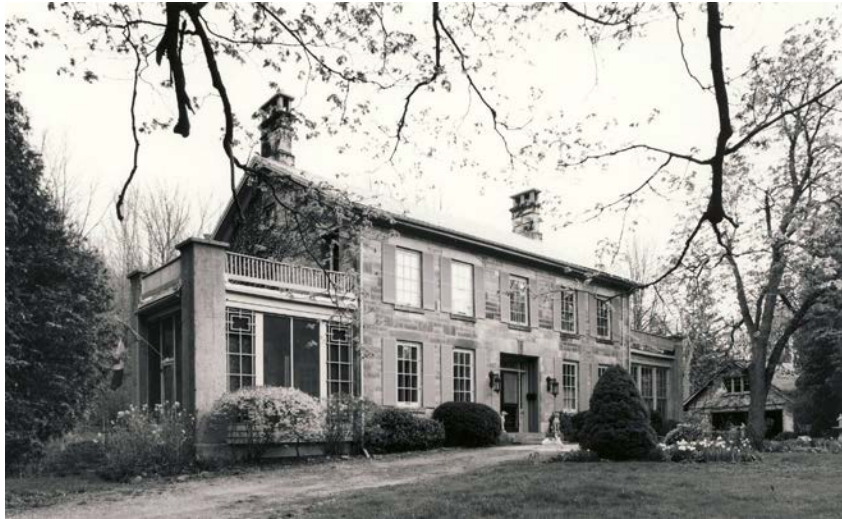
Identical additions, likely built in the early to mid-20<sup>th</sup> century, flank the east and west facades. The additions are each supported by what appears to be concrete pillars which complement the traditional style of the original dwelling. One addition serves as a sunroom, the other a screened in porch. A third addition at the rear, clad in light blue siding and built into the hill, connects to the western addition creating a lower third storey.

**Figure 5:** Front facade showing eastern addition (Flamborough Archives, 2002)

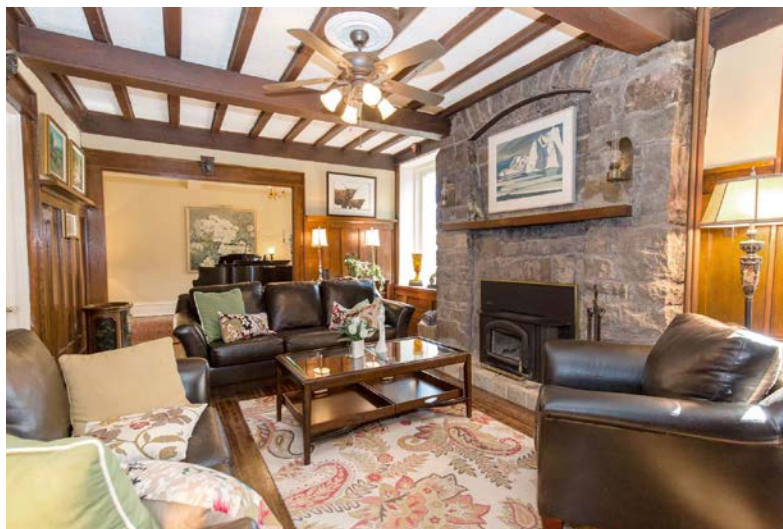
The interior of the dwelling is equally well maintained. Windows and doors feature elaborate moulding, reflecting the wealth of the original builder. Moulded recessed panels sit beneath the sitting room's windows, and a grand fireplace serves as a centre piece for both the sitting and dining rooms. Narrow plank maple hardwood runs through the home. The upstairs is less ornate, with plain baseboards and simple moulding, but still largely original. The basement features stone floors and moulded wood walls, and is almost church like in appearance. The beams throughout the house were likely added in the 1950s, but nonetheless suit the aesthetic of the home.

**Figure 6:** Sitting room, Stone fireplace, original wood floors, moulded wood panels visible (Woolcott Realty, 2018)
