## Appendix "B" of Report PED18143 Page 3 of 10

.1 Long and Bisby Building 1920, Architect unknown, General Contractor W.H. Cooper

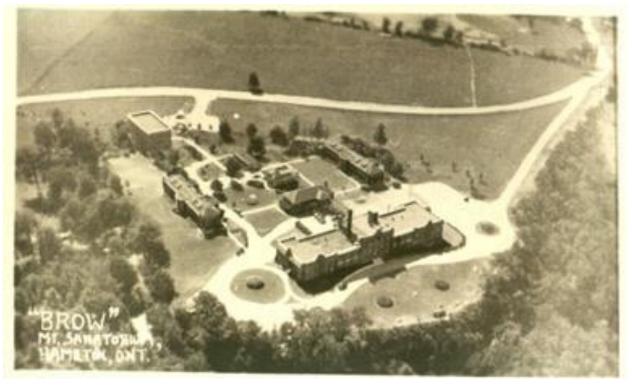
**Figure 1:** An early photograph of the subject property, with the former Brow Building (1916) featured prominently in the foreground. The Long & Bisby Building is believed to be located on the far left-hand side of the image (Hamilton Public Library Archives).

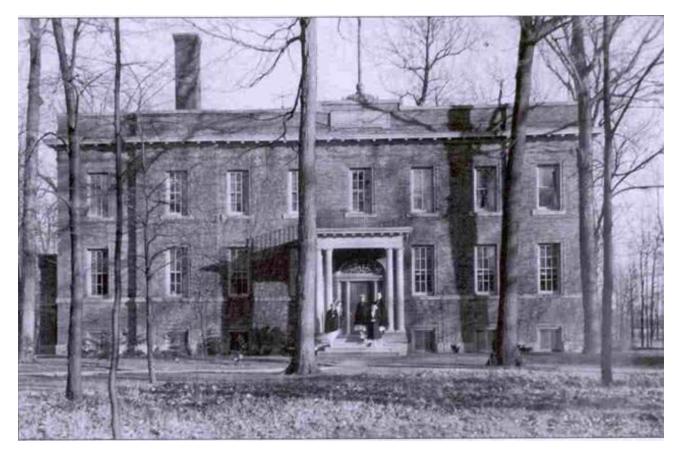
Figure 4: Circa 1930s photograph of the western façade of Long & Bisby Building. A handful of presumed nursing staff pose under the front portico (City of Hamilton Archives).

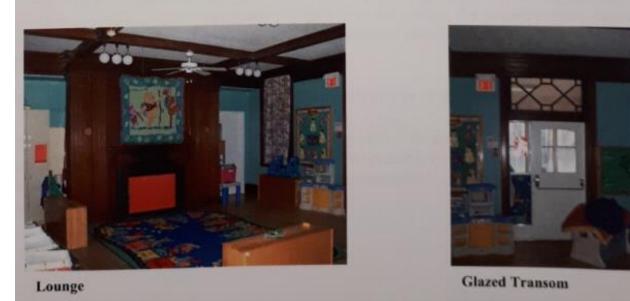
2007 Photo

Figure 10: Interior and exterior photographs taken in 2007 (SBA Architects Ltd. & Wendy Shearer Landscape Architect Ltd., "Heritage Assessment: Browlands, Chedoke Hospital, Hamilton, Ontario", June 2007).

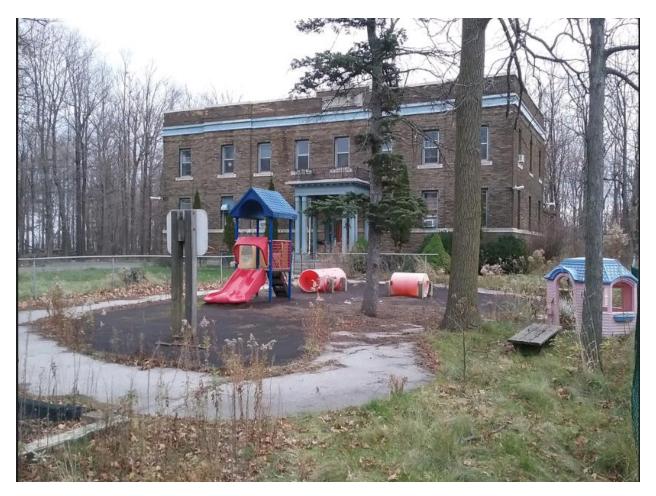
Figure 11: View of the building from the northeast. The children's play equipment in the foreground is a reminder of its recent use as a day care (Dan Collins, 2015).

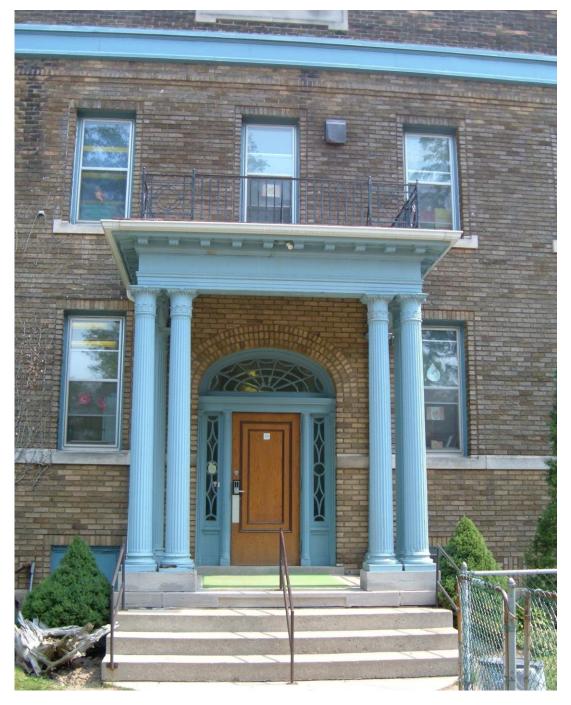
**Figure 12:** A closer view of the entrance portico, from 2007. The entrance features a decorative transom window, sidelights and brick voussoir. The portico includes detailed columns along with simple bracketing and cornice (City of Hamilton Archives).

It is a handsome building made of the same buff tapestry brick as the earlier Brow Building. Its architectural merit is based on its classical symmetry and the restrained use of materials, offset by the neo-classical entry with decorative tablet and flag mast over.

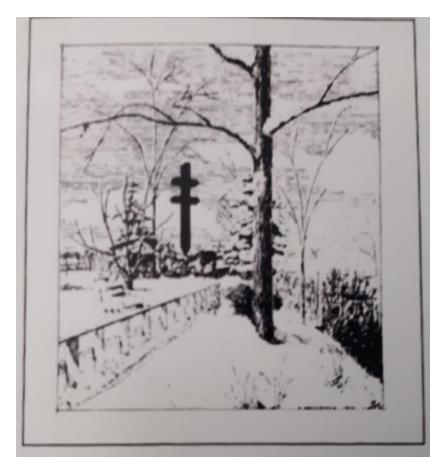
Figure 13: This Mountain Sanatorium greeting card showcases the Hamilton landmark perched atop the Escarpment edge in 1954 (*Chedoke: More Than a Sanatorium*, 2006).

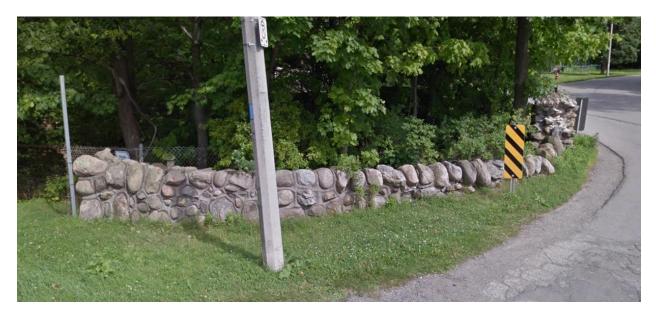
Figure 15: An image of the stone wall and pillars located between Sanatorium Road and the brow's edge (Google Street View, 2015).
