**Re: Notice of Objection to Designation
1389 Progreston Road, Flamborough (Evergreen Farm)
Incomplete Notice of Intention to Designate – Served April 23, 2020
Our File No. 13489**

Heritage Attribute Assessment Report for House

Structural Condition Assessment and Recommendations for
1389 Progreston Road, Carlisle

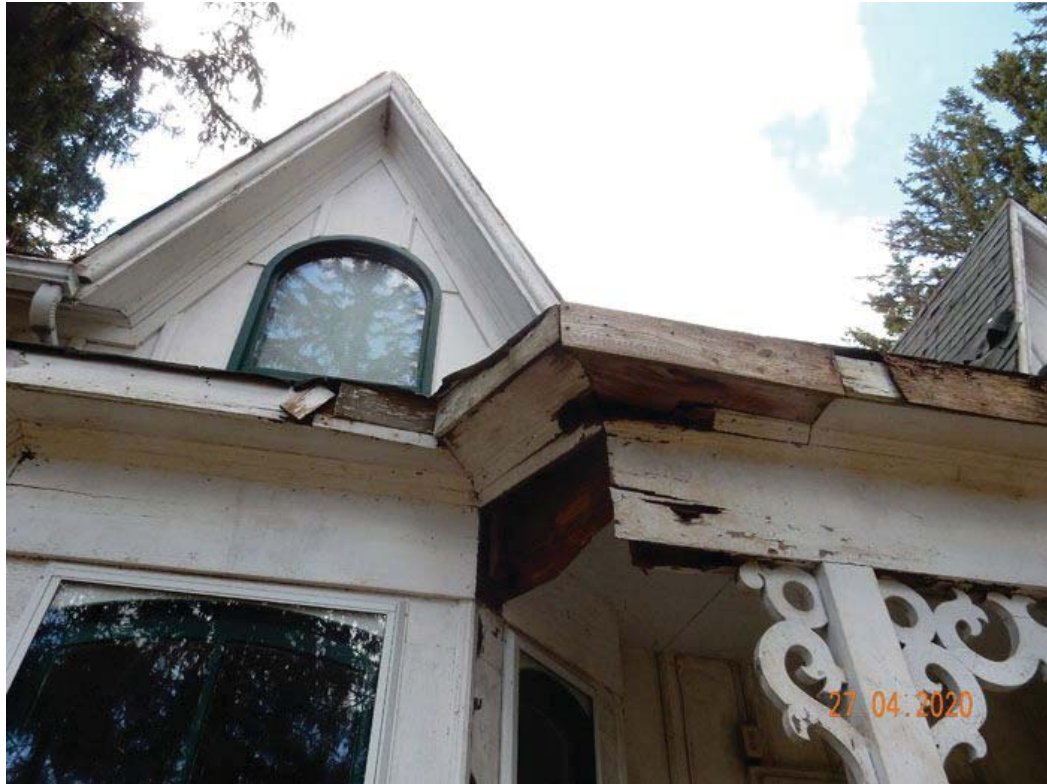
Figure 7: Corner of Porch and Gable Above, 1389 Progreston Road

There is general agreement between the consultants who visited the site that the front porch posts are of modern construction and can be purchased at any building centre. They have been installed upside down. The decorative scroll work was then installed between the posts. There is no evidence that the scroll work came from the house. The City of Hamilton has not provided any early images that might show the scroll work in its original position. In any case, the porch is of poor construction and would have to be replaced.

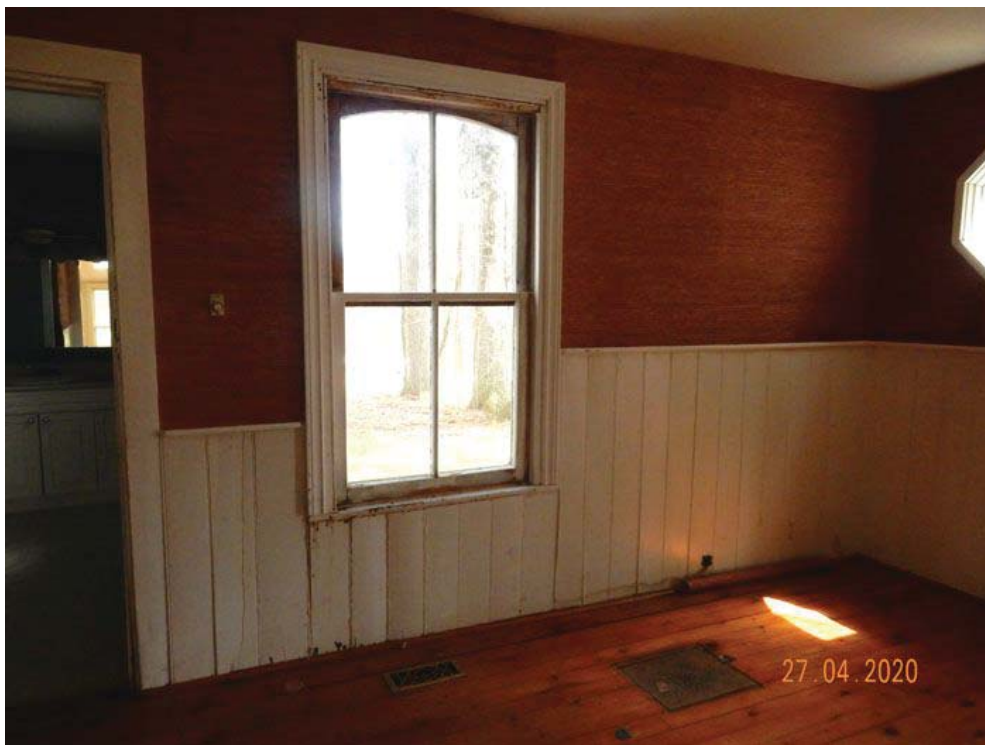
The additions to the house are architecturally undistinguished and in poor condition. A general discussion of the physical condition of the house can be found in Mark Shoalts' structural report.

Figure 9: Interior Rear Addition, 1389 Progreston Road

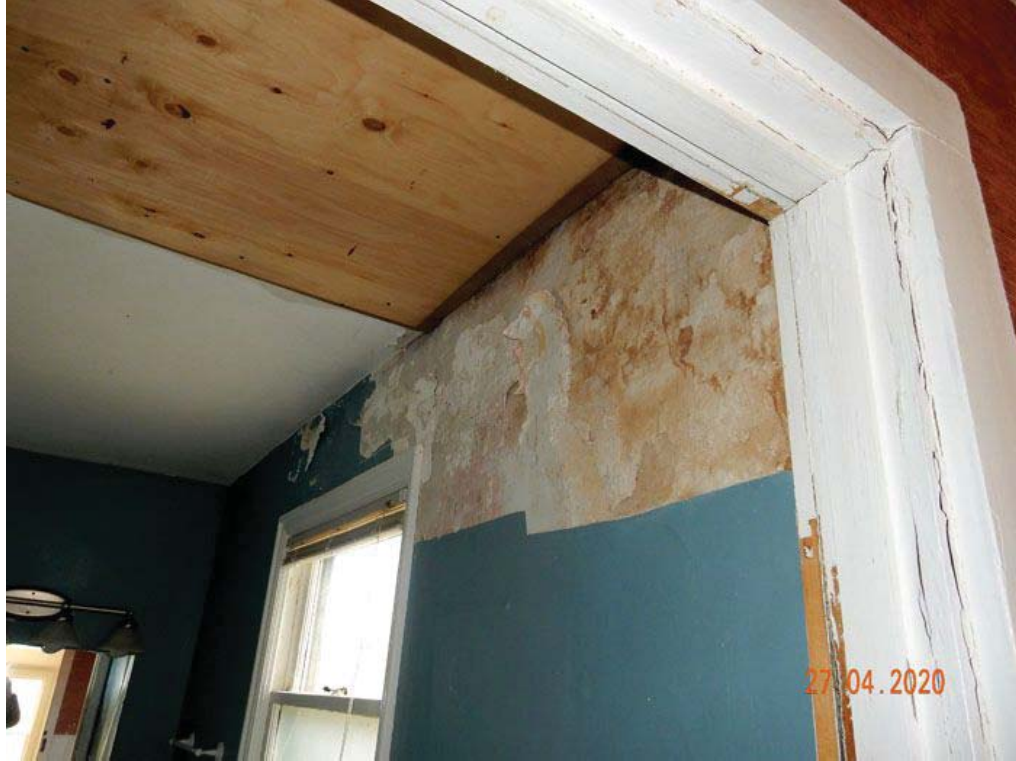
Figure 10: Interior Ground Floor New Trim and Damage Ceiling and Plaster, 1389 Progreston Road

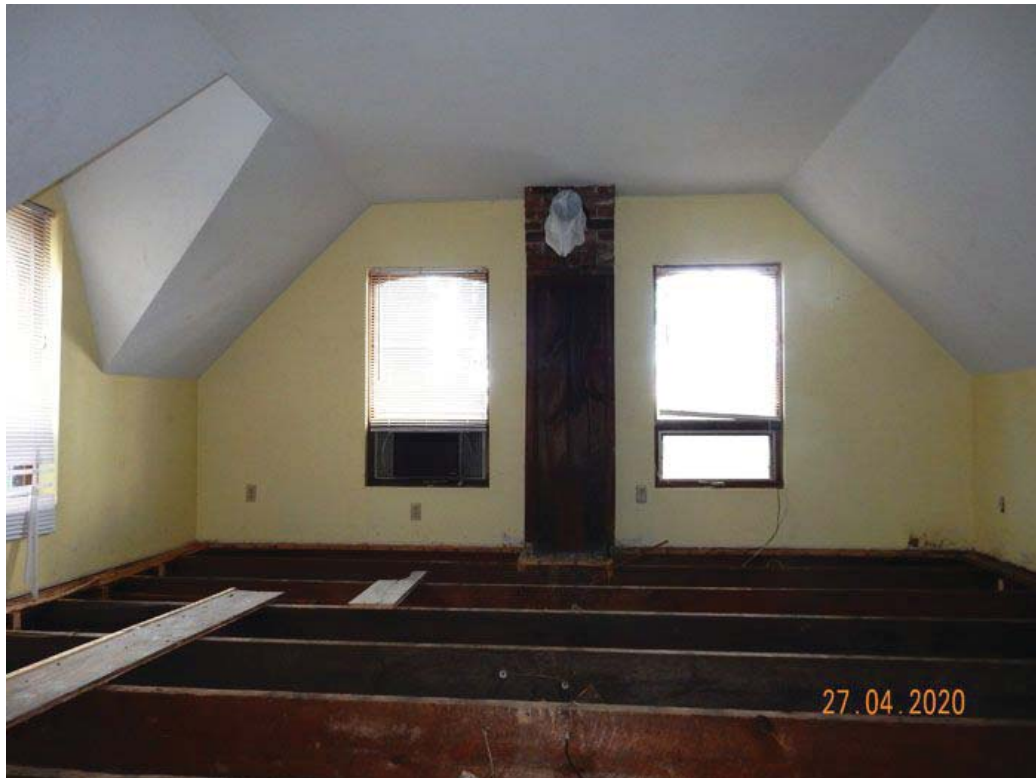
Figure 11: Interior Second Floor Room, Flooring Removed, 1389 Progreston Road

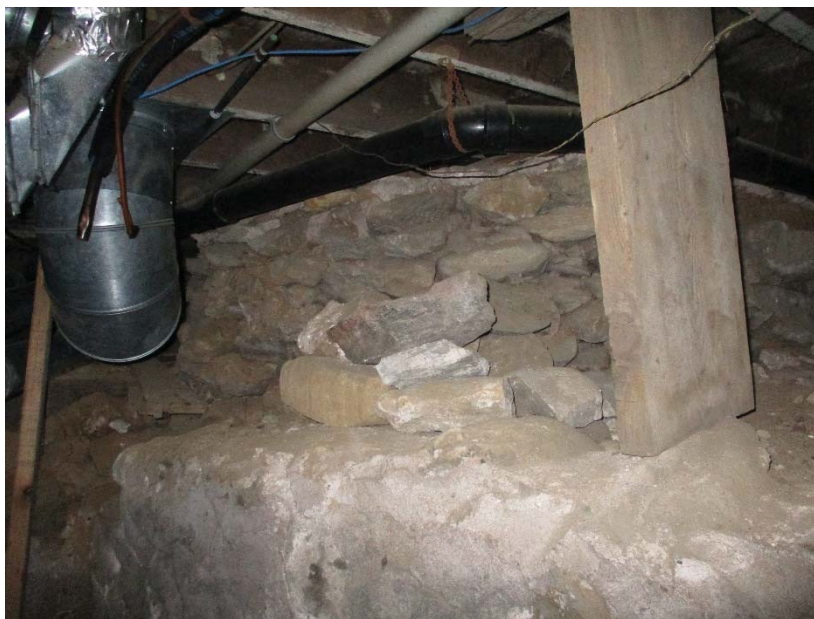
1389 Progreton Road is a Gothic Revival 1 ½ storey house with board and batten siding and restrained exterior trim details. The original plan was a typical farmhouse ell (L-shaped plan) with the main house facing east and a kitchen wing on the west side at the north end. All of this original section of the house sat on a stone foundation enclosing a low crawlspace. Some time later there was an addition to the west side of the house that extended the kitchen wing and added a room to the south in either one or two stages. The addition was likely done in the late 19th century because the basement walls are stone, and stone gave way to concrete and concrete block for foundations in the early 20th century. An unusual curved section of wall in the basement appears to have been done as a bench to retain the soil under the existing shallow stone foundation supporting the earlier house.

Later basement wall (foreground) supporting earlier shallow wall (background)
Also note temporary prop under failing joist

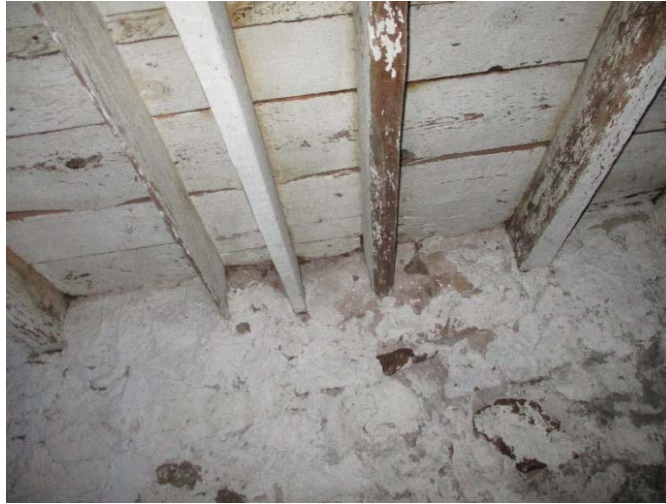
The floor system of the first two additions shows the first transition toward 20th century construction with a subfloor of roughsawn square-edged pine and a finish floor of narrower dressed pine rather than the earlier method of a single layer of thicker T&G pine floor laid directly on the joists. The joists and flooring, as well as the timber sill plates visible in the basement and crawlspace are all of circular sawn lumber. The joists in the southwest wing are a motley collection of small pieces, ranging in thickness from less than ¾" to more than 2" and looking more like slabs from a mill than proper lumber, and they are installed with random spacing. What at first appears to be a beam supporting the centre of the span is actually another slab with the round bark face down, much too thin to provide any support to the joists. There is no evidence of a post having been removed so the purpose of this slab is unknown.

Randomly sized and spaced circular-sawn floor joists

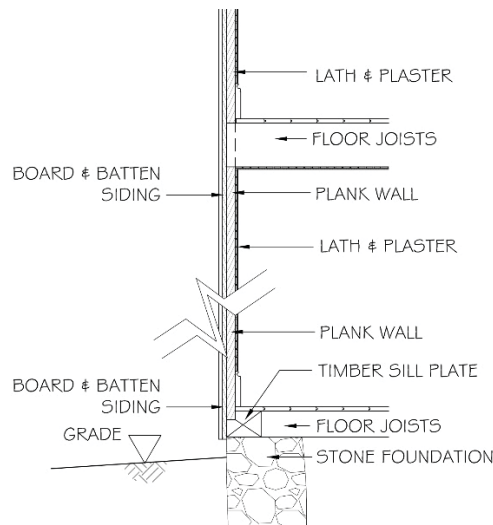
While the circular saw had been invented before 1857, it took many years for new technology to be adopted by existing mills and vertically sawn lumber was the norm into the 1860s in this area. By the 1870s circular sawmills were becoming much more common, evidence that the 1870s date given for the construction of the existing house is logical. Depending upon the sawyer, daily production of lumber from a circular sawmill could be up to ten times that from a muley or vertical frame saw. It would be unheard of for a log house to be built in an area that boasted a circular sawmill, so the floor built of circular sawn lumber is not part of some much-altered log dwelling built in the 1850s or earlier. The oldest section of the house is of vertical plank construction, not commonly used in Canada West but certainly easily done when one had access to plentiful and economical sawn lumber such as that available from a circular sawmill. Vertical plank construction consists of 2" planks set in a rabbet in a timber sill plate, with the second storey joists morticed into and carried by the vertical planks. There are no studs or other primary framing members in the walls. The exterior was clad with vertical 1" boards nailed to the 2" planks with the joints offset, and battens were nailed over the exterior joints. The interior was finished by nailing wood lath to the planks and plastering it. The whole wall assembly is approximately 3 1/2" thick including the plaster but not including the battens.

Wall cross-section

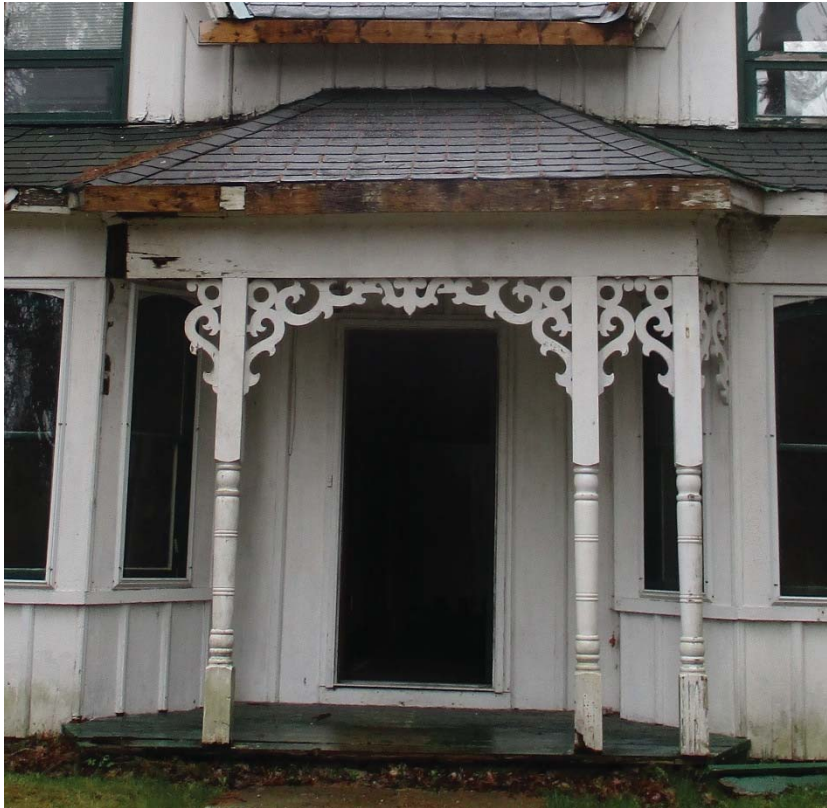
The one exception to the lack of ornamentation on the house is the front porch with its scrolls and turned posts. The posts are laminated finger-jointed pine, installed upside down, clearly of late 20th century construction. The scrollwork is older, apparently salvaged from another building. Flanking the porch on each side are bay windows, original to the house. Above the bay windows are gothic dormers, with what appear to be round-headed windows but are in fact rectangular windows with fixed-over-awning lights, installed in 1982 from the interior against the round-headed trim. The gable trims, soffit, fascia, and frieze on the house appear largely original. The battens have a nicely moulded profile rather than the more common slightly bevelled plain batten.

Porch with upside-down posts

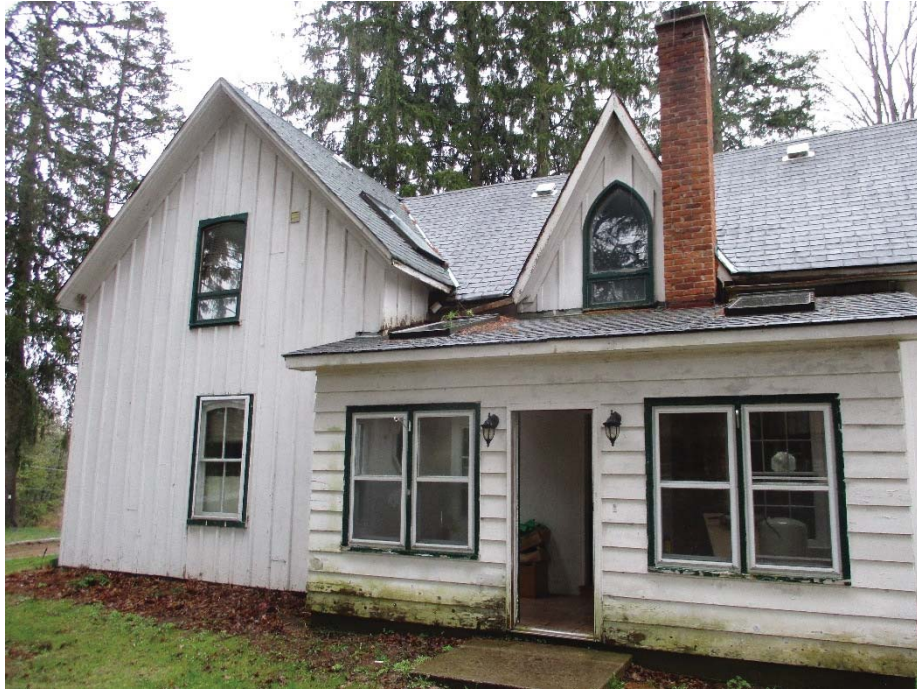
The house at 1389 Progreton has some serious structural problems. The original floor joists in some of the sections of the house are undersized, which is not uncommon in older buildings, but some of them have deteriorated as well and should be sistered or replaced. The wall structure has areas that have deteriorated to the point where they require replacement. The house has roofing issues as a result of configuration, overhanging trees, and aging materials. Valleys run into changes in pitch, chimneys, and lower roofs. There are a number of roof leaks that have damaged interior fabric. Of even greater concern is the management of runoff from the eaves of the roof. Much of the house has no eavestroughs at all, and those troughs that exist are damaged, plugged with spruce needles, or falling off.

North side showing various roof issues

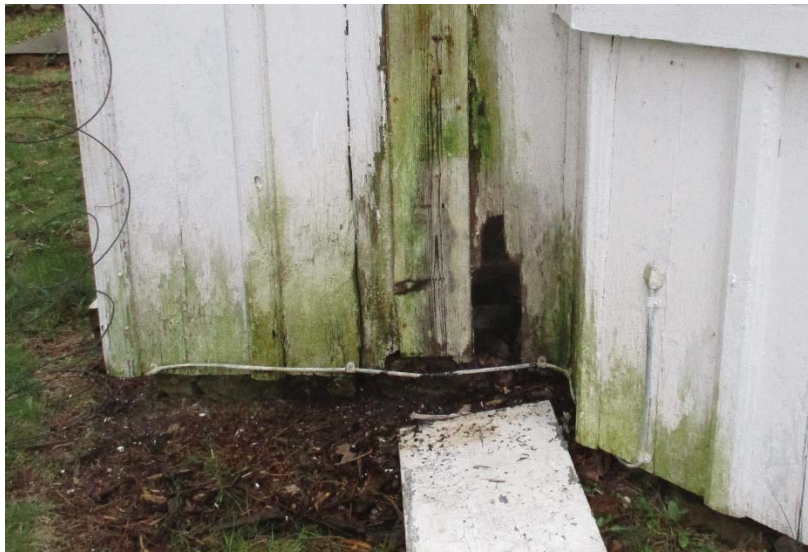
The grade is too high around most of the house, with the wood finish and structure either very close to grade or in places below grade. The water running off of the roof saturates the wall and the ground ensuring a prime environment for deterioration and decay of the wood cladding and structure. There are locations where the wall has rotted completely through.

Hole rotted through wall, grade too high

Unlike a frame building, repair of a deteriorated plank wall is a difficult and very invasive undertaking. The timber sill plate has rotted sections that must be cut out and replaced but as can be seen from the wall section, the plate supports and is concealed behind the floor joists and it supports the plank wall. It cannot be replaced without removing the board and batten siding, the baseboard, taking up flooring, and shoring both floors and the roof structure. In the locations where the plate has rotted, the wall planks are rotted as well. Wall planks cannot be

cut short and spliced in because there is no framing, so there is no lateral support without continuous planks. A damaged plank must be replaced from sill plate to roof plate. This means removing the siding from the exterior and breaking loose the lath from the interior. In very short order the interior and exterior wall finishes of the house have been destroyed, and the structural integrity is gone if more than one plank or one very short piece of plate in any stretch of wall must be replaced.

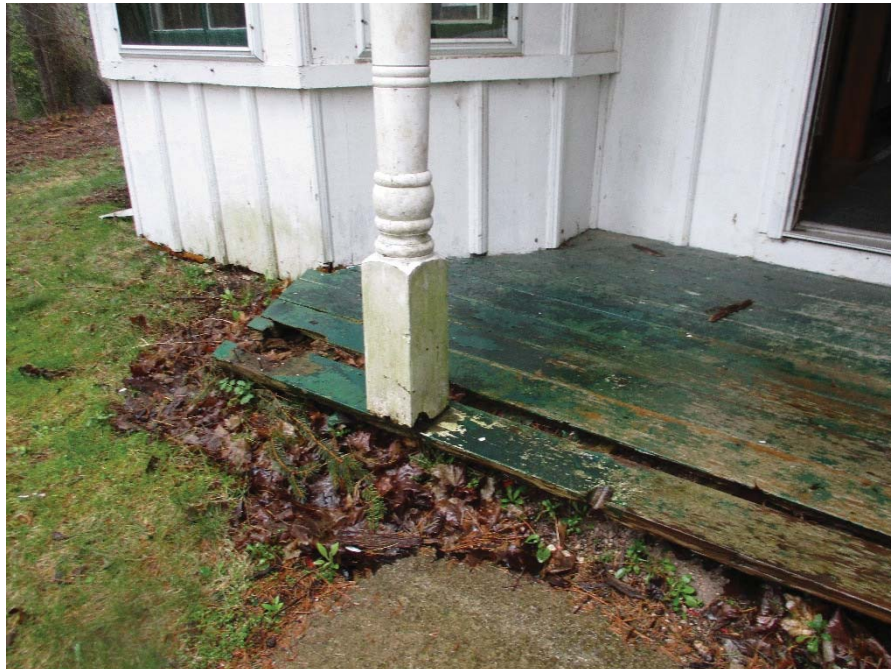
The front porch, mentioned in the Working Group notes, is not heritage fabric. Whether or not the current porch was built to replace an earlier porch can only be determined by destructive investigation or by older photographs or other information. In any event, the existing porch is poorly and improperly built (the upside-down posts were noted earlier) and it has deteriorated to a state where removal is the only reasonable option.

Front porch with rotting modern post and failing floor structure

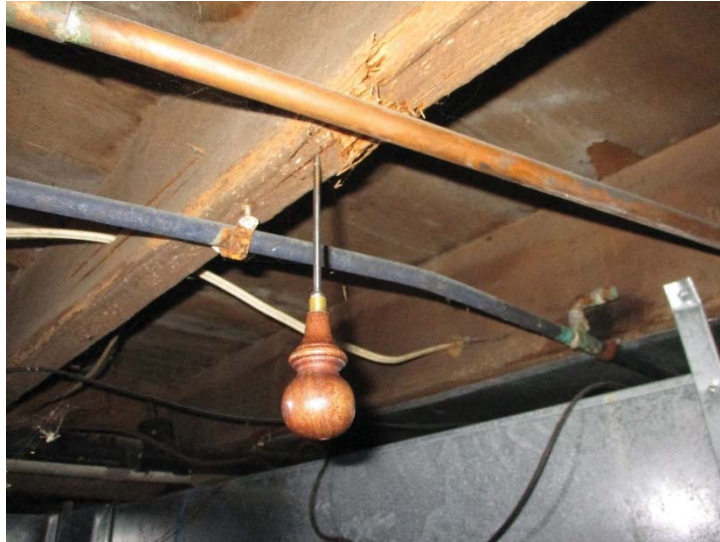
The floor system in the kitchen wing requires work on or replacement of numerous elements. As noted earlier, much of the framing is undersized which could be acceptable if it were in good condition. Unfortunately, several floor joists have deteriorated to the point where they have no strength left. Decay can reduce the strength of wood by up to 10% before it can even be detected. By the time that decay has created weight loss of 5% - 10%, wood has lost 20% - 80% of its strength². Joists that can be penetrated more than ½" with a hand-held awl have no effective service life left. Other floor joists have dropped where mortised into the timber sill plate. Foundation walls have been altered leaving areas of framing with no support. Temporary props have been inserted under failing floor framing.

Deteriorated floor joist, awl inserted >2"

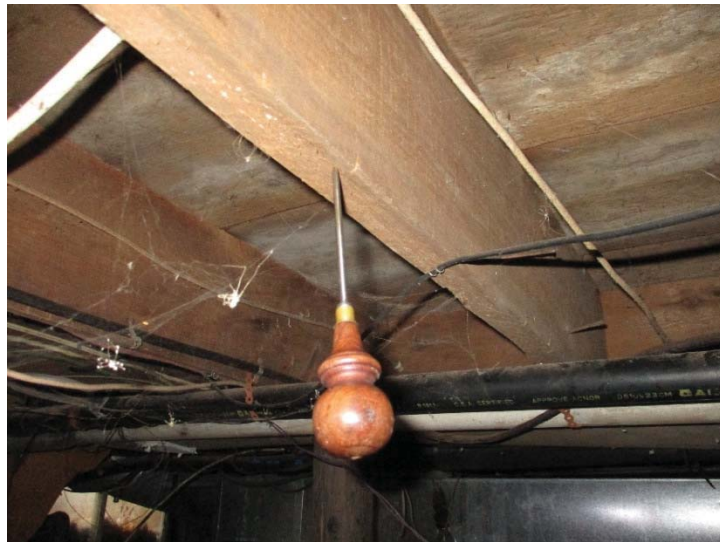
Deteriorated floor joist, awl inserted >2"

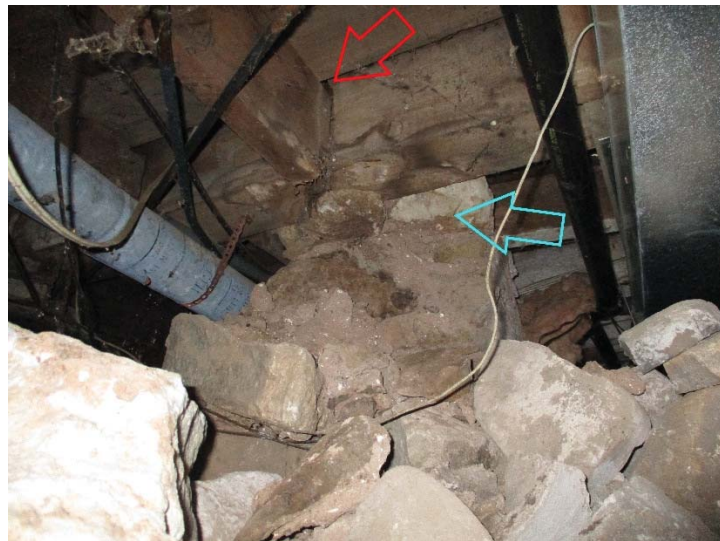
Dropped joist, sawn timber sill plate, altered foundation, missing support
