<b>TO:</b>	Mayor and Members Board of Health
<b>DATE:</b>	October 19, 2023
<b>SUBJECT:</b>	Air Monitoring On-Site Assessment at Green for Life Stoney Creek Regional Facility (Ward 9)
<b>WARD(S) AFFECTED:</b>	Ward 9
<b>SUBMITTED BY:</b>	Dr. Elizabeth Richardson, MD, MHSc, FRCPC Medical Officer of Health Public Health Services
<b>SIGNATURE:</b>

**RE: GFL Environmental September 2023 Ambient Air Monitoring Assessment Survey,  
Stoney Creek, Ontario**

At the request of the Hamilton District Office of the Ontario Ministry of the Environment, Conservation and Parks, the Technical Support Section of West Central Region (WCR) conducted an odour and air quality monitoring assessment of the Green for Life (GFL) Environmental Stoney Creek Regional Facility (the Facility) in Stoney Creek, Ontario on September 1, 14, 15, 22, 28 and 29, 2023.

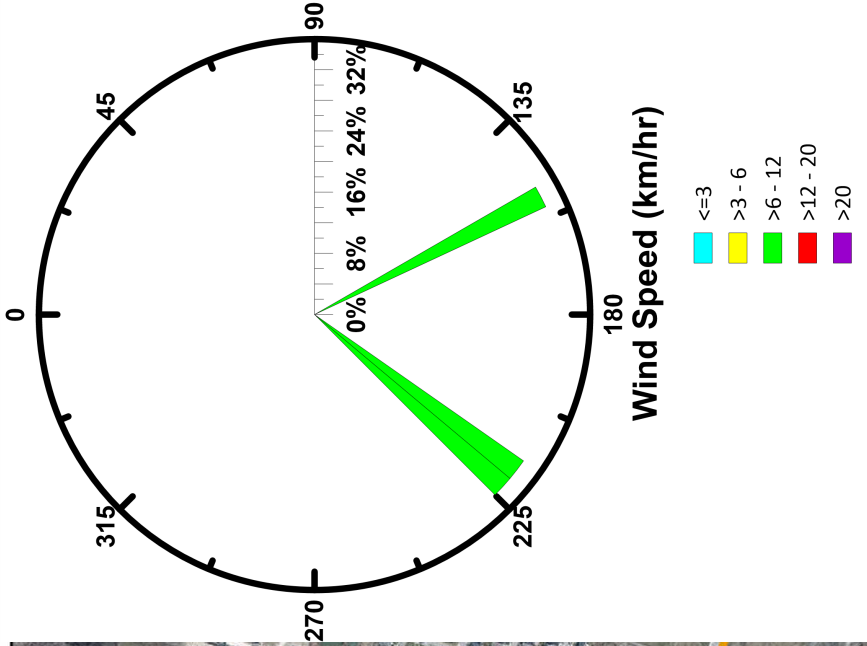
Raw sulphur, rotten egg, leachate, herb and garbage odours were also detected throughout the sampling period. The odour levels could not be quantified using the nasal ranger ( $D/T < 2$ ). Odours were detected north of the leachate pond when winds were blowing from the southwest and southeast where the leachate pond and the GFL facility were upwind and likely sources.

Figure 2 summarizes the odour survey for this day.

Date	Time (Location)	Name	Odours observations	D/T Ratio	General Comments
01-Sep-23	9:50	A	No	-	Non Detect Odour - Very Low wind Speeds
	10:06		No	-	No odour detected
	10:20		No	-	No odour detected
	10:39	B	Yes	D/T<2	Odour detected with nose only - Raw Sulfur, Rotten Egg, Leachate, Herb smell.
	10:55		No	D/T<2	Same odour as above. Odour seems stronger when wind gusts
	11:13	C	No	-	No odour detected
	11:28	D	No	-	No odour detected
	11:44	E	Yes	D/T<2	Garbage odour
	11:59	F	No	-	Non Detect Odour
	12:17	G	Yes	D/T<2	Odour detected with nose only - Raw Sulfur, Rotten Egg, Leachate, Herb Smell
	12:33	H	No	-	No odour detected

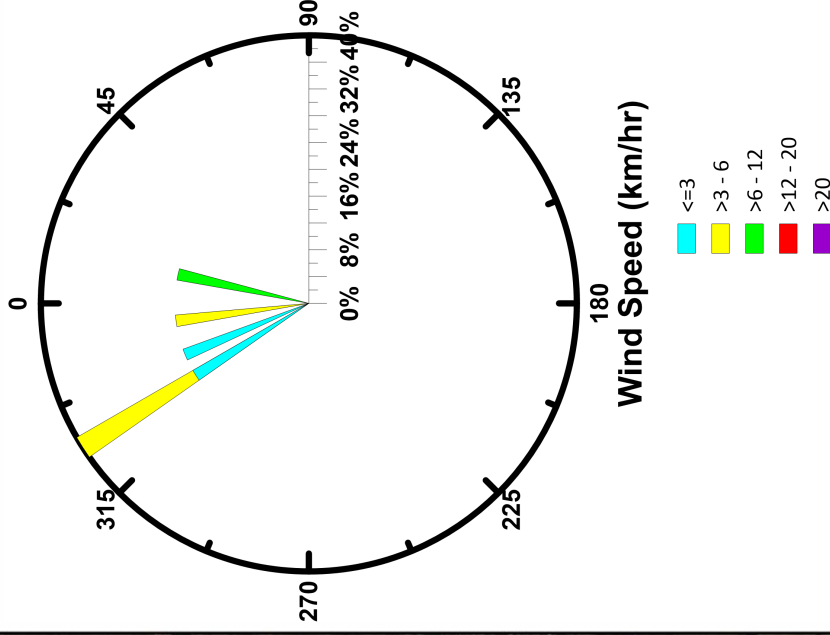
Winds were relatively calm during this period. Winds were generally blowing from the northwest where the GFL facility was upwind of a few locations and was the likely source. However, a few locations were upwind of the GFL facility. It is possible the relatively low wind speeds resulted in temporary stagnant conditions resulting in the inability for odours to disperse. The odour survey is summarized in Figure 4.

Date	Time (Location)	Name	Odours observations	D/T Ratio	General Comments
15-Sep-23	4:50	A	Yes	4 <math>D/T < 7</math>	Strong Odour - Leachate - Rotten Eggs - Very low wind speeds (Calm)

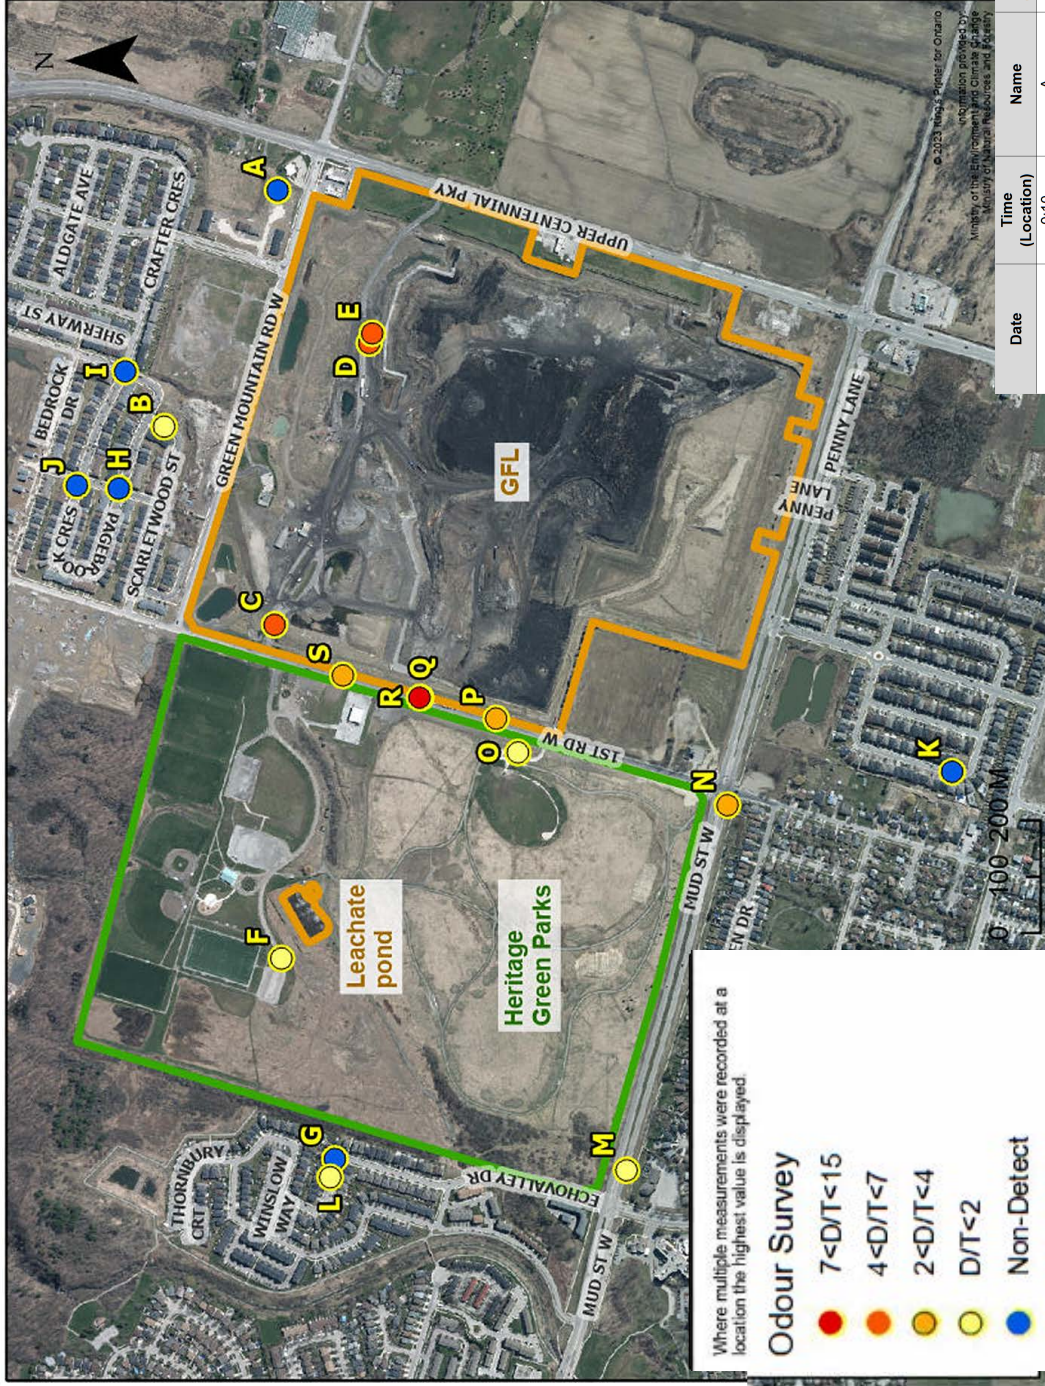
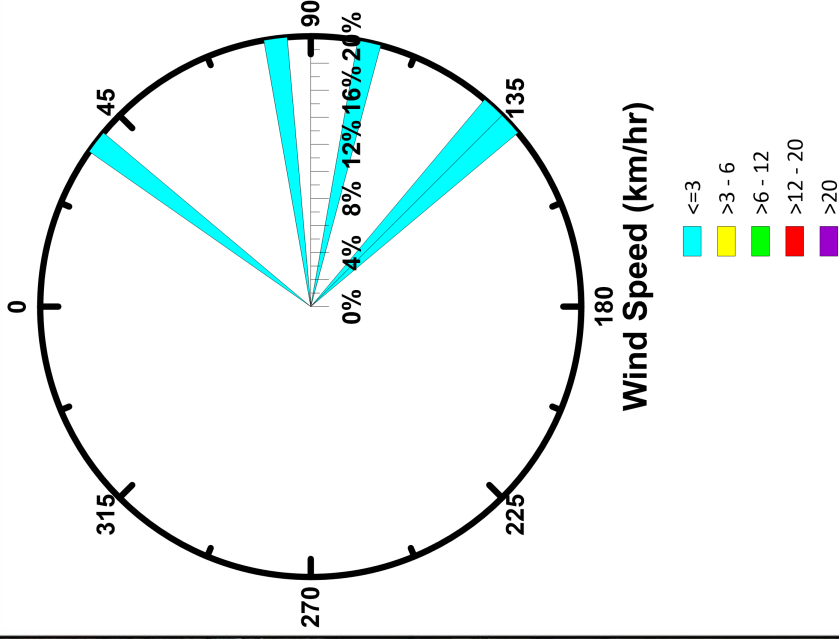
Winds were calm during this period. It is possible the relatively low wind speeds resulted in temporary stagnant conditions resulting in the inability for odours to disperse. The odour survey is summarized in Figure 5.

Date	Time (Location)	Name	Odours observations	D/T Ratio	General Comments
22-Sep-23	0:10	A	No	-	Complainant House #1
	0:20	B	Yes	D/T<2	Complainant House #2 - Sour smell
	0:30	C	Yes	4<D/T<7	Inside GFL Facility - Reference only - Rotten eggs
	0:40	D	Yes	4<D/T<7	Inside GFL Facility - Reference only - Rotten eggs
	0:55	E	Yes	4<D/T<7	Inside GFL Facility - Reference only - Rotten eggs
	1:28	F	Yes	D/T<2	GFL mist machine - deodorizer/ sweet
	1:43	G	No	-	Complainant House #3
	1:54	H	No	-	Complainant House #4
	2:06	I	No	-	Complainant House #5
	2:13	J	No	-	Complainant House #6
	2:30	K	No	-	Complainant House #7
	2:52	L	Yes	D/T<2	GFL mist machine - deodorizer/ sweet
	3:15	M	Yes	D/T<2	Sour smell
	3:32	N	Yes	2<D/T<4	Sour smell
	4:08	O	Yes	D/T<2	Sour smell
	4:25	P	Yes	2<D/T<4	Leachate/ waste
	4:43	Q	Yes	4<D/T<7	Rotten Eggs
	4:51	R	Yes	7<D/T<15	Rotten Eggs
	4:58	S	Yes	2<D/T<4	Rotten Eggs

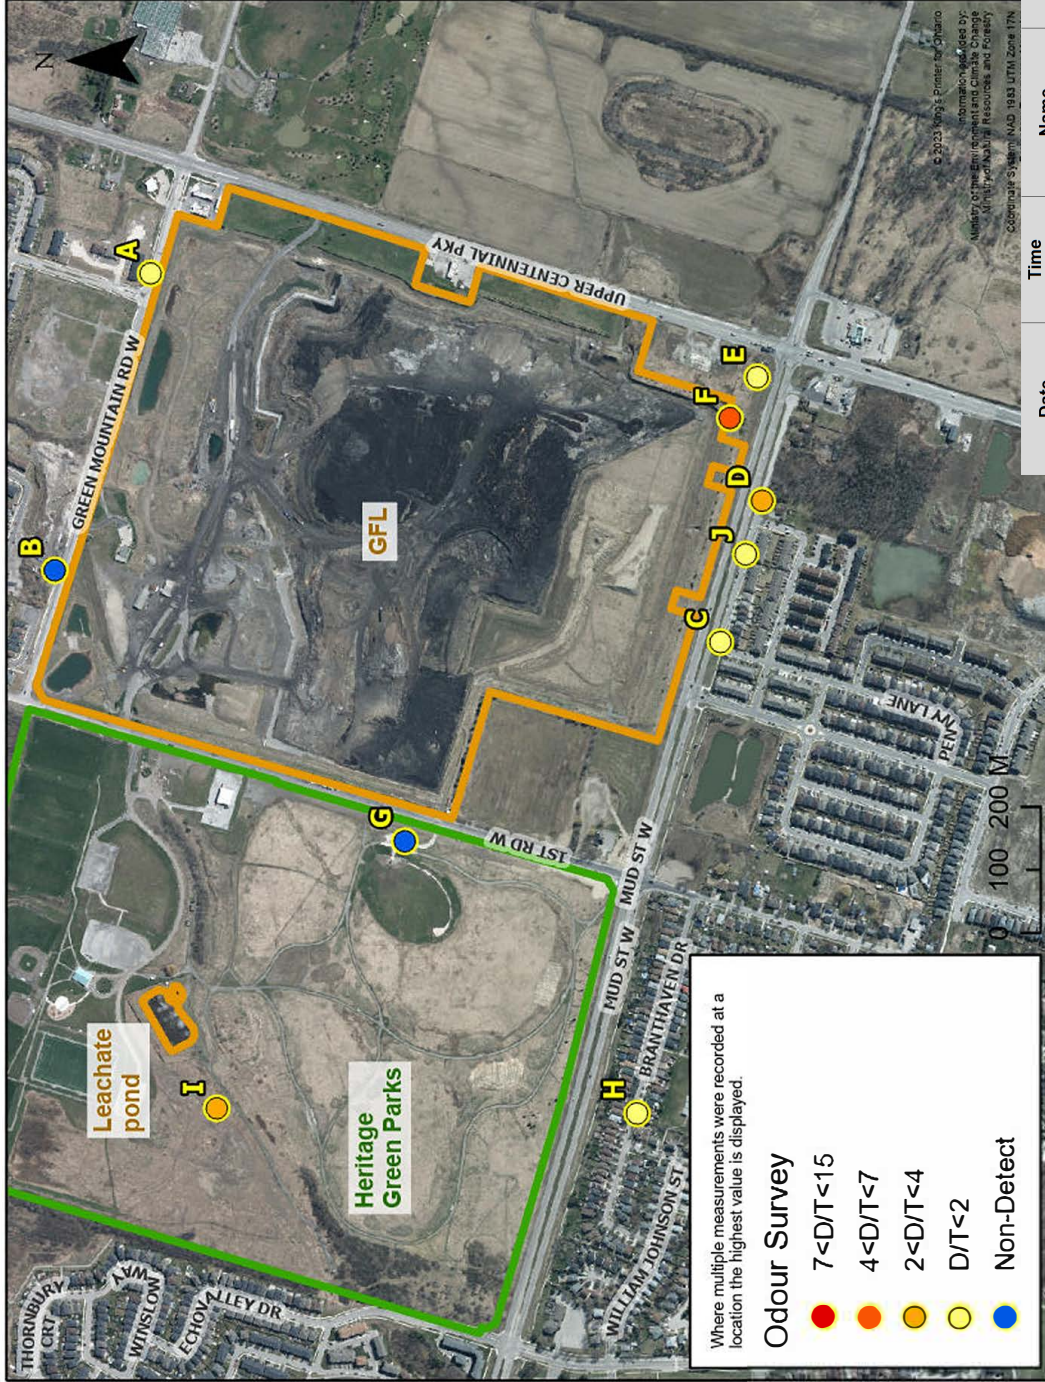
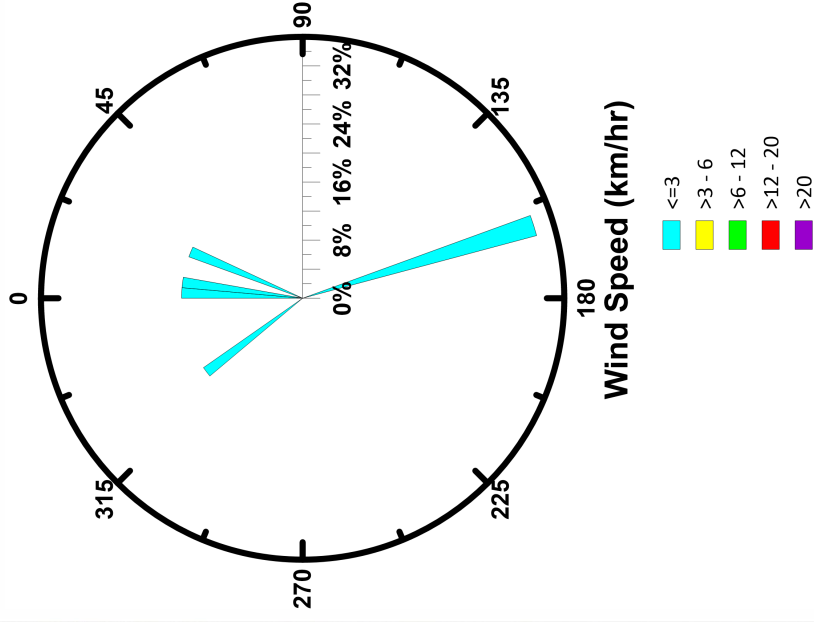
Winds were calm during this period. It is possible the relatively low wind speeds resulted in temporary stagnant conditions resulting in the inability for odours to disperse. The odour survey is summarized in Figure 7.

Date	Time (Location)	Name	Odours observations	D/T Ratio	General Comments
29-Sep-23	4:00	A	No	-	No odour detected
	4:23	B	Yes	<2	Deodorizer + Leachate
	4:39	B	No	-	No odour detected
	5:05	C	Yes	<2	Leachate
	5:22	C	Yes	<2	Leachate
	5:37	D	Yes	2<D/T<4	Leachate, Sour, Garbage
	5:54	E	Yes	<2	Leachate, Burnt
	6:12	E	Yes	<2	Leachate, Deodorizer
	6:27	F	Yes	4<D/T<7	Leachate, Deodorizer, Burnt, Rotten Eggs
	6:44	F	Yes	<2	Leachate, Deodorizer, Burnt
7:20	G	No	-	No odour detected	
7:37	H	Yes	<2	Faint Leachate	
7:59	I	Yes	<2	Leachate, Deodorizer	
8:15	I	Yes	2<D/T<4	Leachate, Deodorizer, Rotten Eggs	
8:45	J	Yes	<2	Solvent, Burnt, Chemical	
9:06	J	Yes	<2	Solvent, Burnt, Chemical

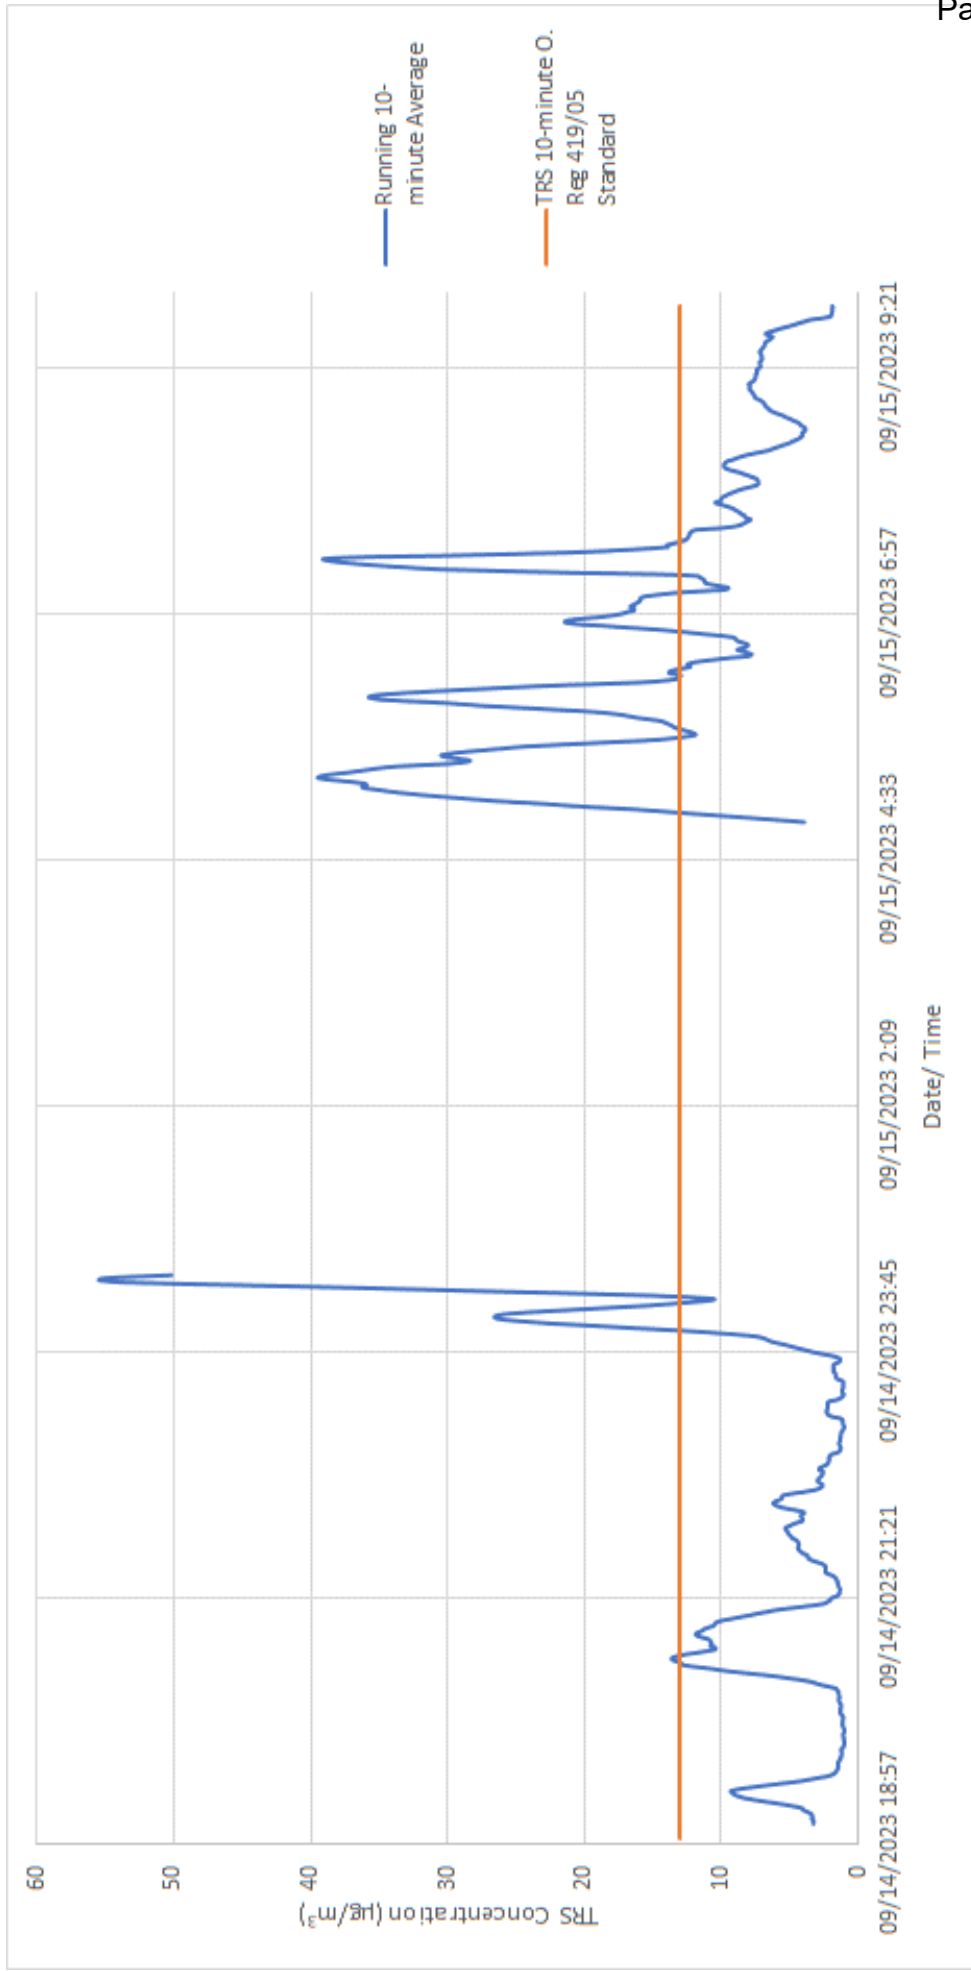
# Figure 8 – GFL Environmental - September 14-15, 2023 Ambient Air Monitoring Assessment Survey Running 10-minute Average TRS Concentrations

A maximum 10-minute TRS concentration of  $55.6 \mu\text{g}/\text{m}^3$  was measured on September 15, 2023, from 00:17 to 00:27 which exceeds the 10-minute TRS O. Reg. 419/05 Standard of  $13 \mu\text{g}/\text{m}^3$ . The maximum measured concentration occurred approximately 275m from the nearest residence. A total of four (4) exceedances of the TRS 10-minute O. Reg. 419/05 Standard were measured over this 5.5-hour period. Exceedances were generally measured northeast of the GFL facility, including residential areas. Winds were blowing from the west to southwest where the GFL facility was upwind and a potential source of odours. A summary of measured TRS exceedances is shown in Table 8. Figure 8 plots the running 10-minute TRS average concentration time series.

A maximum 10-minute TRS concentration of 39.5 µg/m<sup>3</sup> was measured on September 15, 2023, from 05:12 to 05:22, in a residential area, which exceeds the 10-minute TRS O. Reg. 419/05 Standard of 13 µg/m<sup>3</sup>. A total of twelve (12) exceedances of the TRS 10-minute O. Reg. 419/05 Standard were measured over this 5-hour period. Exceedances were measured at many locations surrounding the GFL facility, including residential areas. It is possible the relatively low wind speeds resulted in temporary stagnant conditions resulting in the inability for contaminants to disperse. A summary of measured TRS exceedances is shown in Table 8. Figure 8 plots the rolling 10-minute TRS average concentration time series.

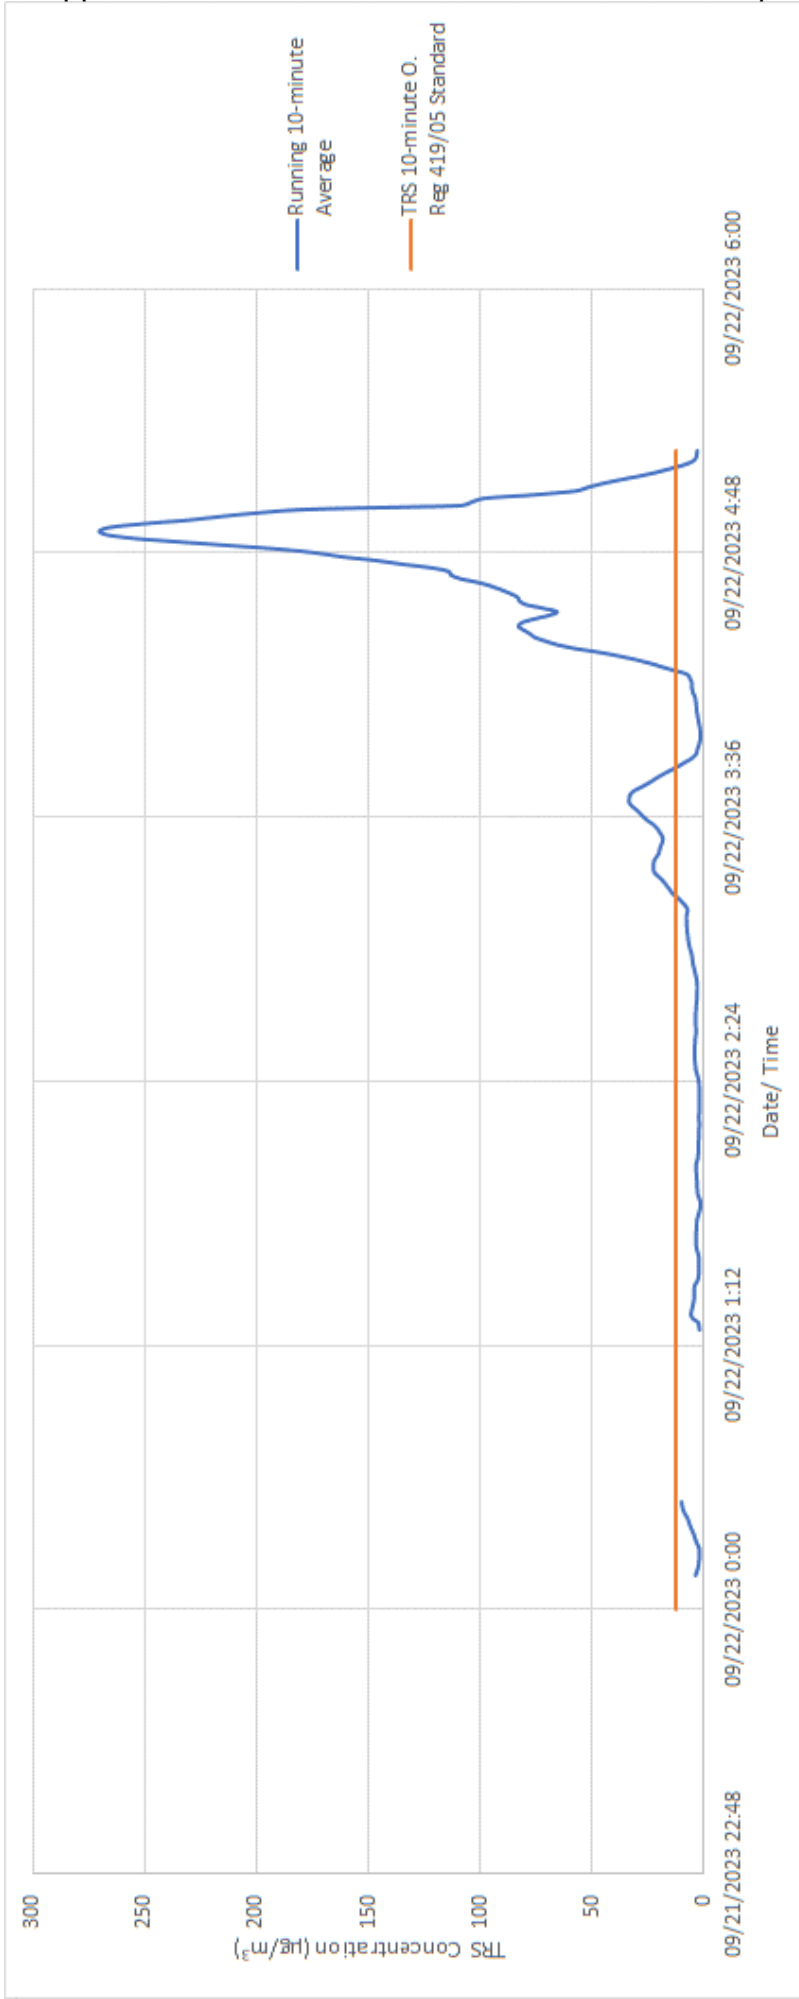
# Figure 9 – GFL Environmental - September 22, 2023 Ambient Air Monitoring Assessment Survey Running 10-minute Average TRS Concentrations

On September 22, 2023 from 4:40 a.m. to 4:50 a.m., the Ministry found that the maximum 10-minute Total Reduced Sulfur concentration to be 266.5 µg/m<sup>3</sup> which was above the Total Reduced Sulfur 10-minute odour-based O. Reg. 419/05 Standard of 13 µg/m<sup>3</sup>. This 10-minute standard is based on odour and, therefore, comfort for residents. The Ministry measured this maximum concentration along the Facility western property line approximately 500m from the nearest residence. Additionally, the Ministry measured a total of twenty-nine 10-minute Total Reduced Sulfur O. Reg. 419/05 Standard exceedances over the following dates: September 14, 15, 22, 28 and 29, 2023. These Total Reduced Sulfur exceedances were measured by the Ministry at many locations surrounding the Facility including residential areas. Hence, exceedances above the standard may understandably decrease comfort for residents

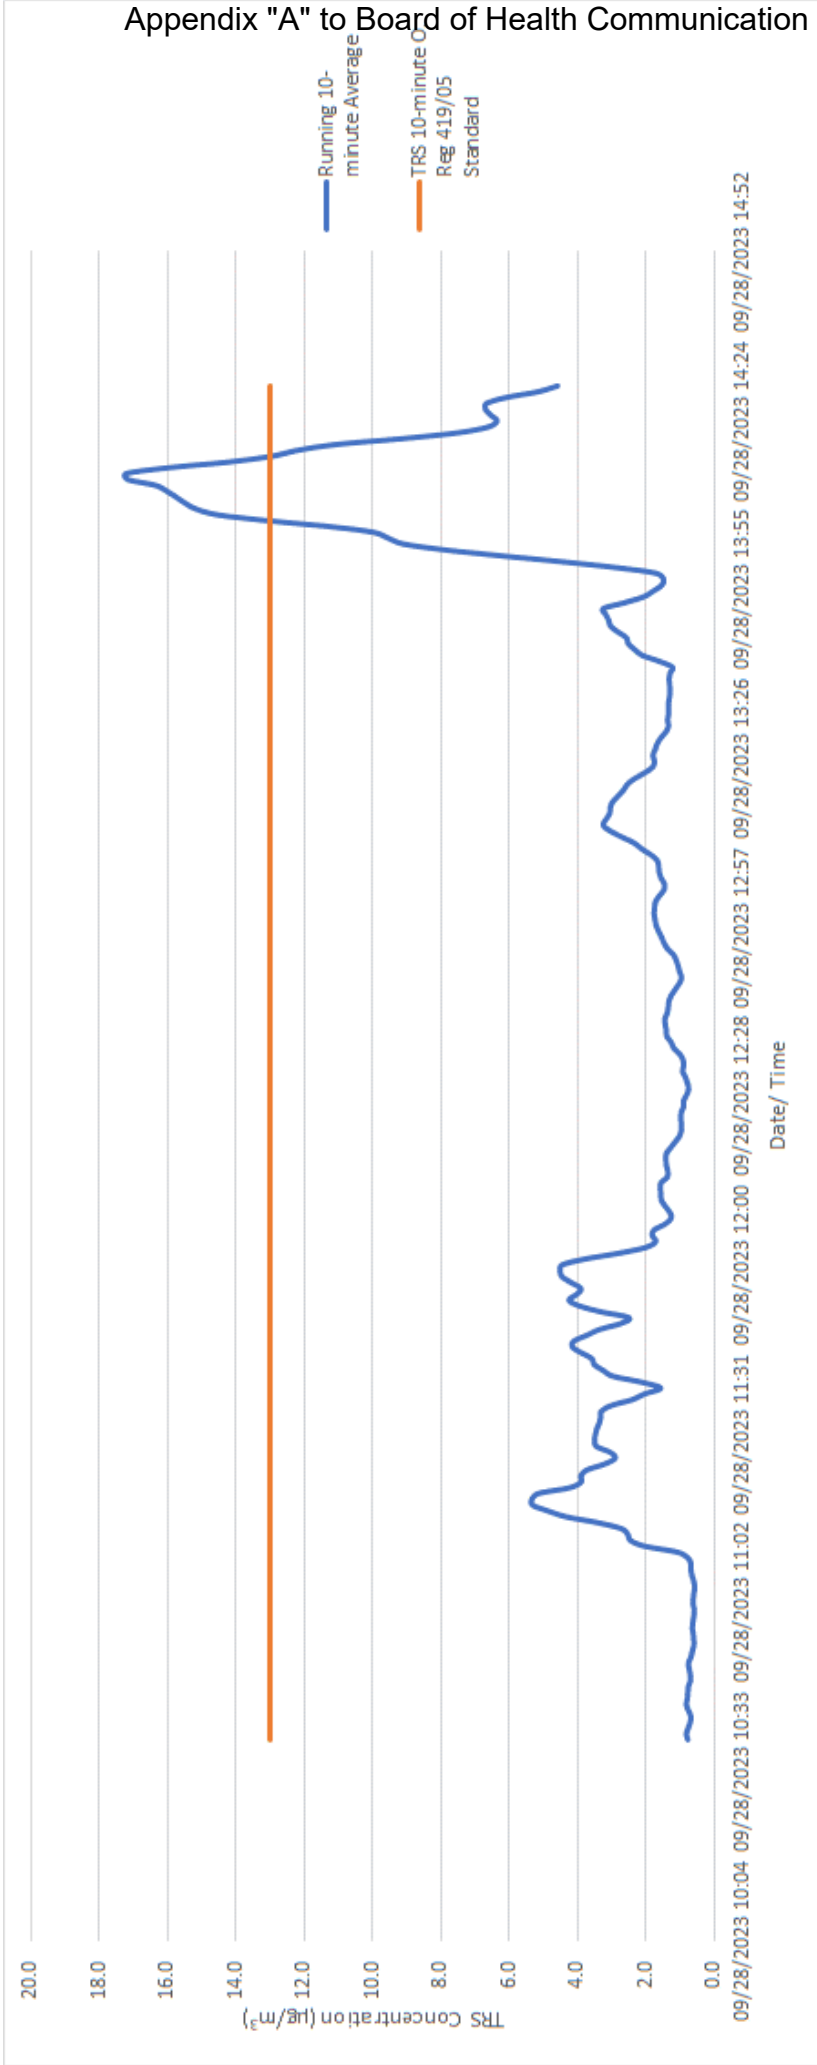
**Figure 10 – GFL Environmental - September 28, 2023 Ambient Air Monitoring Assessment Survey Running 10-minute Average TRS Concentrations**

A maximum 10-minute TRS concentration of 17.2 µg/m<sup>3</sup> was measured on September 28, 2023 from 13:58 - 14:08, which exceeds the 10-minute TRS O. Reg. 419/05 Standard of 13 µg/m<sup>3</sup>. The maximum was measured approximately 250m from the nearest residence. A total of two (2) exceedances of the TRS 10-minute O. Reg. 419/05 Standard were measured over this six-hour period. Both exceedances were measured southwest of the leachate pond which is a potential source of odours. Relatively low wind speeds likely resulted in temporary stagnant conditions resulting in the inability for contaminants to disperse. A summary of measured TRS exceedances is shown in Table 8. Figure 10 plots the rolling 10-minute TRS average concentration time series.

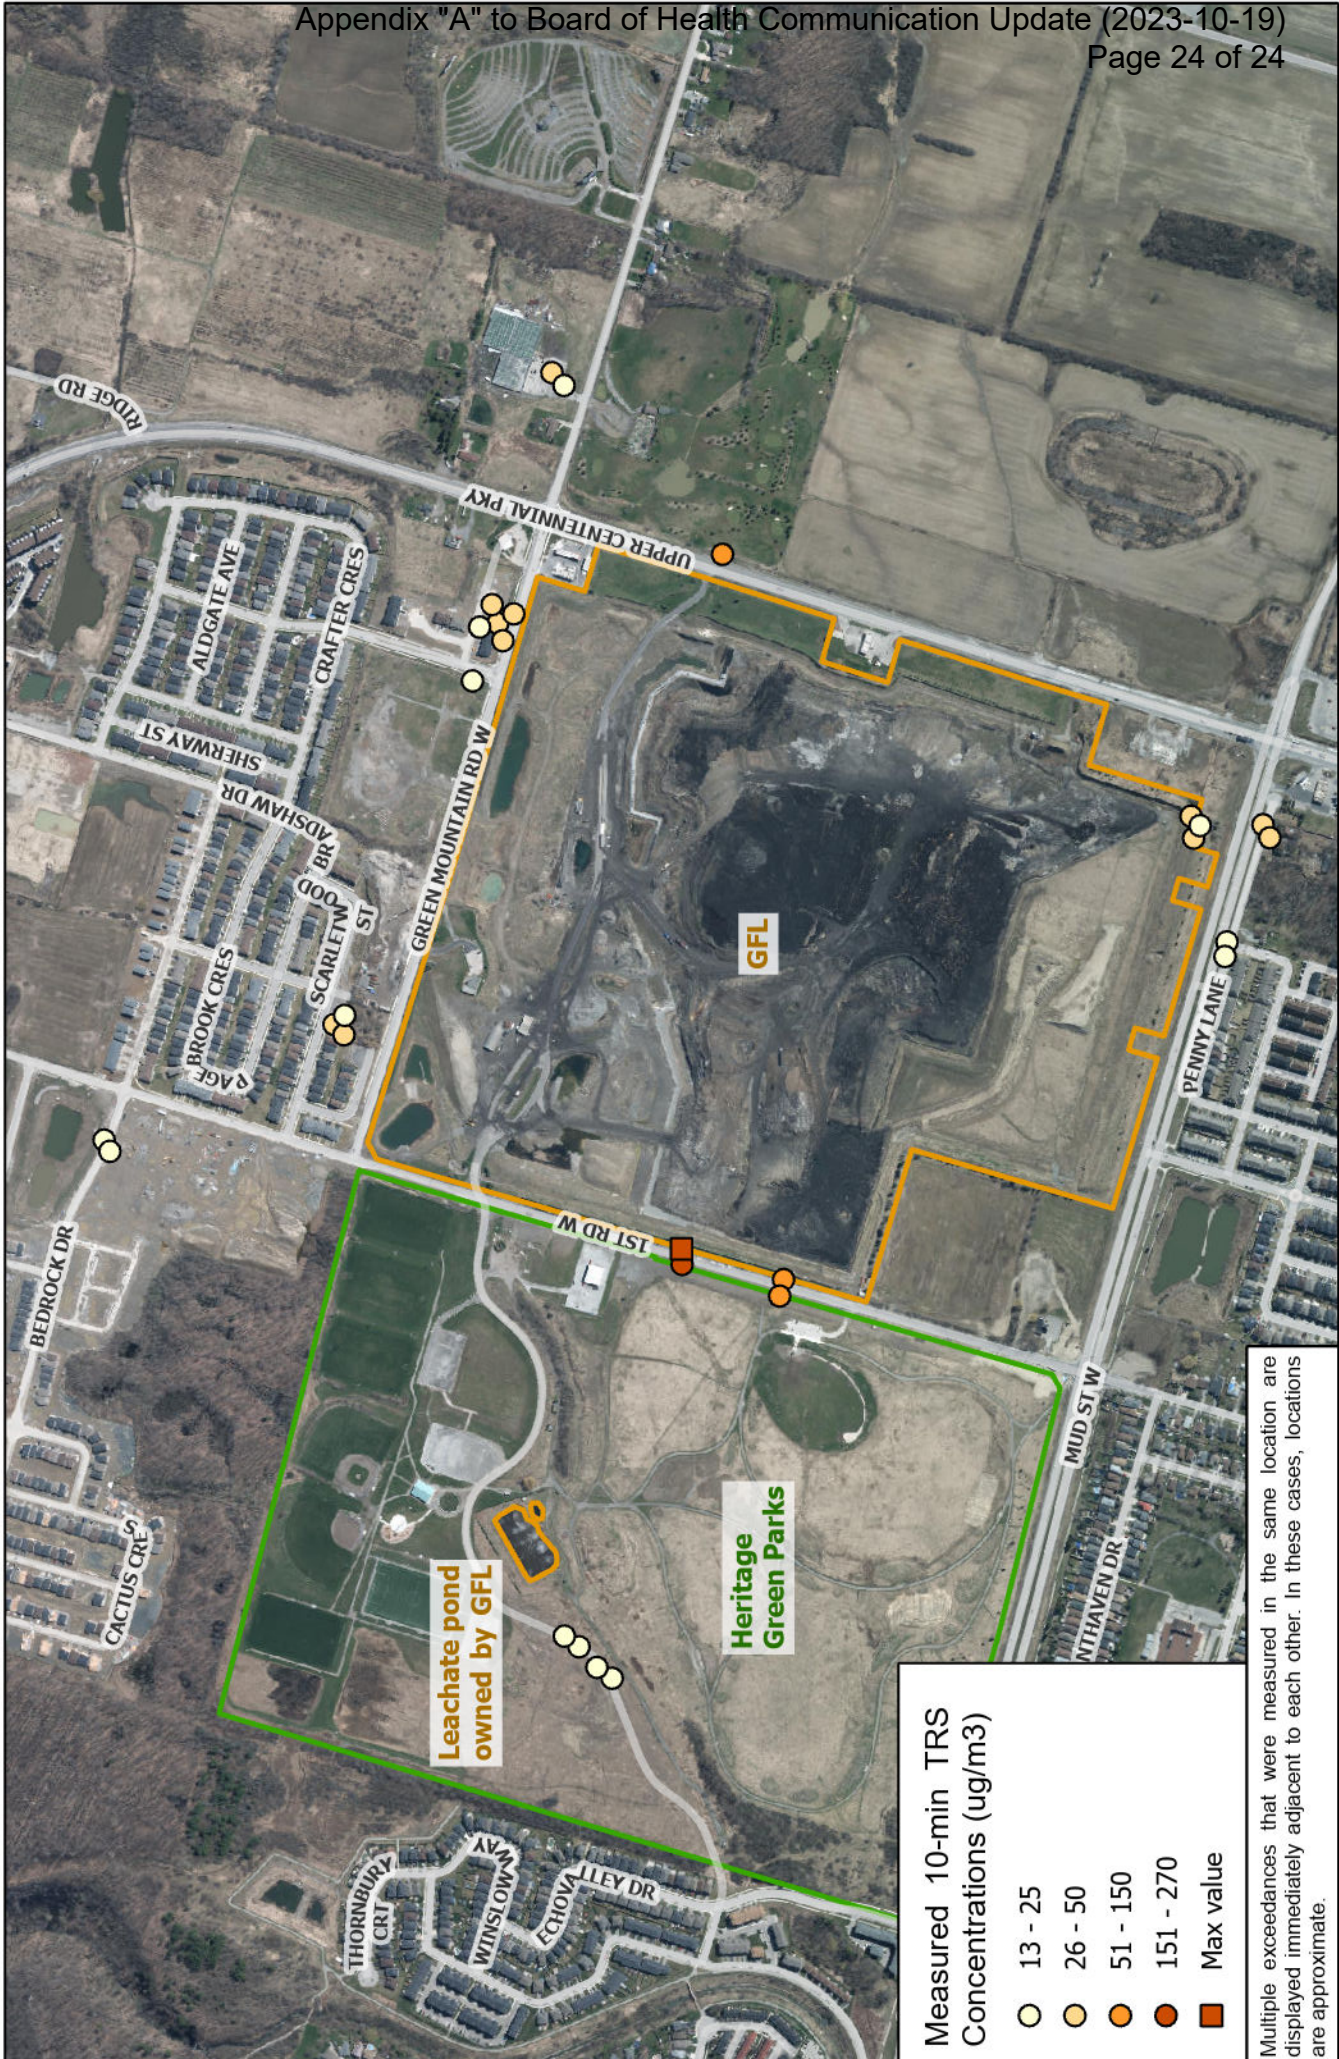
Information provided by:  
Ministry of the Environment and Climate Change  
Ministry of Natural Resources and Forestry

Coordinate System: NAD 1983 UTM Zone 17N  
Projection: Transverse Mercator  
Datum: North American 1983
