## February 27, 2024 Committee of Adjustment – City of Hamilton

### RE: SC/B-24:01294 Green Road, Stoney Creek (Ward 10)

### RE: SC/A-24:04294 Green Road, Stoney Creek (Ward 10)

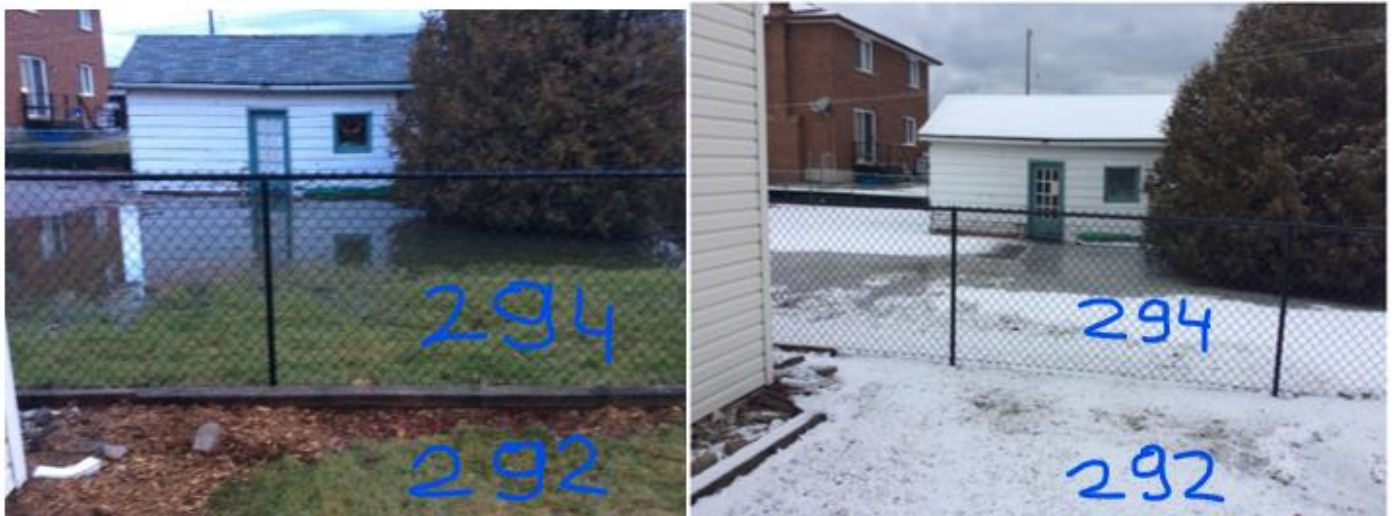
**Fig. 1.** Flooding of 294 Green Road's backyard during winter 2022 as seen from our property.

Our major concern however is with the potential changes to the lot grading and its effect on existing stormwater drainage and seasonal flooding issues facing our properties (Fig. 1 & 2). If there is to be any consideration for severing, re-zoning, or redeveloping this land, a survey of the existing watersheds and their efficacy should be conducted by the applicant and/or the City of Hamilton. Any land grading increases to 294 Green Road will lead to significant flooding to my property.

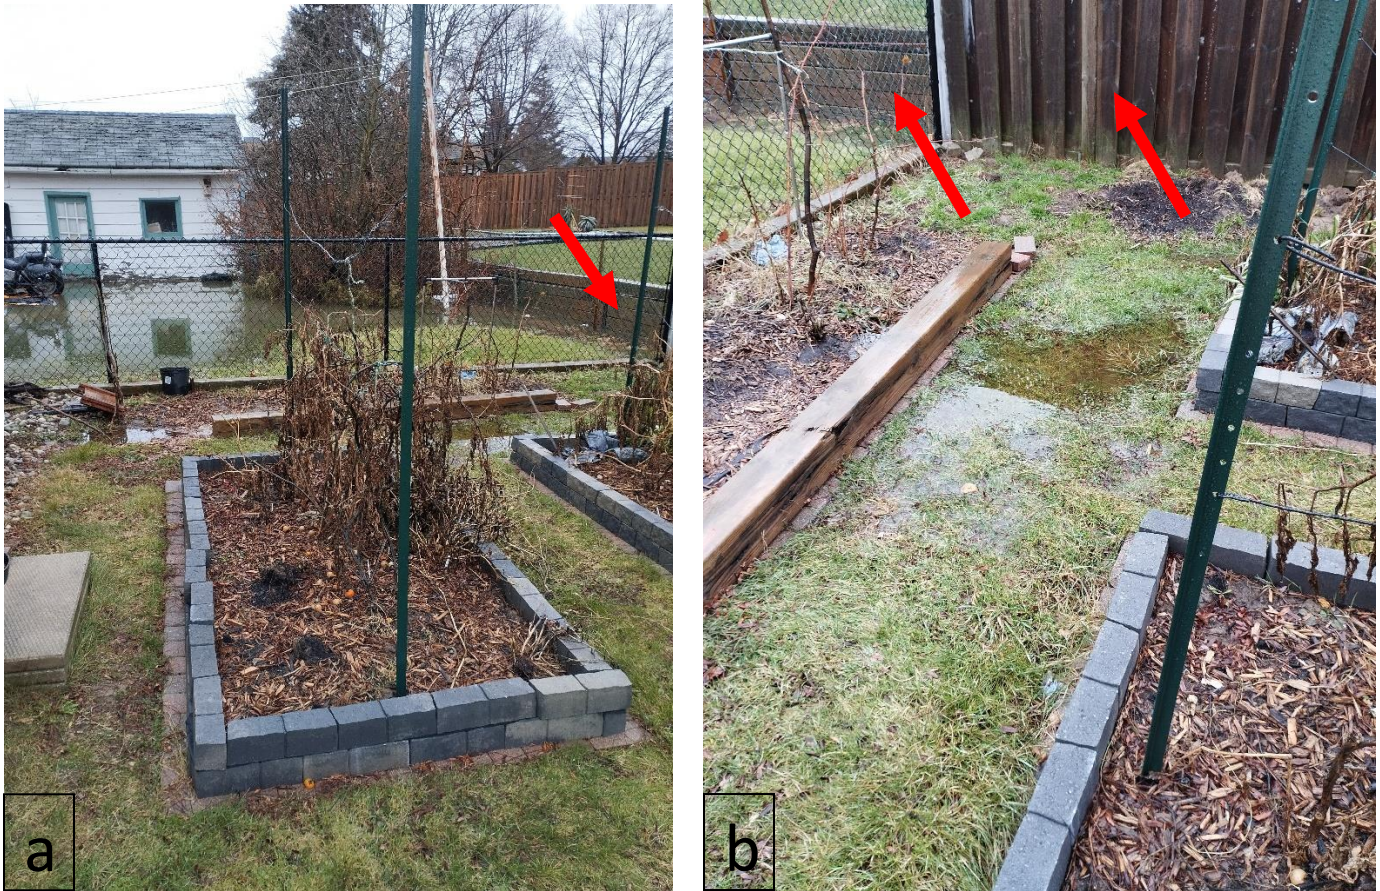
**Fig. 2.** Flooding of 294 (a) and 292 Green Road (b) during fall 2023 with retaining wall between 106 Seaton Place Drive.

Per communications with our neighbour at 106 Seaton Place Drive that backs onto both our properties, and the previous owner of 294 Green Road, this matter has been brought to the attention of the City of Hamilton staff, and the previous Ward 10 Council (Maria Pearce) over the past few years and has not been resolved.

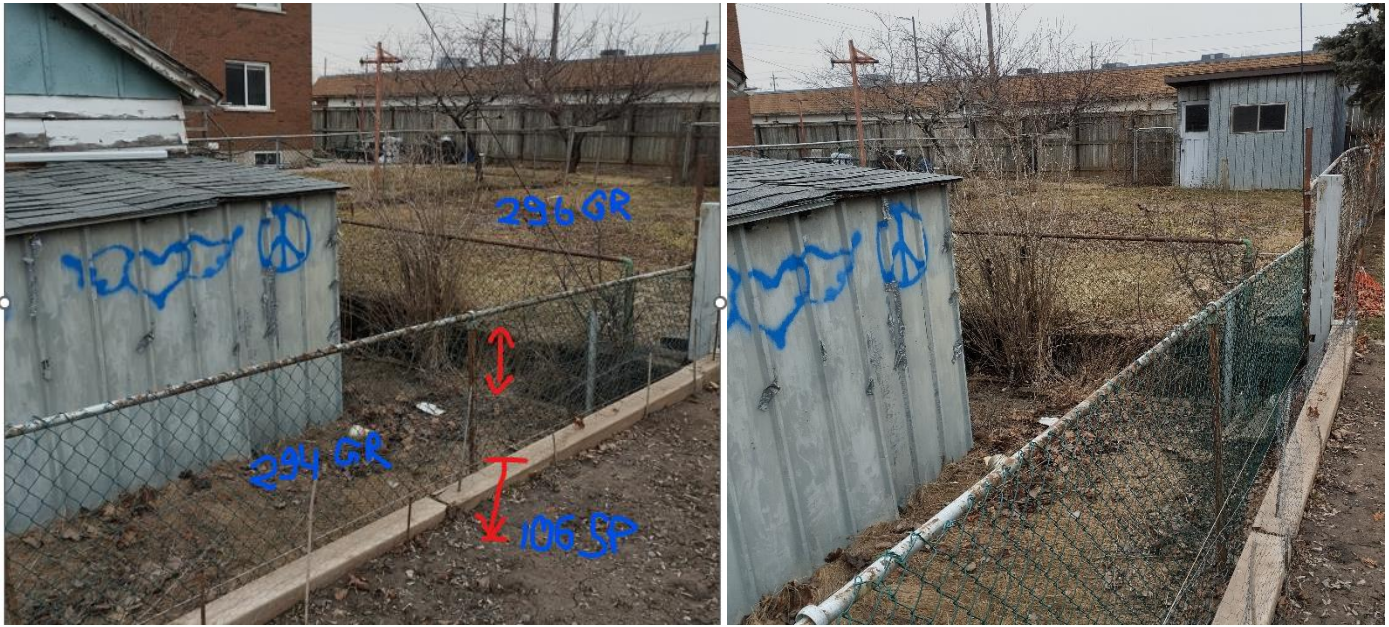
Both 294 and 292 Green Road are older homes surrounded by (approved) newer developments. All the properties surrounding us have a retaining wall of up to 2 ft above (our) ground level (Fig. 3 & Fig 4a). A water catch basin located at the north end of 104 Seaton Place Drive (blue X, Fig. 4a) is above our ground level and not draining standing water from our properties. A second water catch basin (yellow X, Fig.4a) located on the west end of 294 Green Road is positioned near the high point of the property, likewise, not alleviating the flooding issue as both properties have a downward slope from Green Road (Fig. 4b).

**Fig. 3.** Images highlighting lower grade of 294 Green Road with retaining walls separating it from 296 Green Road and 106 Seaton Place Drive (red arrows).

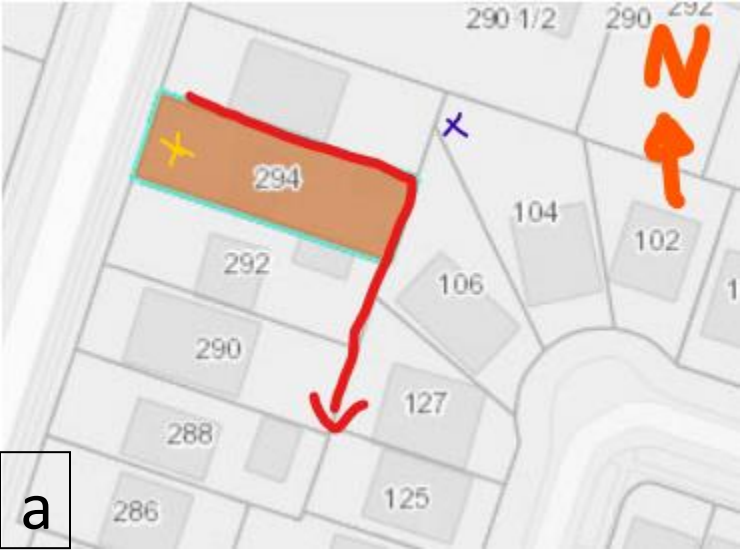
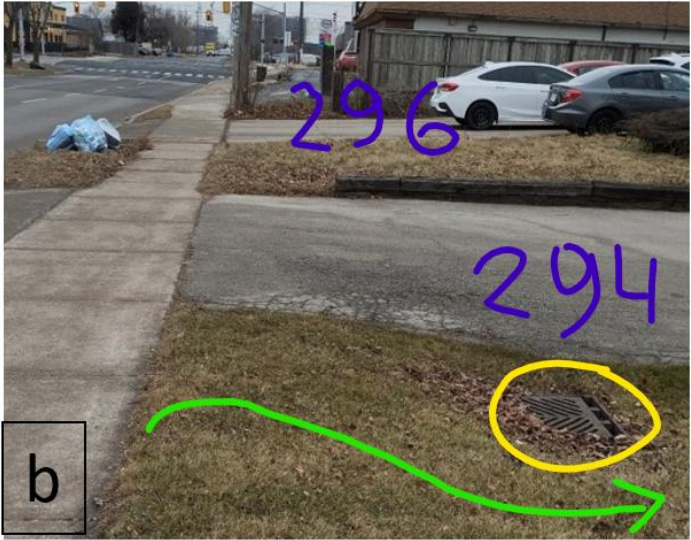
**Fig. 4.** (a) Location of retaining wall (red line) and catch basins (blue and yellow X). (b) Downward slope of 294 Green Road with the catch basin (yellow) near the high point compared to even grade of 296 Green Road.

We are using this opportunity to bring public light to this issue and request action or advice on the part of the City of Hamilton.
