City of Hamilton - Heritage Permit Application Note Sheet

Address: 155 Main Street North, Flamborough (Crimson Maples / Mill Street HCD, Part V)

Permit Number: HP2025-003

Description of proposed alterations:

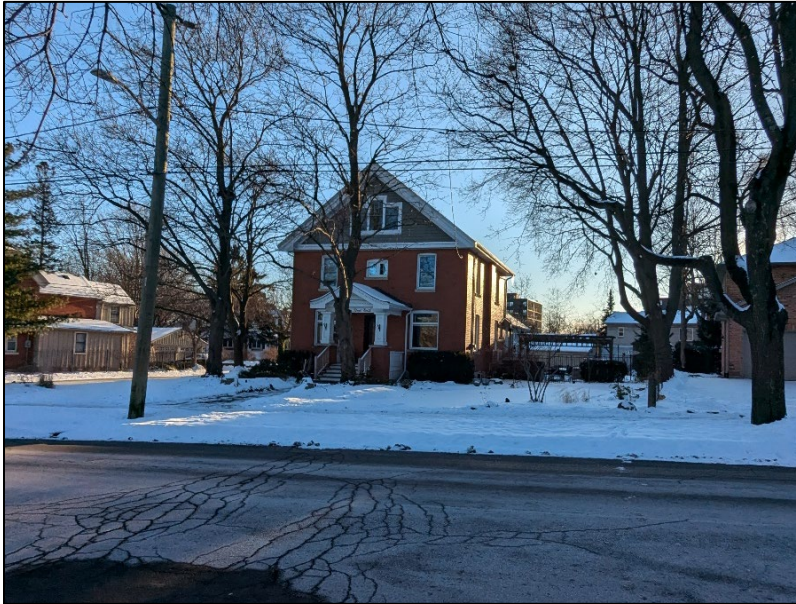
Figure 1: View of the Property and Existing Garage from Main Street North (c.o. Site Visit, January 14, 2025)

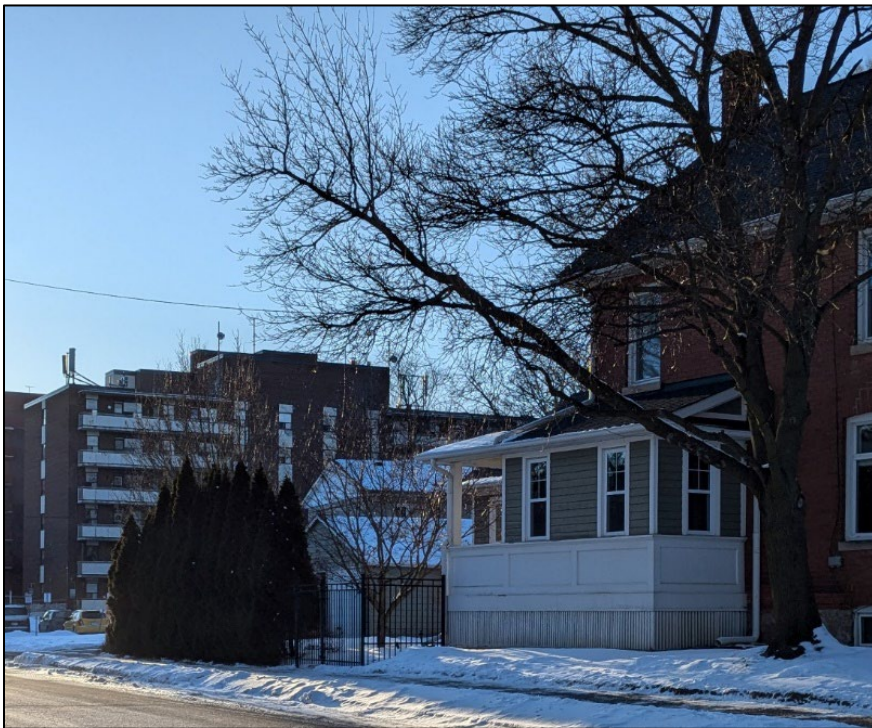
Figure 2: View of the Property and Existing Garage from South corner of the John Street North and Main Street North intersection (c.o. Site Visit, January 14, 2025)

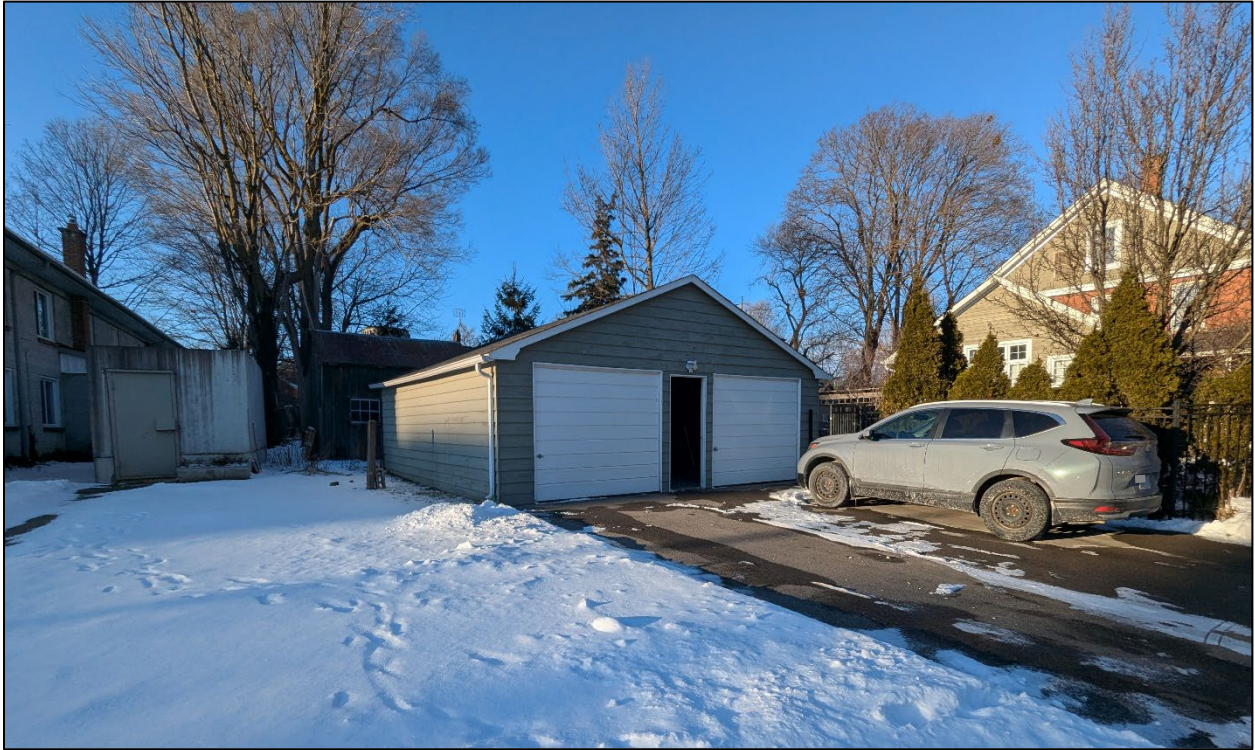
Figure 3: View of the Existing Garage and shed behind as seen from John Street (c.o. Site Visit, January 14, 2025)

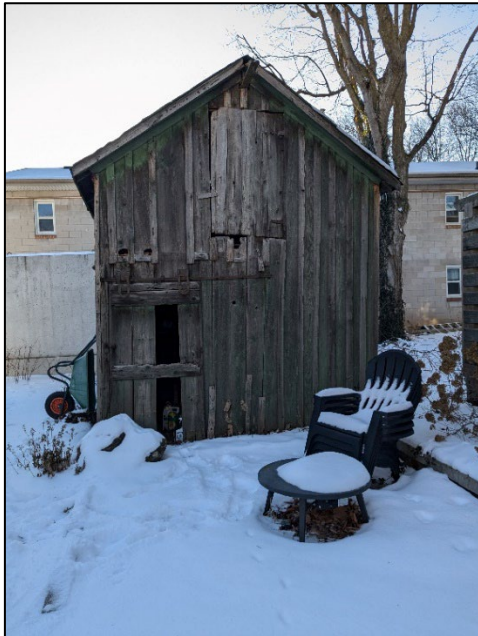
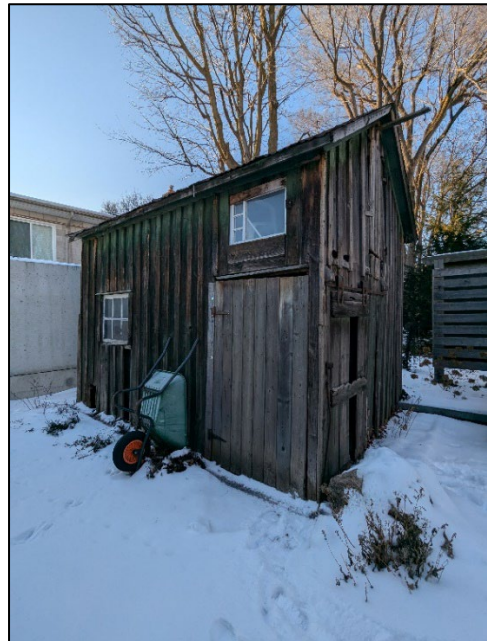
Figures 4 and 5: Front (left) and side (right) elevations of the existing shed structure to be demolished (c.o. Site Visit, January 14, 2025)
