# HERITAGE IMPACT ASSESSMENT

164 - 168 KING STREET EAST  
HAMILTON, ON

25 JULY 2022

MEGAN HOBSON CAHP  
M.A. DIPL. HERITAGE CONSERVATION  
Built Heritage Consultant  
[mhobson@bell.net](mailto:mhobson@bell.net)

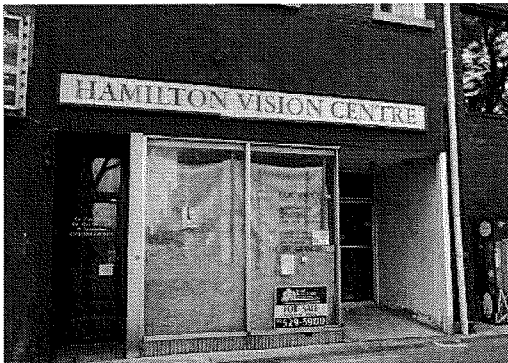
No historic fabric on the ground floor

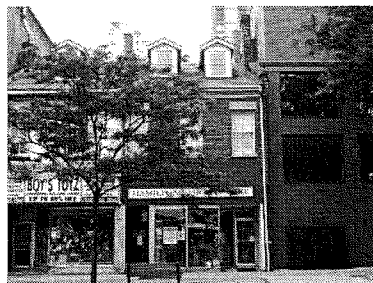
164 KING E – built 1872, heavily altered.

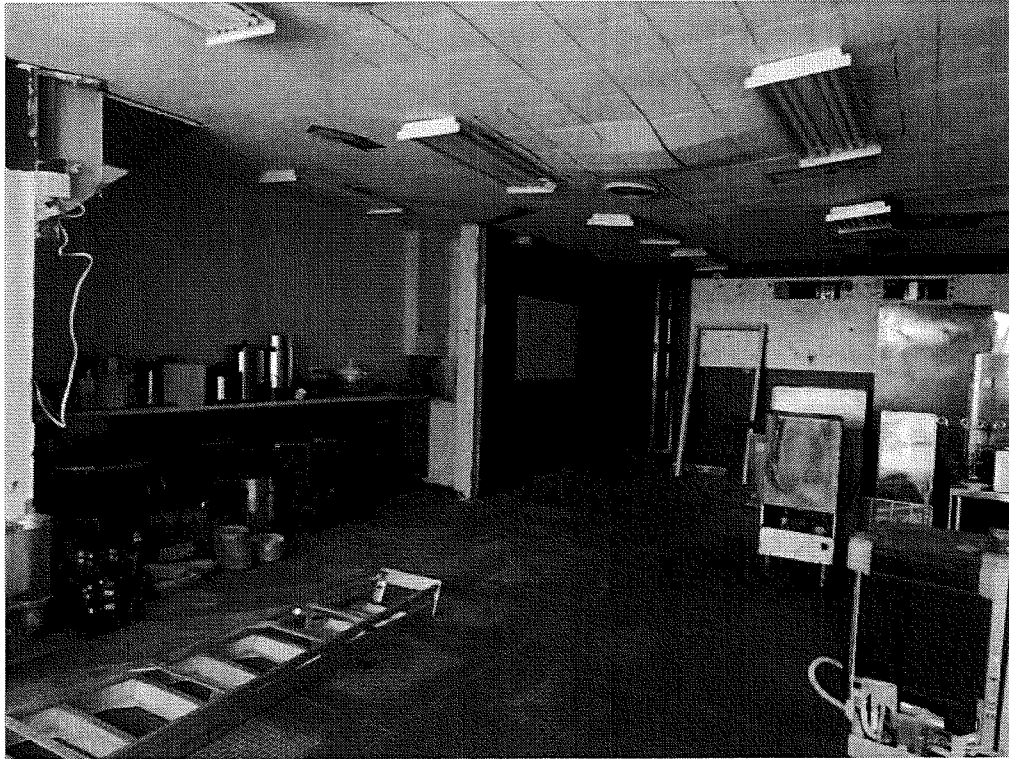
1<sup>ST</sup> FLOOR COMMERCIAL SPACE – no historic fabric

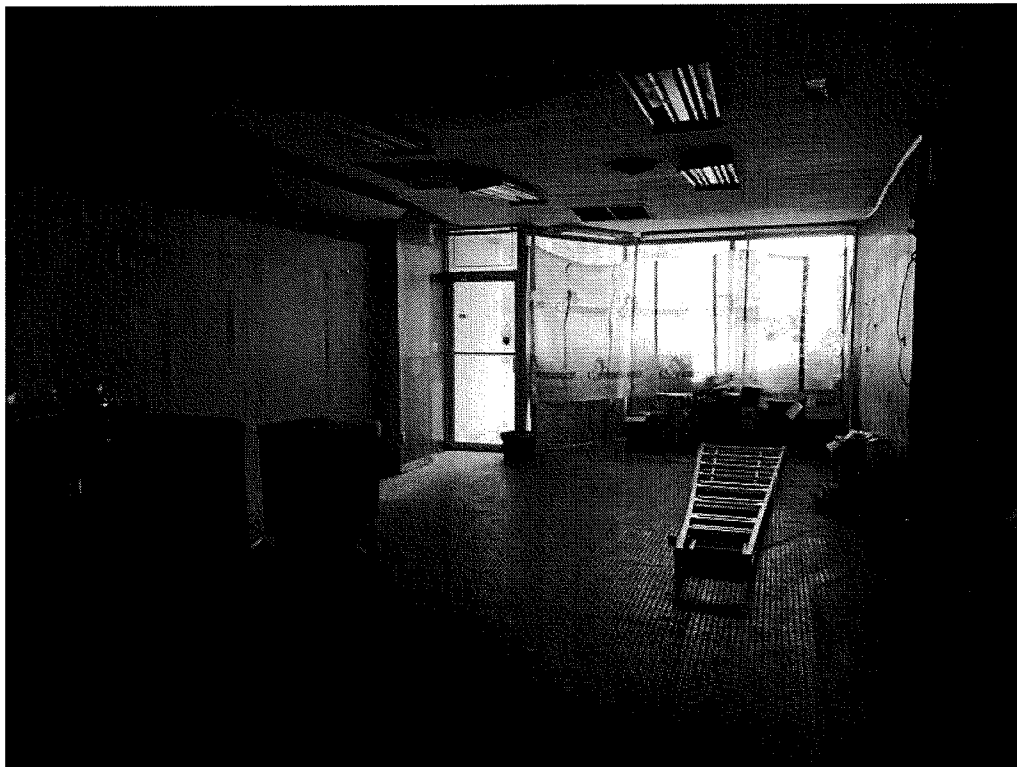
1<sup>ST</sup> FLOOR COMMERCIAL SPACE – no historic fabric

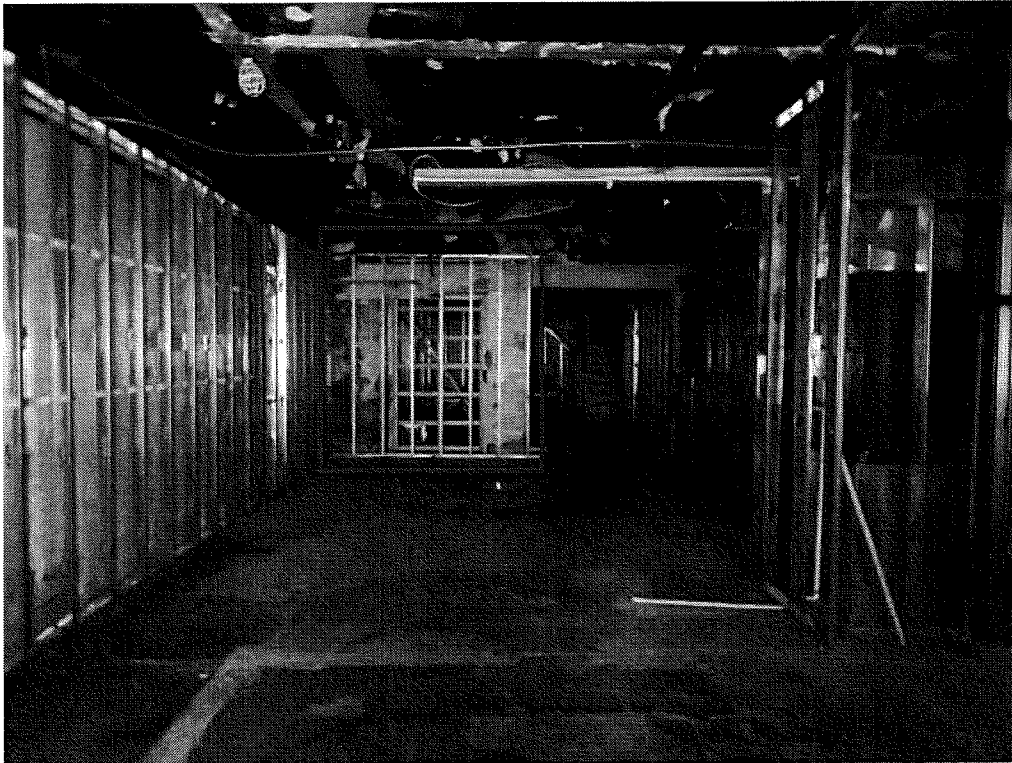
1<sup>st</sup> FLOOR – rear section – this area has been gutted – note the exterior wall of a 19<sup>th</sup>-century brick outbuilding that was integrated into the rear addition when it was enlarged sometime before 1911

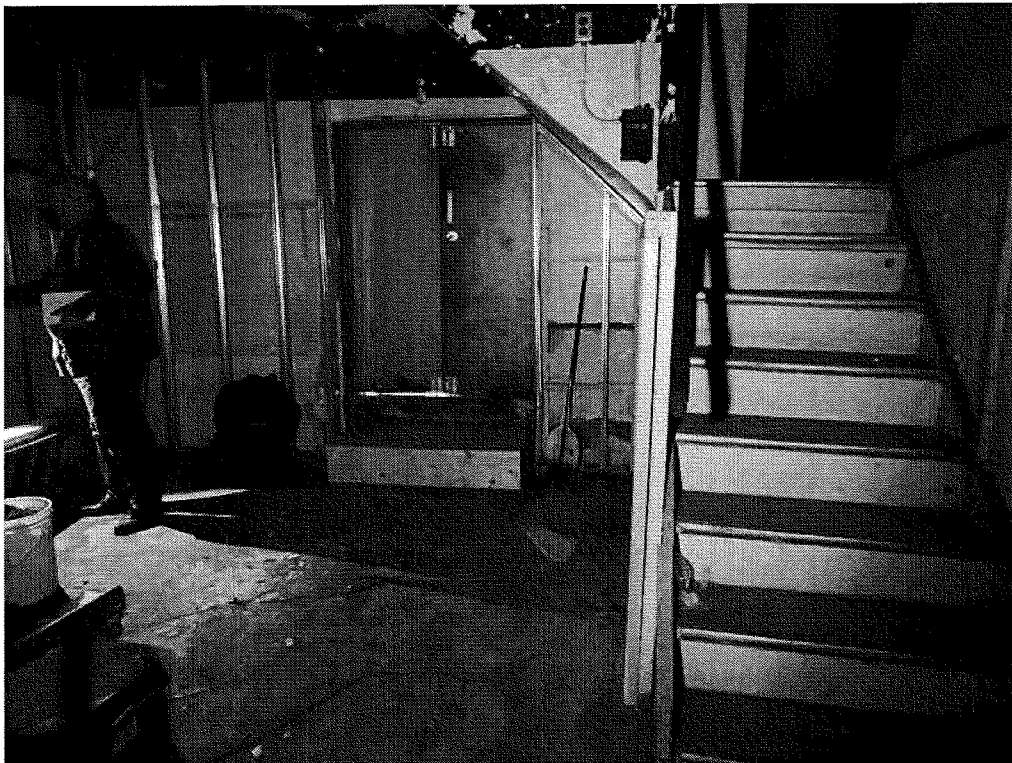
1<sup>st</sup> FLOOR – rear section – this area has been gutted – no historic fabric

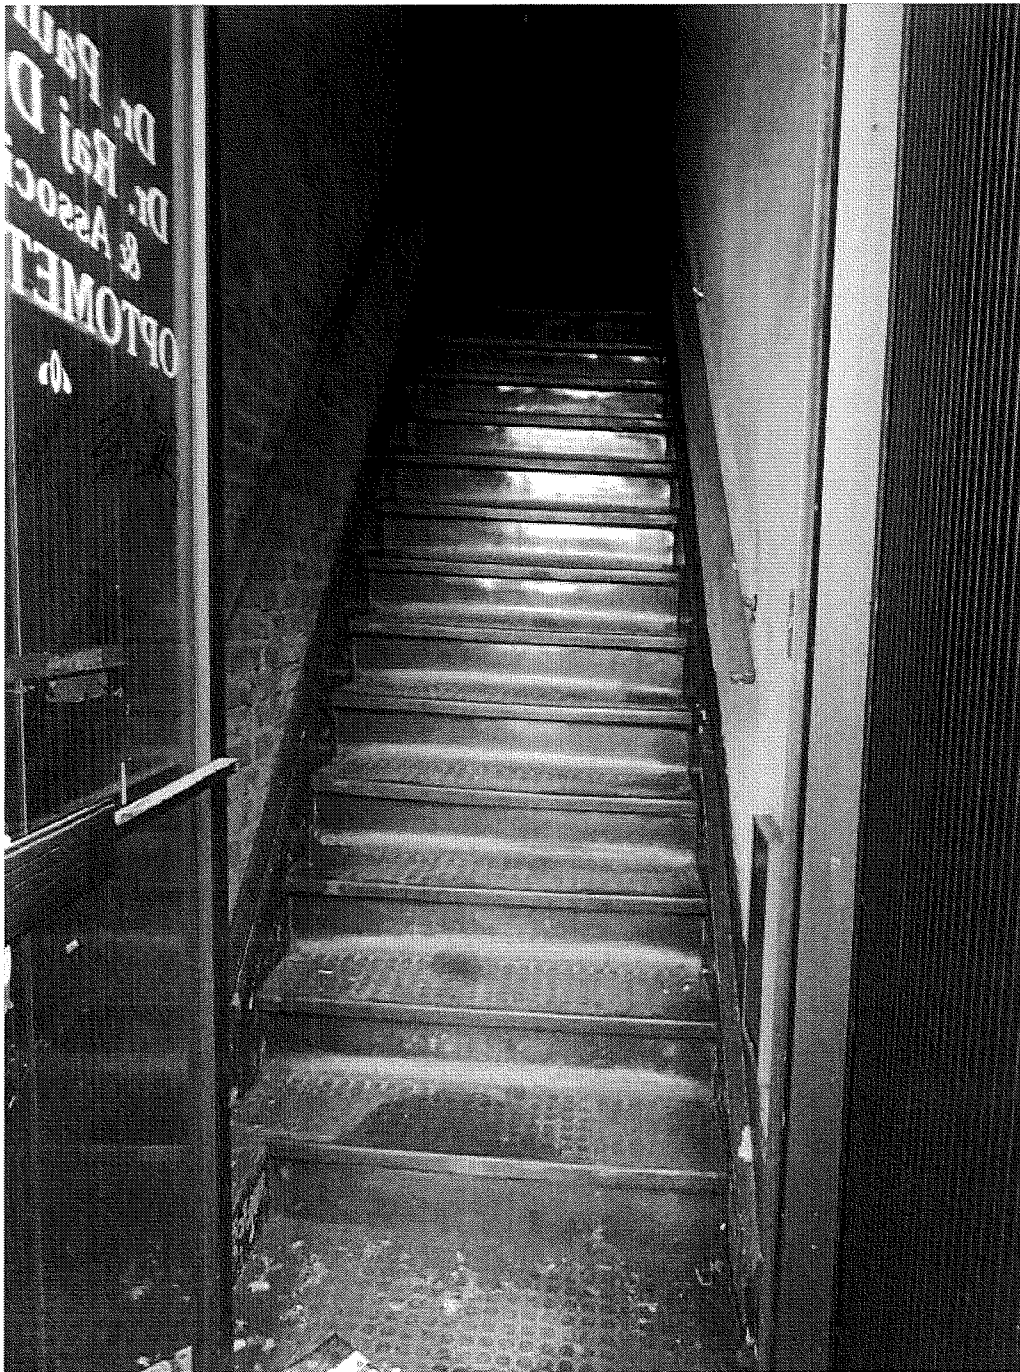
KING STREET ENTRANCE 2 – separate entrance for 2<sup>nd</sup> floor tenant – 19<sup>th</sup> century wood trim indicates an original staircase – the treads and risers have been clad in vinyl

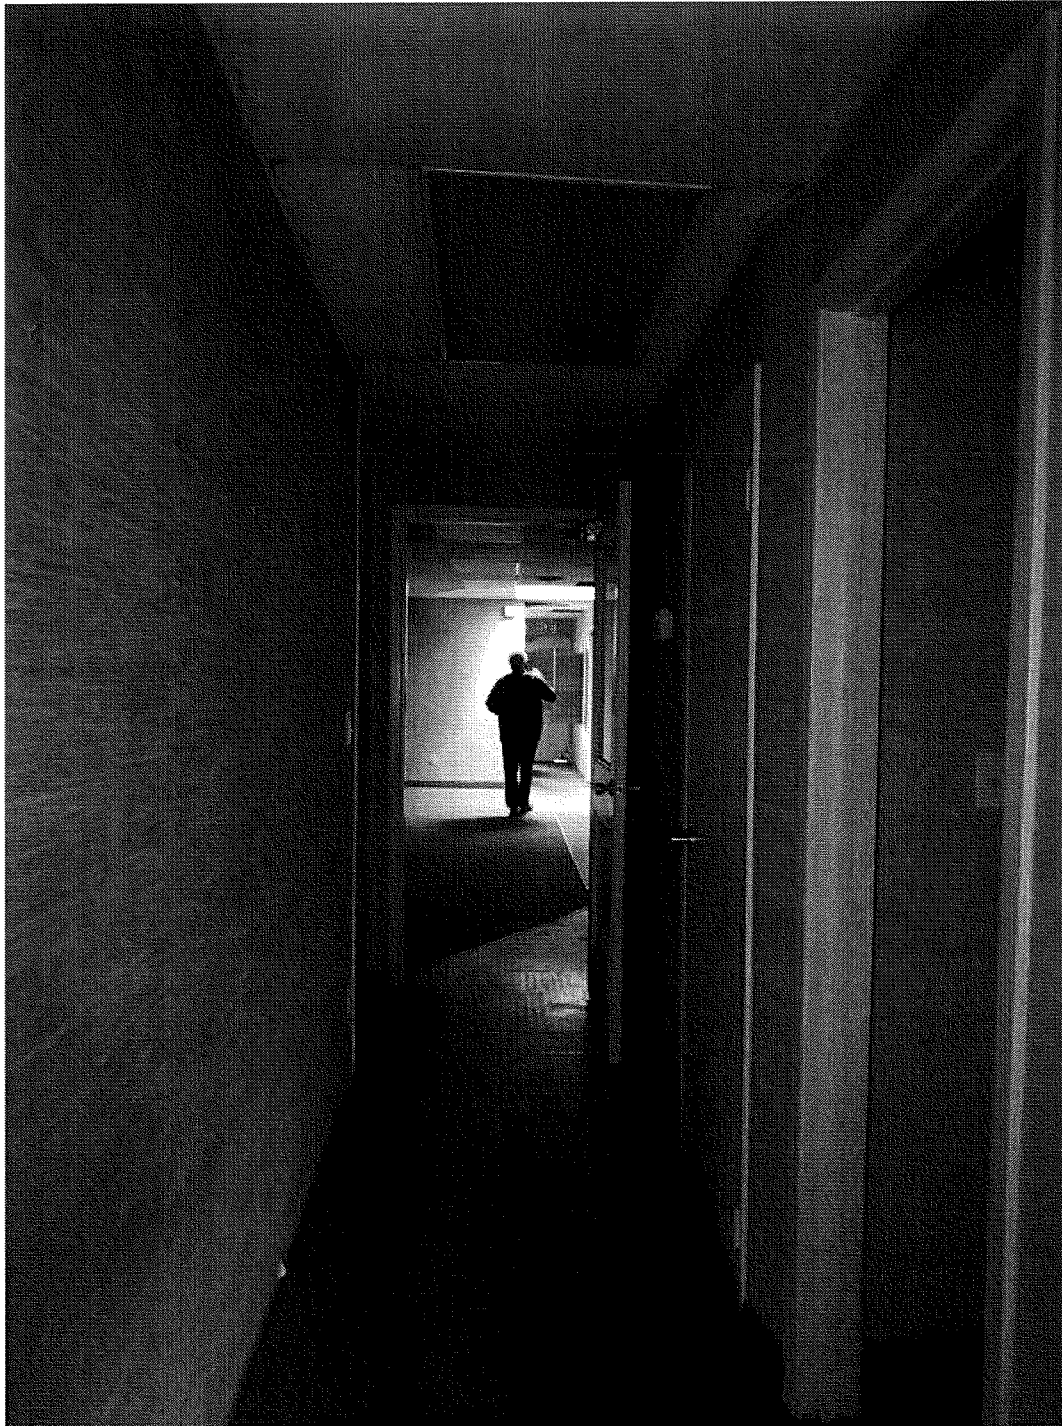
2<sup>nd</sup> FLOOR DENTAL OFFICE – no historic finishes

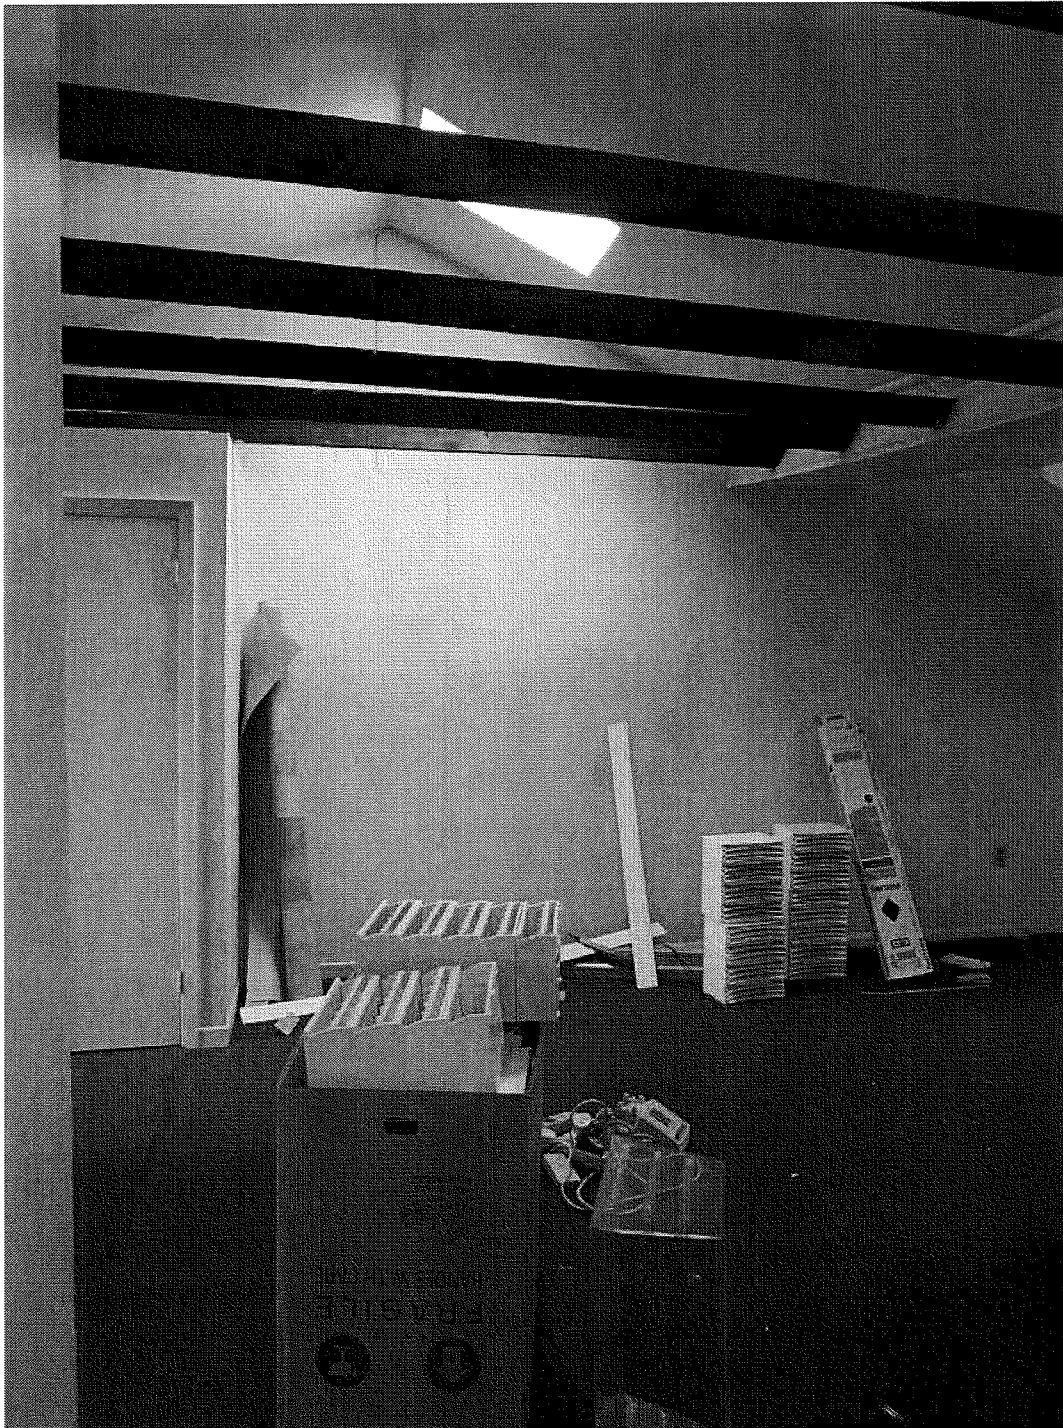
ATTIC – modern drywall and popcorn ceiling – framing timbers are exposed

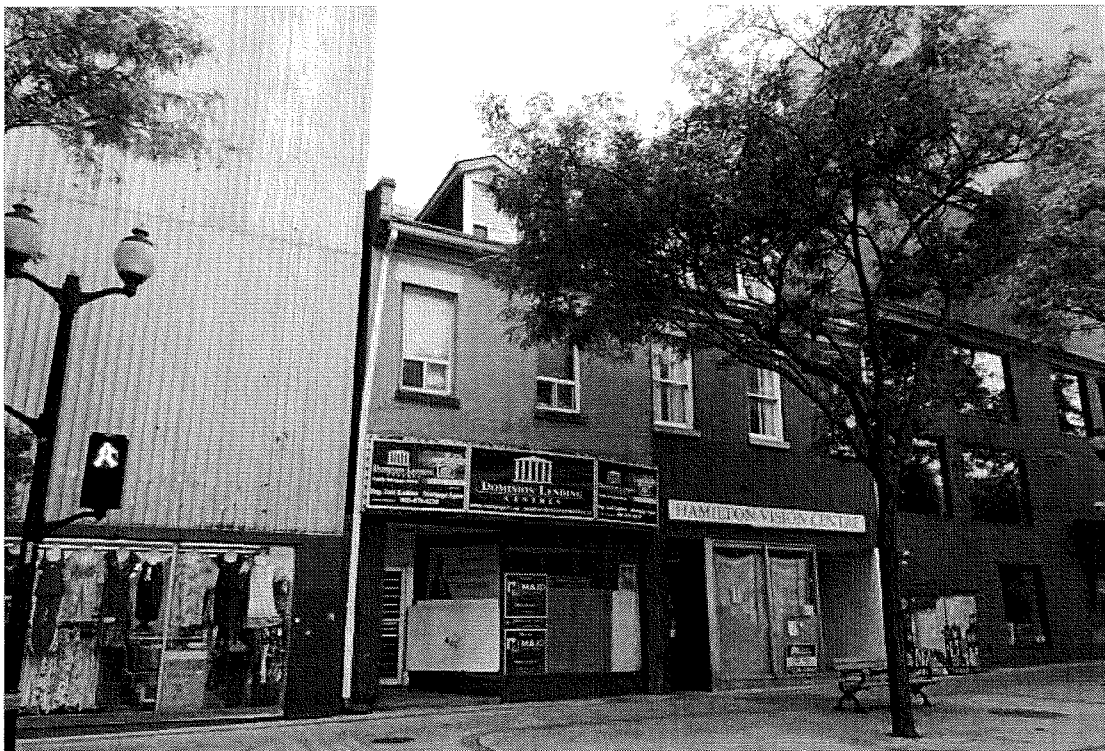
KING STREET EAST – one roof dormer

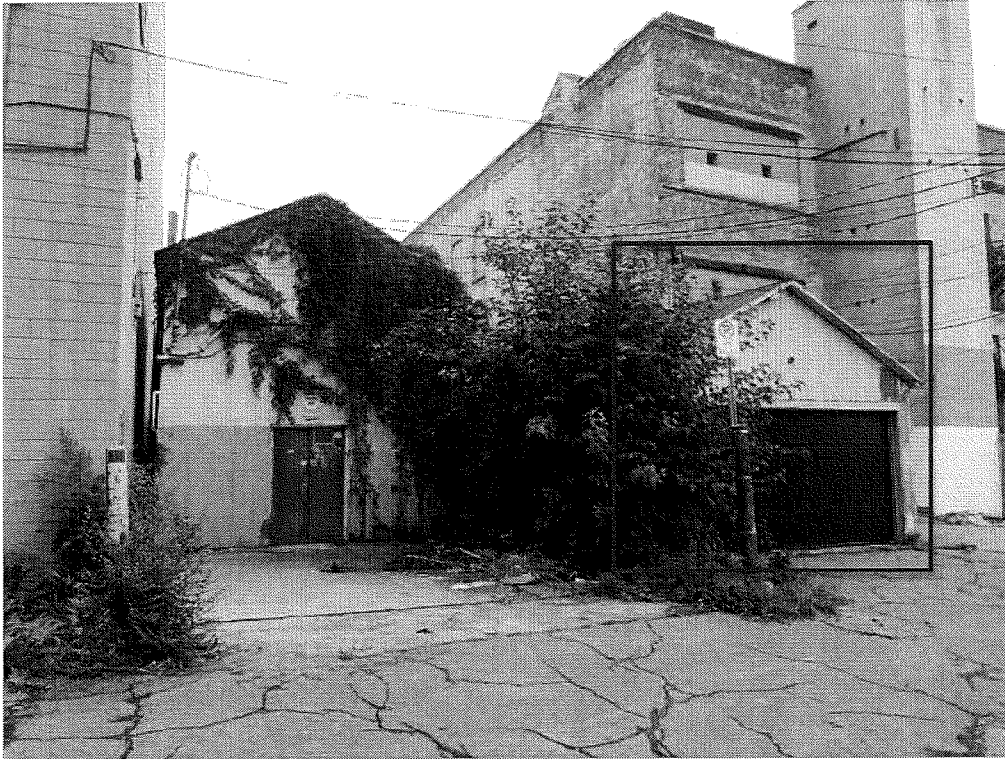
REAR FAÇADE - backs onto an alleyway and surface parking lot – there is a metal clad garage at the back

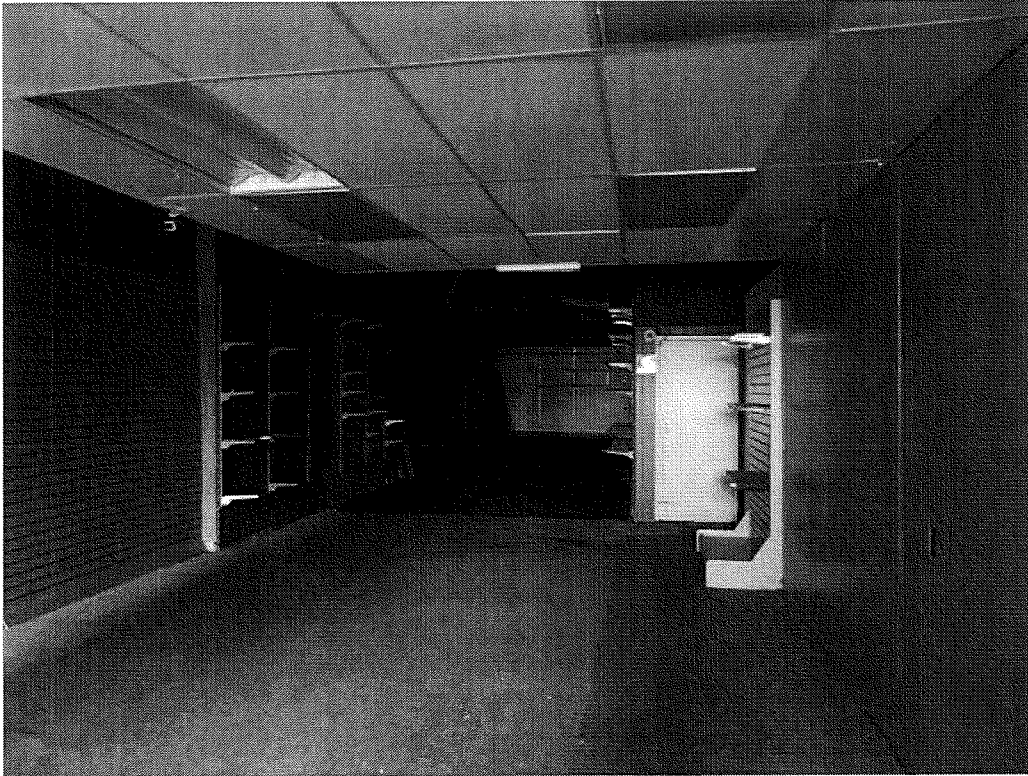
INTERIOR 1<sup>st</sup> floor – no historic fabric

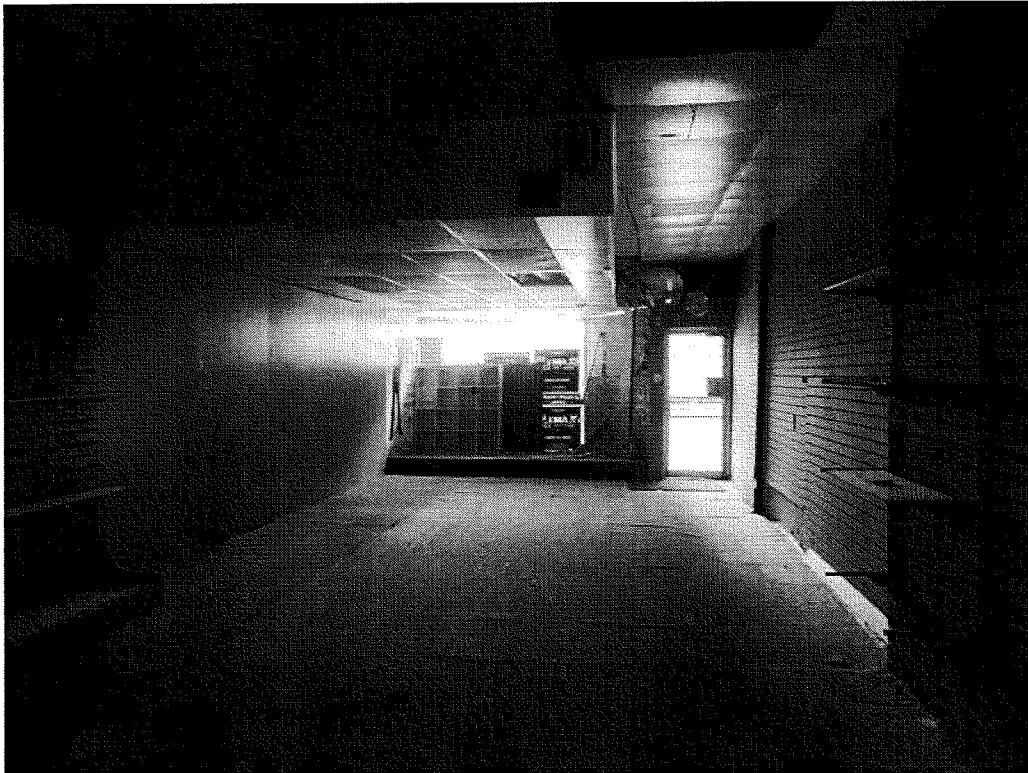
INTERIOR 1<sup>st</sup> floor – no historic fabric

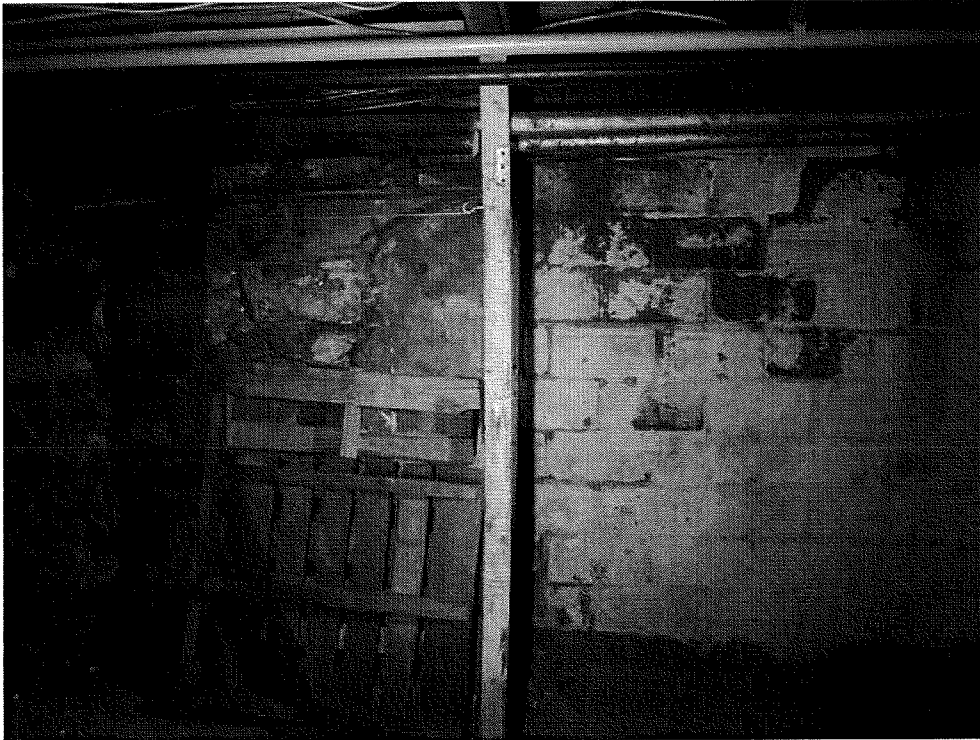
BASEMENT – rubblestone under the historic portion at the front and concrete block under the later additions at the back

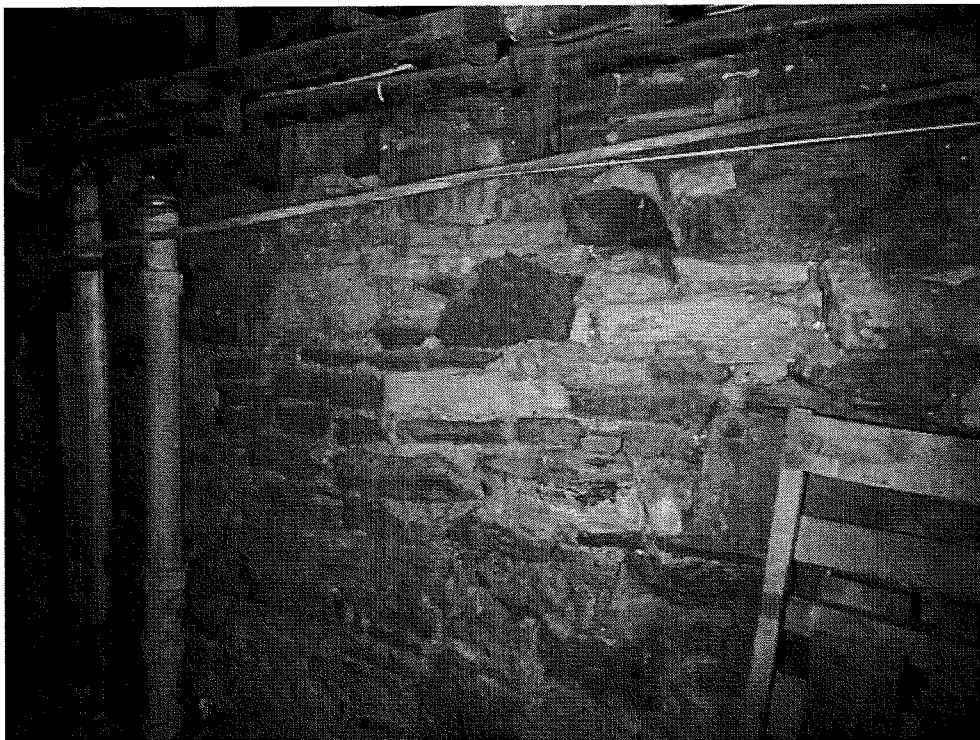
BASEMENT – original rubblestone foundation beneath the historic portion of the building

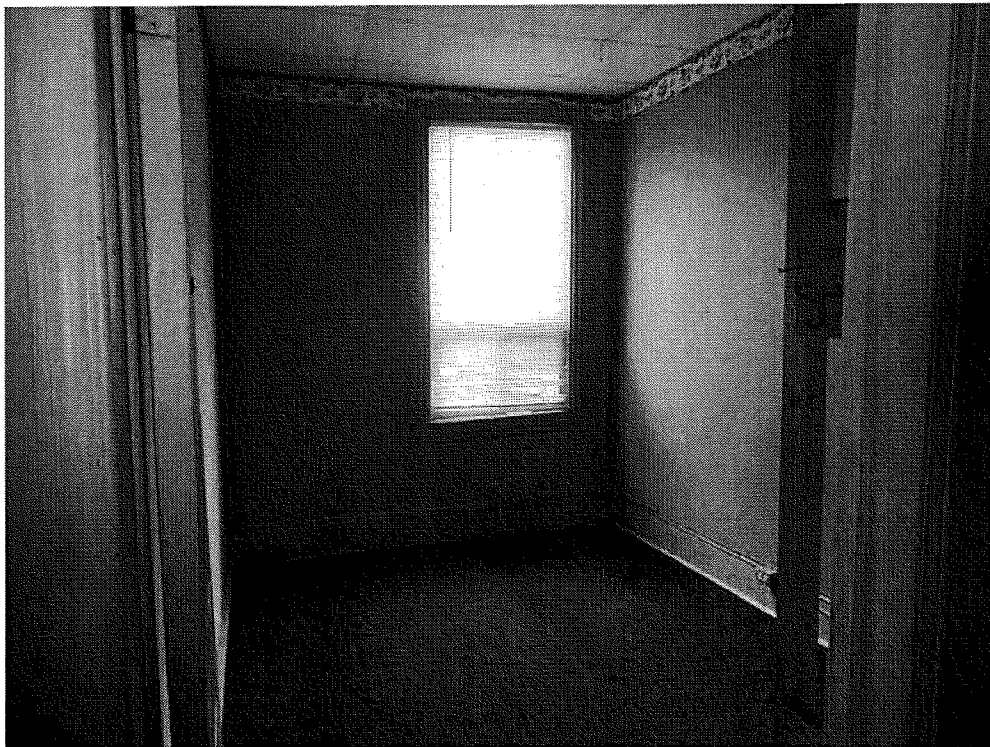
2<sup>nd</sup> FLOOR BEDROOM 1 – window trim is late 19<sup>th</sup> century

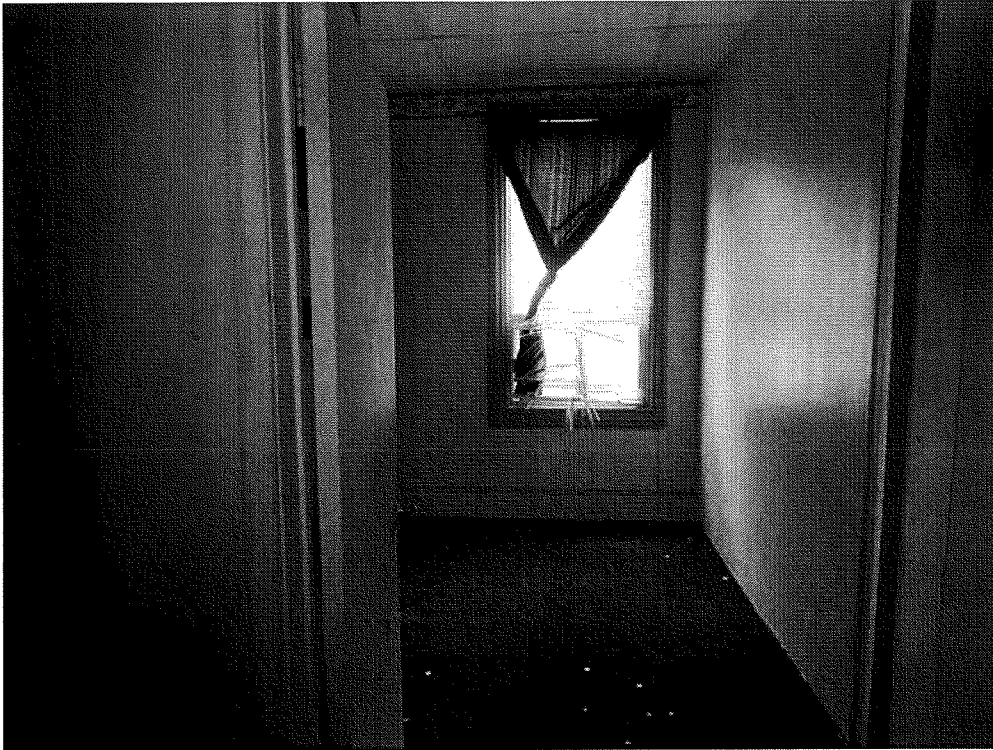
2<sup>nd</sup> FLOOR BEDROOM 2 – window trim is late 19<sup>th</sup> century

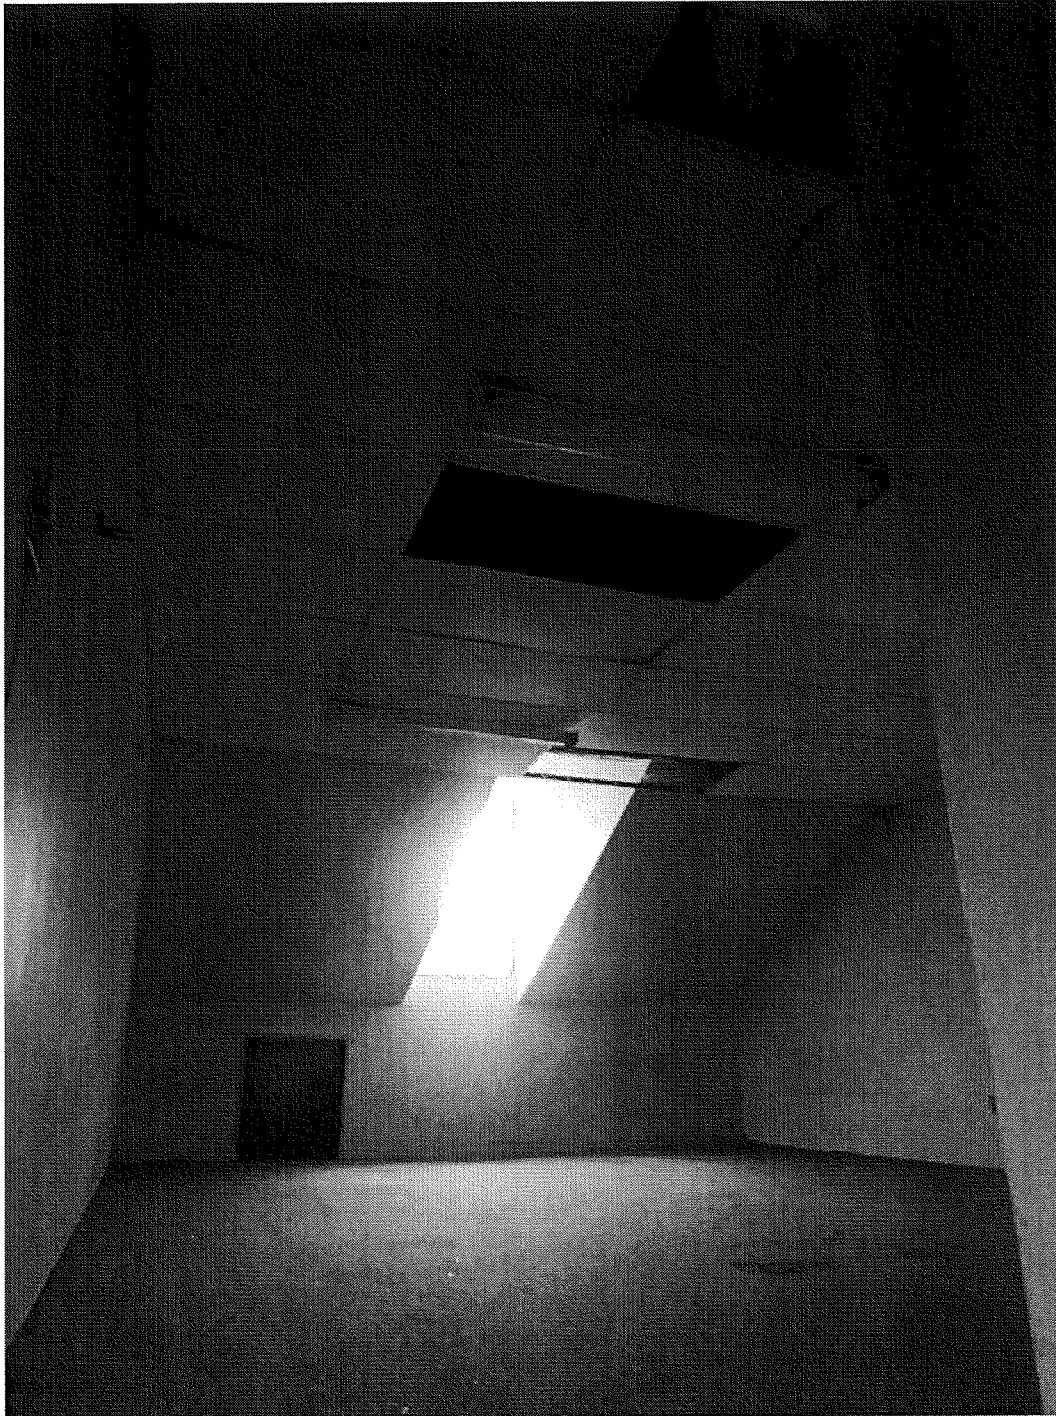
ATTIC – modern drywall and acoustic tile ceiling – no historic fabric

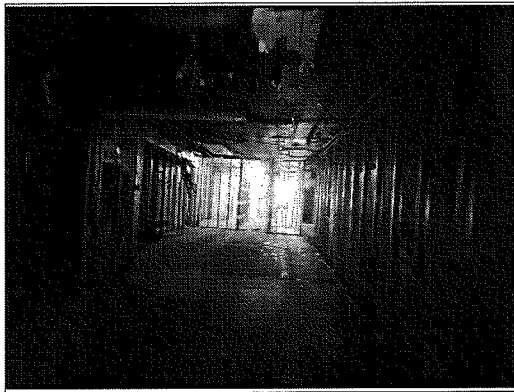
Photo 7 - Unit 164 - Ground floor - framed
