1284 Main Street East
Hamilton, ON

CULTURAL HERITAGE IMPACT ASSESSMENT

August 1, 2023

1284 MAIN STREET HAMILTON CONDITION ASSESSMENT

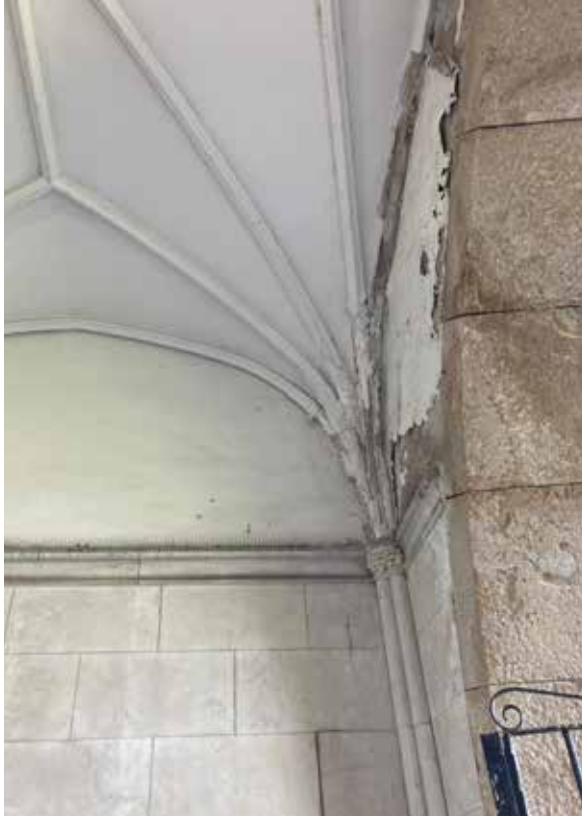
The rib vaulted entrance stair is in fair to good condition overall, with most ceiling and wall elements intact – particularly towards the top of the stair. There is some local deterioration of the stucco coating and rib elements lower down at the outer wall, notably around the upper half of the stone archway (Fig. 34 & Fig. 35). These areas appear to have suffered extensive wetting leading to corrosion and rust-jacking of the expanded metal lath, as well as localized failure of the stucco from freeze-thaw damage. There is general soiling of finish surfaces throughout, primarily from dirt and pigeon droppings (Fig. 36 & Fig. 37). Metal handrails are not original but remain serviceable.

Fig. 34. Local deterioration to to stucco and rib elements.

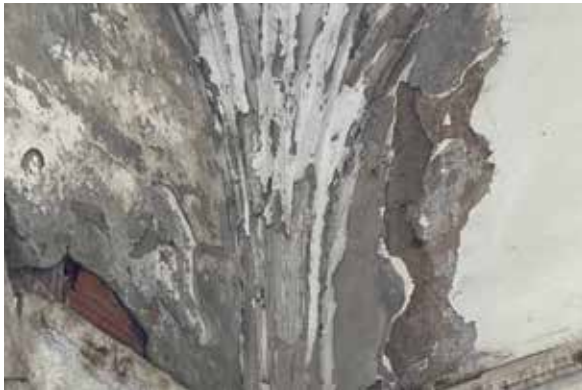
Fig. 35. Local deterioration to to stucco and rib elements.

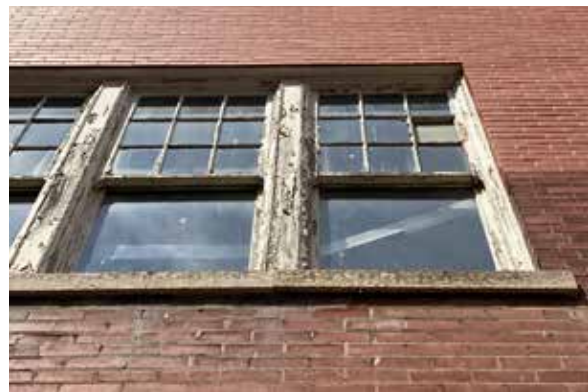
Fig. 44. Cast stone window sills.

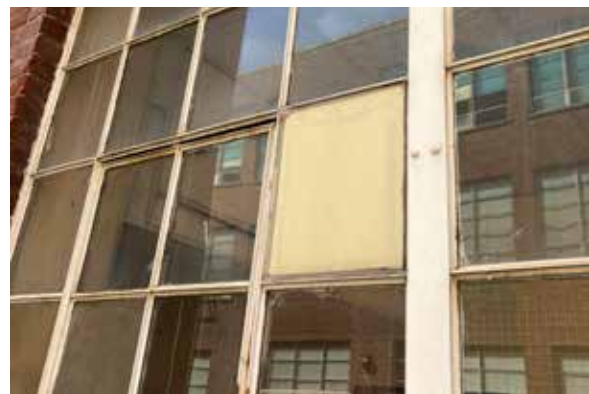
The adjacent walls enclosing the auditorium corridor feature eight original steel factory glazed windows, arranged in a grid pattern with operable casements on the ground floor. Many of the individual lites have been replaced as part of a previous repair and maintenance program (Fig. 55 & Fig. 56). The steel frames have been overpainted several times making it difficult to assess the condition of the underlying steel (Fig. 57). Occasional corrosion blooms were observed on the exterior frame, suggesting light to moderate corrosion of the steel substrate beneath the paint layer. Further testing will be required to confirm this. Caulking joints around the windows have generally cracked and have completely failed at the sills (Fig. 58).

Fig. 55. Infilled window lite.

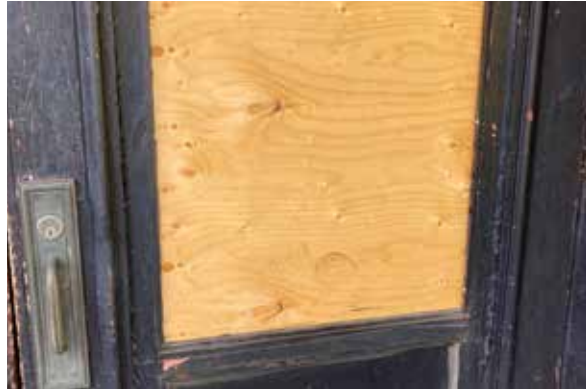
The east facing exterior wood doors are original and remain in fair condition. Two of the transom lites have been replaced with acrylic substitutes (Fig. 85). The glazing insert on the left has been previously replaced with wired safety glass, while the right insert has been boarded up with plywood (Fig. 86 - Fig. 87). One original bronze handset remains intact, while the other has been replaced with a steel pull plate (Fig. 88). Wood surfaces have been painted and are showing signs of moderate wear through repeated use, with previous red paint layers showing through in several spots (Fig. 88). Further paint deterioration has occurred at and around the inset panels and bottom rails (Fig. 89 - Fig. 91). Weatherstripping is not original and appears to be in serviceable condition. There is a small section at the corner of the left lower panel moulding that has separated and is being held in place with a machine screw (Fig. 92).

Fig. 86. Plywood pane infill.

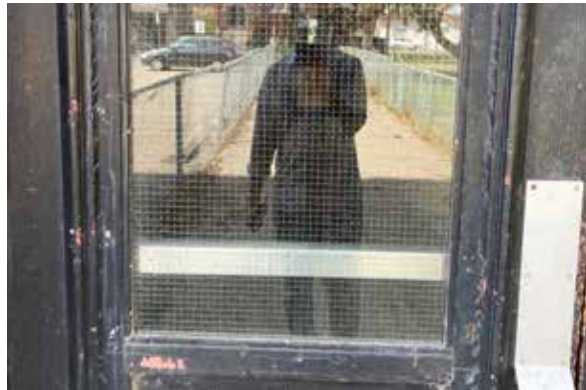
Fig. 87. Wired safety glass panel infill.

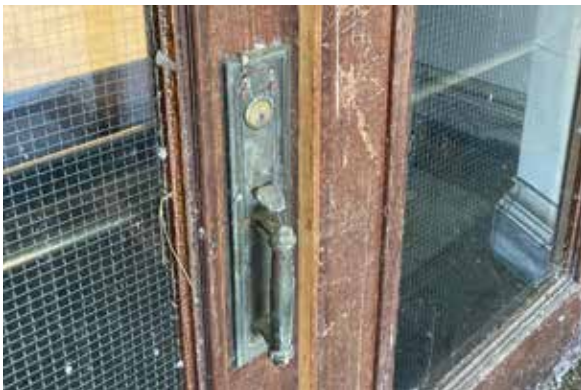
The north entrance doors are original and appear to be in fair condition generally, with some surface scratching present on the exterior facing stiles and bottom rails through repeated use and vandalism (Fig. 77 - Fig. 79). The exterior clear coat over the stain has begun to degrade, as evidenced by the general presence of crazing (Fig. 80 & Fig. 81). The top transom windows are in good condition, with original glass still present and few signs of disrepair aside from bird droppings along the sill line (Fig. 82). One small section of the moulding on the east transom has broken away (Fig. 83). Door hardware appears to be original, and glazing inserts have been previously replaced with wired safety glass (Fig. 84).

Fig. 84. Original door hardware.

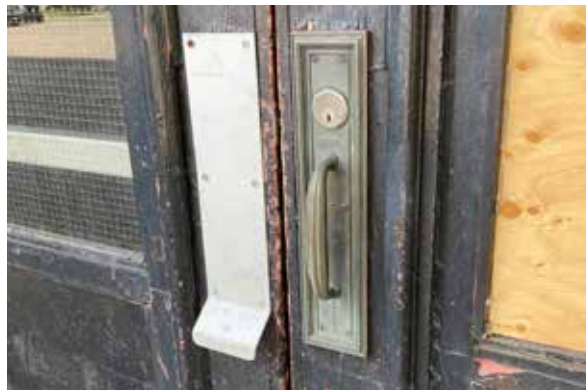
Fig. 88. One original handset and one replaced push plate.

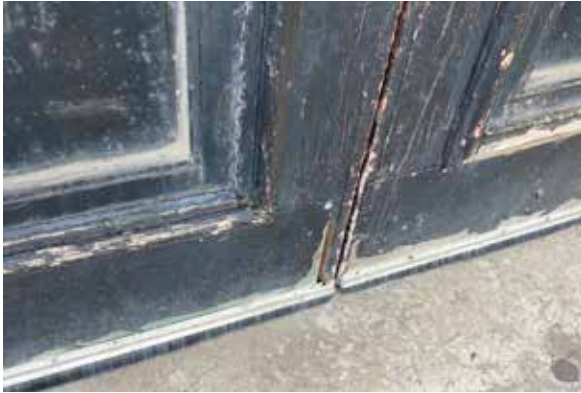
Fig. 89. Paint deterioration.

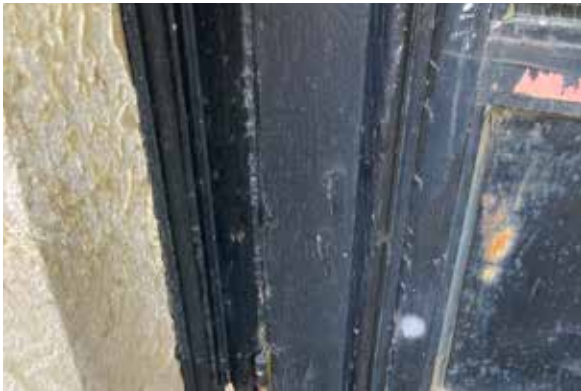
Fig. 90. Paint deterioration.

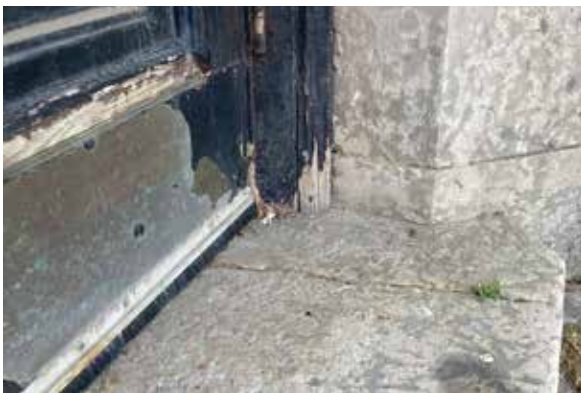
Fig. 91. Paint deterioration.

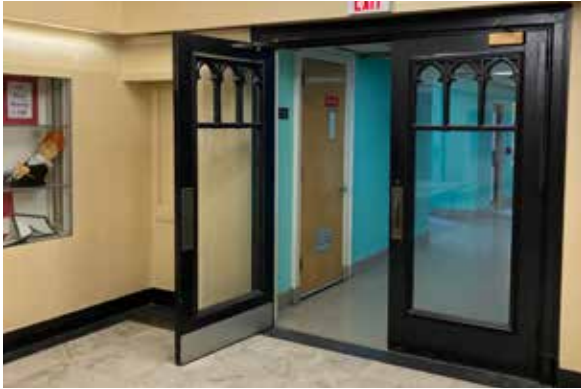
Fig. 95. Main lobby original wood doors.

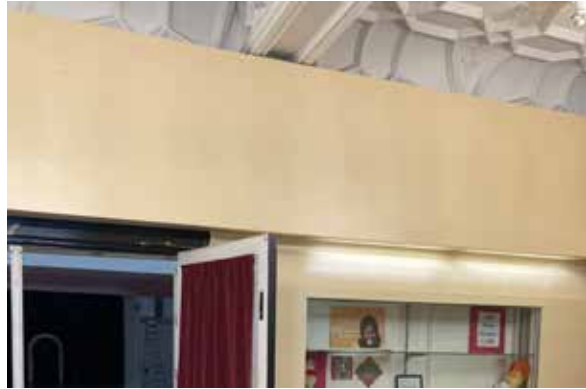
The main lobby and vestibule spaces are in good condition with most finishes, including plaster ceiling elements, original wood doors and marble flooring, intact and exhibiting only minimal signs of surface wear on the floor and doors (Fig. 94 - Fig. 97). The existing pendant lights in the lobby and vestibule are not original. Further destructive work is needed to confirm that the original wood paneling was removed as part of the 1970s renovations (Fig. 98).

Fig. 98. Obscured wood paneling.

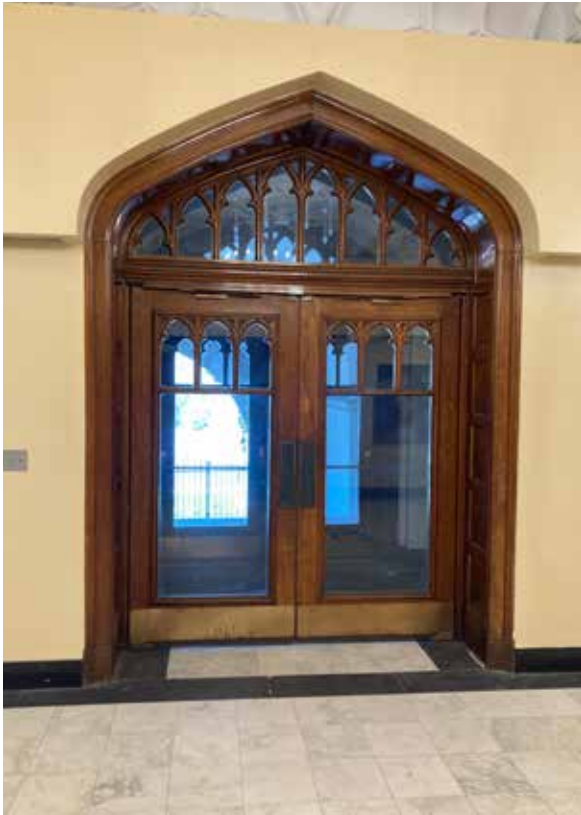
Fig. 96. Main lobby original wood doors.

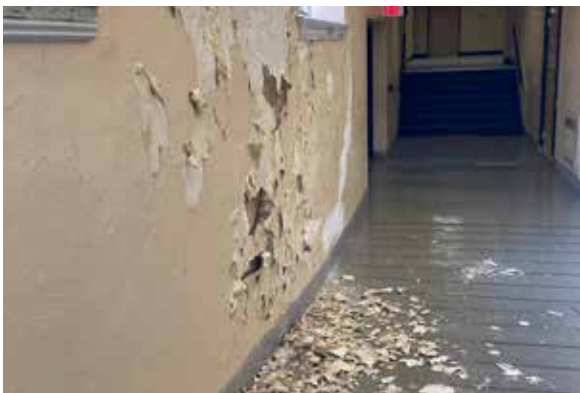
The auditorium space has gone through previous alterations but still features the original plaster ceiling, proscenium arch and wall elements, decorative plaster faced columns, carved wood doors and door surrounds (Fig. 99 - Fig. 101). All original remaining features are in an good state of repair, with only light surface wear observed. Original clerestory steel windows have been infilled and replaced with acoustic panels (Fig. 102). The corridors at either side of the auditorium are in fair condition, also having gone through previous renovations. The wood double doors originally at either end of both corridors have been removed. It is unknown if the original ceiling finishes are intact behind the suspended ceiling panels. Prolonged moisture damage is evident along the exterior wall and has left much of the paint coating and plasterwork in a general state of disrepair (Fig. 103). Damage ranges from light crazing and blistering to severe flaking and widespread loss of paint.

Fig. 103. Moisture damage to plaster and paint.
