CITY OF HAMILTON PLANNING AND ECONOMIC DEVELOPMENT DEPARTMENT Planning Division

то:	Chair and Committee Members Hamilton Municipal Heritage Committee
COMMITTEE DATE:	January 26, 2024
SUBJECT/REPORT NO:	Recommendation to Designate 84 York Boulevard, Hamilton (Philpott Memorial Church), under Part IV of the <i>Ontario Heritage Act</i> (PED24007) (Ward 2)
WARD(S) AFFECTED:	Ward 2
PREPARED BY:	Emily Bent (905) 546-2424 Ext. 6663
SUBMITTED BY:	Shannon McKie Acting Director, Planning and Chief Planner Planning and Economic Development Department
SIGNATURE:	Adulia

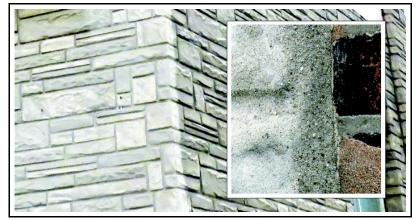
4.1 It was observed that the cement-based mortar had been plastered/parged over the brickwork to simulate rock-faced ashlar modular-coursed stone masonry. (Photograph 1) Although it varied, from a review of the termination joint with the side elevation brickwork, the mortar appeared to have been applied at a nominal minimum one-inch thickness within the simulated mortar joints. (Inset image)

Photo 1 with inset image: The mortar was plastered over the brickwork to simulate the appearance of ashlar-coursed stone masonry. The minimum thickness varied but appeared to be a nominal 1-inch minimum within the simulated mortar joints.

- 4.2 Although sounding techniques were not used during the on-site assessment, from visual observations, the mortar appeared to be well-bonded to the brickwork there was no visible evidence of delaminations.
- 4.3 The author does not know the reason why the plaster was applied to the then approximately forty to fifty-year-old brickwork. However, following a review of the side and rear elevations where there was much evidence of badly weathered masonry and brick replacement it is the author's opinion that the most likely and logical reason was therefore a concern regarding the evident poor quality of the bricks. (Photograph 2)

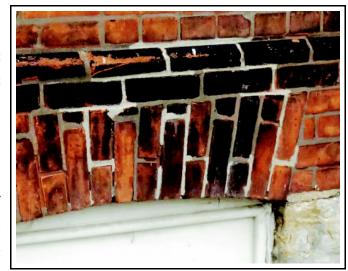
- 4.4 There was also evidence within the side elevation that several attempts had been made to repoint deteriorated/cracked brickwork adjacent to window openings. It was also evident that joints have continued to deteriorate within the repointed areas.

- .1 It is the author's opinion that the damage has been caused and continues to occur because the lintels were not designed nor constructed to extend far enough beyond the openings. This has resulted in a concentration of gravity loads at the openings from the effects of wind, snow-loading, thermal movement, etc.

Photo 3: Evidence of several attempts at repointing cracked or in a concentration of gravity loads at the deteriorated mortar joints adjacent to window openings

- .2 It is the author's opinion that similar damage must be anticipated to be revealed within other elevations, should the mortar be removed.
- 4.5 Although the extent is uncertain without further investigation, there was evidence that the mortar has cracked within some locations.
 - .1 It is the author's opinion that additional damage to the underlying brickwork will have occurred due to the penetration of rainwater through the cracks. Experience indicates that this damage is likely to be in the form of crumbling of the bricks due to the expansive forces created during ice formation within the saturated masonry.

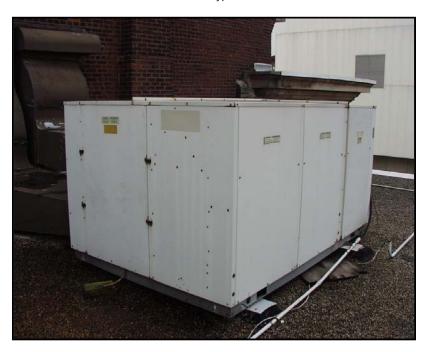
Photo No. 38: Older Keeprite Packaged Air Conditioner

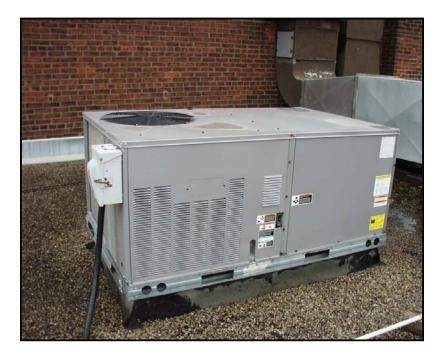
Photo No. 39: Newer Packaged Air Conditioner

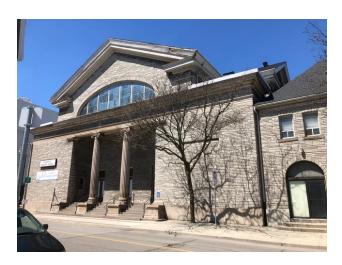
Figure 3: Views of the base stones at the East entry

A major feature of the East elevation is a pair of decorative stone columns in a Corinthian style, with four matching bases. This assembly forms the main entry from Park St. with the bases forming the boundaries of, and defining the stairway at this location into three sections. The stone is exhibiting signs of weathering and deterioration. The original sharp edges of the features are rounded and dull, and there is staining from being exposed to the elements since 1906. There does not appear to be any cracking or other issues that would cause a concern about the structural capacity of the stones, however, any joints between adjacent stone pieces no longer have any sealant protecting them, allowing water to enter the interior cavity of the bases. On one of the bases this has caused significant movement within the assembly due to the freeze-thaw action affecting the water being able to displace the stones. Sealing all the joints and cleaning the stone is recommended in order to ensure these prominent assemblies do not worsen in condition.

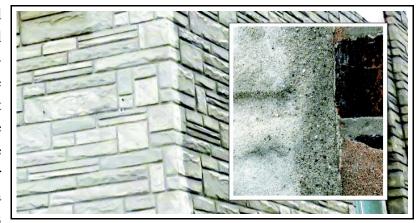
4.1 It was observed that the cement-based mortar had been plastered/parged over the brickwork to simulate rock-faced ashlar modular-coursed stone masonry. (Photograph 1) Although it varied, from a review of the termination joint with the side elevation brickwork, the mortar appeared to have been applied at a nominal minimum one-inch thickness within the simulated mortar joints. (Inset image)

Photo 1 with inset image: The mortar was plastered over the brickwork to simulate the appearance of ashlar-coursed stone masonry. The minimum thickness varied but appeared to be a nominal 1-inch minimum within the simulated mortar joints.

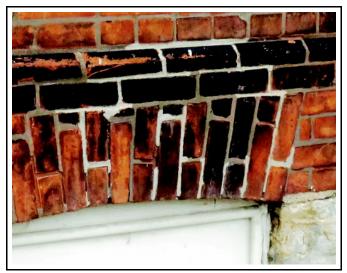
- 4.4 There was also evidence within the side elevation that several attempts had been made to repoint deteriorated/cracked brickwork adjacent to window openings. It was also evident that joints have continued to deteriorate within the repointed areas.

- .1 It is the author's opinion that the damage has been caused and continues to occur because the lintels were not designed nor constructed to extend far enough beyond the openings. This has resulted in a concentration of gravity loads at the openings from the effects of wind, snow-loading, thermal movement, etc.

Photo 3: Evidence of several attempts at repointing cracked or in a concentration of gravity loads at the deteriorated mortar joints adjacent to window openings

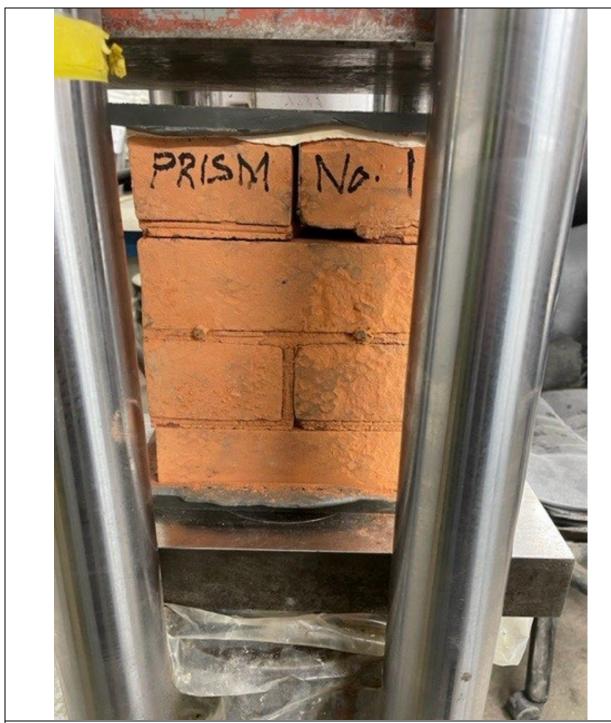
Photograph No. 10
Showing a view of Brick Prism No. 1 in the testing machine, ready for testing.

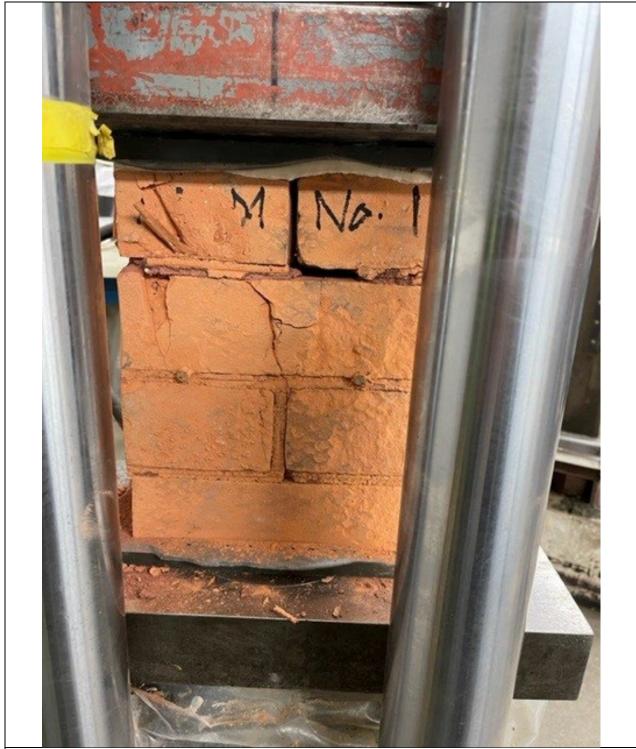
Photograph No. 11
Showing a view of Brick Prism No. 1 in the testing machine, after testing.

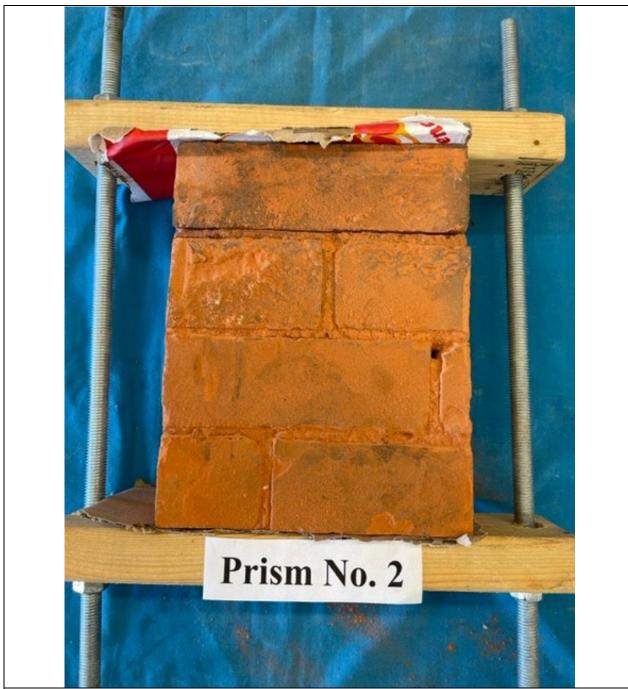
Photograph No. 13
Showing a view of Brick Prism No. 2 in the wood clamps to keep the sample in an intact condition

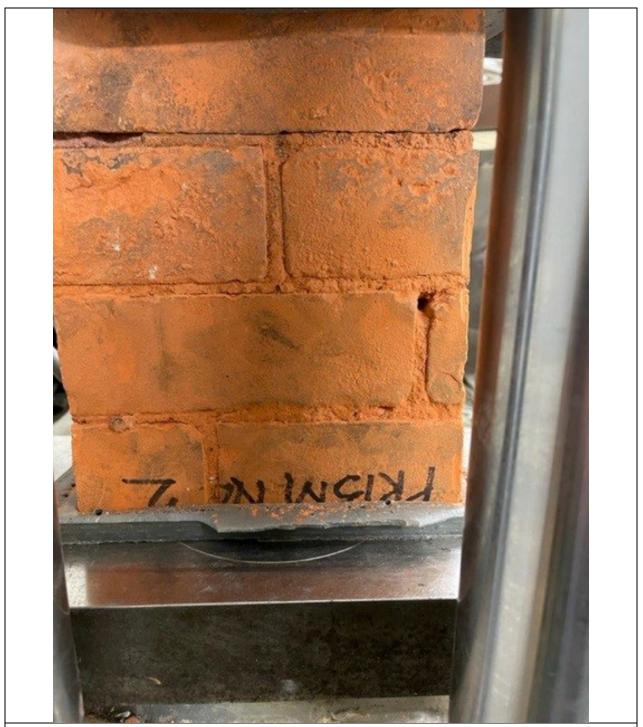
Photograph No. 14
Showing a view of Brick Prism No. 1 in the testing machine, ready for testing.

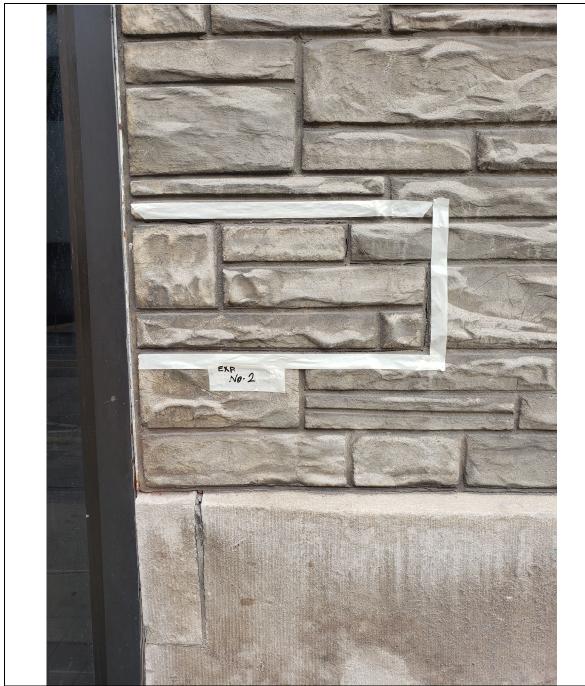
Photograph No. 22, showing a view of the stonework for Exploratory Opening No. 2, adjacent to the door, prior to removal of the stone.

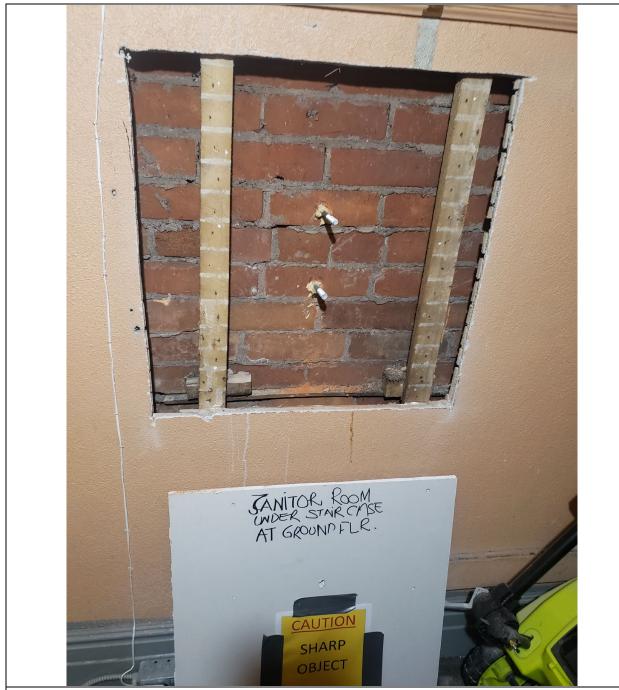
Photograph No. 41, showing anchor bolt installation for Anchor Pull-Out Location No. 4.

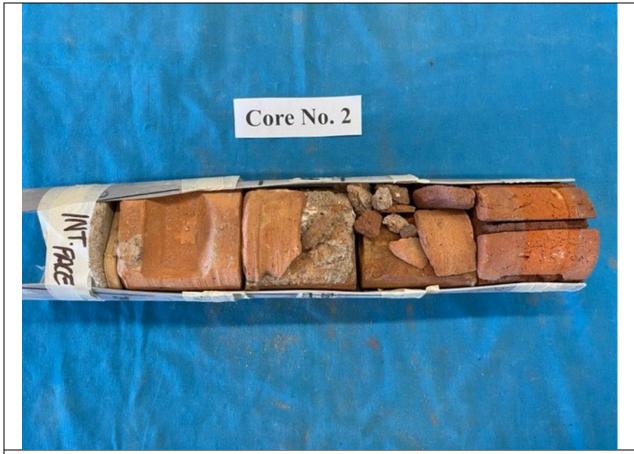
Photograph No. 49, showing an interior view of Core No. 2. Note the wall thickness is made up of four (4) wythes of brick.
